Influence of Precipitation Conditions and Discharge Rates of River Estuary Barrages on Geomorphological Changes in an Estuarine Area

Keywords: Nakdong River estuary; shoreline survey; discharge; sediment; erosion; bathymetry; sandbar; topography

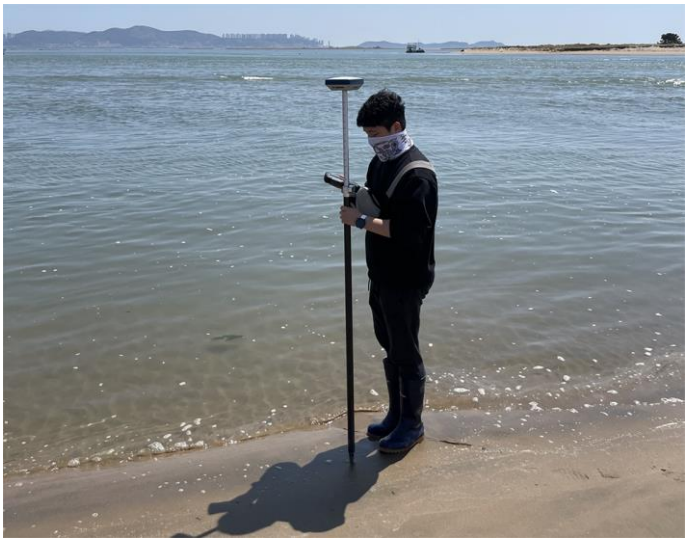
Figure 2. Acquisition of shoreline data using GPS surveying.

two sandbars formed by sedimentation. To obtain accurate results, a triangulation network was formed using nearby tidal benchmarks and adjusted accordingly. The survey was conducted at low and high tides based on tidal forecasts. The coastline was measured every 10–15 m, and Figure 2 shows the surveying process. The results of the shoreline survey were processed using the Universal Transverse Mercator coordinate system, and the heights were based on Korean National Geoid 14. In addition, the data obtained through the field survey were compared with the data surveyed by period using the AutoCAD program, which is effective for creating 2D drawings or 3D object files by sketching/drawing and designing them with graphics software.

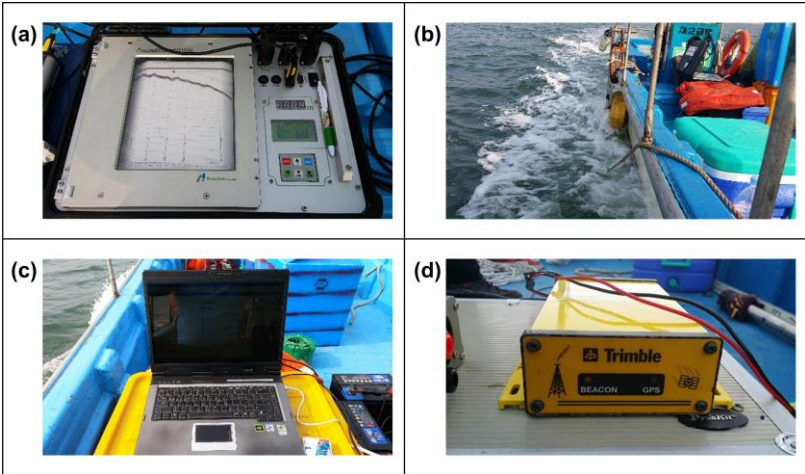
Figure 3. Survey system for bathymetric mapping. (a) Echo sounder system; (b) echo sounder transducer mounted to the side of the ship; (c) data acquisition and navigation system; and (d) DGPS data acquirer.

The bathymetry survey was conducted using the Aqua Ruler 200 echosounder from Sonar Tech Co., Ltd. (Busan, South Korea). The detailed specifications of the equipment used are shown in Table 3. The bathymetry survey data were corrected for sound velocity and draft using the bar-check procedure. The tidal elevation was corrected using tidal data from the Gaduk Island tidal station of the Korea Hydrographic and Oceanographic Agency to convert the data to the Gadeok Island datum. The horizontal position of the offshore area was determined using Trimble's Differential Global Positioning System, and both shoreline survey results and offshore horizontal positions were determined using the Universal Transverse Mercator coordinate system. Figure 3 shows the shoreline survey and seabed topography investigation system.

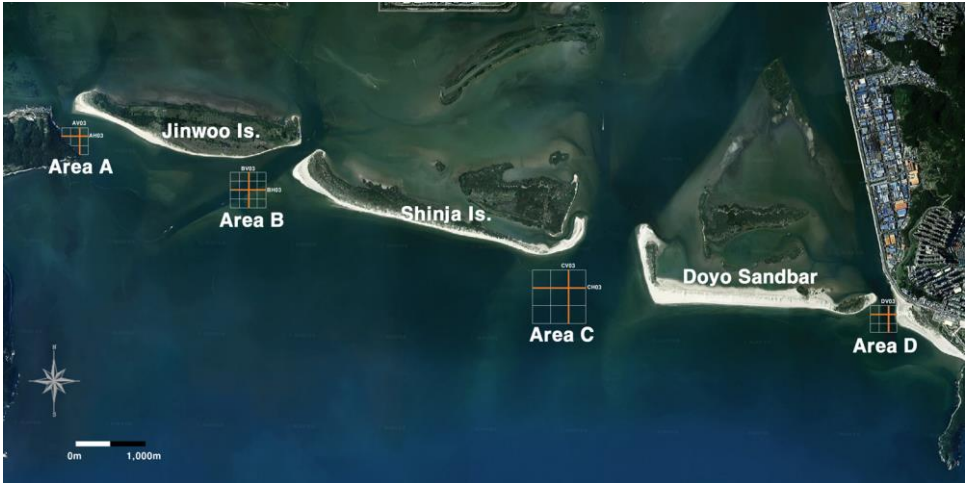
Figure 5. Survey areas for channel analysis. Areas A–D are defined in Table 4.

The sandbars in the study area are not connected to the mainland at either end, forming embayments. Therefore, channels are formed between each sandbar, and erosion and deposition trends in these channels were analyzed by dividing them into four sections from Area A to D, as shown in Figure 5. Each survey was conducted along three to five survey lines, spaced 100 m apart, in the north–south (vertical) and east–west (horizontal) directions, as shown in Table 4.

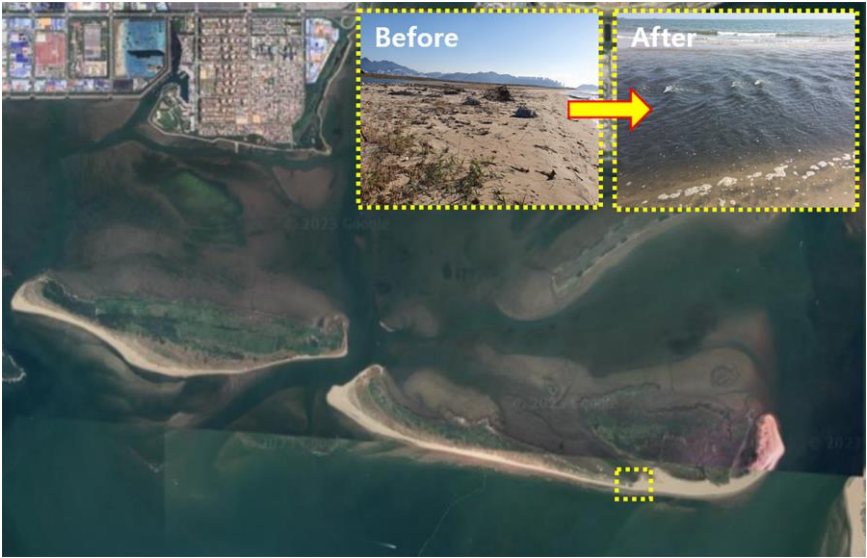
Figure 9. Shoreline surveying using GPS (Oct. 2018–Oct. 2022).

The analysis of Shorelines 1 and 2 represented on CAD (Figure 8) showed that the range of the coastal indentations is changing owing to differences between high and low tides. For Shoreline 1, the shape of the terrain changed based on the tide level, with the reference point being October 2020. This is considered to be associated with changes in the terrain caused by the typhoons MAYSACK and HAISHEN that passed through South Korea in 2020. As shown in Figure 9, in October 2020, it was confirmed that Shoreline 2 was interrupted and a channel was formed.

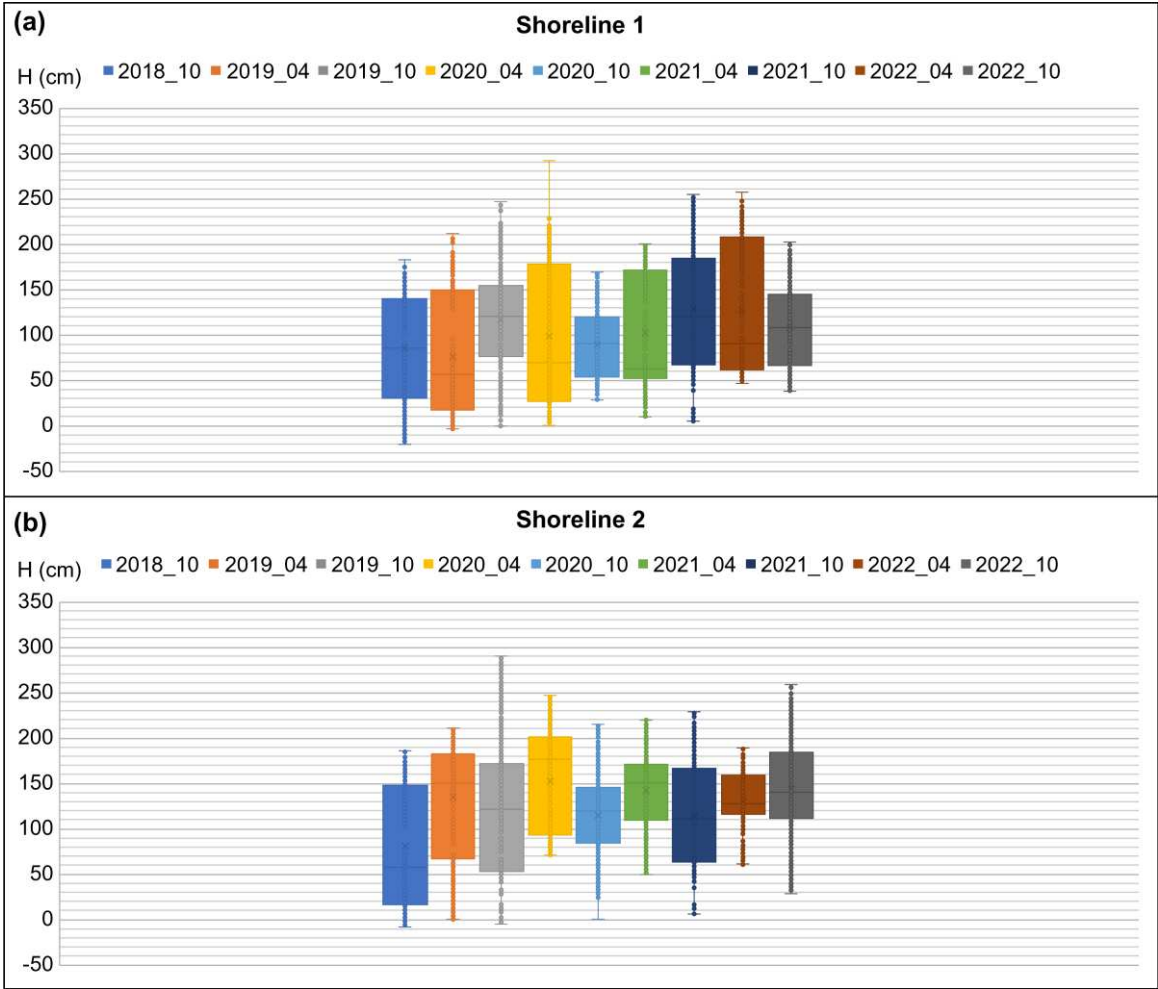
Figure 10. Distribution changes in the height (H) for Shorelines 1 and 2. (a) Shoreline 1: Jinwoo Island; (b) Shoreline 2: Shinja Island. Severe distortion is possible if there is an abnormality in the coastline data of traditionally widely used methods, such as average or standard deviation for shoreline changes.

Furthermore, by analyzing the height distributions and changes in the planar position of the shoreline from a total of nine shoreline surveys, it was found that the height values of the same location increased from 2018 to April 2020. As shown in Figure 10, the maximum height values of both Shorelines 1 and 2 increased. This observation indicates that sediment deposition occurred every year, leading to an increase in the height of the shoreline.

After October 2020, both Shorelines 1 and 2 showed decreasing trends in height, followed by increasing trends. This phenomenon was attributed to erosion caused by typhoons, as observed in the previous analysis of shoreline range. However, in October 2022, Shorelines 1 and 2 showed different patterns. Shoreline 1, where the industrial complex is located, showed erosion, whereas Shoreline 2 exhibited deposition. The industrial wastewater may have affected Shoreline 1, and with the end of the COVID-19 lockdowns, the discharge of industrial wastewater increased, causing an increase in flow velocity in the narrow channel, leading to erosion rather than deposition. In contrast, Shoreline 2 showed relatively slow deposition as suspended sediment flowed slowly through the wider channel, probably facilitated by the increased discharge from the Nakdong River estuary.

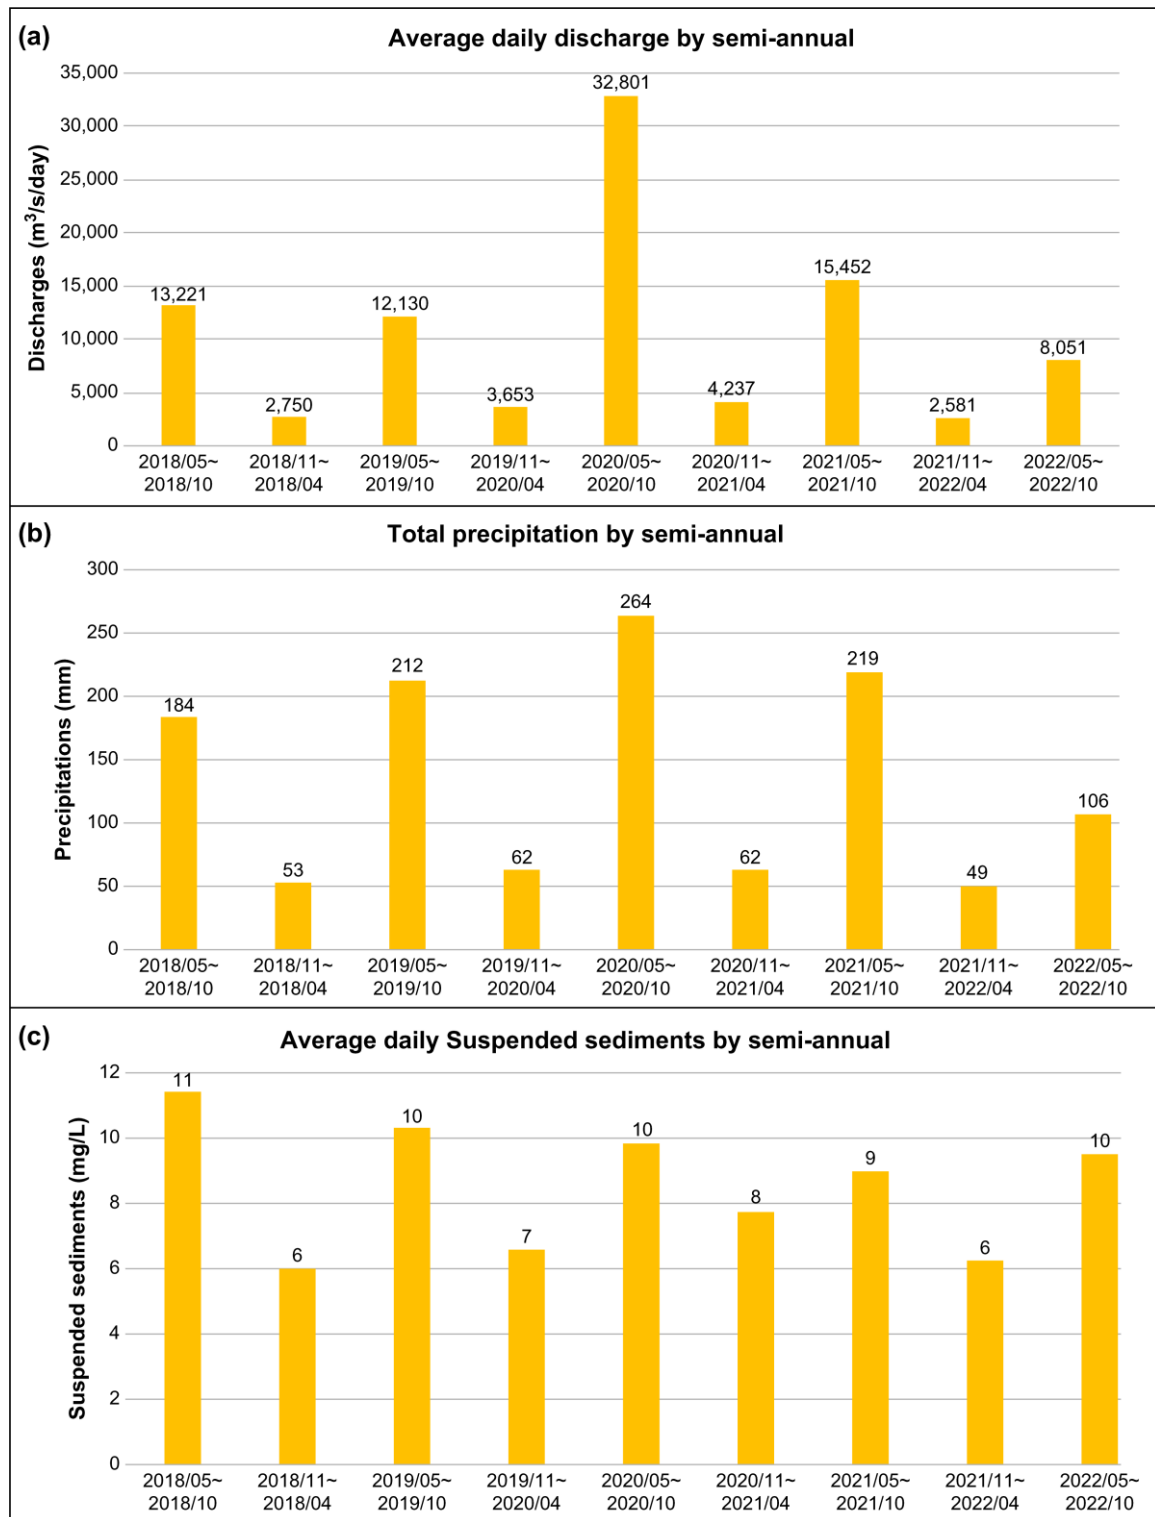
Figure 11. Time series of semi-annual data for the duration of the study (K-WATER, KMA). (a) Average daily discharge; (b) total precipitation; and (c) average daily suspended sediment outflow.

The precipitation data obtained from the Korea Meteorological Administration revealed that both discharge and suspended sediment discharge change similarly when precipitation increases or decreases. This result may be considered to be obvious given that increased precipitation leads to increased inflow to the Nakdong River, and the increased water flow can naturally explain the increase in the sediment discharge. The results in Figure 5 show a general trend that as the discharge increases, the suspended sediment discharge also increases. However, compared with that in the second halves of 2018, 2019, and 2021, the discharge in the second half of 2020 increased by approximately 3-fold, but the suspended sediment discharge decreased or remained almost the same. The seasonal effect showed a clear trend, with a decrease in the first half and an increase in the second half of the year for both discharge and suspended sediment discharge, reflecting the amount of precipitation. However, it was found that the suspended sediment discharge did not increase in proportion to the discharge.

In the latter half of 2020, the average discharge of the Nakdong River estuary dike increased by approximately 2.5-fold compared with that in the same period in previous years owing to heavy rainfall that affected the Korean Peninsula during the summer of 2020. The increase in discharge is estimated to have affected the topography of the estuary. Until the first half of 2020, according to the main outflow route of the discharge from the estuary dike, the Doyo sandbar area was eroded, whereas the Shinja Island area, which was less affected by the discharge, showed a tendency to accumulate sediment. However, analysis in the latter half of 2020 showed that a considerable amount of the Doyo sandbar area had been eroded, and it is necessary to confirm whether the bathymetry will return to its previous trend of erosion in the first half of the year and sedimentation in the second half.
