Flexural Strengthening of Stone Masonry Walls Using Textile-Reinforced Sarooj Mortar

Abdullah H. Al-Saidy ^{1,*}, Manal AlBusaidi ², Sherif El-Gamal ¹ and Kazi Abu Sohail ¹

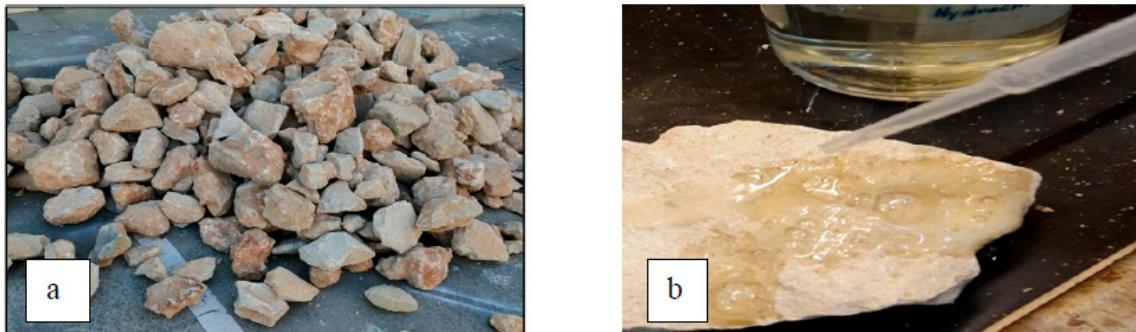
Figure 1. a) Limestone, b) Limestone Reaction with HCl.

Limestone was widely used in the construction of Oman's historical buildings due to its availability, ease of cutting, , and aesthetic appearance. It is defined according to ASTM C51, 2011 [19] as an initially sedimentary rock consisting chiefly of calcium carbonate or calcium and magnesium carbonates. The stone used in this study were limestones collected from a nearby source (see Fig. 1a). Hydrochloric acid was used to initially verify the limestone by the reaction of hydrochloric acid HCl with calcium carbonate CaCO₃ to produce fizzing reaction as CO₂ released from the reaction of HCl with CaCO₃ (see Fig. 1b). Standard procedure was followed to determine the stone's chemical composition [20]. The procedure requires that a crushed sample of the stone in the form of particles, with a passing sieve size of 0.075 mm, prepared for the chemical analysis (see Fig. 2). The chemical analysis results are summarized in Table 1. The major element of the stone was found to be CaO (68%), which indicates that the stone is limestone.

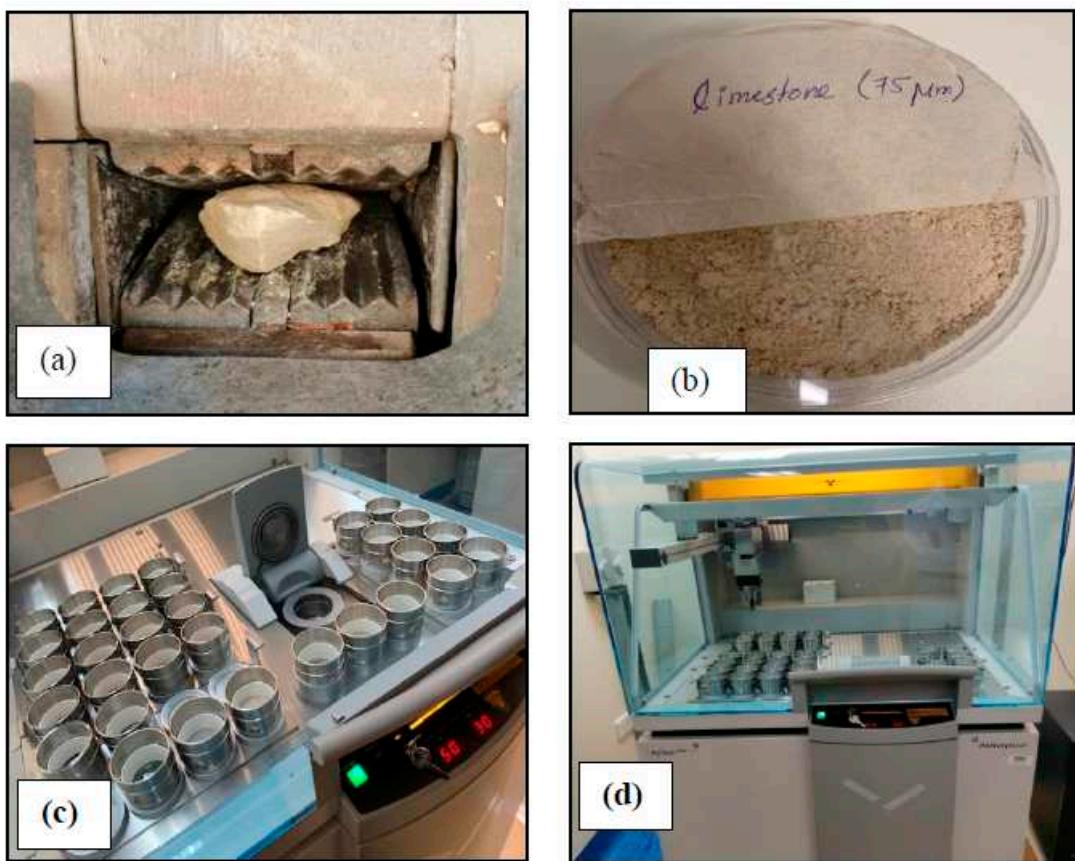
Figure 2. Photographs of (a) Crushing stone sample; (b) Sieved sample; (c and d) XRF Test.

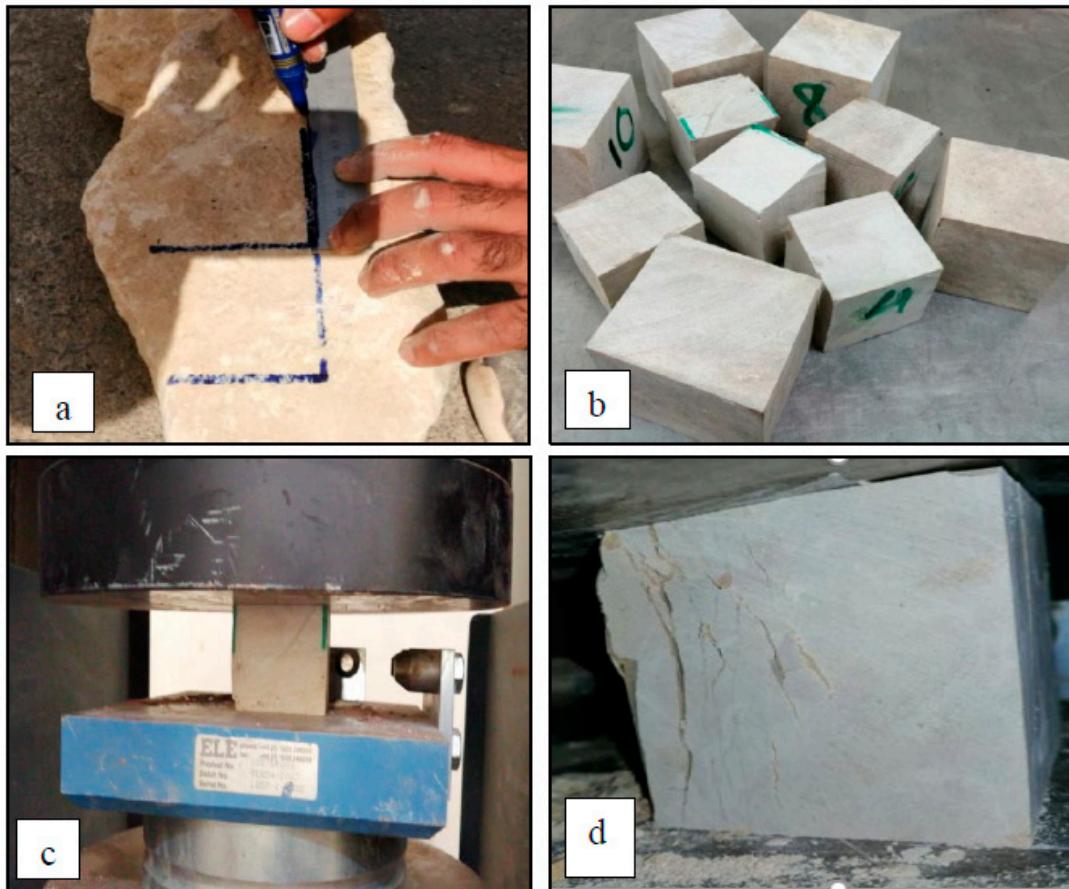
Figure 3. Photographs of (a to b) cutting and extracting stone cube samples; (c to d) compressive Test and failure modes.

The uniaxial compressive strength of the limestone was determined by extracting 10 cubes with dimensions of approximately $70.7 \times 70.7 \times 70.7$ mm from random limestone samples (see Fig. 3). The uniaxial compressive strength was determined as per ASTM D7012, 2004 [21]. It was found to be 57 MPa as an average value from the 10 samples.

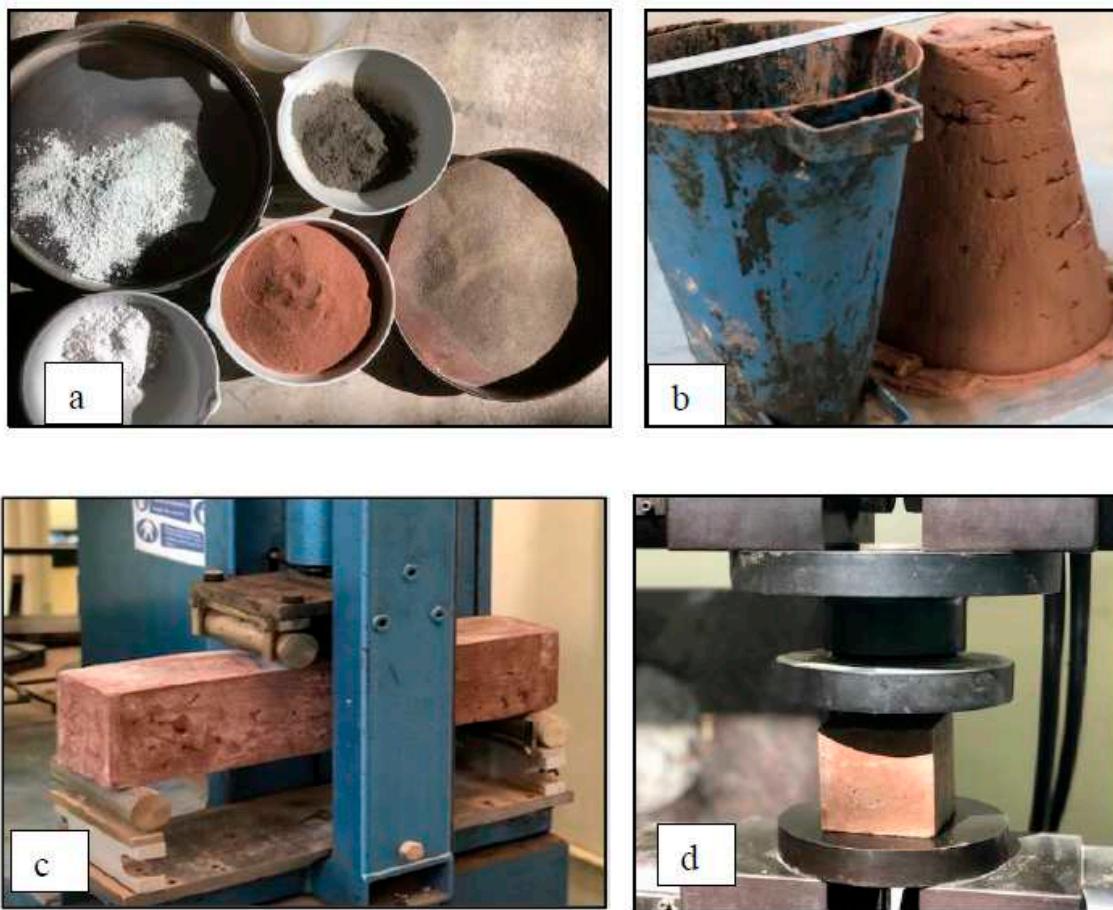
Figure 4. Jointing Mortar (a) Materials used; (b) Slump test; (c) Flexural test; (d) Compression test.

The cementing materials used in the mixtures were sarooj (passed a 600 μm sieve), ordinary portland cement (OPC), white cement and lime. Cement was added to enhance the binding properties of the mortar as recommended by Hago et al [18]. White and gray cement were used in the jointing mortar, while only white cement was used in the plaster (matrix) mortar to preserve the natural color of sarooj. Fine sand (passed a 600 μm sieve) was used in all mixtures to avoid shrinkage and micro-cracking. The matrix of the jointing mortar mix is sarooj, sand, ordinary portland cement, white cement, lime, and water with proportions by weight of 1: 0.4: 0.2: 0.2: 0.1: 0.5, respectively (see Fig. 4). This mix was selected from several mix trials based on workability and mechanical properties. Each mixture was cast into metal molds, producing three identical cubes with dimensions of 70.7 x 70.7 x 70.7 mm and prisms with dimensions of 100 x 100 x 500 mm. All mixtures were cured at a lab temperature of $22 \pm 2^\circ\text{C}$ and a relative humidity of 20 - 30%. The slump for the mix was measured to be 35 mm. The presence of sarooj is the reason for the low slump, sarooj absorbs more water compared to sand. The uniaxial test of the cubes resulted in an average 28-day compressive strength of 11.39 MPa

The plaster mortar mix is sarooj, sand, white cement, lime, and water with proportions by weight of 1: 0.5: 0.5: 0.375: 0.75, respectively (see Fig. 4). The slump for the mix was measured to be 34 mm. This mix was selected from several mix trials based on workability and mechanical properties. A similar procedure as used in the jointing mortar was adopted in casting and curing the specimens.

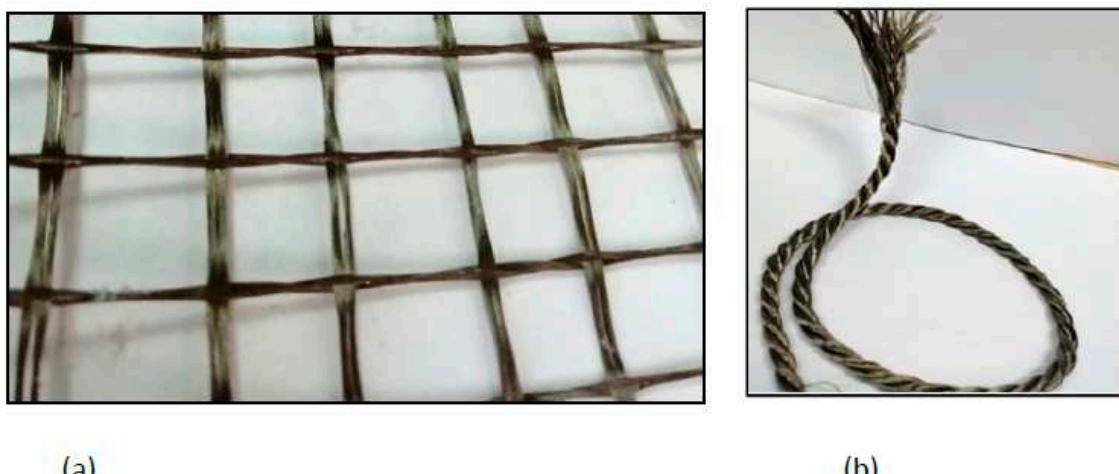
Figure 5. a) Basalt Fiber Textile, b) Basalt Rope.

A basalt bi-directional textile was used to strengthen the specimens. The textile has a roving dimension of 1.6 mm wide by 0.5 mm thick in the longitudinal direction, and a roving dimension of 0.6 mm wide by 0.5 mm thick in the transverse direction. The grid spacing between the rovings is about 10 mm in both directions (Fig.5a).

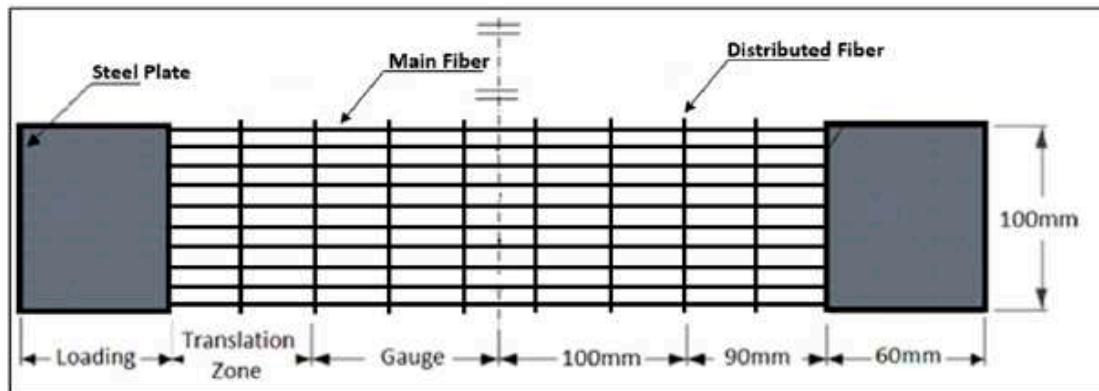
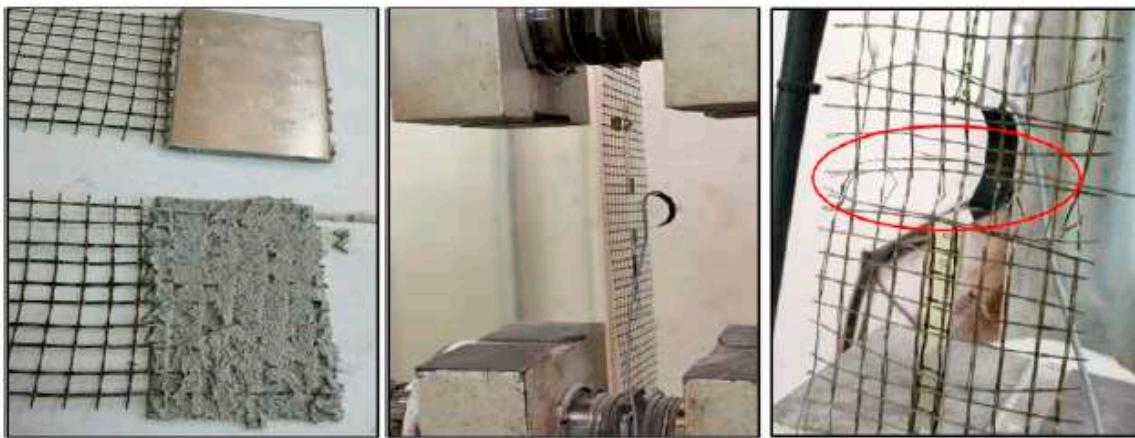
Figure 6. Tensile Test Set up: (a) Sketch of Basalt Textile Grid Testing Sample.; (b) Preparing Sample with Steel Plate Ends; (c&d) Test Set up with LVDT.

The uniaxial tensile strength was determined according to ASTM D5034 - 09(2013) [25]. The textile tensile test samples were cut to be 500 mm long and 100 mm wide as shown in Fig. 6. In addition, composite coupon specimens consisting of one layer of textile fibers embedded in sarojoj mortar was also tested to determine uniaxial tensile strength as shown in Fig. 7. First, a 500-mm long, 100-mm wide, and 22-mm thick panel was cast on a flat wooden mould. Once one layer of mortar was cast and smoothened, one ply of the textile grid was applied. Then, the cover layer of mortar was cast to fill the mould as shown in Fig. 7. The composite specimens were cured in room temperature for 28 days. A uniaxial load was monotonically applied in a displacement-controlled routine. Metal plates of approximately 2.5 mm thickness were attached to the ends of test specimens using grout to avoid stress concentration beneath the clamp. Fig. 8 shows the tensile test results of the textile and the composite specimens. The load versus the displacement of the textile fiber shows a linear curve until failure, while the curve for the composite shows two characteristic phases: an initial steep curve representing the non-cracked section phase and then a reduced-slope curve corresponding to the cracked section phase. The failure of the textile specimens was characterized by the successive rupture of the weft yarns. The rupture occurred randomly, as shown in Fig. 6d. The failure of the composite specimens was due to the complete rupture of the specimen as shown in Fig. 7e. The peak load for the fiber mesh reached an average of 1.7 kN, while the peak load for the composite specimens reached an average of 3.0 kN. The mortar matrix in the composite specimens helped in distributing the load among the textile fibers resulting in a higher load resistance.

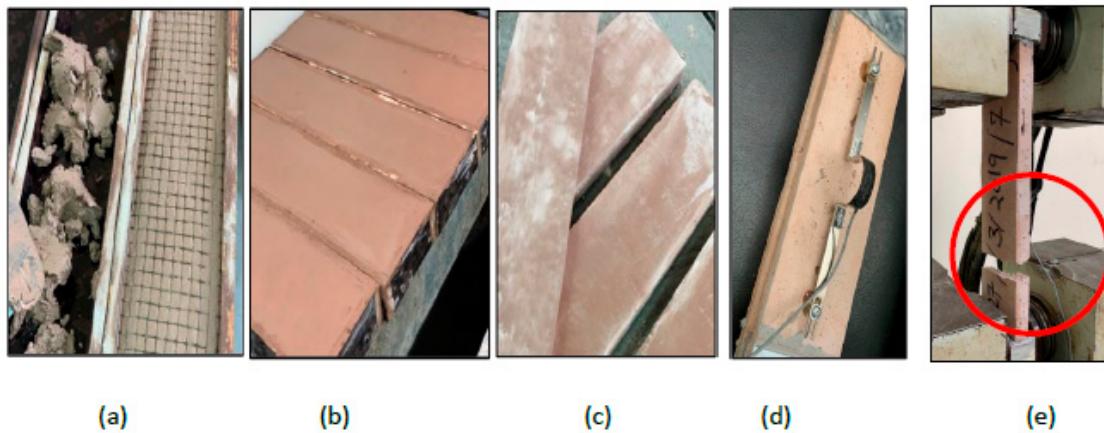
Figure 7. Composite Samples (Basalt + mortar) Tensile Test Set up: (a-c) Preparing Sample with Steel Plate Ends; (d) Test Set up with LVDT; (e) Failure Mode.

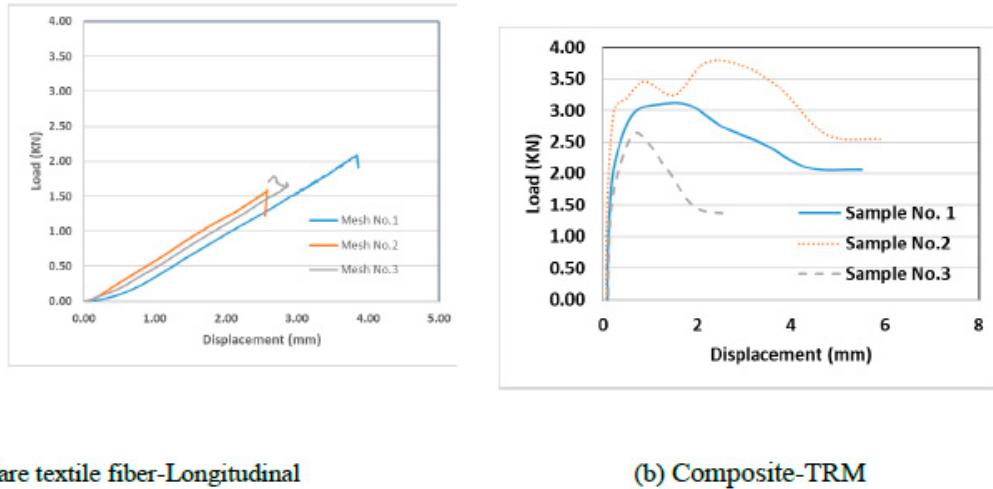
(a) Bare textile fiber-Longitudinal

(b) Composite-TRM

Figure 8. Tensile Load vs. Elongation of tested Samples.

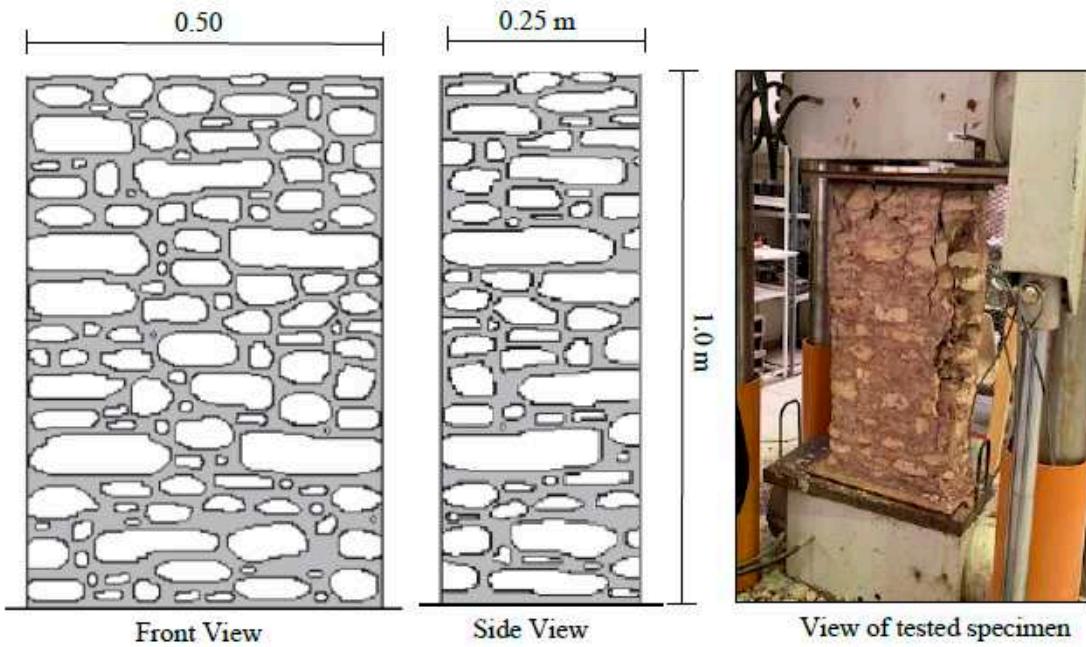
Figure 9. Schematic and photographs of the Stone Masonry Wallets Specimens.

Two specimens were constructed with dimensions of 500 mm long, 250 mm wide, and 1000 mm high as sketched in Fig. 9. They are unreinforced walls consisting of only stones and jointing mortar. These walls were constructed to evaluate the compressive strength of the stone masonry. The wall specimens were tested under compression (monotonic load) using a 4000 kN universal testing machine as illustrated in Fig. 9. The load was applied by a hydraulic cylinder, which is computer controlled at a rate of 0.6 kN/s, and was measured using the machine's load cell, and displacement was measured via the displacement transducer. A typical load displacement curve is shown in Fig. 10. Initially, the curve looks flat, as the load increases after some displacement. This is due to the neoprene (rubber) pad at the top of the wall at the point of the load application and due to the squeezing of the mortar layers until the stones pick up the load resistance and the load-displacement curve turns into a steep response, as illustrated in Fig. 10. The load then dropped once the peak load was reached, and the wall suffered from vertical cracks due to the effect of the Poisson's ratio (see Fig. 9). The wall then started to crumple at which point the test was stopped. The average compressive strength from the two walls specimens was 3.0 MPa.

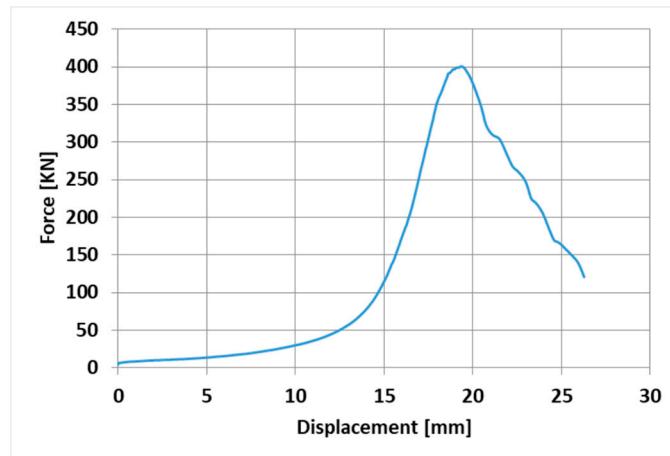
Figure 10. Load vs displacement of the Stone Masonry Wallets Specimens.

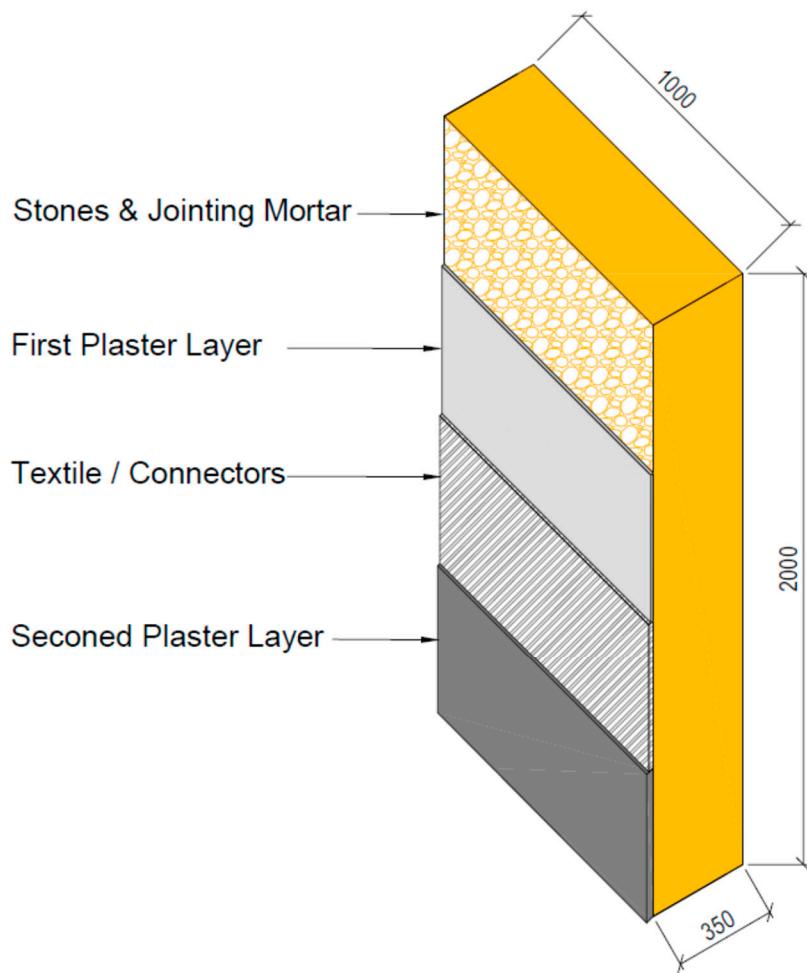
Figure 11. Schematic illustration (units in mm) of strengthened wall specimens.

The experimental program of supporting the stone wall specimens consisted of strengthening 2000 mm high, 1000 mm wide, and 350 mm thick stone walls with basalt TRM. This type of masonry is common in the masonry buildings of a large part of Oman and other countries. Four different walls were constructed to be tested for bending. One specimen was unreinforced (URM) and the other three specimens were reinforced with basalt textile mesh. The details of each wall are illustrated below, and the schematic illustration of the geometry of the walls is shown in Fig. 11.

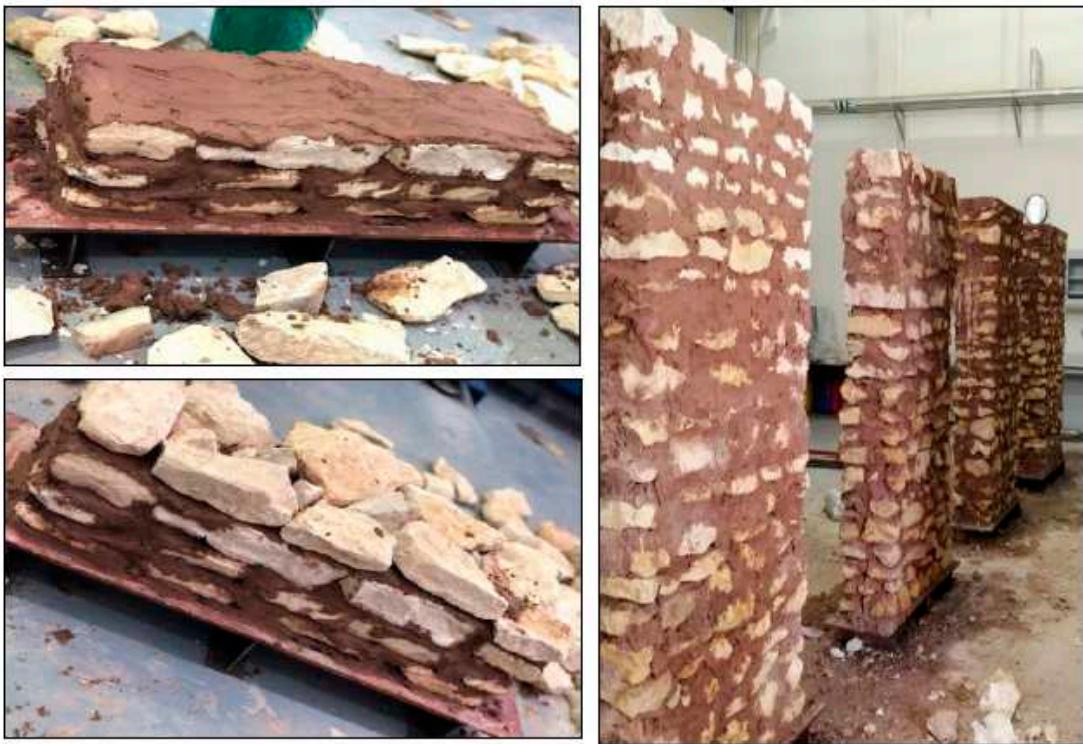
Figure 12. Construction of stone masonry wall specimens.

This wall is considered the reference wall. It was constructed from stones and jointing mortar only. All walls were constructed by layering alternative layers of stone and mortar. Each wall was constructed until reaching a height of approximately 60 cm and was then left for the mortar to set (24 hours). The construction of the next layers was then resumed until reaching the full height of 2.0 meters. Fig. 12 shows photos of the construction of the unreinforced masonry wall specimens.

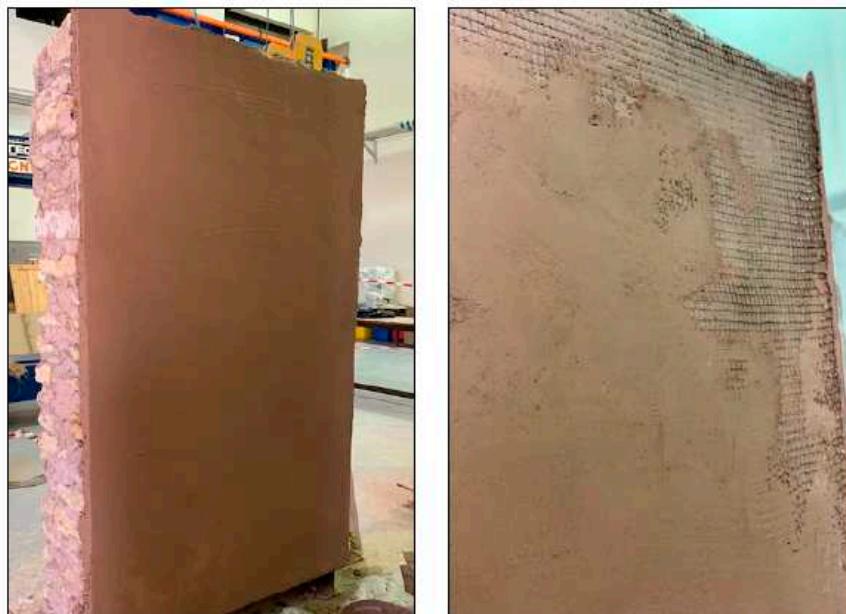
Figure 13. Strengthening of first wall with one textile layer (RT).

The second wall was strengthened using basalt fiber textile. The first layer of sarooj mortar was applied on one face of the wall (tension face) to receive the textile mesh. The first layer of plaster varied between 2-3 cm to have a levelled face to stick the basalt mesh. The textile layer then was applied and pressed by hand to stick to the first layer of mortar. A second plaster layer of 0.5 cm thick was applied to cover the mesh. Photos of the wall construction are presented in Fig. 13.

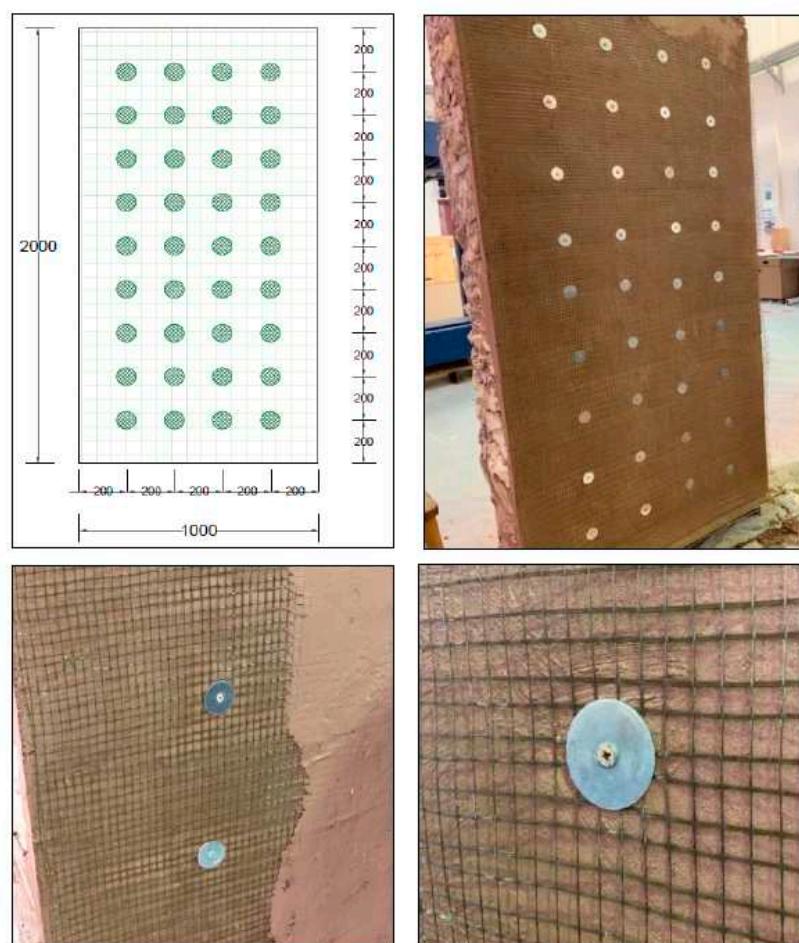
Figure 14. Strengthening of the second wall with one textile layer + screws ((RTS)).

The third wall was strengthened using a basalt mesh and stainless-steel screws and washers. Holes for the screws were first drilled into the walls. The distance between the holes was 20 cm in both directions, as shown in Fig. 14. Brass screws with plastic plugs were inserted inside the holes. The layer of sarooj mortar was then applied to receive the textile mesh. The textile layer was then applied and pressed by hand to stick to the first layer of mortar. After applying the basalt mesh, the brass screws were removed and reinserted again with steel washers to connect the mesh to the wall, as illustrated in Fig. 14. A second plaster layer of 0.5 cm thick was applied to cover the mesh.

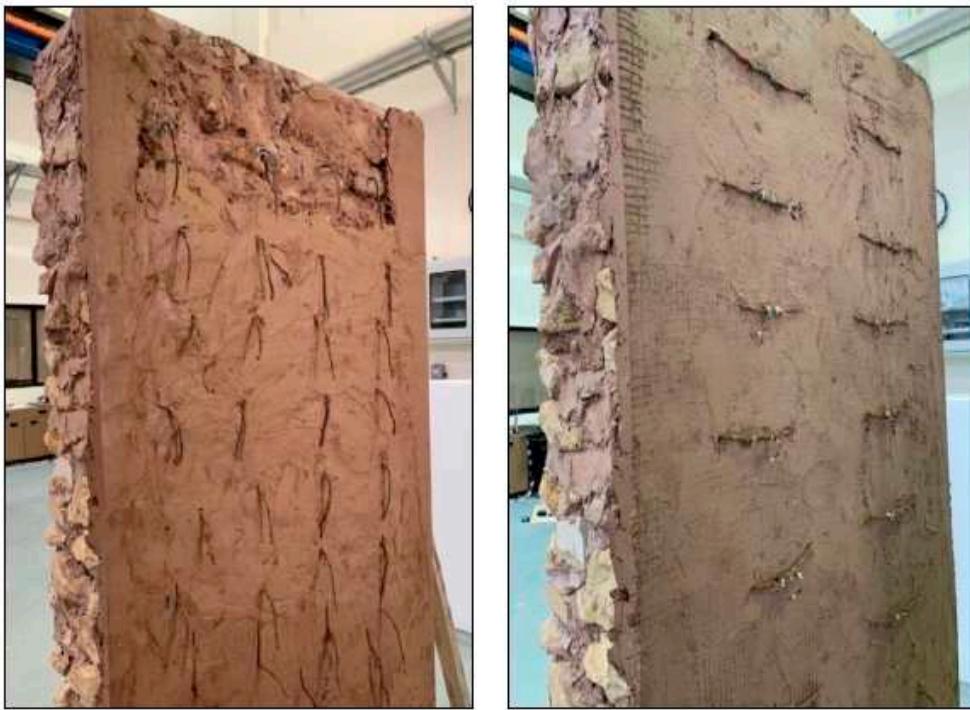
Figure 15. Strengthening of the third wall with one textile layer + ropes (RTR).

The fourth wall was strengthened using a basalt mesh tied with basalt ropes. Holes for the ropes were first drilled into the walls. The distance between the holes was 20 cm in both directions. The ropes were inserted inside the wall and grouted with a high strength epoxy to fill the holes. The layer of sarooj mortar was then applied on the tension face of the wall to receive the textile. After applying the basalt mesh, basalt ropes were tied and overlapped horizontally using steel cable ties (see Fig. 15). Finally, A second plaster layer of 0.5 cm thick was applied to cover the mesh and left for curing.

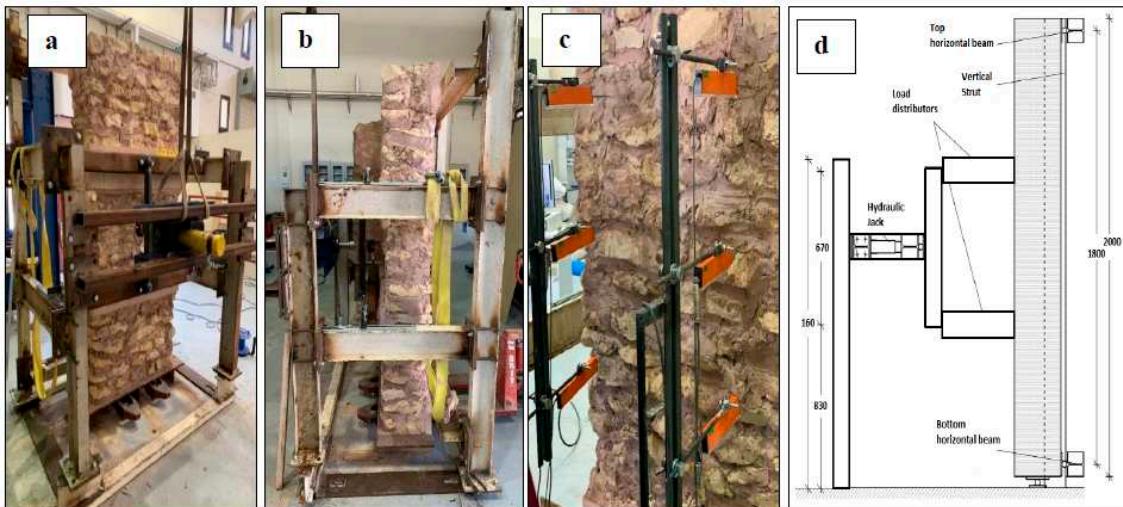
Figure 16. Experimental Apparatus for Bending Tests: (a)&(b) Global View (c) LVDTs and (d) Vertical Section.

All walls were tested for bending using four-point bending tests. The bending tests were performed by applying two forces laterally against the wall at the top and bottom third of the wall height. The reaction frame was designed and built for this research program, as illustrated in Fig. 16. To measure the deflections, displacement transducers were placed on the tension side of the wall face at the top, bottom third, and mid-point (see Fig. 16). Application of the force was load controlled until the first cracking; it was then switched to displacement control to prevent overturning and wall collapse.

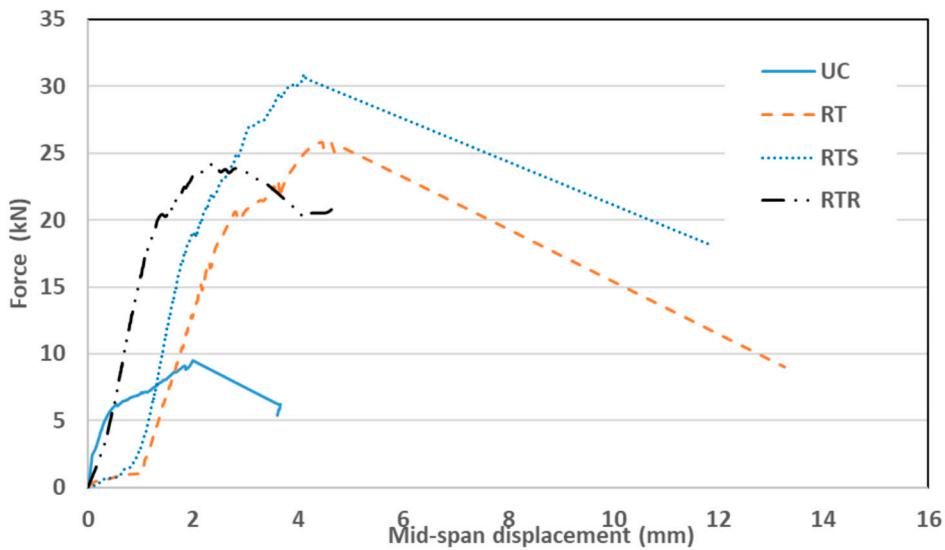
Figure 17. Load vs midspan displacement all walls.

The load versus out-of-plane mid-span deflections for all wall specimens are shown in Fig. 17. For the control wall (UC), the behavior shows a linear behavior, and no cracks were observed on the

wall up to 6 kN load, as the specimen remained undamaged. At this stage, the wall started to crack on the tension side, at about the center of the top third of the wall, and this was followed by other cracks in the bottom of the wall (see Fig. 18a). The first crack opened at the top of the wall, since the compressive weight force of the wall is the smallest at the top and highest at the bottom, where it might counteract (due to the normal compression force of the weight) the tensile stress from bending. The crack affected, for the most, the masonry mortar interface and involved the whole masonry thickness. The slope of the load versus the mid-span deflection shows the decreased stiffness beyond the cracking load. At a maximum failure load of 9.15 kN, the top one-third point exhibited the largest displacement of 1.93 mm. Fig. 19 shows the displacement profile along the wall height. The wall displacements are maximum at the top third height of the wall where the cracks were first observed.

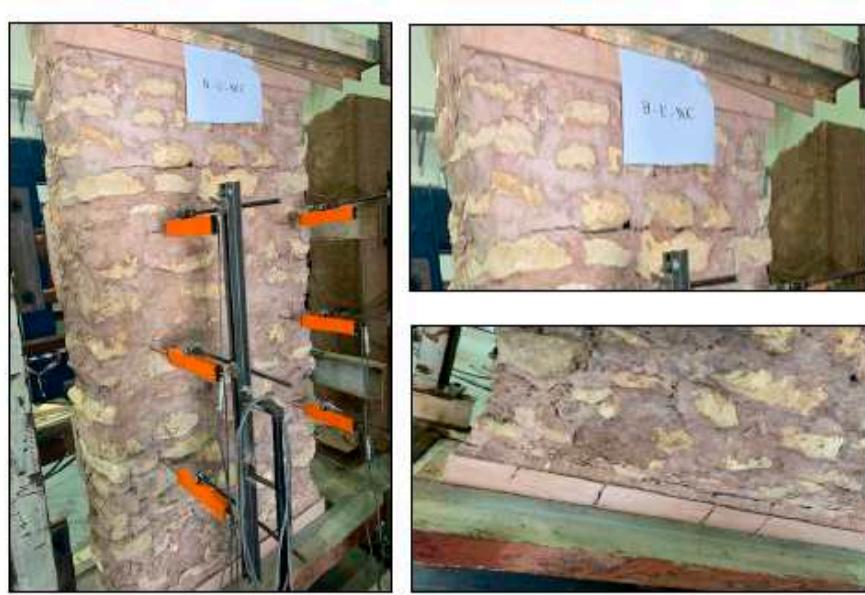
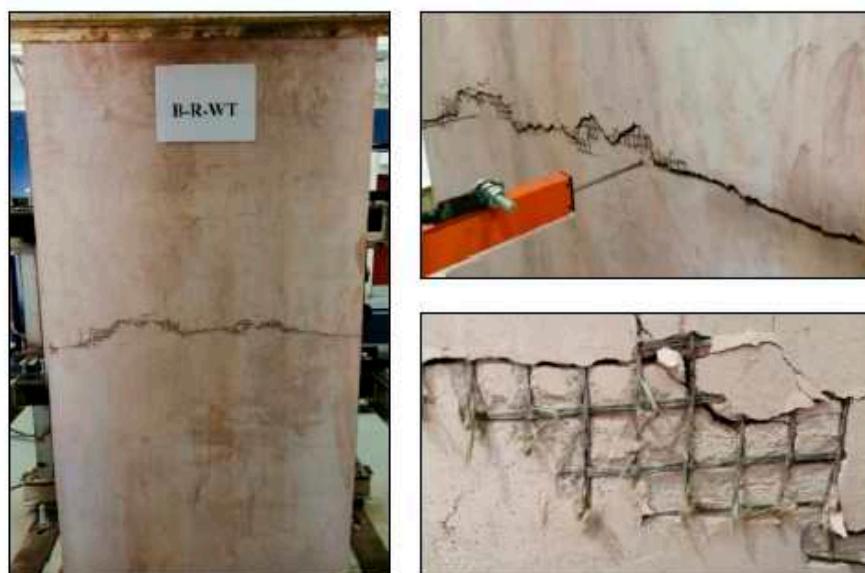
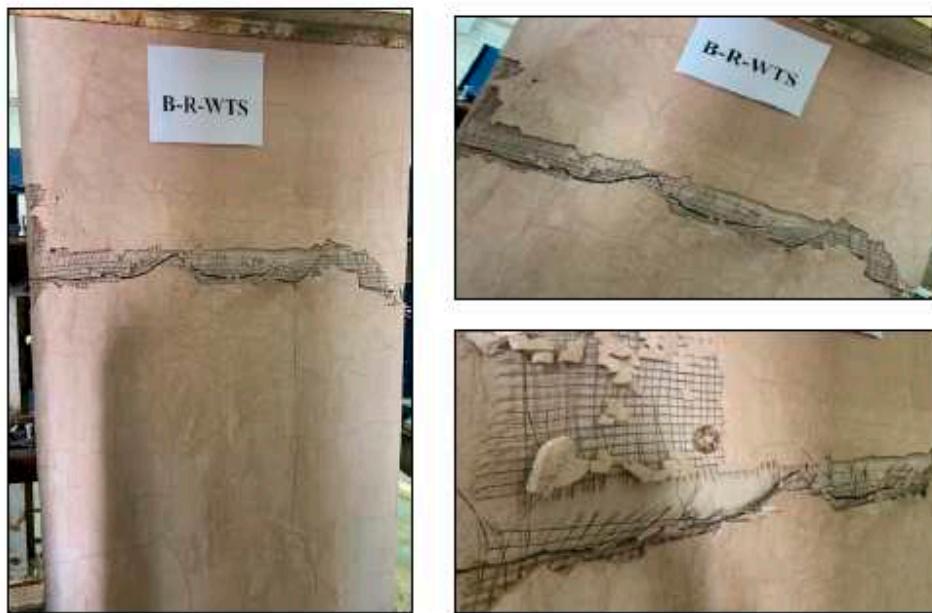
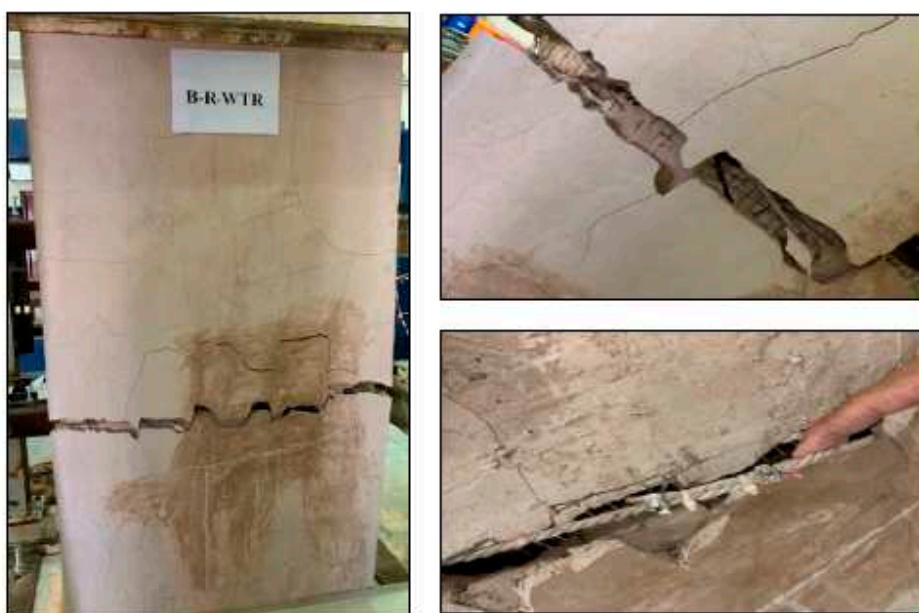
(a) Cracks in the control wall (UC)

(b) Cracks in wall RT

(c)... Cracks in wall RTS

(d) Cracks in wall RTR

Figure 18. Failure modes and crack pattern.

The wall strengthening with one layer of textile (RT) shows, at the initial stage, a relatively linear behavior and no cracks were observed on the wall up to 20 kN load. Beyond this load, a horizontal crack started to develop in the mortar at about the mid-height point of the tension side of the wall (see Fig. 18b). Consequently, basalt textiles started to bear tension loads leading to a continuous widening in the crack width until failure. The walls failed after the rupture of the textile layer. The crack affected the masonry mortar interface and involved the whole masonry thickness. At the maximum failure load of 25.8 kN, the mid-point exhibited a displacement of 4.61 mm. Fig. 19 shows the displacement profile along the wall height. The wall displacement was maximum at mid-height of the wall. The test was stopped after reaching the maximum load to prevent wall overturning collapse. The main crack (where the textile fibers ruptured) involved the whole masonry thickness, and no debonding was observed between the mesh and substrate.

The second strengthened wall (RTS) was strengthened with one layer of textile augmented with mechanical connectors consisting of brass screws and washers. Similar response is observed of linear behavior before cracking at 18 kN at which cracks developed at about the center of the top third of the wall. A small shift in the load versus the mid-span deflection curve was observed due to the initiation of the crack with a minor change in the slope of the curve, indicating a minor stiffness decrease (Fig. 17). This wall performed the best in terms of the maximum load attained compared to the reference wall. At the maximum failure load of 30.9 kN, the mid-point exhibited a displacement of 4.1 mm. Fig. 19 shows the displacement profile along the wall height. The wall displacement was maximum at the top third of the wall. The effect of the screws' mechanical anchoring and the stabilizing of the textile mesh obviously augmented the bond strength provided by the mortar. The disadvantage was the extra work required to install the screws. The main crack (where the textile fibers ruptured) involved the whole masonry thickness, and there was no debonding observed between the mesh, substrate, and screws, as shown in Fig. 18c

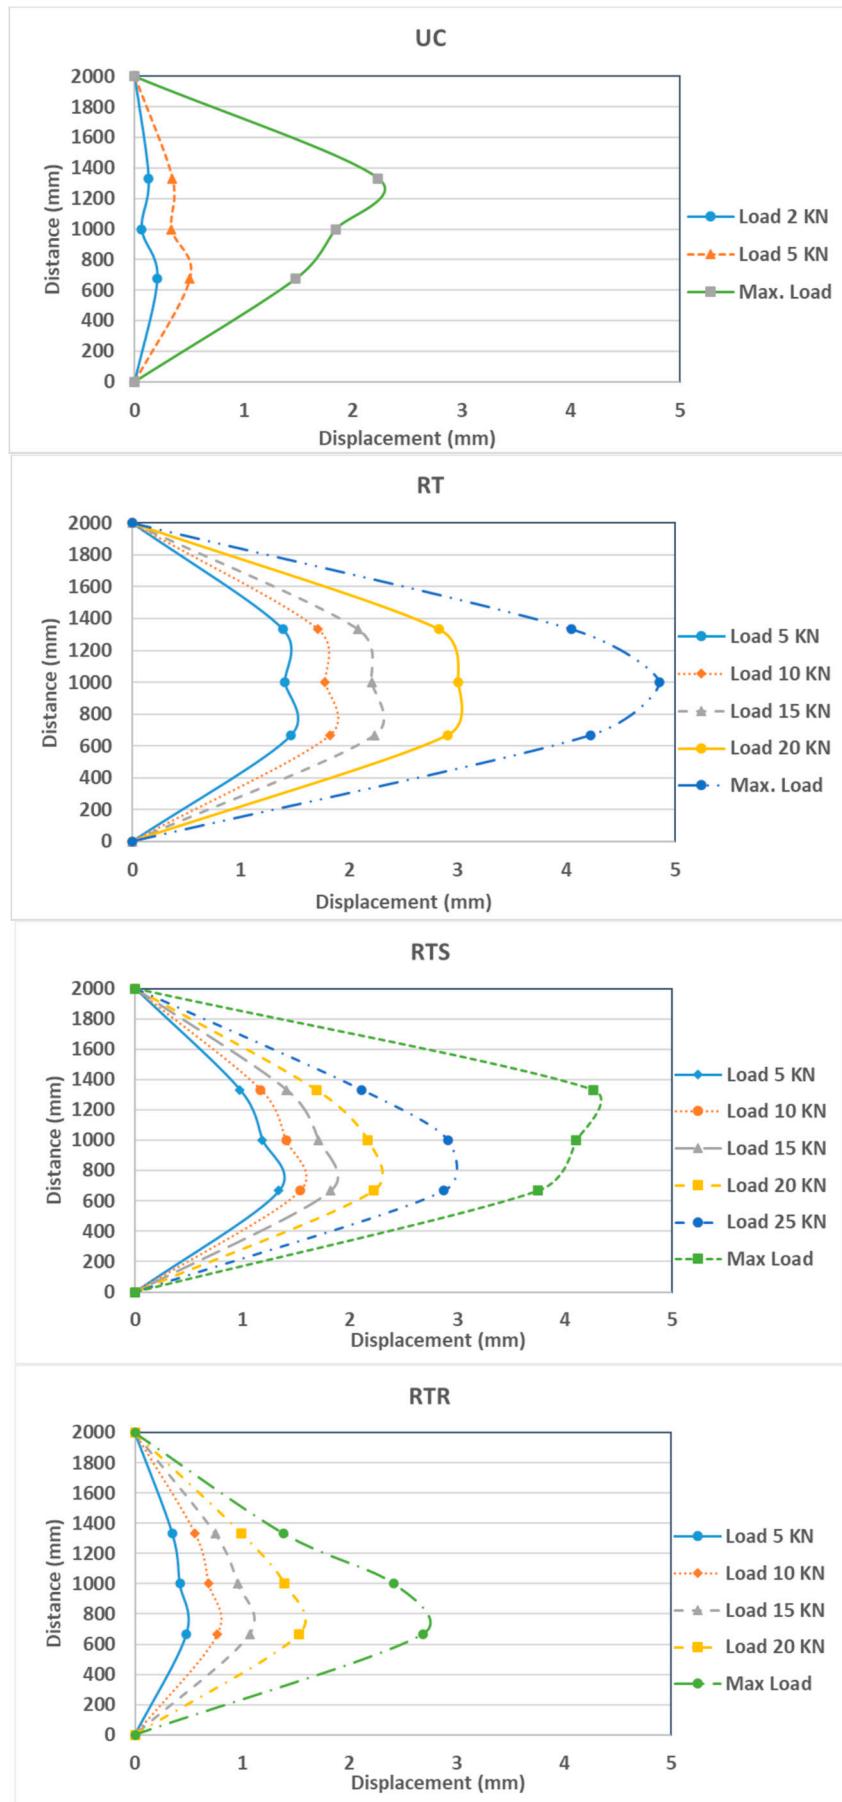
Figure 19. Displacement profile along the wall height.

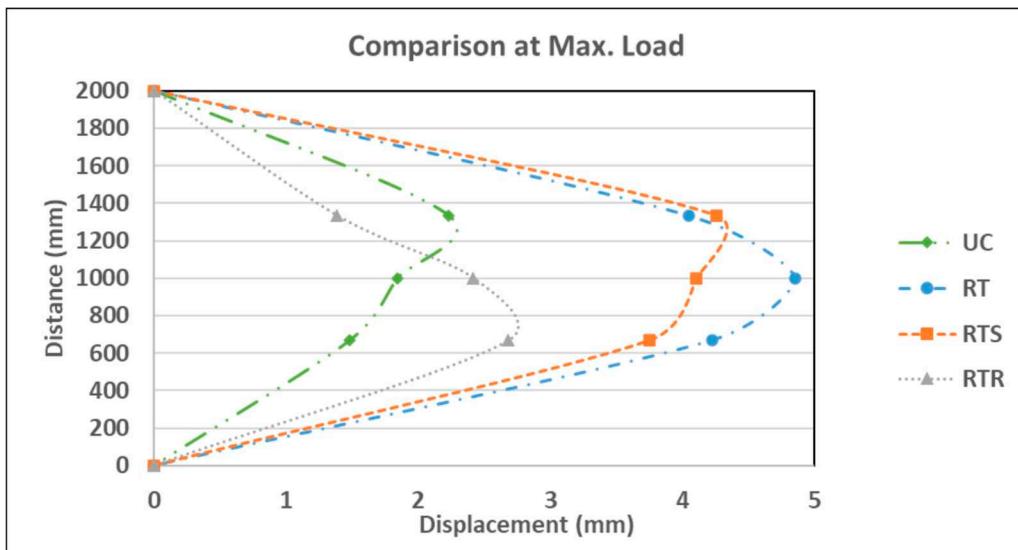
Figure 20. Displacement profile along the wall height at max. load for all walls.

The last strengthened wall (RTR) was strengthened with one layer of textile augmented with 5-mm basalt rope tied around the textile layer in a horizontal direction at 200-mm intervals. The load versus mid-span deflection is shown in Fig. 17. Similar behavior was observed as in the other strengthened walls of relatively linear behavior until the first crack appeared at a load of 20 kN corresponding to the mid-span deflection of 1.48 mm. At the maximum failure load of 24.2 kN, the bottom one-third point exhibited the largest displacement of 2.415 mm. Fig. 19 shows the displacement profile for the wall height. Using ropes was a laborious job and turned out to be the least effective among the strengthened walls in with respect to the maximum resisting load as well as deformation. At the end of the test, it was observed that the tying ropes were loose and relaxed (see Fig. 18d), which seems ineffective. It might have disturbed the plaster layer while tying the ropes and might have caused local pockets of loose mortar layers around the rope area, which in turn affected the overall textile layer. As evidence, this wall even performed less well than the wall strengthened with textile only (see Fig. 20).

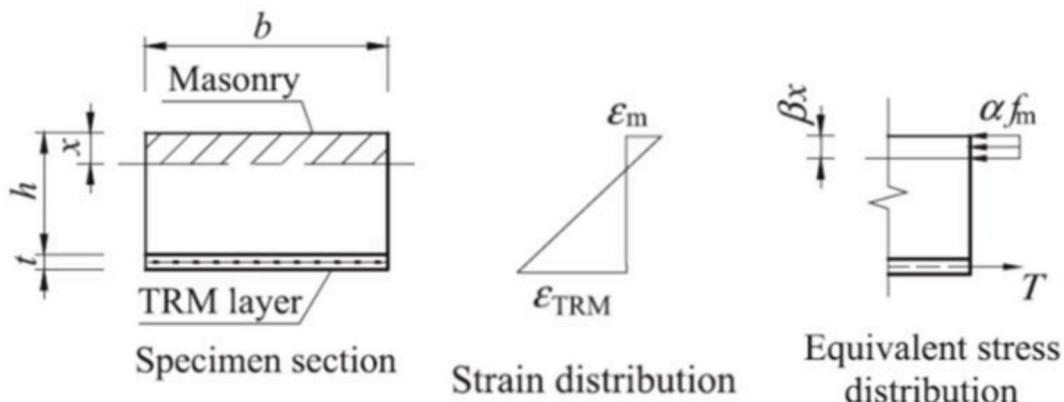
Figure 21. Theoretical ultimate state stresses at flexural failure of strengthened specimens [27].

For strengthened wall specimens with a failure due to textile rupture, which is the case in this study, the flexural model proposed in the literature based on the assumptions that plane-section remains plane after bending, tensile strength of masonry is neglected, and the equilibrium condition of section forces is satisfied [27]. As shown in Fig. 21, the moment capacity can be estimated as follows:

$$T = \alpha f_m b \beta x \quad (2)$$

$$M_{UR} = T \left(h + \frac{1}{2} t - \frac{1}{2} \beta x \right) \quad (3)$$

where, t , b , and x are the thickness of the TRM composite layer, the width of cross section, and the compressive depth of masonry, respectively. f_m is the compressive strength of masonry, α and β are the equivalent rectangular stress coefficient and stress block depth coefficient, respectively. The values of α and β are taken to be as 0.67 and 0.75 as recommended by Deng et al. [28]. The value of T was determined from the composite coupons presented earlier. The theoretical values of moment capacity for the strengthened wall are listed in Table 3. Equation 3 reasonably estimates the moment capacity for the wall with screws (RTS) and slightly overestimates the other two walls. This is due to the heterogeneous nature of the stone masonry, which has more variations compared to brick masonry. However, this model may be used to provide a rough estimate of the moment capacity due to its simplicity.
