Corrosion Hazards on Urban Infrastructure Structures on the Example of the Al Bayt Stadium in Katar

[Agnieszka Królikowska](#) and [Pier Luigi Bonora](#) *

Posted Date: 24 July 2023

Keywords: corrosion; failures; mistakes; stadium

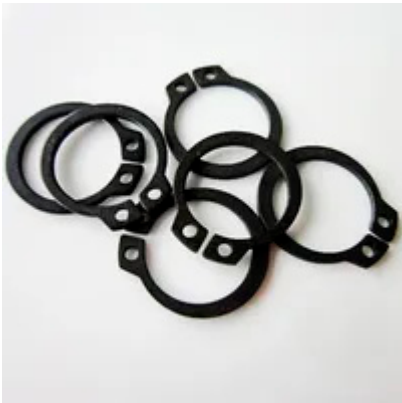
Figure 5. A seeger is a retaining ring consisting of a metal ring with open ends which can be forced into place, into a machined groove in order to allow rotation but to prevent lateral movement.

Regardless of the above-mentioned phenomena, the most pressing problem concerns the behavior of the seegers located in a narrow groove carved on the support roller for the movement of the mechanism, (Figure 5) which is built in AISI 410 steel with good resistance characteristics, even if it is not recommended to use in highly corrosive environments. It is however anodic with respect to the material used for the seegers (AISI 316) and, in principle, it might provide the seeger with some form of cathodic protection. The galvanic chain is however irrelevant in this case in view of another phenomenon much more serious and directly responsible for the early breaking of the seegers. It is dependent on construction and the aggressiveness of the environment and is called crevice corrosion.

Considering the critical role of the seegers, the safest possible solution is the use of beryllium bronze, a non-passivated material with a much greater resistance to generalized corrosion than spring steel. However, the problem of the cavity remains, which causes the differential aeration cell to act. The stressed bronze, although not passivated, nevertheless presents areas with less noble potential where the tension accumulates, and the risk of preferentially localized breakage remains.

It is then possible to try to inert all the elements of the cell by means of surface protection. By covering both the slot and the seeger, both anode and cathode can be disengaged. The problem now remains limited to the duration of protection provided by the coating. The operating conditions exclude any painting, with the risk of staining the white tissue of the ceiling.

The only possibility is given by the use of a viscous protecting creams widely used in the automotive building procedures, for example in spot-welded sheets or in the hidden underbody. Those creams are very adherent, do not drip, contain products such as Teflon and Lithium soaps which ensure its stability over time, allowing therefore to propose only a five-year monitoring.

- Disassembly of the seeger,
- Cleaning the seat and adjacent areas with a bronze brush,
- Spraying of the entire surface area of the roller,
- Spraying or immersion of the seeger,
- Assembly of the seeger.

In principle, this solution could avoid the use of more noble materials than spring steel. However, as they used to say: belt and suspenders...So, the final solution was actually beryllium copper.

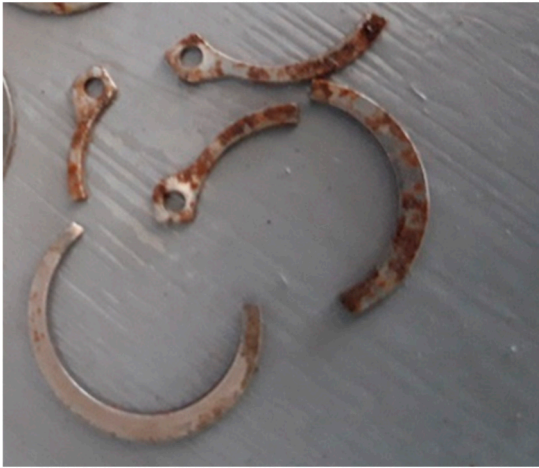
Al-Bayt Stadium (Figure 1) ('Istād al-Bayt, i.e. 'The House Stadium') is a football stadium in Qatar, which was opened in time for matches in the 2022 FIFA World Cup. The stadium has a retractable roof (Figure 2) that can close completely within 20 minutes, to enable play throughout the year. The roof weighs around 1,600 tons – the equivalent of almost 380 medium sized motor cars. Each roof truss measures 94.4 meters and weighs between 82 and 104 tons. It is possible to close the roof at the touch of a button, in a three-phase movement. The movement for locking / unlocking the trolleys is obtained through sixty four actuators (Figure 3), a couple at the end of each one of the 32 trolleys of the movable ceiling. The following (Figure 4) shows the apparatus for the transmission of motion from the motor to the trolley (left) and for blocking the motor (right). Pins allow the continuity of the structure, and they are kept in place by means of mechanical stops called "seegers" or "circlips", (Figure 5). By design, the 384 pins (six in each actuator) were made out of AISI 316 stainless steel. It was observed that many of them showed signs of corrosion and break after a relatively short service period (less than 1 year), (Figure 6).

Figure 6. Examples of stress corrosion cracked seegers.

Crevice corrosion (16,17) occurs in those hidden sites where oxygen does not circulate freely. In these areas, oxygen is progressively consumed and cannot be renewed by diffusion or convection. Outside the confined area, the cathodic reaction of oxygen reduction still occurs on the metal surface, whereas, in the confined area, the metal surface becomes the anode. The corrosion processes lead to the modification of the chemical composition of the electrolyte in the crevice with simultaneous acidification and an increase of chloride ion concentration. When the pH and the Cl^- concentration in the crevice solution reach critical values, depassivation of the stainless steel with active dissolution occurs which is localized in the points where passivation is weakest, i.e. in the anodic areas. In the specific case, the seeger was designed to be built in AISI, a passively alloy that critically depends on the passive ceramic oxide layer that covers it and which by default should reform itself in a very short time in case of damage. The ring is inserted under tension in the thin groove engraved in the cylinder. Inside the cavity, the conditions described above are very suitable for crevice corrosion. The attack on metal occurs mainly in those more anodic areas, that is, where the oxide is most damaged and the metal structure most weakened. These areas are mainly located where the effects of the applied mechanical tension are more pronounced and there will begin a localized self-stimulating corrosion, until (in very short time) the crack formed does not produce the fracture of the arc according to the mechanism of corrosion under tension (stress corrosion).

Here are therefore overlapping the most dangerous corrosion conditions: a cell with differential aeration: oxygen rich external cathodic areas, asphyctic, acidic, chlorides rich anodic internal areas; breakdown of local passivity producing pitting; applied mechanical tension giving rise to stress corrosion. Under such conditions, it could be deduced that a non-passivated spring steel seeger could resist longer because the attack would be distributed over the entire surface of the seeger with lower current density and much less risk of stress corrosion. The unknown factor is given by the corrosion rate (rust and general thinning) of the metal. It is therefore better decision to choose an alternative alloy with low corrosion rate.

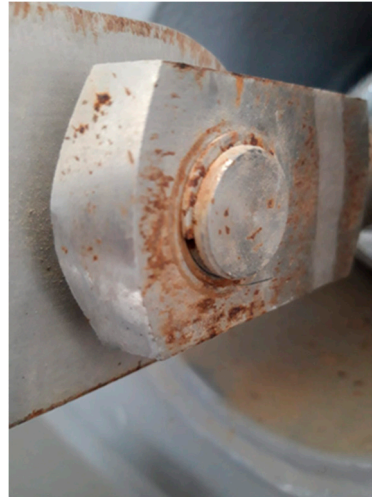
The aim of the present paper is to show how important and sometimes critical is the conscious choice of both materials and their connections, even in the smallest details, especially when such details are present in very large number. We took as a significant example the movement mechanisms of the movable roof, in particular of the actuators for locking / unlocking the trolleys (Figure 7).

Figure 7. Detail of the support roller showing the seeger located in a carved narrow groove. Localized corrosion and rusting are shown.

Figure 7 shows that the object is pervaded by the presence of generalized rusting and widespread pitting phenomena denoting a particularly aggressive environment, the effects of which are enhanced by some mistakes in both design and construction, namely:

- a) The object is composed of a chain of different stainless steels of different composition and structure with obvious difference in behavior towards corrosion (5, 12): AISI 316 steel is the noblest one and acts as a cathode compared to AISI 303 steel, which is not recommended for use in highly corrosive environments due to the presence of sulfur in the composition.

- b) The electrochemical corrosion due to the presence of a galvanic chain of different corrosion potentials of the differently “noble” components might have been minimized by the peculiar property of stainless steels to be “passivable alloys”: the main feature of all stainless steels is that they are suitable to build a nanometric surface layer consisting mainly of chromium oxide, named passive layer. It is self-healing and the rate of restoring passivity after damage is a feature of the quality of the alloy. Nevertheless, heat treatments, mechanical working, handling cause many surface defects to be produced, hence reducing the corrosion resistance of the passive layer. In order to increase and optimize the formation of the chromium oxide layer it is necessary to perform a repassivation procedure. Immersion of stainless steel in an acid bath dissolves free iron from the surface while leaving the chromium intact (14). The acid chemically removes the free iron, leaving behind a uniform surface with a higher proportion of chromium than the underlying material. This treatment was not performed on the structure. In our case, the AISI 303 s.s, both for the galvanic coupling and for the poor finish is subject to widespread pitting.

- c) The poor surface finishing is the third construction mistake. Both reliability and durability of the passive layer are strictly connected with the smoothness of the surface; it is not obviously possible to reach the perfectly planar surface, and at the crystallographic level all surfaces are rough. Hence, passivity is a dynamic situation where activation phenomena happen in a very high number of sites, quickly followed by repassivation. The speed of reestablishing passivity is a function of both surface uniformity and quality of the alloy.

- d) All edges should be rounded, not only to allow more uniform distribution of possible coatings, but also to avoid accumulation of current density on sharp edges, enhancing localized both rust and pitting, as clearly shown in figure 7.

- e) Moreover, the designer coated the cast iron and SS355JO steel components which are anodic to both the joined S.S. and the bronze bearings: huge cathode, small anode, high corrosion current density through the pores of the paint (see the archetypic example of such a mistake in the book: Corrosion Engineering, by M. Fontana, N.Green) (15).
