Post-Earthquake Strengthening of RC Coupling Beams with GFRP Wrapping: Experimental Investigation

[Namık Eser](#)*, [Erkan Töre](#), [Alper İlki](#), Kutay Orakçal, İhsan Engin Bal

Posted Date: 26 July 2023

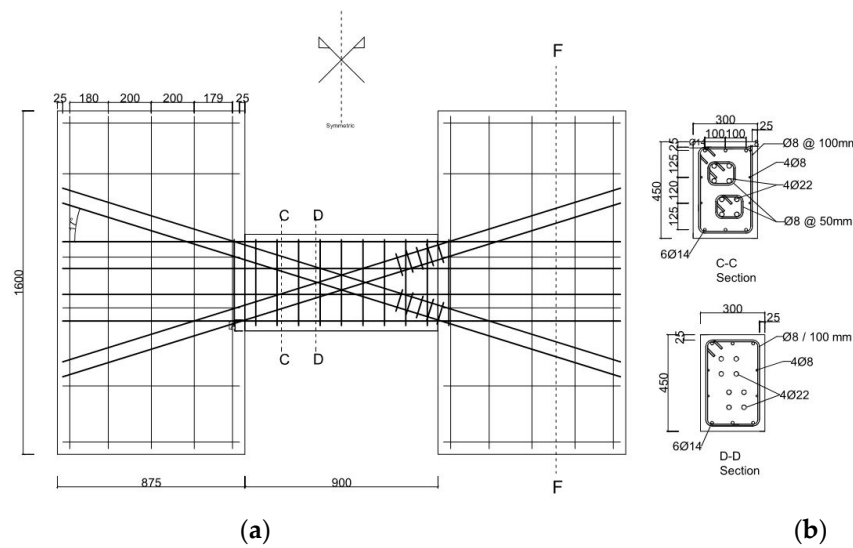
Figure 2. Detailing of CB2-PCB sample and geometry.

In the second example, the diagonal bundles were constructed with a partial wrapping application, which differs from the standard regulations. The wrapping process was specifically applied to the tightening regions of the tie beams, located at a distance of $d/2$ from the effective beam depth (where d is the depth of the beam). We designated this sample as CB2-PCB, with “PCB” representing “Partially Confined Bundle.”

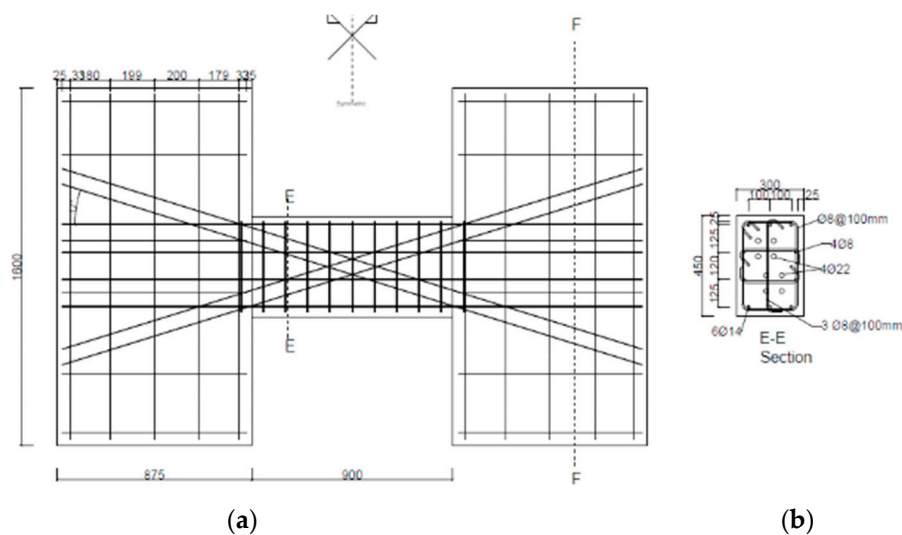
Figure 3. Detailing of CB2-RCR sample and geometry.

In the third example, we completed the construction of the diagonal bundles without any wrapping around them. Generally, ACI 318, Eurocode, and TSDC recommend increased stirrup wrapping for unwrapped diagonal bundles. However, for this study, we chose to stretch the wrapping application while adhering to the regulations. We named this sample CB2-RCR, with “RCR” indicating “Reduced Section Confinement Ratio.”

In CB2-RCR, the reduction in the wrapping ratio implies that the tie beam is fully wrapped, but with a decreased stirrup ratio, while the diagonal bundles remain unwrapped. This unique configuration allowed us to assess the effectiveness of reducing the stirrup confinement on the seismic behavior of the coupling beam, providing valuable insights for potential retrofitting strategies.

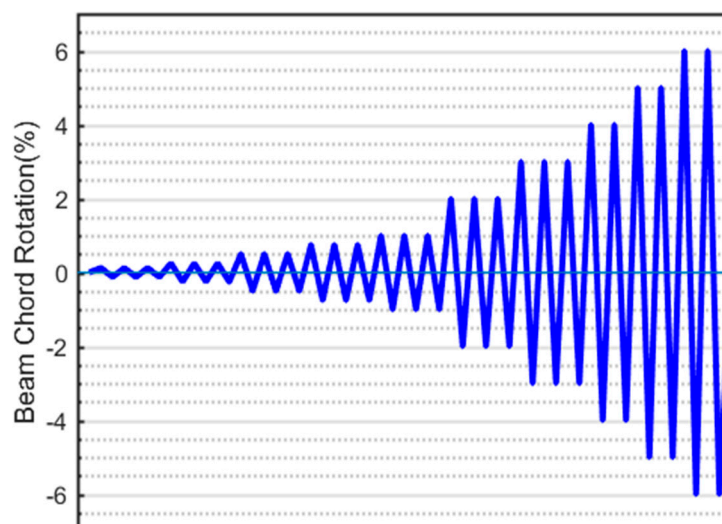
Figure 5. Loading protocol.

The testing procedure for all samples followed a displacement-controlled reversal test method. The displacement control was achieved by steadily increasing the beam chord rotation. The beam chord rotations were calculated as the ratio of the relative displacement perpendicular to the beam axis at the ends to the clear beam span.

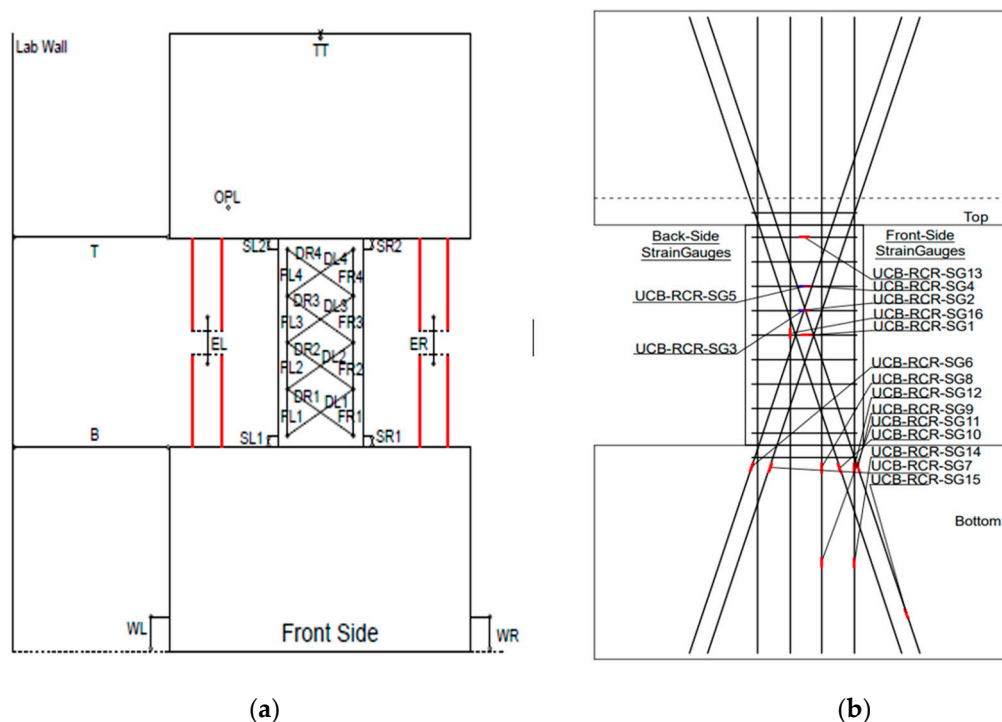
**Figure 6.** Potentiometer layout (left), layout of strain gauges placed on the CB-RCR sample(right).

Strain gauges played a crucial role in our experimental setup, providing valuable data on the behavior of the coupling beams during testing. We strategically placed strain gauges on longitudinal, diagonal, and transverse reinforcements to monitor their respective stress and deformation responses. Additionally, some strain gauges were affixed to the stirrups of the diagonal bundles and the section stirrups in the middle position.

To gain insights into the stress penetration within the wall, we carefully positioned strain gauges along the development length of the diagonal and longitudinal bars. TML – YFLA-5-3L type strain gauges were utilized in our study due to their reliability and precision.

In addition to the strain gauges, we employed potentiometers to measure bending, shear, shear-elongation, shear, and axial deformations along the beam (as depicted in Figure 6). However, it should be noted that data could not be obtained from the specimens after the strengthening process for 16 strain gauges placed following damage, which rendered them unusable for further testing. Nevertheless, potentiometers positioned on pendulums and on the sample were successfully employed to capture important data during the experiments.

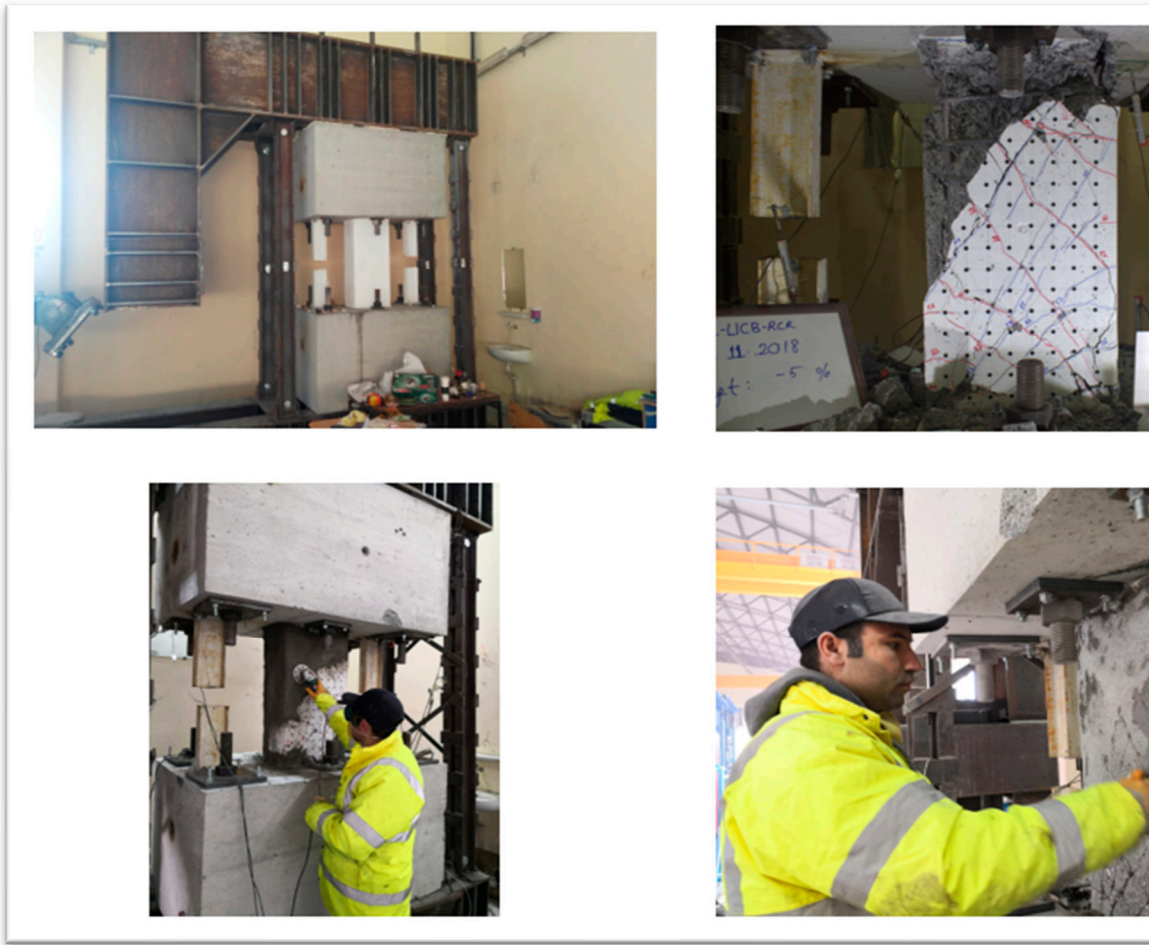
Figure 7. CB-RCR sample before damage (top left), CB-RCR sample after damage (top right), CB-RCR sample when strengthening (bottom left and right).

The damaged specimens resulting from the experiments were initially repaired using Teknorep 300-ex repair mortar. Once the rough surface of the mortar dried, it was cleaned by using sandpaper. Subsequently, the sample edges were rounded to a diameter of 3 cm in preparation for wrapping. Any bird's eye gaps and capillary cracks that formed in other damaged areas of the samples were closed using Mapei Adesilex metered mixture (an epoxy repair solution). The surfaces where

Mapewrap 31 T/A epoxy was applied were then wrapped with 2 layers of Tyfo SEH-25A FRP, completing the retrofitting process. The preparation stages are illustrated with images in Figure 7 and Figure 8 below.

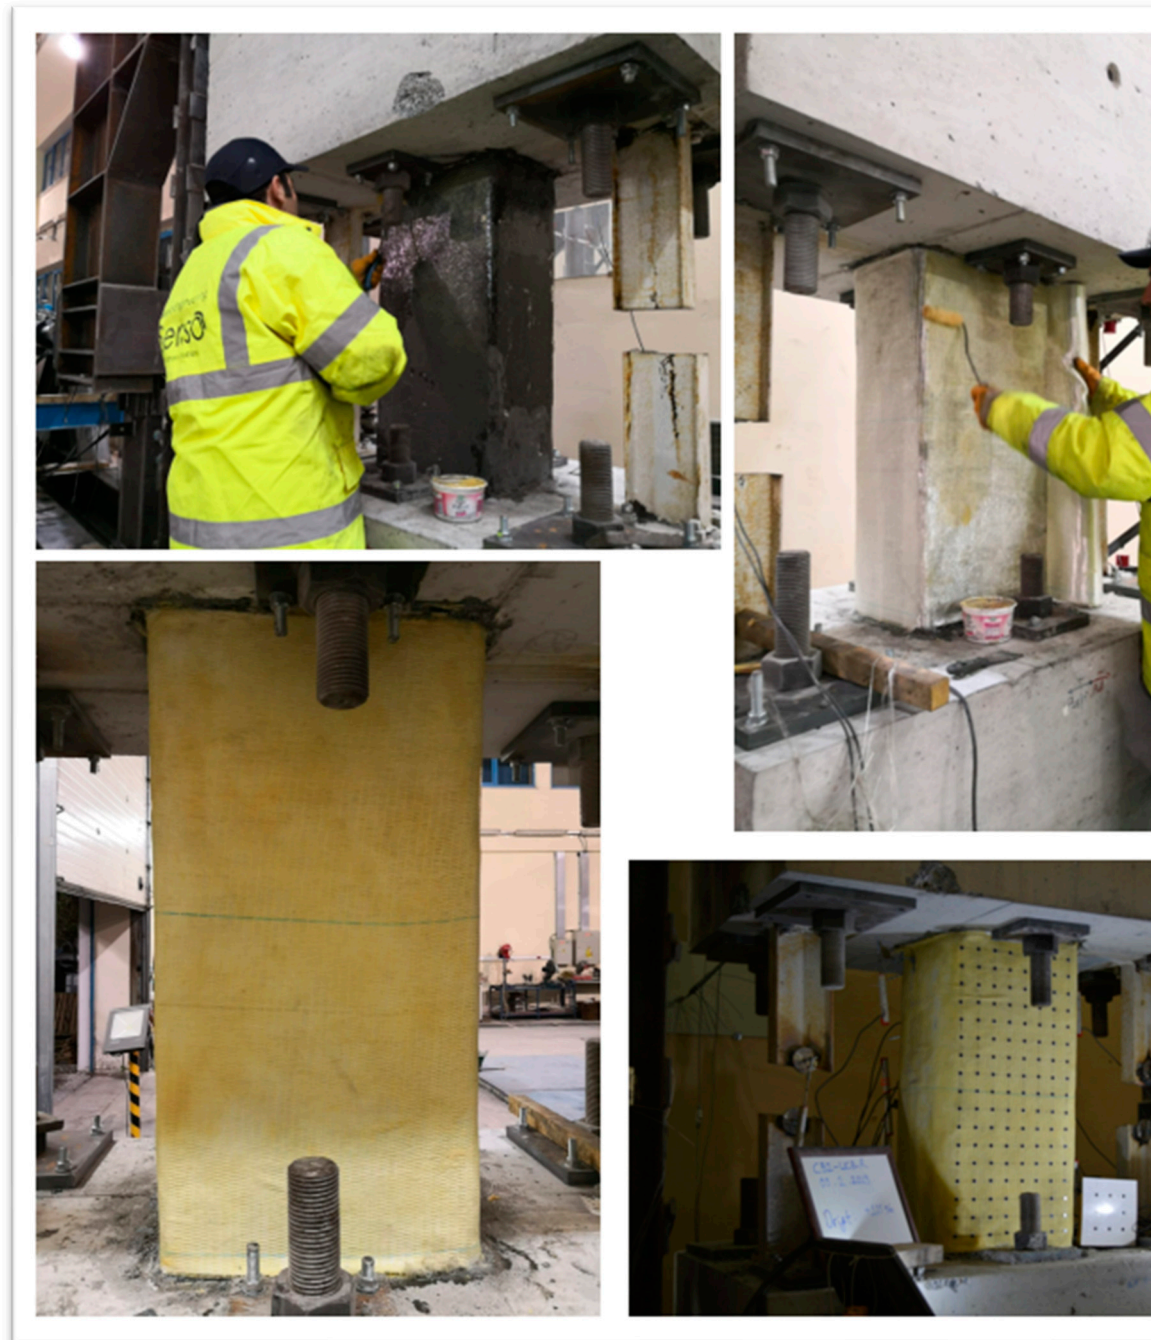
Figure 8. Strengthening process of CB-RCR sample.

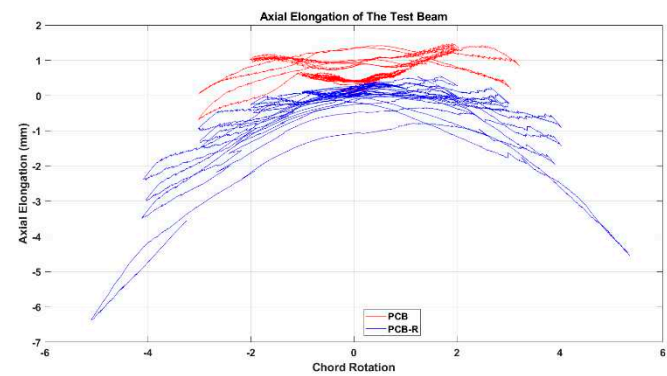
Figure 10. Comparison of the axial elongation of PCB specimen before and after strengthening.

The test results, depicted in Figures 10-15, include the axial elongation and shear force distribution via chord rotation. Notably, the axial elongation values predominantly exhibited negative behavior. This can be attributed to several factors associated with the repair and retrofitting process of the damaged beam:

Closure of Cracks: The use of repair mortar without epoxy injection has not resulted in the closure of cracks in the beam, which had previously experienced high drifts and wide crack formation. During cyclic loading, the main surfaces of the beam had come into contact with each other, leading to the closure of the cracks.

Plastic Elongation and Buckling: The observed plastic elongation in the reinforcement and the presence of buckling could have been influenced by the advanced level of buckling experienced in the previous experiment. The buckling phenomenon might have reached an advanced stage during the subsequent tests.

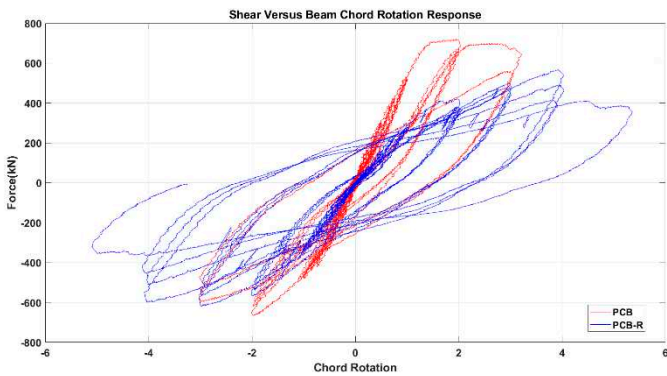
Figure 11. Comparison of pre- and post-reinforcement shear force and chord rotation of PCB specimen.

When examining the three fundamental properties of hysteresis response, ultimate strength, initial stiffness, and degradation, the following observations were made for each sample:
Partial Confined Bundle (PCB) Sample:

The strength of the PCB sample before strengthening was higher than after strengthening, but the rate of strength reduction decreased after damage.

The initial stiffness decreased by approximately 50% after damage, considering 1% chord rotation.

The degradation increased rapidly after reaching the displacement corresponding to ultimate strength as the confinement effect disappeared in the first test state. However, the strengthened state still showed desired performances by exceeding the targeted displacements.

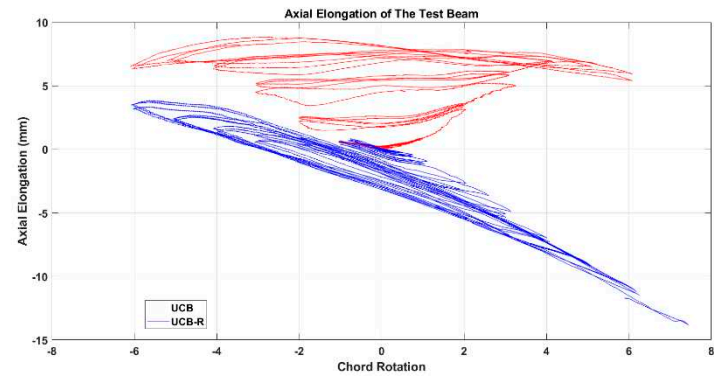
Figure 12. Comparison of the axial elongation of UCB specimen before and after strengthening.

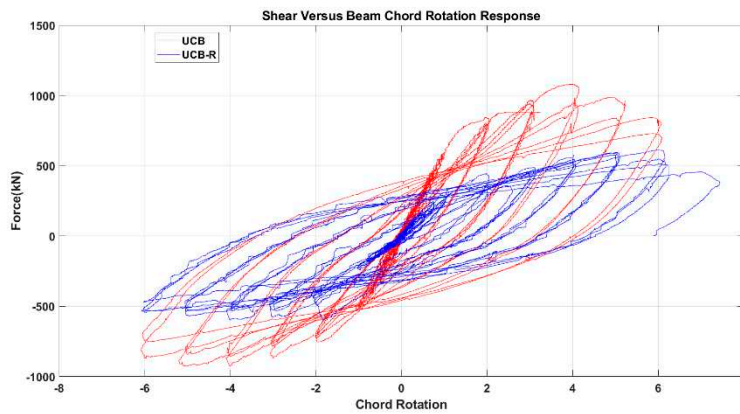
Figure 13. Comparison of pre- and post-reinforcement shear force and chord rotation of UCB specimen.

Unconfined Bundle (UCB) Sample:

The ultimate strength amounts of the UCB sample were still higher before strengthening at ongoing chord rotations. However, in the strengthening state also ultimate strength reaches the half time of ultimate strength with the same chord rotation level.

The initial stiffness again decreased by roughly 50% compared to the 1% chord rotation value after damage.

The degradation types were similar to the initial state in the retrofitted sample but increased further with the disappearance of the wrapping effect at the end of the test.

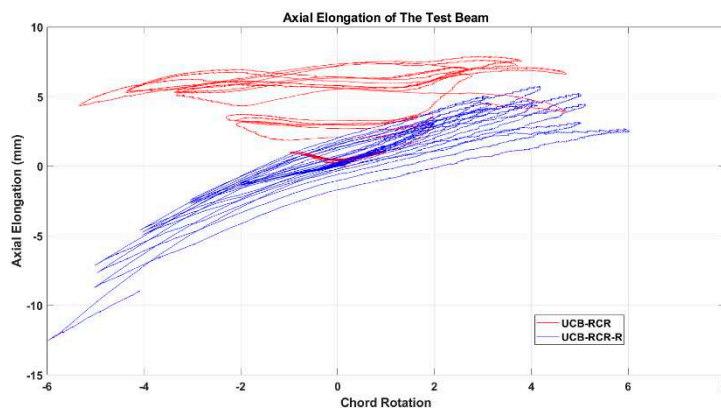
Figure 14. Comparison of the axial elongation of UCB-RCR specimen before and after strengthening.

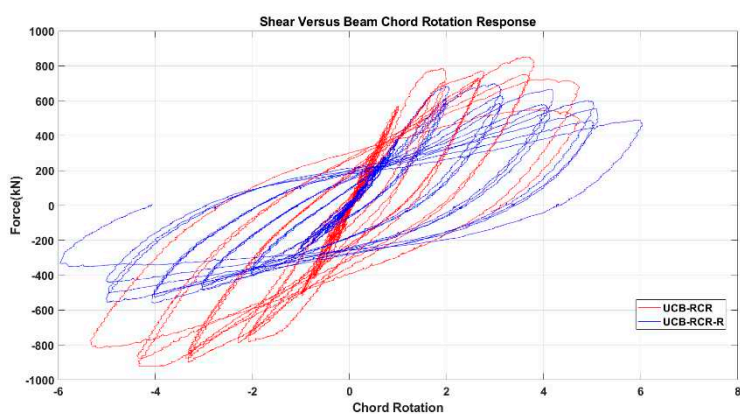
Figure 15. Comparison of pre- and post-reinforcement shear force and chord rotation of UCB-RCR specimen.

UCB-Reduced Confinement Ratio (RCR) Sample:

The strength amounts were close in the first cycles, but as the number of cycles increased, the strength of the strengthening specimen decreased further due to inner damage.

There was roughly a 40% difference between the initial stiffness value and the 1% chord rotation value.

The degradation levels were higher in the initial test sample with the ongoing chord rotations and the strengthening sample went on a higher chord rotation level due to the higher confinement ratio.

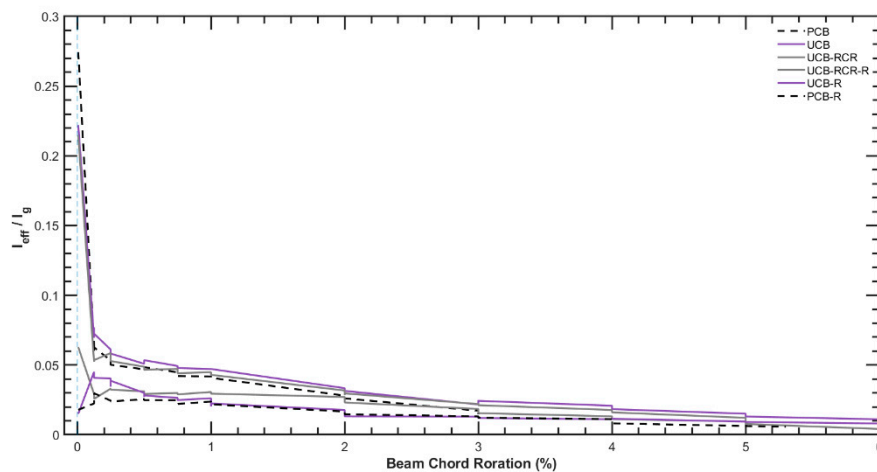
Figure 16. Comparison of I_{eff}/I_g changes of samples before and after reinforcement.

When analyzing the effective stiffness values, Figure 16 indicates that the values at the end of the tests before strengthening are predominantly maintained during the tests conducted after the strengthening process. This observation suggests that the strengthening measures applied to the samples have effectively preserved their overall stiffness characteristics, especially after 2% chord rotation. This finding suggests that the retrofitting measures, such as GFRP wrapping and repair mortar application, effectively maintain the overall stiffness of the coupling beams even after undergoing cyclic loading and experiencing damage. The strengthening technique has successfully enhanced the structural stiffness, contributing to the improved performance and seismic resistance of the coupling beams throughout the test cycles. This finding further supports the feasibility and efficacy of the proposed strengthening approach in maintaining the structural integrity and enhancing the safety of the coupled wall systems..

The ability to retain effective stiffness is crucial for the structural performance of coupling beams, as it ensures that the beams can continue to provide the necessary lateral stiffness and ductility during seismic events. By demonstrating the capability to preserve effective stiffness through strengthening, this study further supports the feasibility and reliability of the proposed method in enhancing the seismic resilience of reinforced concrete structures.
