Soil Erosion and Landslide Susceptibility Mapping Using Rock Engineering System Methodology. The Case of Mandra Fatal Flash Flood (2017) in Western Attica, Greece

Nikolaos Tavoularis

Regional Authority of Attica/Directorate of Technical Works, Department of Technical Support of Attica's Region Municipal Islands, 185 45, Greece; ntavoularis@patt.gov.gr or ntavoularis@metal.ntua.gr

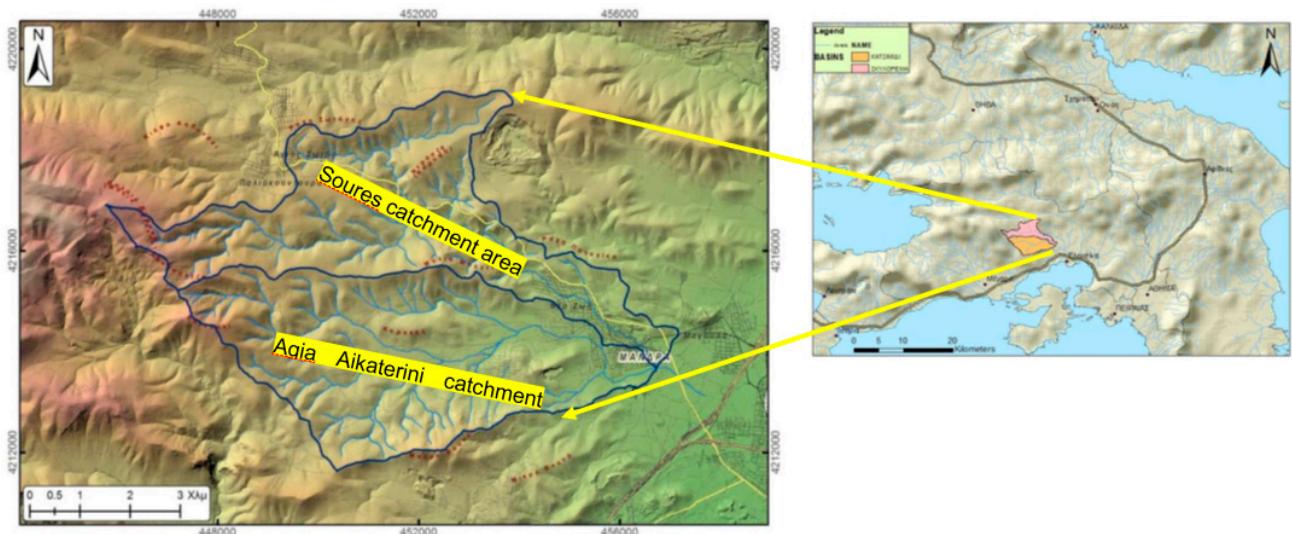
Figure 1. The case study of Mandra fatal flash flood (2017). On the left, the project area map is depicted (background Digital Terrain Model of 2m accuracy. On the right, the boundaries of the catchment areas in the wider study area are presented [19].

The study concerns the area upstream of the residential area of Mandra and extends from the ridge of the adjacent mountain range (Mount Patera) with an altitude of 841m to the settlement of Mandra (Figure 1). The study area covers the catchment areas of the two streams Agia Aikaterini and Soures located upstream of the settlement of Mandra.

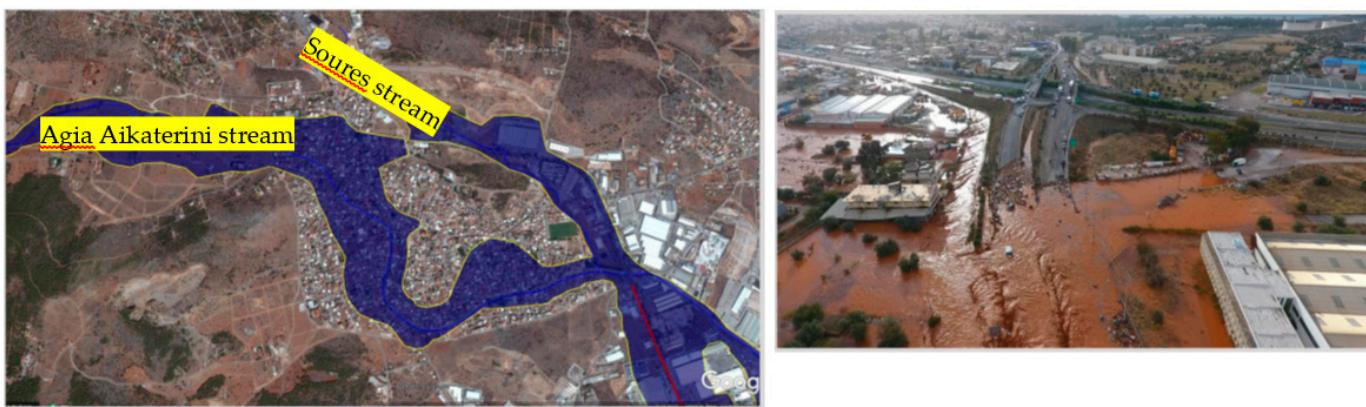
Figure 2. Two characteristic views from the fatal flash flood. On the left a flood zone in Mandra and on the right a Mandra-Elefssina road, Attiki Odos junction [21].

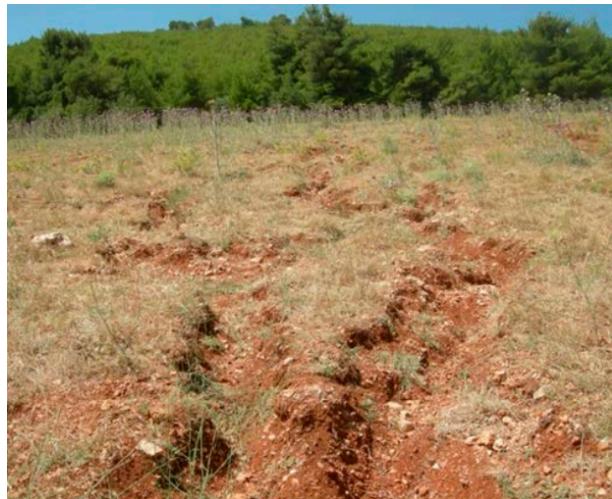
Figure 3. Rill erosion on Holocene deposits of Mandra hydrological basin [19].

produced by surface erosion and consists mainly of medium-sized gravels and coarse sand. The development of rill erosion in the catchment area of the Mandra catchment is particularly pronounced in areas structured by the engineering geological unit of Holocene deposits, where vegetation is also absent (Figure 3).

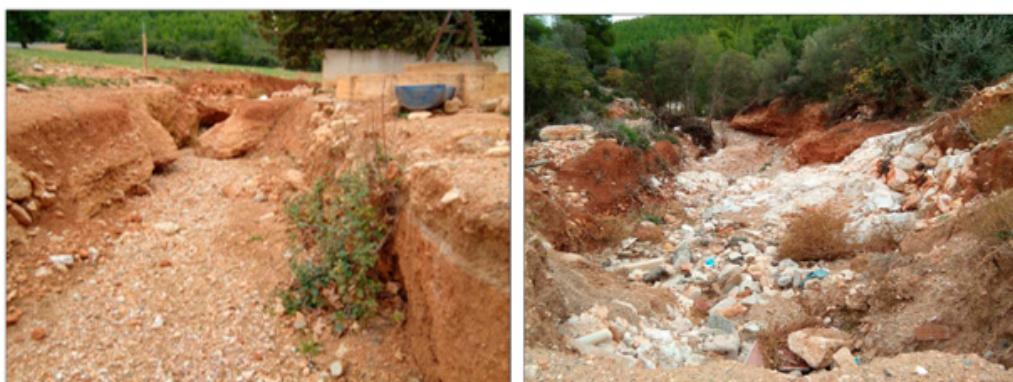
Figure 4. Typical forms of gully erosion developed on Holocene deposits of Mandra's hydrological basin.

This type of erosion is developed by the flow of water along the axes of maximum slope gradient of the slopes, where gullies of more than one meter in depth are formed. The mechanism of their formation is like that of rill erosion, but on a larger scale, due to the greater concentration of water and the increase in its erosive and transport energy. The cross-section of the trenches depends on the erodibility of the soil with depth. In easily corroded materials, there is usually continuous dredging, and the cross-section is typically triangular, but deep erosion slows down considerably when the bottom of the trench reaches a corrosion-resistant formation. In this case, erosion progresses mainly laterally, and the cross-section of the gully is U-shaped. In the catchments of the Mandra River, intense trench erosion developed after the heavy rainfall that occurred on 14-15/11/2017, which contributed significantly to the production of fine and medium size sediment. Gully erosion developed in the upper and mainly in the middle elevations of the two basins, especially along valleys with a strong gradient, where the increased water volume significantly increased its erosive energy. Typical forms of gully erosion in the Mandra catchments are shown, which were developed mainly within the Holocene deposits (Figure 4).

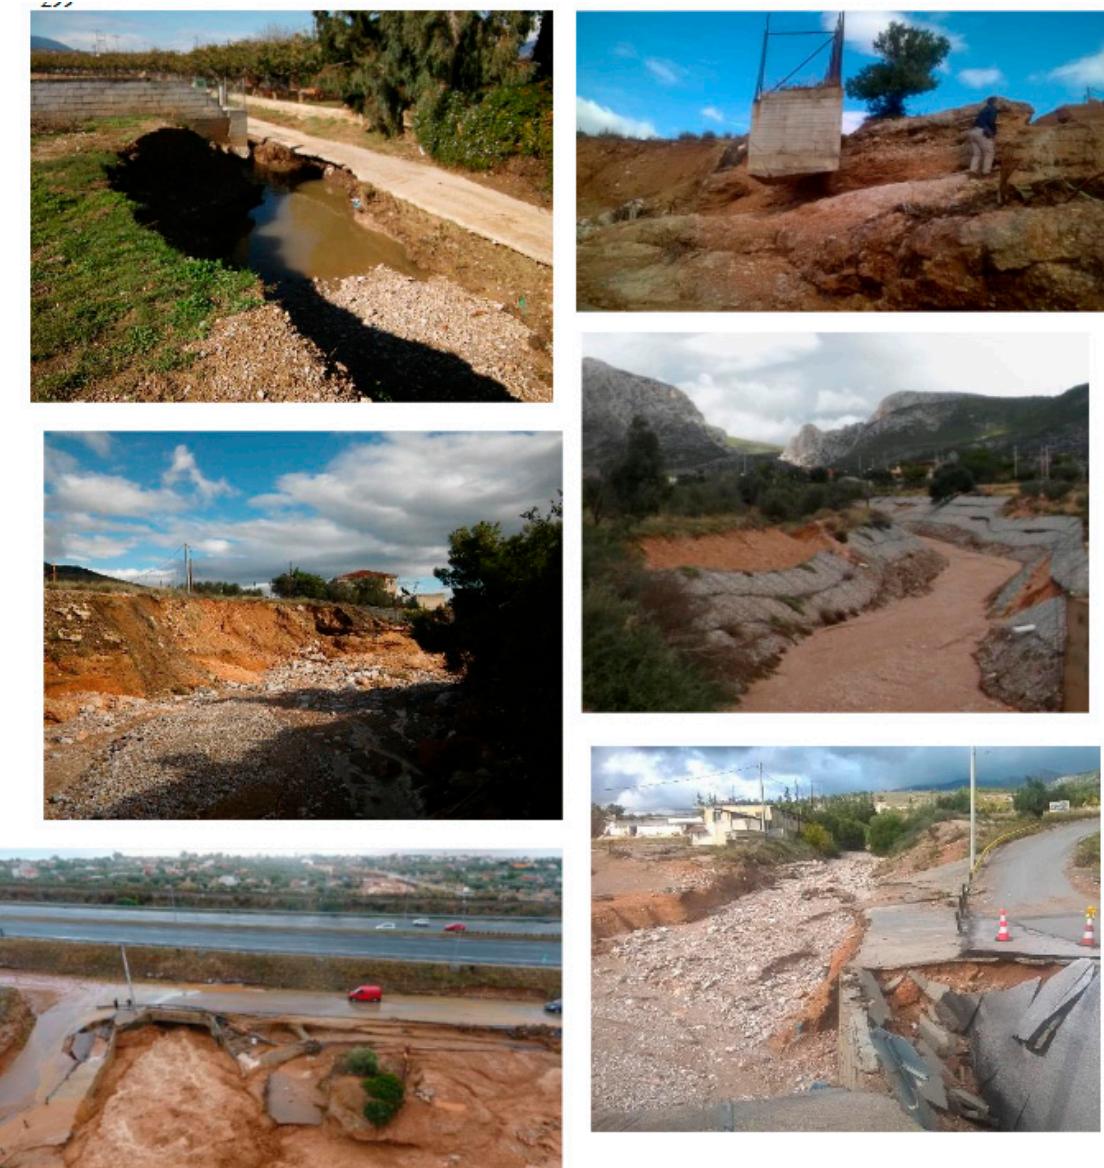
Figure 5. Different views of slope and sub-slope erosion after the flash flood event of 14-15 November 2017 in Mandra area.

In the central beds of the streams of the two catchments of the Mandra and as the elevations and gradients decrease, gully erosion develops into slope and sub-slope erosion taking the form of riverbank erosion feature (Figure 5). The strong flow of stream water detaches and carries materials from the foot of the slopes downstream, widening or deepening the bed. The amount of erosion depends on the force of the water, the slopes of the bed, the meanders and bends it creates, and the erodibility of the geological formations through which the stream flows. The presence of vegetation or the local accumulation of coarse material in the streambed often diverts the main flow of the stream towards the slope, resulting in severe erosion. Slope and sub-slope erosion can be localized, as they usually develop perpendicular to the flow direction of the stream. Sub-slope erosion also is also created in the bed of streams, in places of abrupt changes in elevation, where small waterfalls are formed. These forms of erosion can be observed in almost all the main and some secondary branches of the hydrological network of the Mandra catchment areas. The intense runoff that caused the major flooding in Mandra in November 2017 led to extensive slope and subslope erosion, resulting in the large widening of stream valleys and the removal of large volumes of material that were transported downstream. The slope and sub-slope erosion in the Mandra basin primarily affects the Holocene deposits of the stream slopes, but at a second level also the Pleistocene deposits, with differential erosion of the less cohesive horizons.

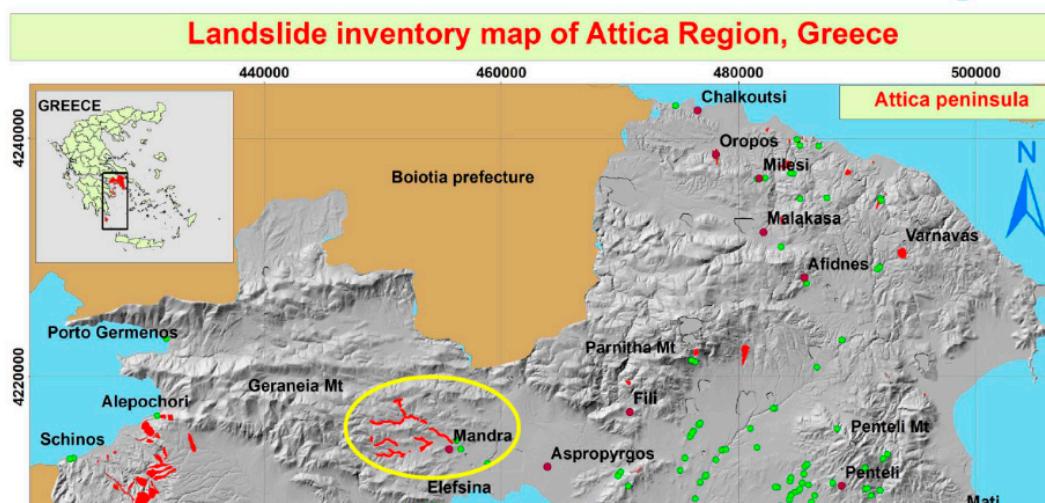
Figure 6. Soil erosion lines (derived after classification of erosivity based on the combination of the three final maps) depicted inside the yellow circle over the landslide inventory map of Attica Region, excerpt of this map is shown here [18]. Red colour corresponds to potential slope failures, green colour equals to existing landslides.

The above parameters are the criteria for assessing the susceptibility to soil erosion and assuming equivalent weighting and linear correlation between them, the thematic maps were superimposed and the corresponding susceptibility map in the Agia Aikaterini and Soures catchments was obtained. Moreover, the previously mentioned findings are in line with Hydroment Associate's site-investigation work (2021) in those two examined watersheds (Agia Aikaterini and Soures), which executed under the auspices of Region of Attica's Authority which is responsible of designing and implementing mitigation measures against flooding [26]. The combination of the three final maps produced the erosivity map, part of which is depicted as soil erosion lines in the following map (Figure 6).

The above-mentioned soil erosion types recorded during the in-field site investigation were validated through an already generated landslide susceptibility map [18], which is shortly described in next section. In this map, a strong correlation between the defined soil erosion lines and the landslide susceptibility zones that come up from a semi-quantitative methodology named Rock Engineering System (RES) was confirmed.

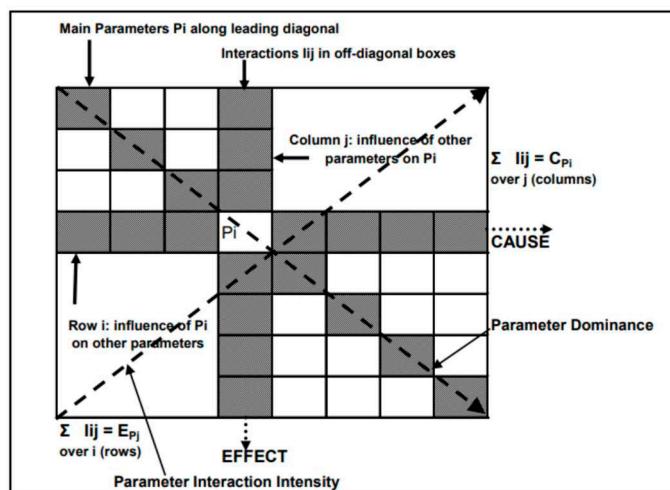
Figure 7. RES interaction matrix-table [28–30].

This approach is mainly based on the correlation of mechanisms between landslide parameters through a matrix-table and uses slope failure factors that can potentially be identified during the preparation phase of a preliminary, final or implementation study of a civil engineering project. The scope of using RES, is to estimate the landslide instability index which results in generating landslide susceptibility, hazard and risk maps [18]. RES is a semi-quantitative rock engineering approach and the basic tool for representing the parameters and their interaction mechanisms (Figure 7). It is based on an interaction matrix which represents the key parameters, as leading diagonal terms, and their binary interaction mechanisms as off-diagonal terms. RES has been developed by Hudson in 1992 [27] to determine interaction of several parameters in rock engineering design and calculate instability index for rock slopes. Since then, it has been modified and applied to rock stability problems, landslide susceptibility analysis and rock engineering [28]. Thus, implementing RES methodology expert defines the most important causative and triggering factors responsible for the slope failures, quantifies their interactions, obtain their weighted coefficients, and calculates the instability index, which refers to the potential instability of the examined natural slope.

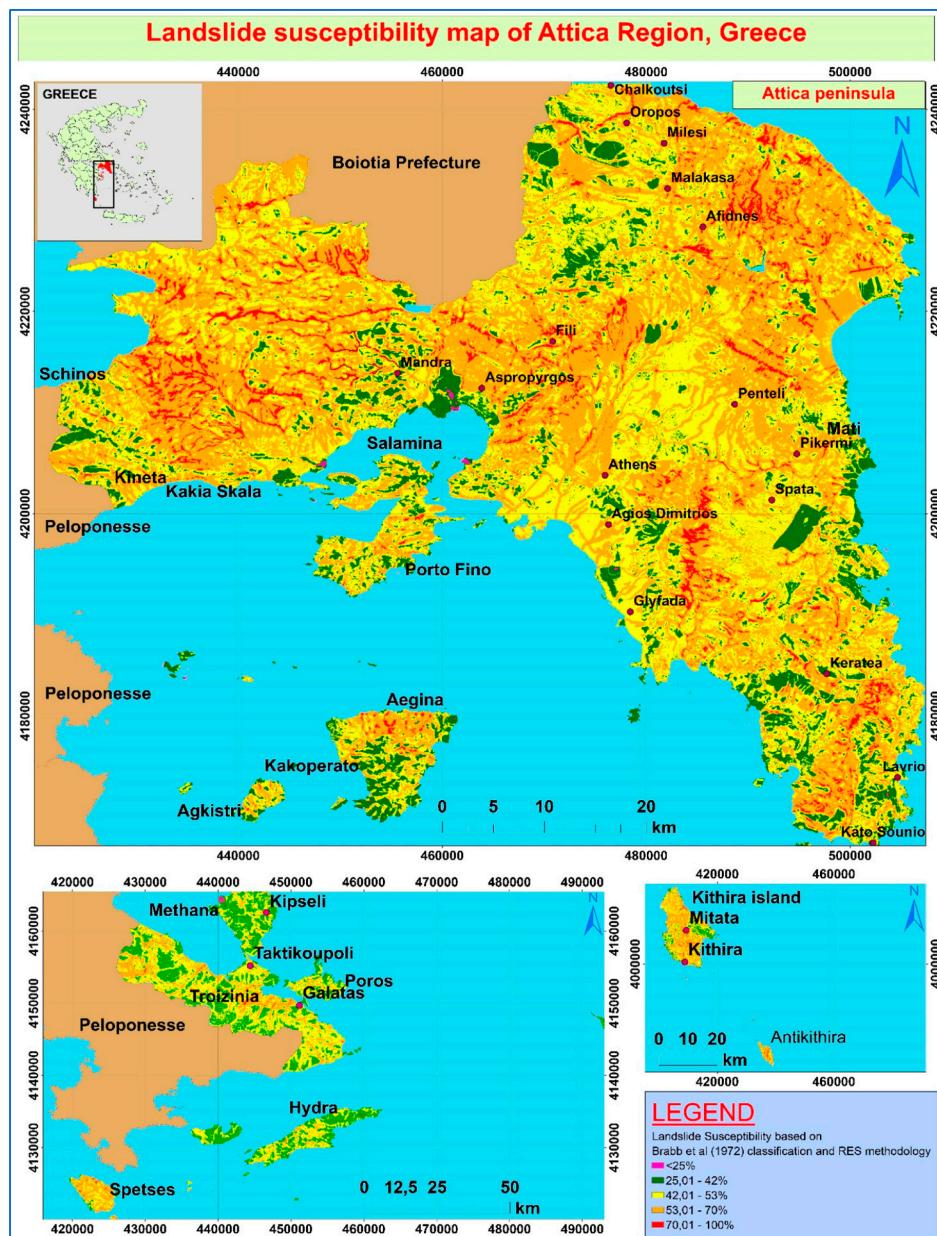
Figure 8. Landslide susceptibility map of Attica Region [18]. The landslide susceptibility index (LSI) values in the susceptibility map were classified into five categories: “Low-Middle”, with Instability index (I_i) < 25 (Light green color zone in the map), “High” with $25 < I_i < 42$ (Green color zone), “Very High” with $42 < I_i < 53$ (Yellow color zone), “Extremely high” with $53 < I_i < 70$ ” (Orange color zone),

and "Landslide" with $Li > 70\%$ (Red color zone). From this classification, it can be clearly notified that the higher the LSI, the more susceptible the area is to landslides (instability index higher than 70%). The area inside the black rectangular scheme, corresponds to the present study Mandra area.

Rainfall, (viii) Elevation, (ix) Distance from streams and (x) Distance from tectonic elements. The generated landslide susceptibility map can be used with the already produced potential highly flood hazard zoning maps of Attica Region authorized by the Greek Ministry of Environment and Energy, and with the produced flooded area maps, delivered by the Copernicus Emergency Management Service-Mapping. The outcome of the DIAS project is accessible to the public, through an open-access web-based platform (<https://gis.attica.gov.gr/en/node/1216>), so as to aid awareness of landslides among different stakeholders (e.g., landslide experts, government agencies, planners, citizens). Moreover, the DIAS project can facilitate the role of Civil Protection Authorities, by providing inputs for prevention and preparedness. For further study of the previously briefly described methodology, readers are kindly suggested to read the following relevant research [18,28,30,31]. Ultimately, the generated landslide susceptibility map for the entire county of Attica Region is the following (Figure 8).

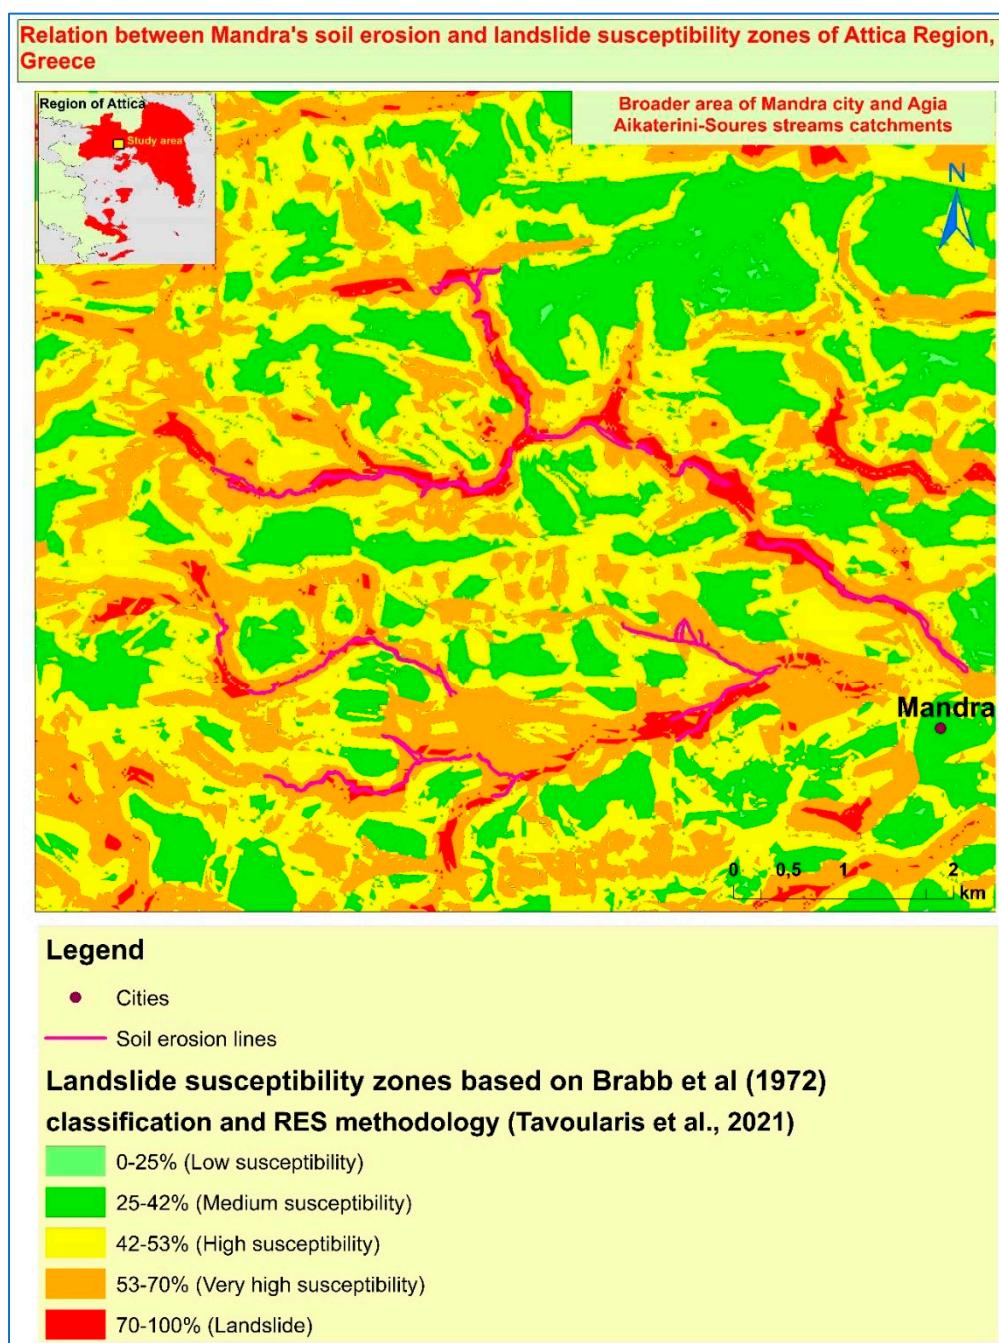
Figure 9. Focus on the area depicted in the circle of previous map. Relation between soil erosion lines in pink colour and the high and very high landslide susceptibility zones.

The afore-mentioned soil erosion types were subject to expert-based cross-check and validated through on-screen visual interpretation of the generated landslide susceptibility map of Attica Region. The soil erosion types depicted as lines and were overlaid on the landslide susceptibility map (on landslide susceptibility zones) in order to identify the correlation of potential slope failure zones with soil erosion lines. All the depicted erosion lines were associated with "Extremely high" to "Landslide" susceptibility zones, based on the generated landslide susceptibility map of Attica Region (Figure 9) and Brabb et al. [31].

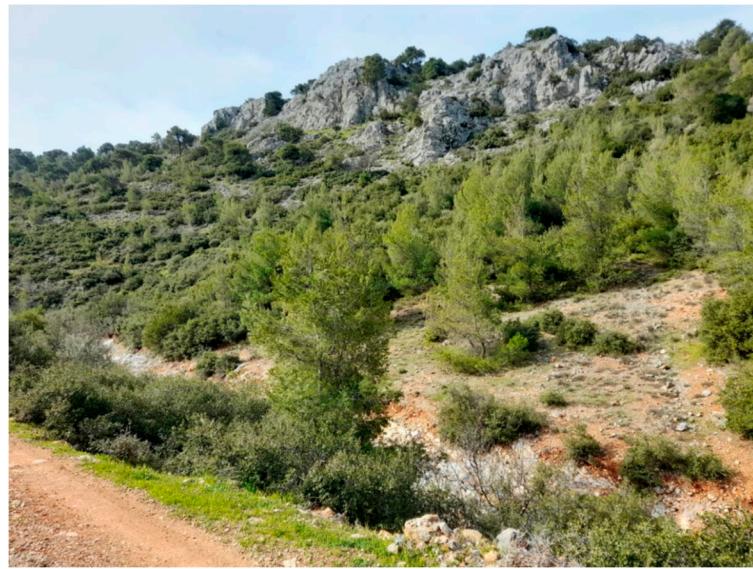
Figure 10. From a characteristic broader view of Mandra area, a partly soil erosion degraded area (located west of capital city of Athens, Greece) where a small dam is going to be constructed for coping against future (flash) flood events [35].

requirements of being as low as possible in terms of cost and short implementation time. To be more specific, the types of the recommended dams are as follows (Figure 10):

- (a) Construction of sediment barriers are intended to be between 3m and 8m high with reinforced concrete or unreinforced concrete construction material. The purpose of these dams is to counteract the axial erosion of the bottom of the stream bed, by reducing the drag force of the water and retaining the sediment.
- (b) Construction of graduation dams - slope stabilization: These dams are proposed to be made of concrete (reinforced or unreinforced) or of reinforced wire mesh (e.g., sarsenet). The construction of the dams will be carried out either in places where there is evidence of gradual erosion, or in places where there is axial erosion of the bottom of the bed, in combination with the above-mentioned sediment barriers. The height of these dams according to the theoretical assessment carried out, is proposed to be between 1m and 2m.
