# Soil Erosion and Landslide Susceptibility Mapping Using Rock Engineering System Methodology: The Case of Mandra Fatal Flash Flood (2017) in Western Attica, Greece

Nikolaos Tavoularis <sup>1\*</sup>

<sup>1</sup> Dr. Engineering Geologist of National Technical University of Athens Regional Authority of Attica / Directorate of Technical Works, Department of Technical Support of Attica's Region Municipal Islands, 185 45, Greece; ntavoularis@patt.gov.gr

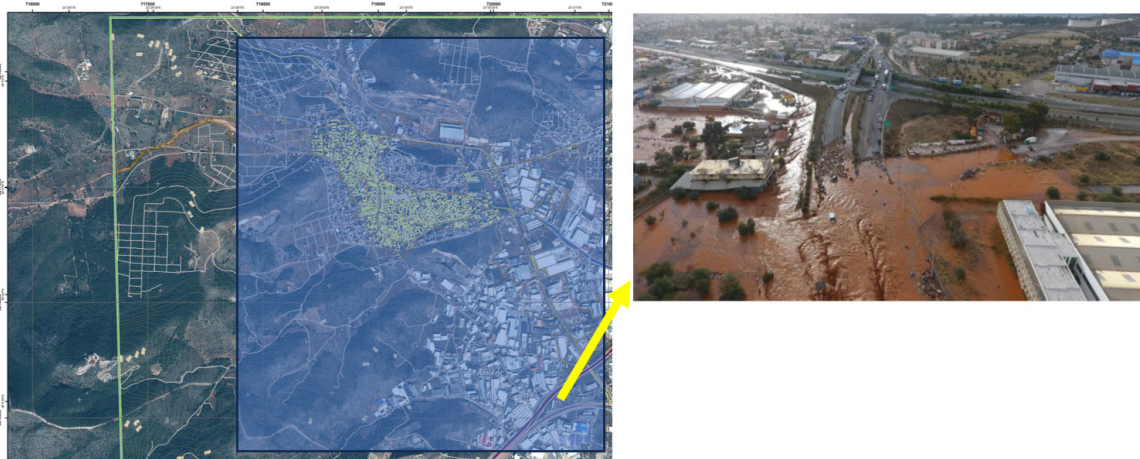
**Figure 2.** Two views from the fatal flash flood. On the left a picture of the flood zone in the Mandra city is depicted (in rectangular shape), delivered by the Copernicus Emergency Management Service-Mapping [54] and on the right a characteristic view of the flooded Mandra-Elefsina road [55].

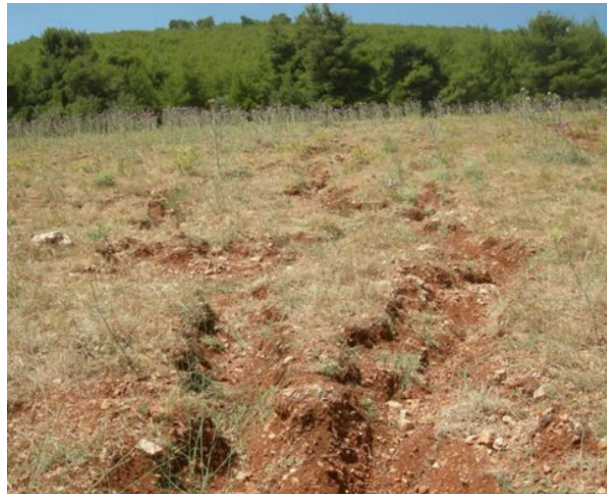
**Figure 3.** This photo shows rill erosion on Holocene deposits of the Mandra hydrological basin, and it is located in Figure 1.

Rill erosion is a development of surface (sheet) erosion and is caused by the concentration of rainwater, which cannot percolate down to the subsoil, in small soil cavities, which progressively overflow and form irregular longitudinal surface runoff [53]. As the volume of runoff gradually increases, both the carrying capacity of the already extracted material and the potential for new material to be extracted along the water path increases. The erosive power of water depends on the volume, velocity, and rate of supply of surface runoff, slope gradient and soil erodibility. This creates many, small and shallow (<1m) rills that follow the direction of maximum slope of the soil surface, forming water flow axes of usually triangular cross-section. The resulting sedimentary material is coarser than that produced by surface erosion and consists mainly of medium-sized gravels and coarse sand. The development of rill erosion in the catchment area of Mandra, is particularly pronounced in areas structured by the engineering geological unit of Holocene deposits, where vegetation is also absent (Figure 3).

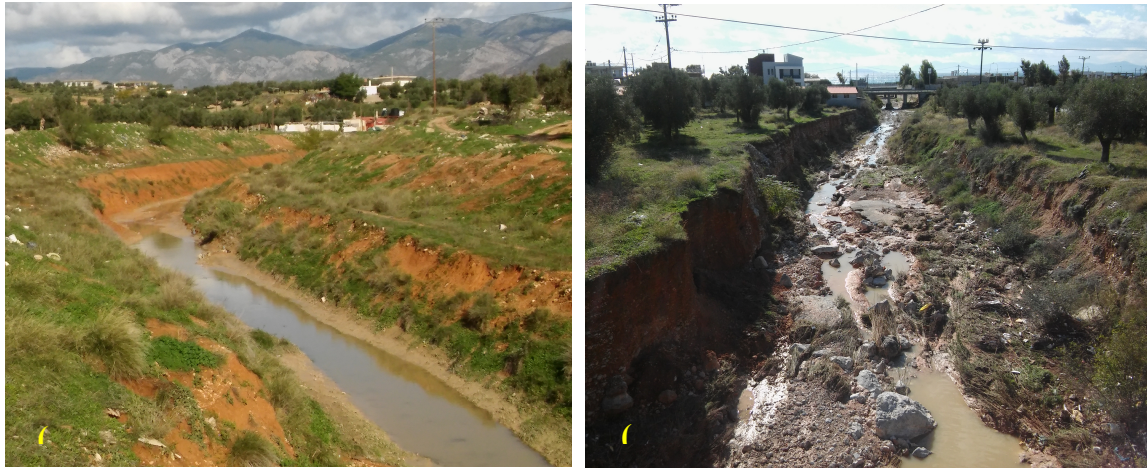
**Figure 4.** Those photos (e.g., 4a, 4b) show typical forms of gully erosion developed on Holocene deposits of the Mandra hydrological basin and it is located in Figure 1.

This type of erosion is developed by the flow of water along the axes of the maximum slope gradient of the slopes, where gullies of more than one meter in depth are formed [53]. The mechanism of their formation is like that of rill erosion, but on a larger scale, due to the greater concentration of water and the increase in its erosive and transport energy. The cross-section of the trenches depends on the erodibility of the soil with depth. In easily corroded materials, there is usually continuous dredging, and the cross-section is typically triangular, but deep erosion slows down considerably when the bottom of the trench reaches a corrosion-resistant formation. In this case, erosion progresses mainly laterally, and the cross-section of the gully is U-shaped. In the catchments of the Mandra rivers (e.g., Agia Aikaterini and Soures), intense trench erosion developed after the heavy rainfall that occurred on 14-15/11/2017, which contributed significantly to the production of fine and medium size sediment. Gully erosion developed in the upper and mainly in the middle elevations of the two basins, especially along valleys with a strong gradient, where the increased water volume significantly increased its erosive energy. Typical forms of gully erosion in the Mandra catchments are shown, which were developed mainly within the Holocene deposits (Figure 4).

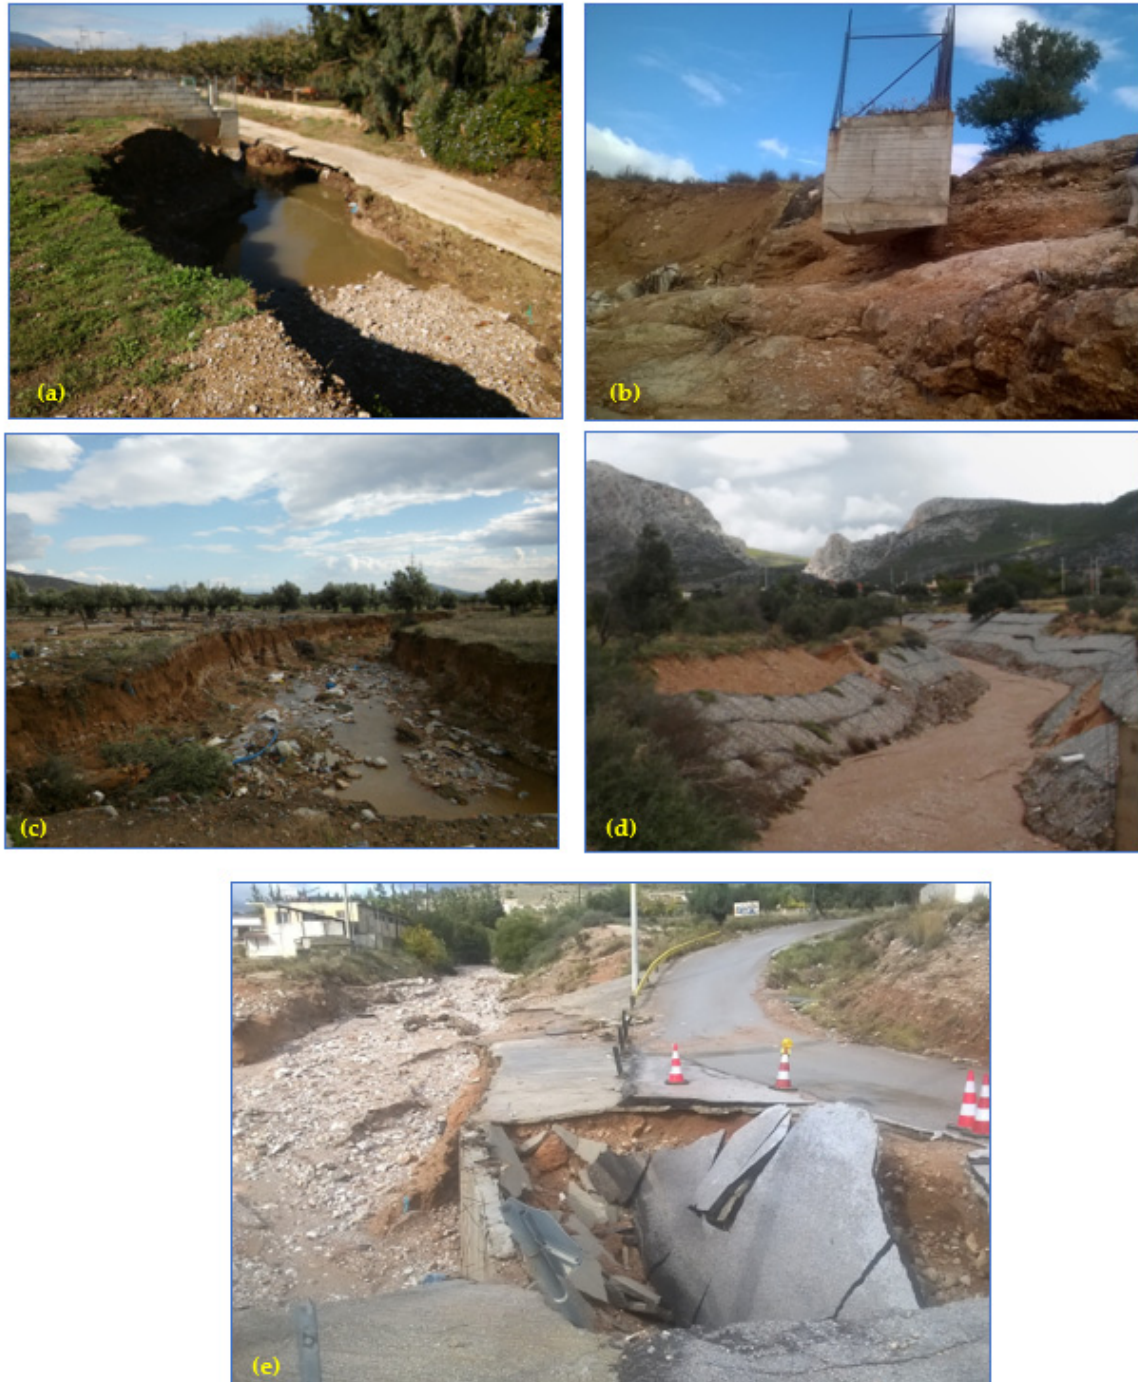
**Figure 5.** Those photos (e.g., 5a, 5b, 5c, 5d, 5e), show typical forms of slope and sub-slope erosion developed on Holocene deposits of the Mandra hydrological basin and they are located in Figure 1.

In the central beds of the streams of the two catchments of the Mandra and as the elevations and gradients decrease, gully erosion develops into slope and sub-slope erosion taking the form of a riverbank erosion feature (Figure 5). The strong flow of stream water detaches and carries materials from the foot of the slopes downstream, widening or deepening the bed [53]. The amount of erosion depends on the force of the water, the slopes of the bed, the meanders and bends it creates, and the erodibility of the geological formations through which the stream flows. The presence of vegetation or the local accumulation of coarse material in the streambed often diverts the main flow of the stream towards the slope, resulting in severe erosion. Slope and sub-slope erosion can be localized, as they usually develop perpendicular to the flow direction of the stream. Sub-slope erosion also is also created in the bed of streams, in places of abrupt changes in elevation, where small waterfalls are formed. These forms of erosion can be observed in almost all the main and some secondary branches of the hydrological network of the Mandra catchment areas. The intense runoff that caused the major flooding in Mandra in November 2017 led to extensive slope and sub slope erosion, resulting in the large widening of stream valleys and the removal of large volumes of material that were transported downstream. The slope and sub-slope erosion in the Mandra basin, primarily affects the Holocene deposits of the stream slopes, but at a second level also the Pleistocene deposits, with differential erosion of the less cohesive horizons.

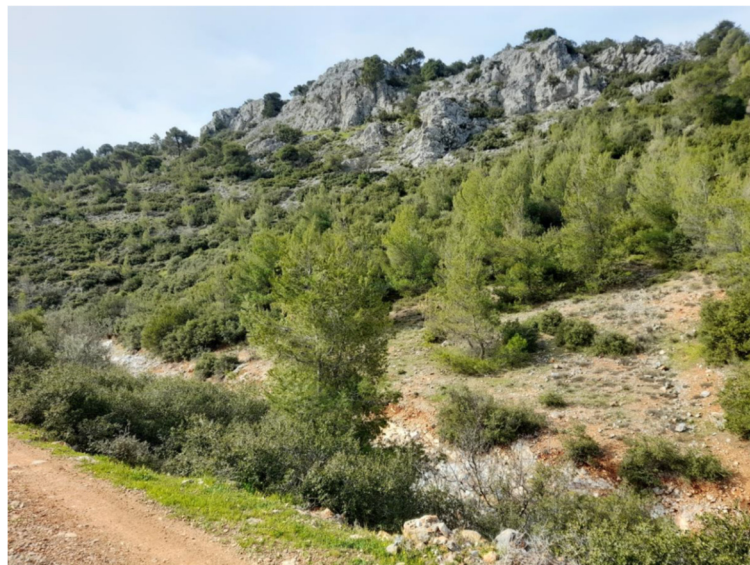
**Figure 10.** From a characteristic broader view of Mandra area, a partly soil erosion degraded area (located west of capital city of Athens, Greece) where a small dam is going to be constructed for coping against future (flash) flood events [75].

Particularly, given that the purpose of the interventions is to reduce flood risk and prevent catastrophic events, it was considered appropriate to limit the proposed measures to small dams, which are mainly of a preventive nature and aim to manage runoff effectively. These measures were considered to be the most appropriate proposal for the area, at least because they meet the requirements of being as low as possible in terms of cost and short implementation time. To be more specific, the types of the recommended dams are as follows (Figure 10):

- (a) Construction of sediment barriers is intended to be between 3m and 8m high with reinforced concrete or unreinforced concrete construction material. The purpose of these dams is to counteract the axial erosion of the bottom of the stream bed, by reducing the drag force of the water and retaining the sediment.
- (b) Construction of graduation dams - slope stabilization: These dams are proposed to be made of concrete (reinforced or unreinforced) or of reinforced wire mesh (e.g., sarsenet). The construction of the dams will be carried out either in places where there is evidence of gradual erosion, or in places where there is axial erosion of the bottom of the bed, in combination with the above-mentioned sediment barriers. The height of these dams according to the theoretical assessment carried out, is proposed to be between 1m and 2m.
