Welding under Service Conditions—Resulting Weld Quality and Fatigue Strength Assessment

Florian Begemann ^{1,*}, Johanna Müller ², Julian Unglaub ¹, Klaus Dilger ³, Klaus Thiele ¹ and Jonas Hensel ²

Abstract: Steel structures, such as bridges, must be continuously maintained. Due to increasing traffic loads, design and execution shortcomings, many steel bridges are subject to various types of damage, such as cracks. The bridges must be maintained by crack removal and re-welding the cracks. During this work, the bridge is closed for traffic in order to suppress the crack flank movement during welding. As a result, traffic loads on other routes are higher, which increases further damage on detour routes and subsequently additional welding work and costs on these structures. Therefore, the aim is to provide a method that allows welding work on steel structures under running traffic, respectively under cyclic loads. First, measurements at a representative steel bridge were conducted to derive gap opening parameters of amplitude and frequency for welding tests under cyclic loads. In a test setup for reproducible and comparable welding tests, specimens were welded under cyclic loads. D

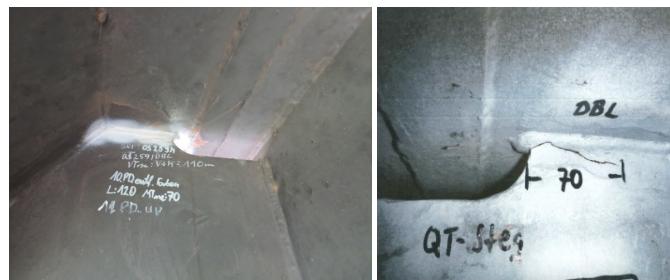
In addition to the increase in traffic, the vehicle weights, both of passenger cars and of goods and freight transports, have also become increasingly higher. Exceeding the maximum load capacity causes damage in the form of cracks, which are mainly located near weld seams. One detail that suffers from overloading is, for example, the connection between the cover plate and the cross member, as shown in Figure 1. Since the cover plate is usually only a few millimeters thick, it bends when vehicles pass over the weld seam on the cross member. This results in a high bending fatigue stress and the formation of fatigue cracks. Such a cracked weld seam is depicted in Figure 1.

Figure 1. Crack between cover plate and cross member

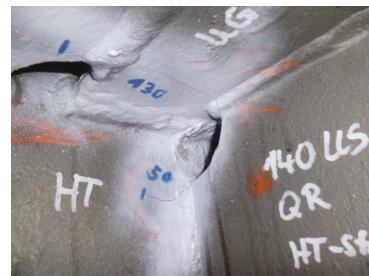
penetration [1]. In addition, the design of the parts to be welded was not suitable for execution. Many cracks occur on details with welds around free cuts, which is illustrated in Figure 3. Exposure of these cracks at welds around free cuts revealed welding defects such as impurities, slag inclusions and lack of fusion. These weld imperfections ultimately lead to crack initiation. [10].

Figure 3. Weld detail with poor accessibility

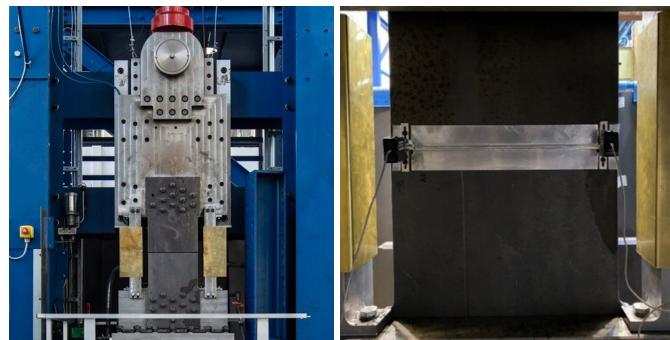
The test setup is equipped with a 1.2 MN force measuring sensor, a displacement sensor and an eddy current-based displacement measuring instrument. The force measuring sensor (type GTM serie RF) is integrated directly into the hydraulic cylinder via individually manufactured adapters. The displacement sensor (type Trans-Tek F-7) is a linear variable differential transformer (LVDT) based on an inductive measuring principle. The LVDT sensor is coupled to the hydraulic cylinder for rough positioning of the bearing slide, especially for specimen installation and removal. For the eddy current-based displacement measurement system, two displacement sensors (type Micro-Epsilon eddyNCDT 3300) are used to record the slide movement during the welding test. The fine displacement sensors are positioned under the bearing slide, on both sides next to the specimen as shown in Figure 13.

The fine displacement sensors only record the slide movement during the welding test. As soon as force is transmitted via the welding of the root layer, the relative displacement between the seam flanks is less than the actual slide movement, due to the elastic deformation of the specimens. Direct measurement of the relative displacement with the fine displacement sensors is desirable, but not possible due to thermal and mechanical influences. In order to detect the actual relative movement between the seam flanks, two clip-on extensometers (type MTS model 632-02F-20) are used during the welding test. As shown in Figure 13, these are attached to the back of the specimen directly at the level

Figure 13. (a) Front view of the bearing slide and the welding specimens in the test setup, (b) Back view of the welding specimens with the attached Clip-on extensometers

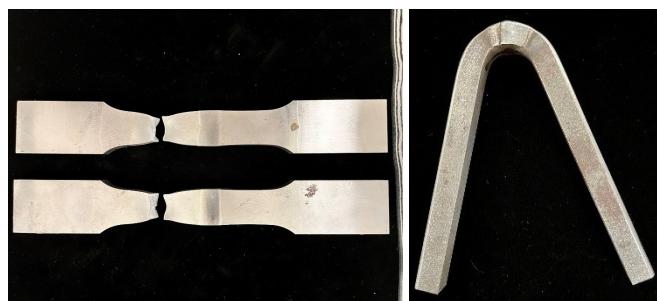
Tensile tests to determine the tensile strength were conducted with two specimens. Both specimens showed a tensile strength of 565 MPa and the failure was in the base metal, compare Figure 19 a). The bending test (lateral bending test transverse to butt weld) was conducted up to 145 ° and resulted in crack-free samples. After the successful implementation of the welding procedure specification, the welding parameters were applied to the manufacturing of fatigue test specimens.

Figure 19. Photographs of the samples after a) tensile testing and b) bending testing
