The Relative Values of a Moisture Percentage in Building Envelopes: Moisture's Spots With a Moisture Meter

Keywords: hygrothermal traits; moisture percentage; wall lining systems; moisture meter; building envelope

The Relative Values of a Moisture Percentage in Building Envelopes: Moisture's Spots with a Moisture Meter

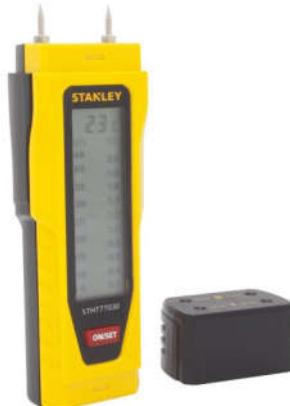
The experimental apparatus, which was used in the supervision and metering of moisture content on inner and outer wall surfaces of different building blocks, is a moisture meter 3 x CR-2032 Stanley Black & Decker, Figure 1. The moisture meter has a metering accuracy of 6-44 % for moisture content in wood. According to the engraved moisture numerical scale, the moisture meter can also estimate the moisture content in other materials: drywall, plaster, concrete, cement screed, and aerated concrete. The metering accuracy for moisture content in the aforementioned building materials is in the range of 0.2-2.0 %., Figure 2. The operating temperature storage for a moisture meter is in the range from -10 °C to 50 °C. The metering data notation lasts up to 1 minute. Comprising all metering boundaries of a gadget, it is the best that can be found on the market.

Figure 1. 3 x CR-2032 Stanley Black & Decker moisture meter.

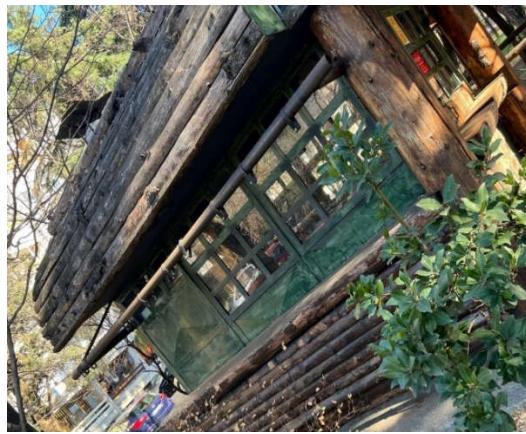
The local wooden log hut was subjected to the moisture percentage inquiry, which was executed by the moisture meter 3 x CR-2032 Stanley Black & Decker. The probes of the moisture meter were nailed to the wooden logs, on the outer side of the wooden hut., Figure 3. The columns of the log hut were huge trunks, and on the lateral sides of the log hut were thinner trunk pieces. A referent height for putting the moisture meter was 50 cm from the ground. The meterings of the moisture content were executed outwardly because the interior of a wooden log hut was not accessible. The key metering spots were selected, between 3 and 4. A metering day was pluvial.

Figure 3. The wooden log hut for a moisture percentage inquiry.

The wooden log hut outwardly absorbs the rainwater, due to the nature of the wood itself. A wood puffs up, when it contains more water within itself. According to the exposed data in Table 1., the right side of a wooden log hut was closer to the outdoor rain, and therefore the moisture percentage in the wood was maximal. Moving to the left side of a wooden log hut, the moisture percentage in the wood was much less, because of the existing canopy. The rainwater that did not get through the pores of wooden logs, leaked on the junctions of logs, as superfluous. The wood on its surface was cold since it was cooled by the rain and low outdoor temperature. The metering accuracy of 6-44 % for moisture content in the wood is a boundary condition for this field test.

The outer surface of the wooden log hut		Location on the house, 50 cm from the ground
Metering spots with a moisture meter	Moisture content in percentage (%)	
1. spot	44 %-45 %	right side
2. spot	40%-42 %	right side
3. spot	21 %	middle side
4. spot	25 %	left side

The wood of a wooden log hut was slightly truncated, and frayed, but there were no other signs of deterioration made by moisture.

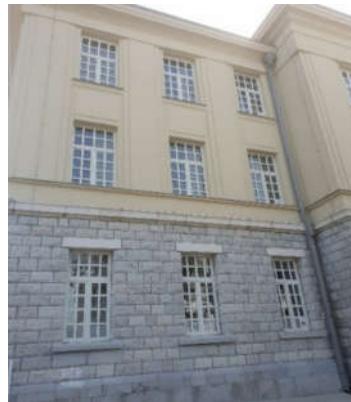
Under the moisture percentage inquiry were the inner and outer surfaces of a stone-sheeted building, Figure 4. The probes of a moisture meter were nailed to the stone, 80 cm above the ground. An exemplary building was edged with concrete at lower heights. The number of metering spots was arbitrarily determined. The metering day was with a clear sky and sunshine, given that the weather forecast was irrelevant to the measurements. A few parts of the exemplary building were in the shadow, the others in the sun.

**Figure 4.** The stone-sheeted building for a moisture percentage inquiry.

In Table 2. and Table 3 are given the moisture percentages on the outer surface and inner surface of a stone-sheeted building. An interesting fact is, that it was built in 1910th, which means that it belongs to the old massive constructions and building time with thick walls. A building was refurbished not so long ago. The data were collected only on the ground floor of a building.

The data from Table 2., point out that the outer surface of a stone-sheeted building was directly exposed and influenced by the sunlight. The metering spots on the stone tiles, at the outer surface of a stone-sheeted building that demonstrated 0% moisture were probably under the sun and relatively dry. The second metering spot on the stone tiles, at the outer surface of a stone-sheeted building, which demonstrated 0.20 % moisture presumably was in the shaded part of the building, retaining a neglected quantity of superficial water. According to the moisture quantity conversion table for different building materials, Figure 2., the superficial moisture content within stone tiles, of 0.2 %, matches the superficial moisture content within a plaster, which is taken as a dry surface of a wall or a dry finish material.

Taking into account the recent refurbishment of a stone-sheeted building and that it belongs to a building time with thick walls, there were no stains, peeling, or bubbles (blistering) on the inner wall surface of the building. The thickness of a stone-sheeted wall, d is up to 60 cm, which is a relatively thick wall for the present time. An inner wall surface was half coated with oily, (fat) paint. The clear sky and sunshine through the windows towards the interior of the building, have only intensified the dryness of the walls on that day.

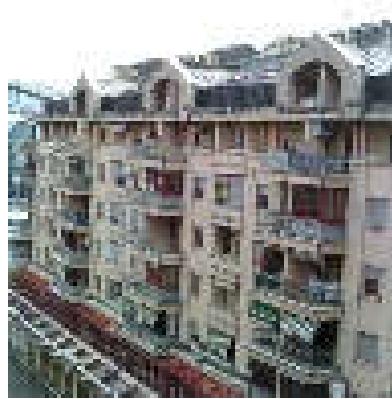
The spots for a moisture percentage inquiry of a masonry building were the inner and outer linings of a ground floor, landing (mezzanine floor) above the ground floor, and landing (mezzanine floor) beneath the ground floor. The accessibility of the metering area was confined, and therefore only on the ground floor, both surfaces were examined. The number of metering spots at each landing was arbitrarily determined, 50 cm from the ground, Figure 5. The metering day was pluvial.

Figure 5. The masonry building for a moisture percentage inquiry.

As for the ground floor of a masonry building, its inner surface absorbed lower quantities of moisture, according to the metering capacity of the used moisture meter. The numerals in percentage from Table 4. indicate the certain porosity of the inner surface, resembling the data from the column for plaster, in Figure 2.

Table 5. for the moisture percentage at the outer surface of a masonry building, at the ground floor, had similar data as in Table 4., prevailing in the 3. spot, probably because in that spot the building was more exposed to the outdoor rain and moisture source. The metering day was pluvial, so the water penetrated more easily from outside of the building.

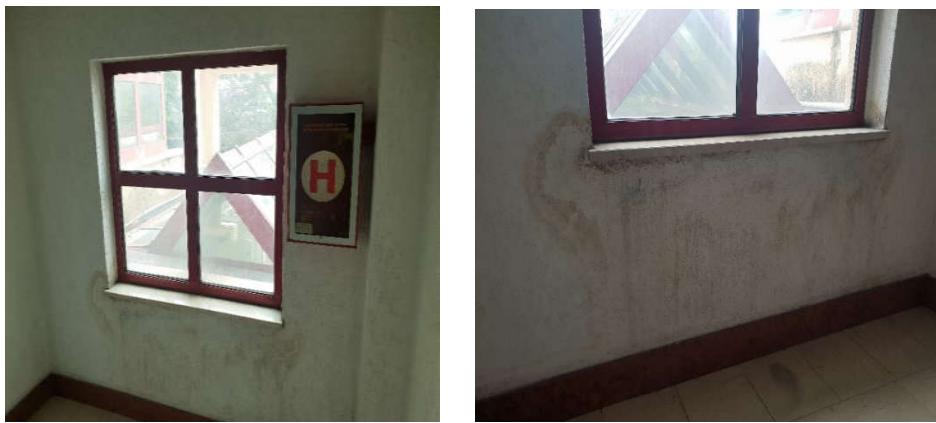
In Figures 6. and 7., the parapet wall at the landing, above the ground floor, was yellow-stained due to moisture condensation. The values of superficial moisture percentage in Table 7. are above average and slightly warning values. That means the air tightness of the window, the type of gasket, the thickness of thermal insulation, or the non-existence of the hydro insulation could be questionable at the parapet wall. During this building's potential renovation, the window and parapet wall above the ground floor should be considered for an upgrade or a total replacement. Figures 6. and 7. are examples of negative effects on building aesthetics, that had a moisture release.

Figures 6,7. The moisture percentage inquiry for a parapet wall, above the ground floor in a masonry building

In Table 7. are given the moisture percentage results at the parapet wall, above the ground floor in a masonry building.

Landing (mezzanine floor) above the ground floor, 1/2, 50 cm from the ground	
Metering spots with a moisture meter	Moisture content in percentage (%)
1. spot	1.50%
2. spot	1.60 %
3. spot	1.85 %

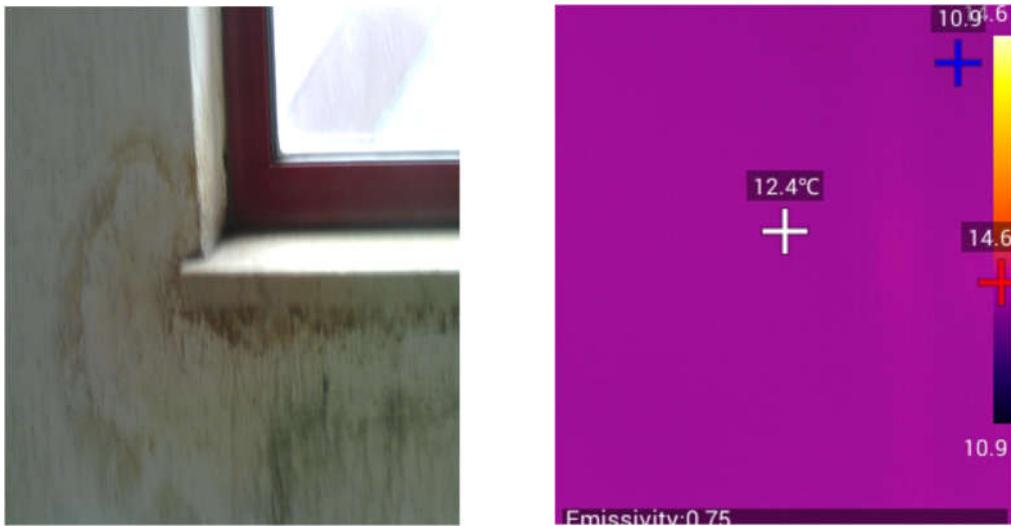
Additionally are given a closer photo of a moisture stroken area and its thermographic snapshot, the Figures 8. and 9.

Figure 8,9. A closer photo of a moisture stroken area at a parapet wall above the ground floor and its thermographic snapshot.

In Table 8. below, are exposed the thermographic values, related to the thermographic snapshot in the Figure 9.

Basic info	Details
Tmax	14.6 °C
Tmin	10.9 °C
Tavg	12.4 °C
Center Temperature	12.4 °C
Emissivity	0.75
Reflected Ambient Temperature	21 °C
Humidity	51 %

The numeric values from thermographic snapshots show that the inner surface of a parapet wall was a relatively cold, purple zone of the light spectrum. The lowest mapped temperature was 10.9 °C and the center temperature corresponded to the average measured temperature. The superficial identified humidity was relatively high, so it indicated the presence of moisture.

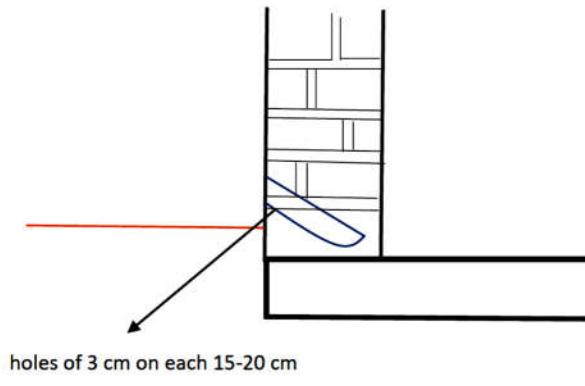
- The wall is drilled with a drill bit of the diameter 22 mm, at an angle of 30 °, with two lines of holes, at a distance of 15 cm. The first line of holes is 10 cm above the ground and the second line of holes is 25 cm above the ground. In the drilled holes, is placed as first the lime milk. The lime milk is placed through the funnel in the holes.
- After the lime milk, all holes are poured with the TP-Liquid Power-4MS for 4 to 5 days, several times per day. The holes are closed with the TP mortar. After crystallization, the waterproofing buffer in the wall withstands the water pressure of 7 bar.

In the figure below, Figure 10., the implantation of a waterproofing liquid is visible.

Figure 10. Setting up the horizontal waterproofing liquid, TP-LP-4MS (by author).

A waterproofing liquid TP-Liquid Power-4MS is used as a waterproofing coating for horizontal cutting of capillary moisture and water in concrete, stone, and brick walls.
