# The Buildings (Dis)pathology: Analysis of Management Tools for Building Maintenance Services

Keywords: maintenance management; failure; life cycle

# The Buildings (Dis)Pathology: Analysis of Management Tools for Building Maintenance Services

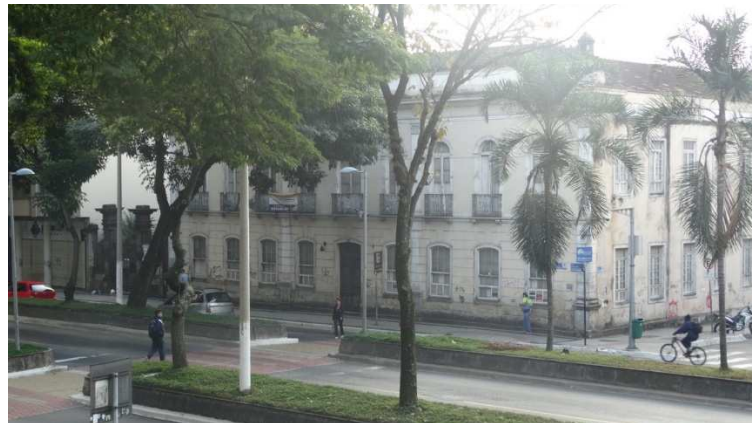
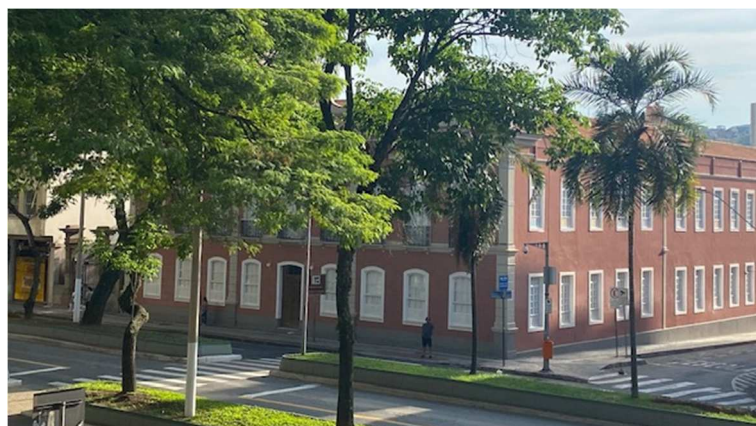
**Figure 4.** Delfim Moreira School.

Delfim Moreira School, see Figure 4, stands as a testament to Brazil's architectural heritage during the late 19<sup>th</sup> and early 20<sup>th</sup> centuries, Situated in Juiz de Fora city, Minas Gerais, this historic building serves as a vivid reminder of the past. The mansion's main façade exudes an elegant symmetry, characterized by three distinct panels flanked by prominent pilasters topped with Corinthian capitals. These panels are seamlessly interwoven with a rhythmic sequence of elongated spans, with the parapet windows taking center stage. However, these windows have seen better days, now appearing weathered and worn [7].

On the ground floor of the façade, the windows boast lintels and superlintels in a graceful arched design, framed in wood. The wooden sills, slightly protruding outward, add a touch of character.

The windows are further adorned with a delicate frame that gracefully surrounds the entire perimeter, seamlessly integrating with the masonry for a polished finish.

(a) January 2020, before rehabilitation [7].

(b) October 2023, after rehabilitation.

When it comes to preserving this architectural gem, the primary challenge lies in dealing with the pervasive issue of moisture. The passage of time has exposed these venerable structures to numerous cycles of wetting and drying, significantly impacting the integrity of their materials. To safeguard this historical treasure, meticulous attention must be paid not only to investigative processes but also to the material's response to these environmental factors.

One of the primary determinants impacting the preservation of this building is the ever-present challenge of moisture infiltration. Addressing this issue necessitates careful consideration of investigative processes, as well as a thorough understanding of how various building materials interact with moisture, as outlined in [7].
