# Assessing Conservation Conditions at La Fortaleza De Kuelap, Peru Based on Integrated Close-Range Remote Sensing and Near-Surface Geophysics

**Abstract:** In this article, we combine datasets from multiple research projects and remote sensing technologies to evaluate the conservation conditions of La Fortaleza de Kuelap, a pre-Hispanic monument in Peru's northeastern Andes that suffered significant damage during historically high seasonal rains in April 2022. Our analyses seek to identify the main causes of the collapse and locate places where the monument is likely at risk of further deterioration. To do so, we model surface hydrology using a digital elevation model (DEM) derived from drone LiDAR data, reconstruct a history of previous collapses, and calculate the volume of the most recent by fusing terrestrial LiDAR and photogrammetric datasets. In addition, we examine subsurface water accumulation through electrical resistivity data, reconstruct the stratification of the monument from seismic refraction data, and analyze vegetation loss and ground moisture accumulation using high resolution satellite imagery. Our results point to water accumulation as the most significant sou

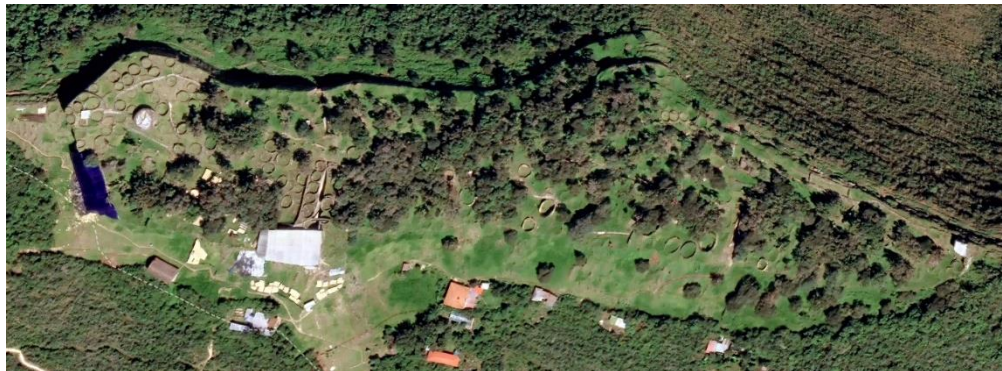
**Figure 8.** La Fortaleza on a Google Earth Pro image from June 2022 (source: Google Earth ©).

A cursory analysis of historical satellite images available on Google Earth Pro reveals ongoing deforestation at the top of La Fortaleza (**Error! Reference source not found.**). Even more dramatic changes can be observed by comparing the present state with aerial pictures from 2000 (Figure 1), showing that, relatively recently, most of the top of La Fortaleza was densely covered by vegetation, save for areas around the gates and the main buildings, such as Plataforma Circular, Templo Mayor, and Torreón.

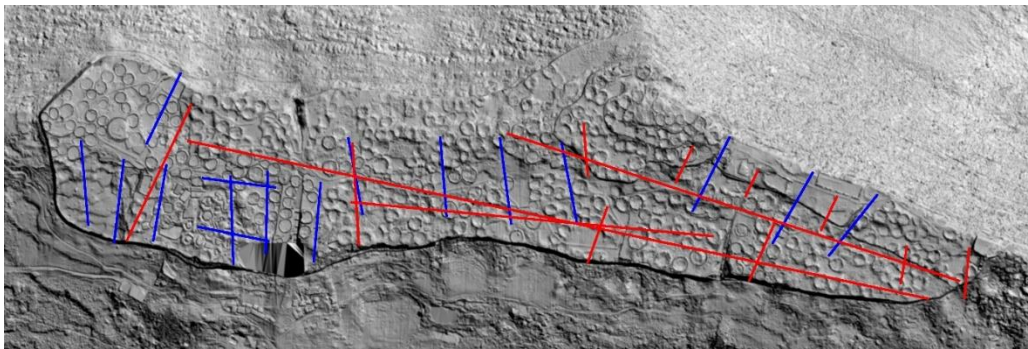
**Figure 9.** Location of geoelectrical profiles. Blue – ALEPH Asociados [80]; Red – Mori [78]. Data assembled by Kościuk.

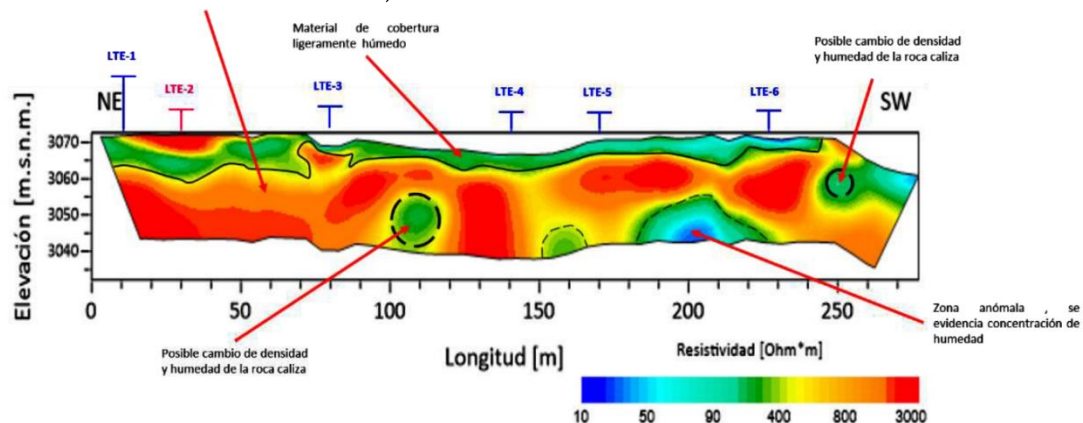
**Figure 10.** Example of composite ERT profile, incorporating results from transects LTE-1 through LTE-6 (Mori [78]).

The results of the application of ERT and VES in these three geophysical surveys are consistent and complementary to each other. Due to the quality of graphics available, the illustrations of further analyses of resistivity data in this study are based on the ERT data collected and processed by Mori (**Error! Reference source not found.**).

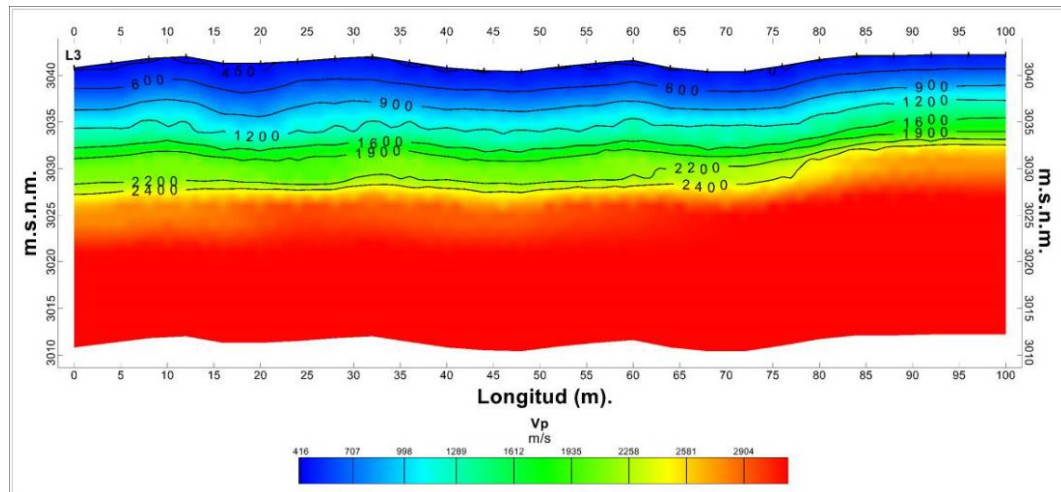
**Figure 11.** Geo-seismic profile LS-03, representative of La Fortaleza (Mori [81]).

In 2023, Mori developed a geo-seismic profile of La Fortaleza (**Error! Reference source not found.**), by measuring with an array of geophone sensors, the variations in the velocity of the primary compression waves generated by 40 seismic refraction lines, evenly divided between 50 m and 100 m arrays [81]. The technique is used to interpret the depth and composition of soils and rocks, to characterize subsurface geologic conditions and stratification. With this data, Mori modeled in 3D the bedrock under the platform and estimated the size of the fill.

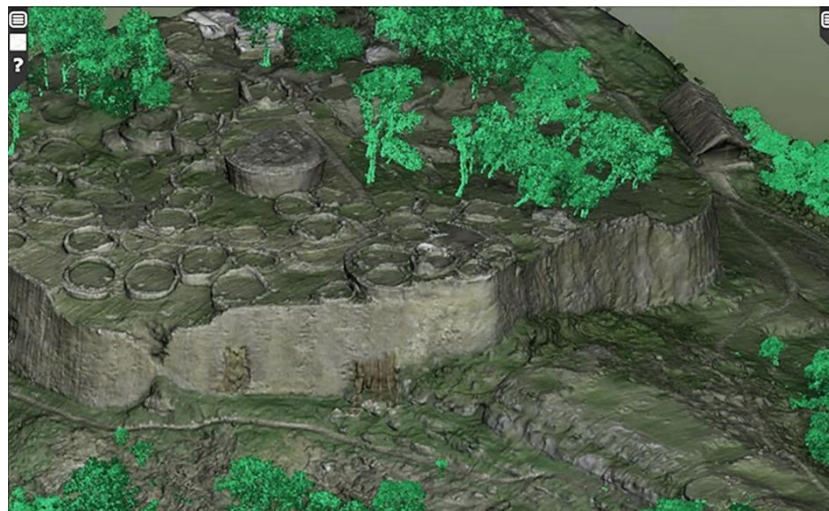
**Figure 15.** Filtered and classified LiDAR data covering La Fortaleza. Data previously reported by Righetti et al. [74,75].

As already mentioned, our data source for describing the terrain and architectural remains atop La Fortaleza was the UAV LiDAR survey provided by MEDS AMSTERDAM. The primary data filtering and classification processes were conducted with ATLAS ([www.theatlasgis.com](http://www.theatlasgis.com)), proprietary software created by MEDS AMSTERDAM (**Error! Reference source not found.**).

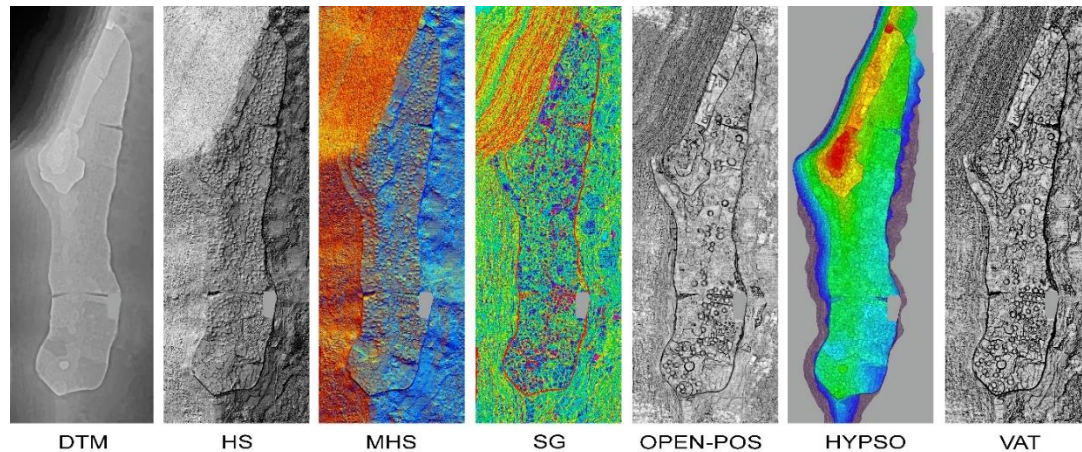
**Figure 17.** Examples of different visualization modes of LiDAR data: (DTM) 10 cm resolution digital terrain model; HS - unidirectional hill-shading (azimuth 315°, vertical 35°); (MHS) multidirectional hill-shading (8 directions, vertical 30°); (SG) slope gradient (no parameters required); (OPEN-POS) openness-positive (search radius 10 pixels, 16 search directions); (HYPISO) 5cm resolution 3D model colored with elevation data; (VAT) general terrain Archaeological Mixer (sky-view factor, multiplication 25% opacity blending mode; openness-positive, overlay 50% blending mode; slope gradient, luminosity 50% blending mode; analytical hill shading, normal blending mode 100%). Based on LiDAR data from MEDS AMSTERDAM, prepared by Ćmielewski and Kościuk.

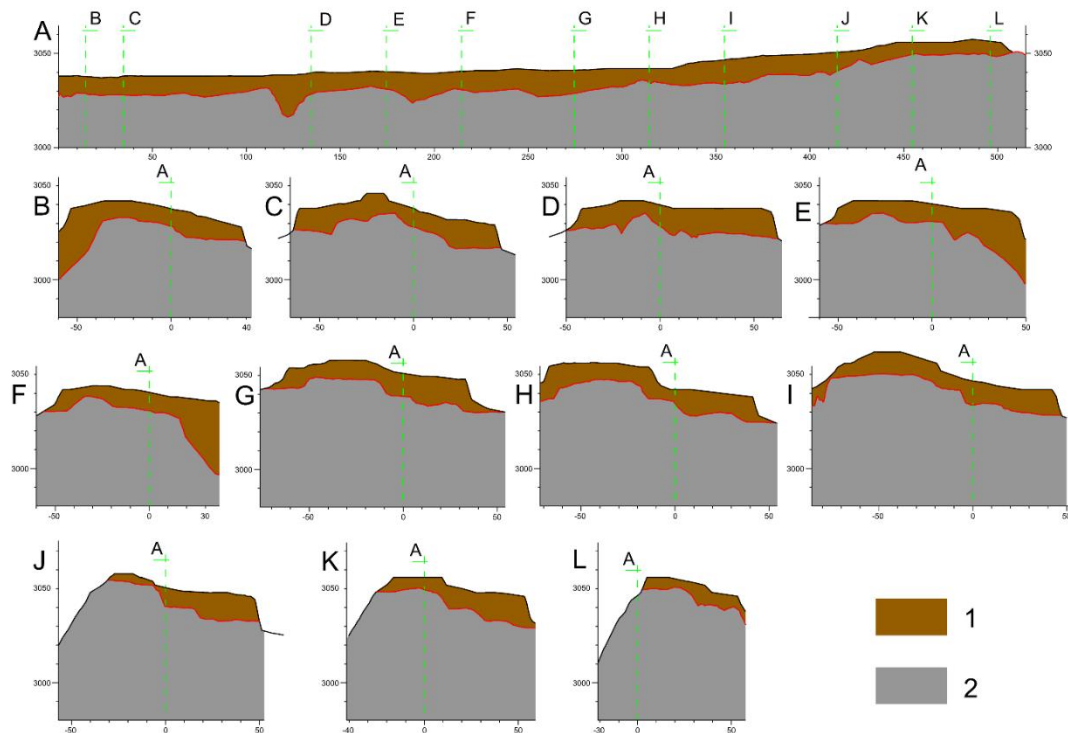
**Figure 21.** Stratigraphic sections of La Fortaleza based on the processing of seismic refraction data. 1) Construction fill; 2) Limestone bedrock; A) Longitudinal section. B) – L) Transversal sections.

The measured variations in the velocity of the primary compression waves ( $V_p$ ) generated by the seismic refraction lines were processed using the applications SeisImager2D, version 3.3 and Easy Refract, version 20.4.518, to generate 2D geoseismic profiles of La Fortaleza (**Error! Reference source not found.**). To estimate the volume of the existing construction fill, the resulting stratification was reclassified into two major strata: the construction fill, composed of limestone blocks and argillaceous clay plus the topsoil, as a single unit, and the underlying limestone bedrock (**Error! Reference source not found.**). To estimate the difference between both strata Mori used the application Oasis Montaj, version 9.3, to model in 3D and in high resolution the current surface of La Fortaleza's platform and of the bedrock, using as a point of contact with the bedrock a  $V_p$  speed of 2000 m/s. Finally, the 3D surfaces of the bedrock and the current surface were analyzed in AutoDesk Civil 3D 2023, and from the difference between both, the volume of the existing construction fill was calculated at approximately 600,000 m<sup>3</sup>.

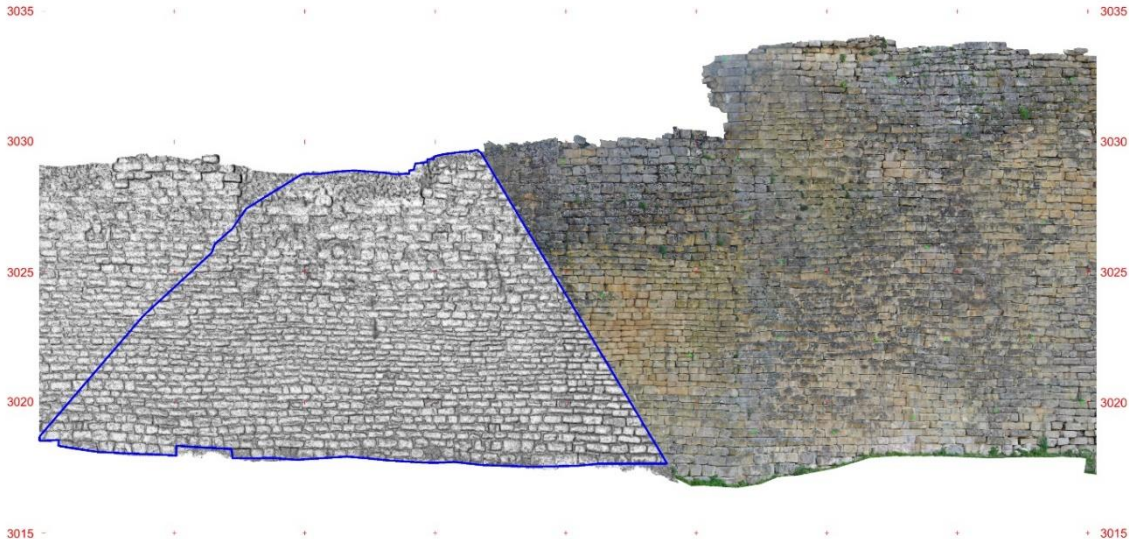
**Figure 22.** Sample of the fusion of digital photogrammetry and TLS data at the southeastern corner of La Fortaleza’s perimeter wall. Blue lines - overlap between TLS and photogrammetric projects; green crosses - ground control points for photogrammetric project. TLS 3D point cloud data from Kucera, VanValkenburgh and Rojas. Elaborated by Kościuk.

Recent advances in the fusion of digital photogrammetry and TLS data offered by AgiSoft Metashape 2.0.4 render this working path even more efficient [88,89]. Given a sufficient overlap between TLS and photogrammetry projects, and supplying well-spaced and equally distributed ground control points, such integrated documentation can provide a fast and accurate source for a more detailed study (**Error! Reference source not found.**).

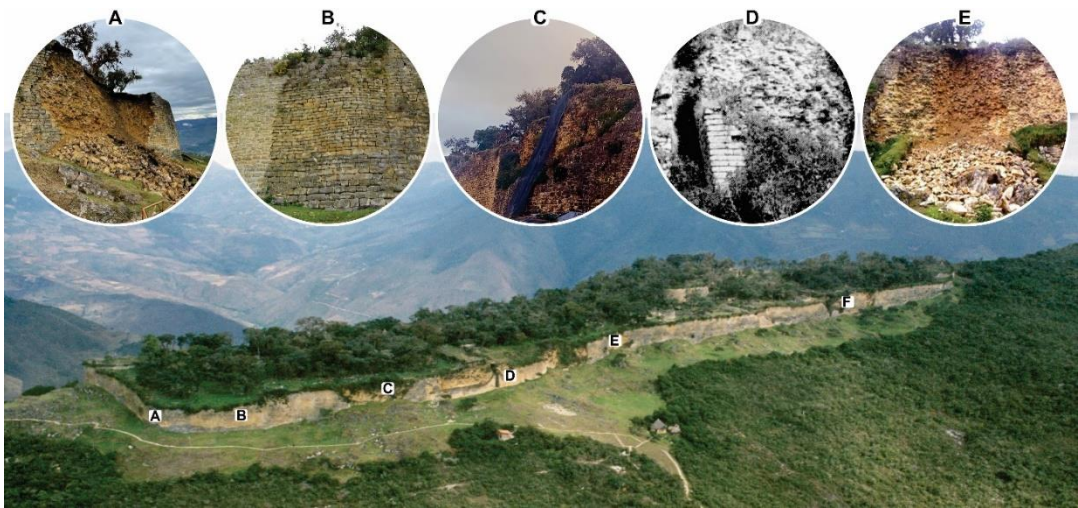
**Figure 24.** Aerial view of La Fortaleza in 1995, indicating some episodes of collapse recently documented. A) 10-11<sup>th</sup> of April, 2022; B) Pre-Hispanic collapse and repair; C) June-July 2023; D) 1910-1933; E) April 2013. F) Date unknown. Photograph by M. Chumbe.

Our review of background information and the ground-truthing of features detected in our remote sensing surveys reveal ongoing stability problems at La Fortaleza, reported since the late 19<sup>th</sup> century. We have begun to document the long history of collapses on the perimeter wall [73]. Obviously, this history is very incomplete, and more populated for the past 100 years. Nevertheless, we have evidence, which will be discussed in detail on section 4.5.3, of a massive pre-Hispanic collapse, involving an area of at least 1750 m<sup>2</sup> on the eastern half of the Southern Sector of La Fortaleza (**Error! Reference source not found. B**). Photographs published in the reports of various explorers and visitors [14,32,40,64,69,71] reveal that, between 1910 and 1933, a large collapse occurred on the east perimeter wall of the Southern Sector, just north of Acceso 1 (**Error! Reference source not found. D**). The above-mentioned 2013 collapse affected the eastern perimeter wall north of Acceso 1 (**Error! Reference source not found. E**). Finally, the April 2022 collapse (**Error! Reference source not found. A**), which occurred during an exceptional period of precipitation [27].

This fragmented history of collapses at La Fortaleza reveals the fragile state of the perimeter wall, and indicates that its structural instabilities long predate the 2022 crisis, affecting mostly the southeastern quarter, despite decades of conservation efforts. One important reason for this is the shape of the underlying limestone bedrock: it has been characterized by inclinations or dips towards the east (**Error! Reference source not found.**) [27,72,82] and south (**Error! Reference source not found.**), which Mori modeled for this research processing seismic refraction data. The combination of these two dips in the underlying limestone, the low permeability of this type of rock, and the high rates of rainfall infiltration of the layers above [84], create geotechnical conditions that strongly influence the geomorphological processes and groundwater circulation at La Fortaleza, favoring a trend for the preferential distribution of sub-surface water towards its southeast quadrant. To this characterization one must add topographical conditions resulting in surface rainwater flowing mainly towards the eastern perimeter walls.

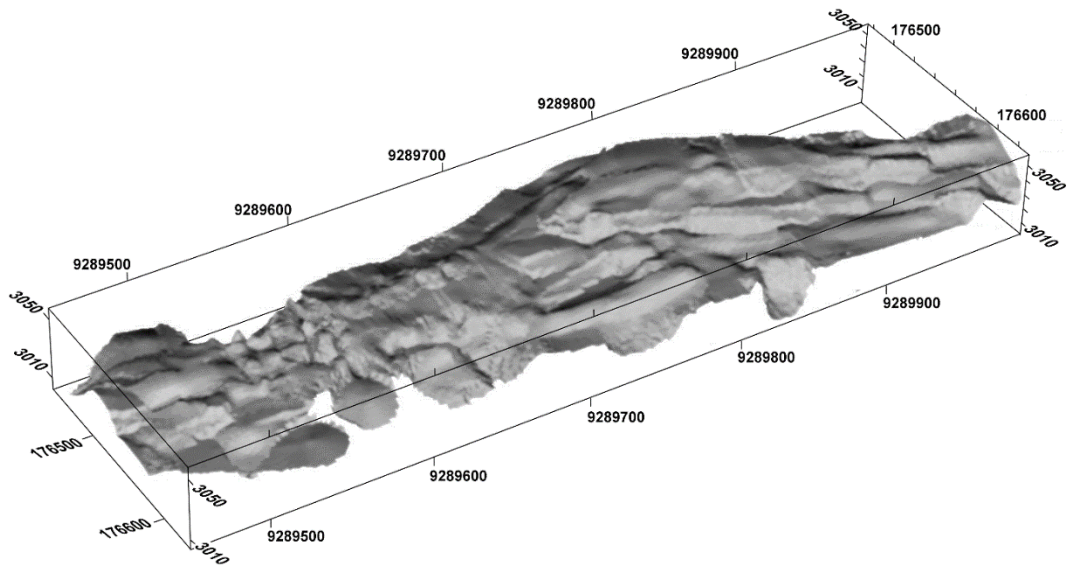
**Figure 25.** 3D model of the surface of the limestone bedrock underneath La Fortaleza de Kuelap.

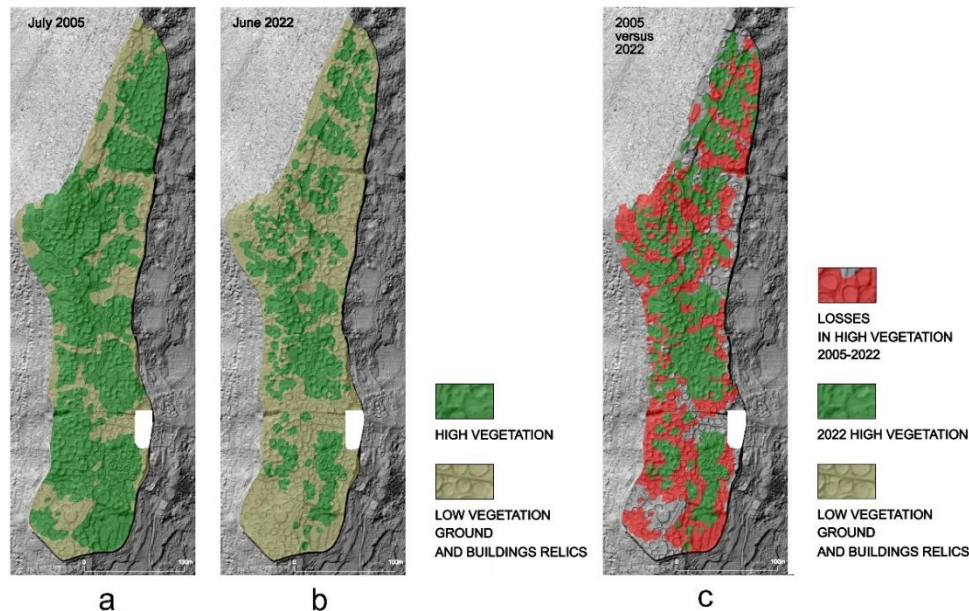
**Figure 26.** Deforestation at La Fortaleza between 2005 and 2022: (a) High vegetation extent in 2005; (b) High vegetation extent in 2022; (c) Changes in high vegetation extent between 2005 and 2022. Prepared by Kościuk.

Background research reveals two at least partially successful initiatives to clear-cut Kuelap's trees and shrubs during the late 19<sup>th</sup> century, and a successful clear-cut during the mid-20<sup>th</sup> century. Satellite image research at La Fortaleza (Figure 14) has permitted the documentation of a significant change in its forestation between 2005 and 2022. As shown by the comparison in **Error! Reference source not found.**, the area covered with tall vegetation has decreased by approximately 30%. Whereas the management of heritage sites must seek a compromise between protecting the built heritage and preserving its environmental context [110], the change observed may have well affected the permeability and absorptivity of the ground.

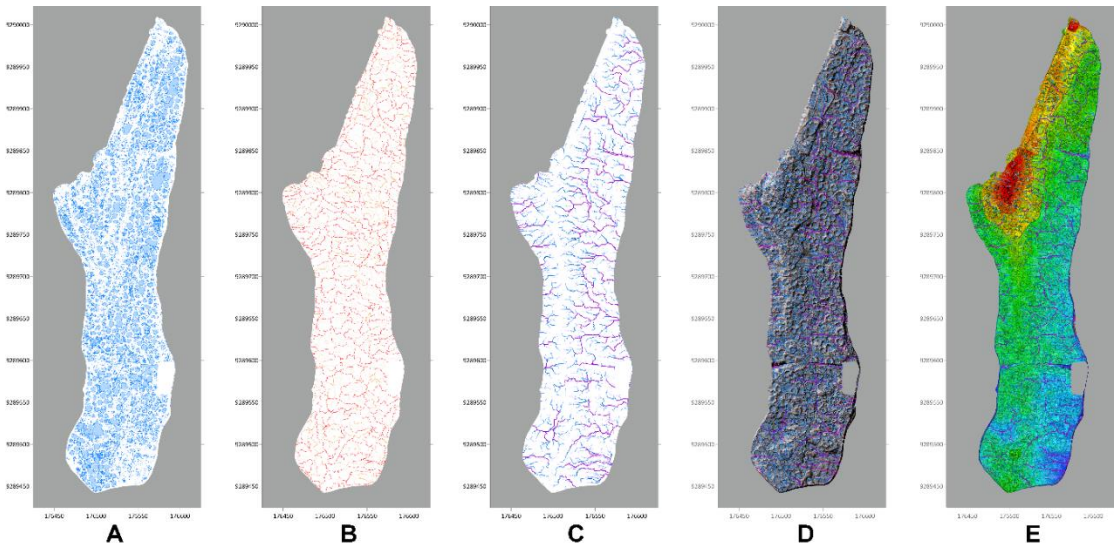
**Figure 27.** Hydrological analysis based on DTM: (a) local depressions; (b) primary and subsidiary catchments; (c) rainwater flow accumulation lines (the intensity of the colors represents the catchment size from which rainwater is drained); (d) depressions, catchments, and flow lines superimposed on a hillshaded 3D model; (e) the same as (d) but with the hypsometric model in the background. Prepared by Dąbek and Kościuk.

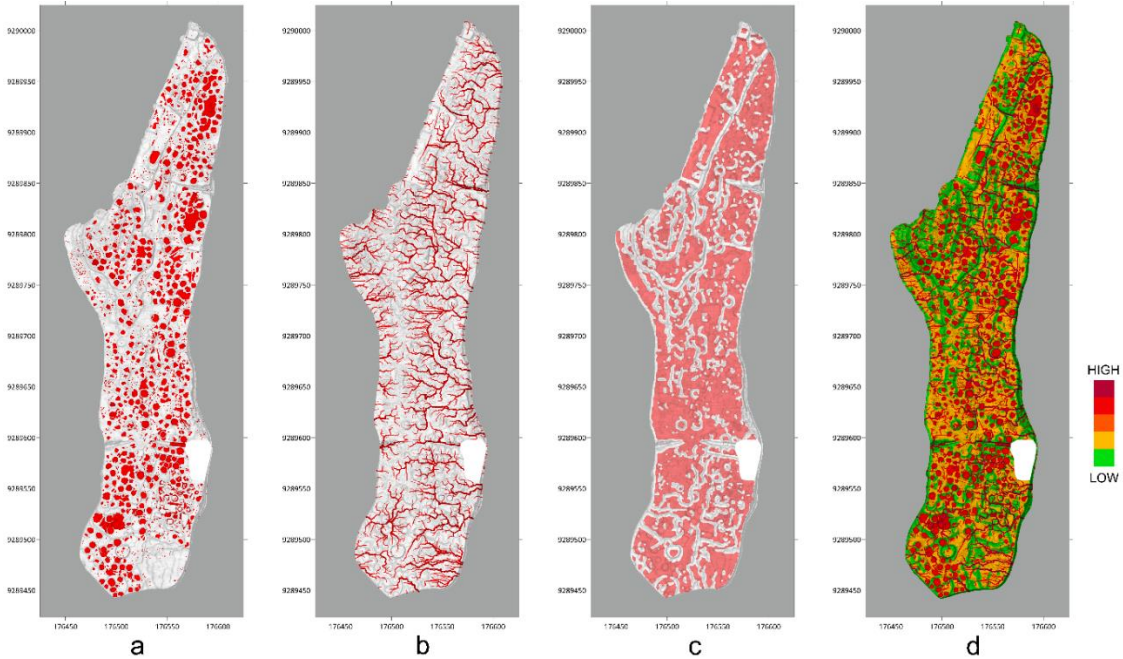
**Figure 28.** Risk maps caused by precipitation, with terrain relief in the background: (a) Depressions; (b) Rainwater flow accumulation lines; (c) Terrain with an average slope of less than 5%; (d) Accumulated risks. Prepared by Kościuk.

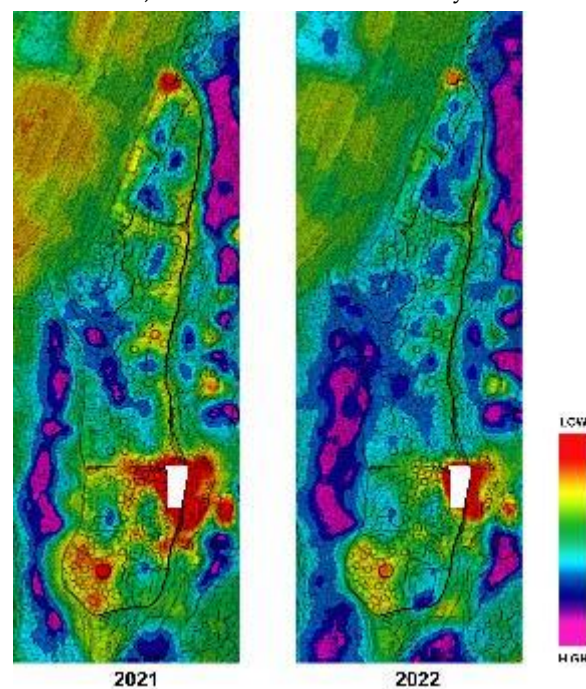
**Figure 29.** Ground moisture analysis based on Normalized Difference Water Index (NDWI). Primary data source: Sentinel-2 L2A satellite. Prepared by Kościuk.

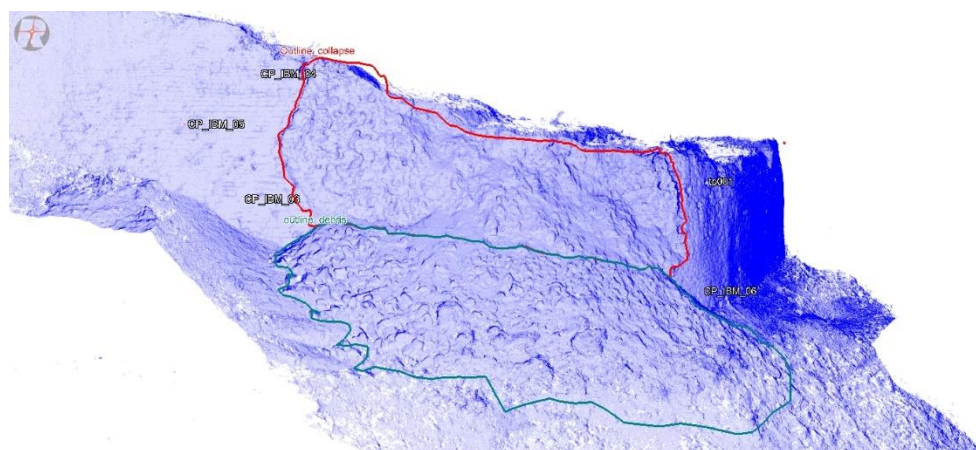
**Figure 31.** Integrated TLS, ALS, and IBM model of the collapsed perimeter wall (red outline) and corresponding debris (green outline) on the southeastern corner of La Fortaleza, centered on the collapsed area. The indicated control points are derived from TLS data from 2019 by Kucera, VanValkenburgh and Rojas. Prepared by Kucera. Image data courtesy of R. Vigo and N. Vargas.

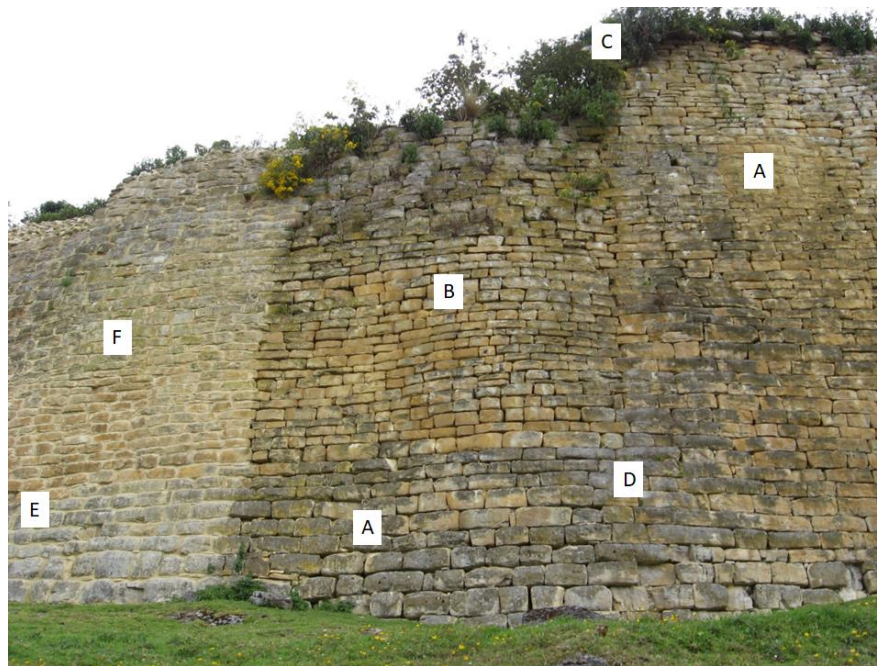
**Figure 32.** Evidence of pre-Hispanic collapse and rebuilding on the southeastern perimeter wall of La Fortaleza. A) perimeter wall in its original height and condition (notice the original eaves at the top of the wall); B) partially rebuilt perimeter wall, with stonework different from A; C); difference in wall height between original and rebuilt sections; C-D) zig-zagging vertical margin between the original (A) and rebuilt (B) perimeter wall sections; D-E) horizontal margin between the original (A) and rebuilt (B) perimeter wall sections, or leveling layer; F) rebuilt perimeter wall, with conservation mortar added by repointing. Photograph by Church (2007).

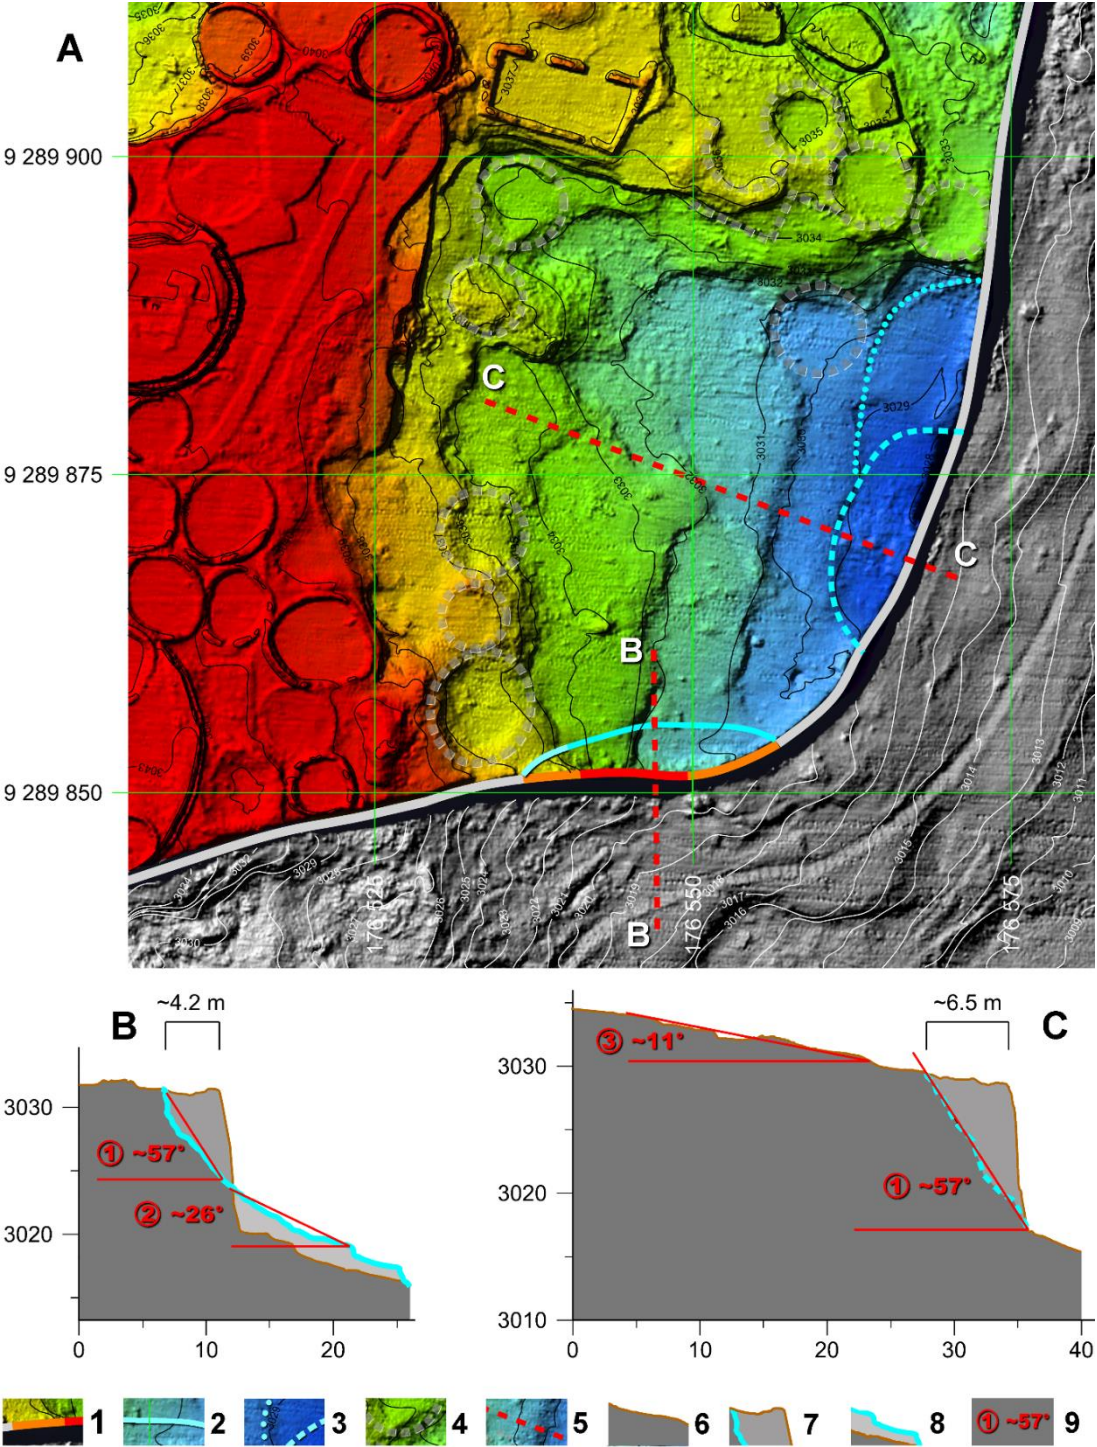
**Figure 33.** The region of the April 2022 collapse in the southeast corner of La Fortaleza: (A) hypsometric plan; (B) profile B-B (data by Kucera); (C) profile C-C; (1) collapsed part of the perimeter wall; (2) horizontal extent of the April 202 collapse; (3) horizontal extent of hypothetical pre-Hispanic collapse and its northern extension; (4) ground imprints from dismantled or destroyed circular buildings; (5) profile locations; (6) preserved surface of the La Fortaleza platform; (7) splinter wedge; (8) loose landslide debris; (9) slope inclination angles. Elaborated by Kościuk.

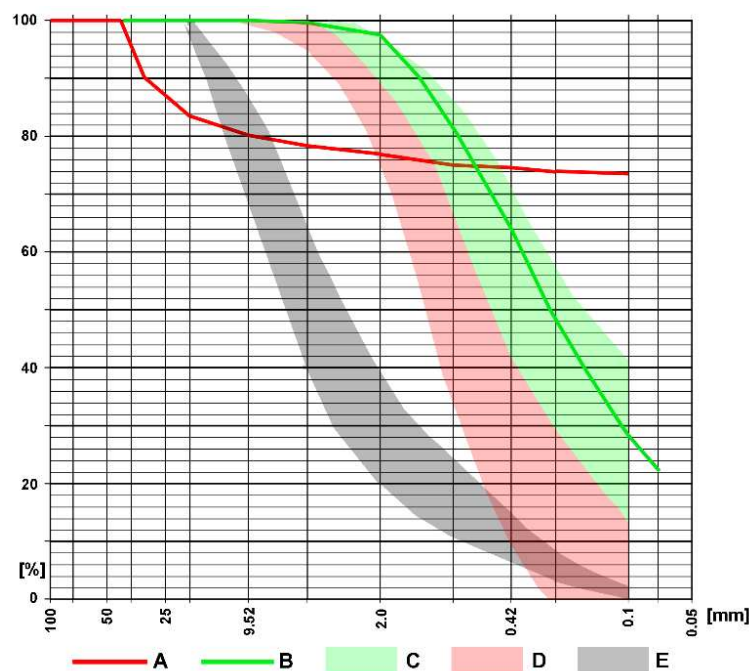
**Figure 34.** Comparison of grain size curves; (A) average of samples of the original mortar used in the construction of La Fortaleza's walls\*; (B) modern mortar used for conservation of La Fortaleza's walls\*; (C) typical grain size curves of sandy-clay soil and loam-clay soil; (D) typical grain size curves of sandy-clay soil and sandy-gravel soil; (E) typical grain size curves recommended for modern construction mortars. \*Source data from UNESCO (2022). Elaborated by Kościuk.

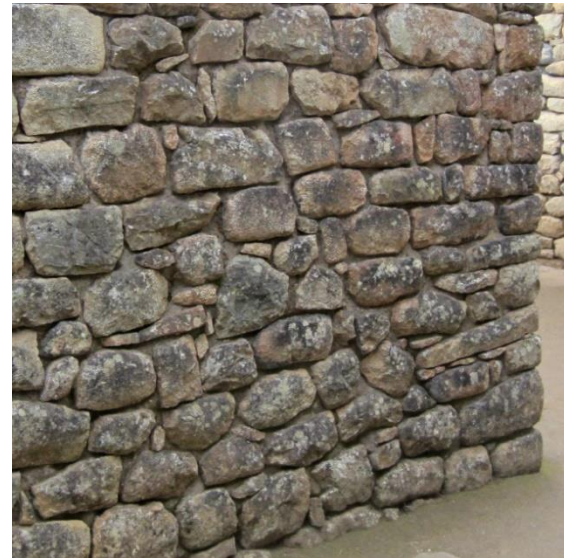
B

**Figure 35.** (A) Cracks (red arrows) in the stone blocks of the La Fortaleza retaining wall observed in February 2020. Photo by Kościuk; (B) Machu Picchu. An example of repointing a wall using clay-earth mortar. Photo by Kościuk.
