Static and Dynamic Testing of Sei Dareh Cable-Stayed Bridge West Sumatera, Indonesia

Abstract: The Sei Dareh Bridge is a cable-stayed bridge located in West Sumatra Province, Indonesia. The bridge, which crosses the Batanghari River, has a main span of 123 meters long and 9 meters wide. Traffic load is transmitted through 24 prestressed cables to a 42.4-meter-high pylon made of concrete. The bridge deck and traffic loads are directly supported by steel box girders as main beams that are reinforced laterally with cross beams IWF 800.300.16.24 and stringers IWF 350.350.12.19. This paper discusses static and dynamic testing on the bridge which aims to assess its feasibility before it is opened to the public. Based on the test, it was concluded that a static load of 73% could not be achieved because the deflection that occurred was beyond the allowable deflection. This is exacerbated by a loud clanging sound on the ST2-X1 prestressed cable when loading to 240 tons or 58% of the targeted load. In addition, this bridge is included in the "lazy bridge" category because it takes 24 hours to return to an undeformed condition after loading. As a recommendation for this bridge, it is necessa

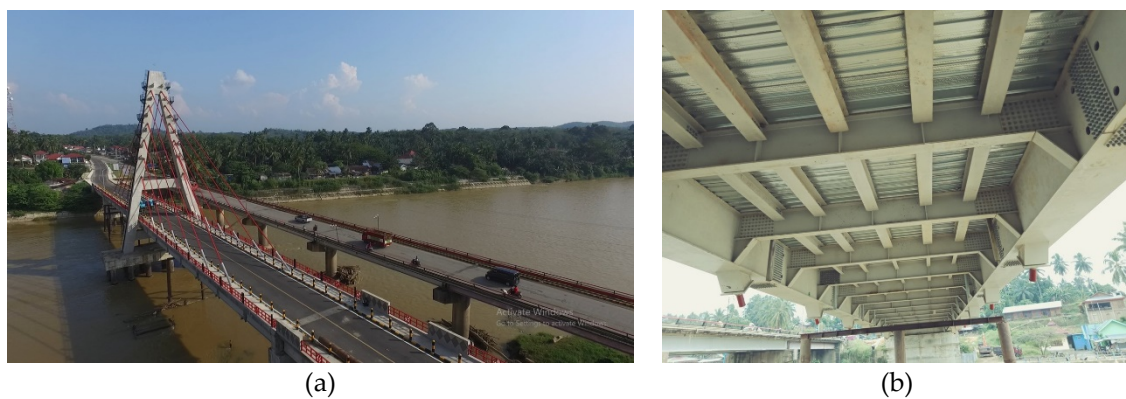
Figure 2. (a) Aerial photo of Sei Dareh Cable-Stayed Bridge; (b) Structural Deck of the Bridge.

The Sei Dareh Cable Stayed Bridge is a new bridge built next to the existing bridge which is intended to unravel the congestion of road traffic. The location of the bridge is in West Sumatera Province, Indonesia. Figure 1 shows a map of the bridge location and an aerial photo. Figure 2 (a) shows an aerial photo of the Sei Dareh Bridge, while Figure 2 (b) shows the structural deck of the bridge. The bridge that connects two riversides of Batang Hari River is 123 meters long and 9 meters

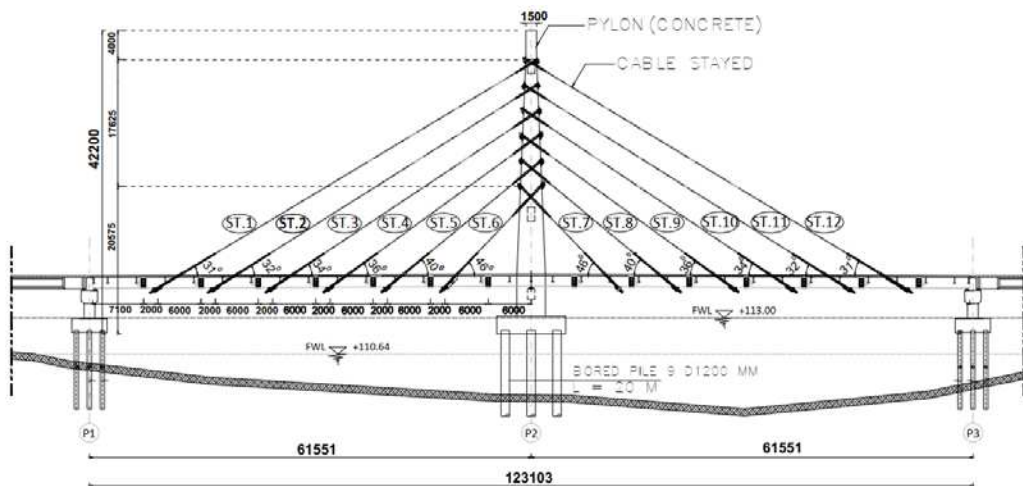
Figure 3. Side View of Bridge.

wide, and the pylon height is 42,4 meters as shown in Figure 3 and cross section in Figure 4 (a). The main girder on the deck structure of the bridge uses a steel box section, while the transverse and longitudinal girder uses IWF steel sections with a minimum yield and breaking stress of 490 MPa and 610 MPa, respectively on cross section of the deck structure as shown in Figure 4 (b). The grade of the concrete used in the pylon is 30 MPa. In addition, the prestressed cables have a modulus of elasticity of 195000 MPa, and A416-270 material is used (normal relaxation strand). Detail of material property and force for each cable is attached respectively in Table 1 and Table 2. Then, the bridge was performed by static and dynamic tests which have different objectives and methods that will be explained in the next section.

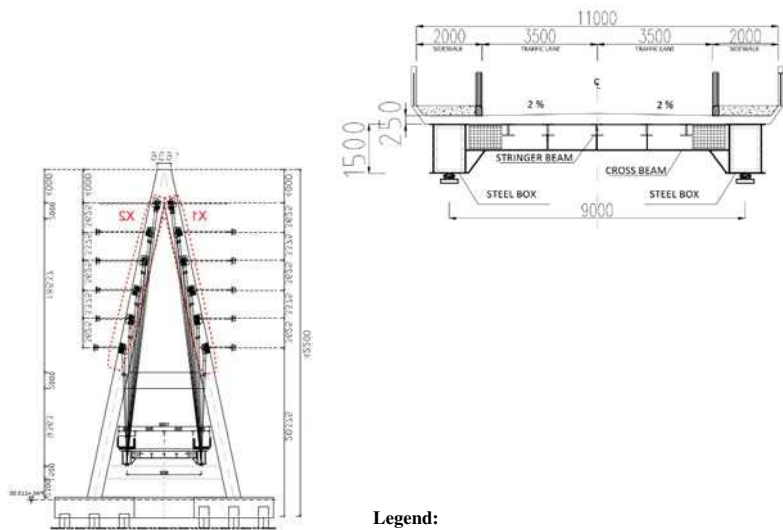
Figure 4. (a) Cross Section of Pylon; (b) Cross Section of Deck Structure.

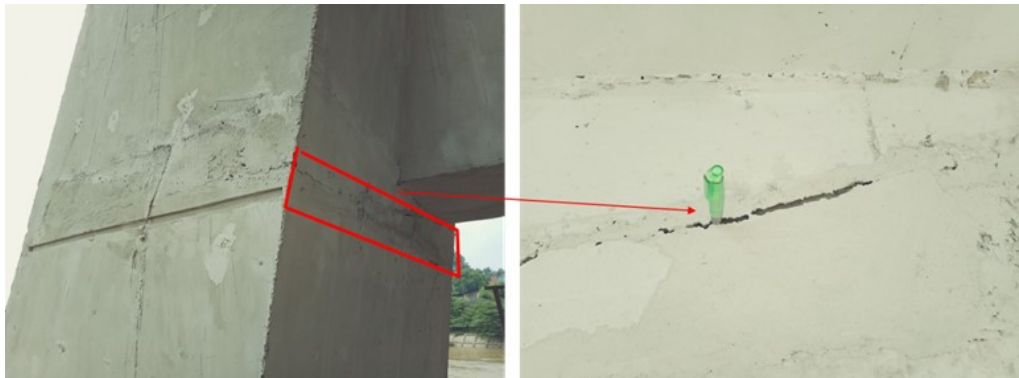
Figure 5. Part of the pylon with unfilled concrete.

In general, the load test on this bridge begins with a visual inspection which aims to ensure that the structural components are properly installed and ready to be loaded, such as bolts between joints, stay cable, etc. Then the static and dynamic load testing was carried out and ended with a final visual inspection. Based on the visual inspection that was carried out before the test, it was found that the general conditions of the structural elements were in fair condition with unfilled concrete about 10 mm on the pylon as shown in Figure 5. However, this had been repaired before the test.

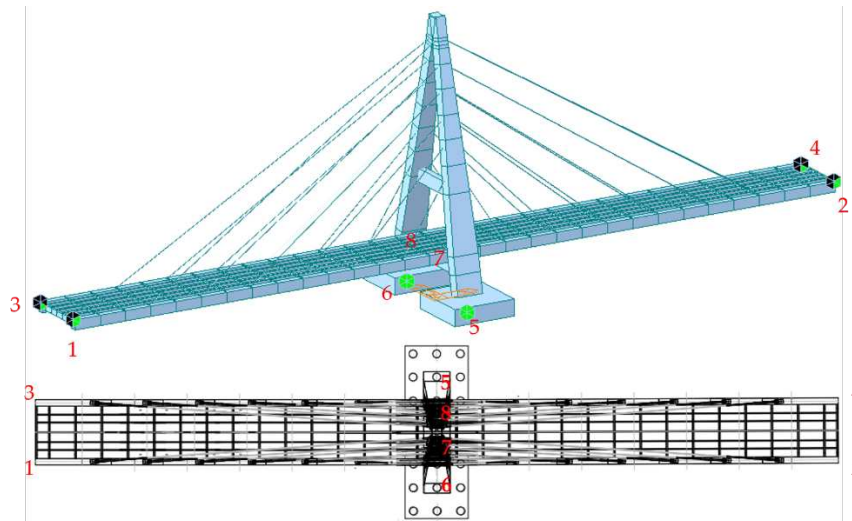
Based on Figure 6, the scope of the 3D model is just on the upper structure and pile cap while the bored pile is not modeled. The upper structure components consist of the deck structure, pylons, cables, and slabs. The deck structure consists of steel box elements, cross girders, and stringers that are modeled in the software as “Beam” elements so that these elements can experience bending, shear, and axial forces, likewise on the pylon model. Meanwhile, the cable component is modeled as a “Tension only” element so that the element can only encounter axial tension and the initial tension force of the cable can be adjusted. The slabs were modeled as “thin-shell” without auto-meshing. Therefore, the model has 2773 nodes, 4290 beam elements, 24 tension-only elements, and 1800 shell elements. The boundary condition of the model consists of support (nodes 1, 2, 3, and 4) and link (nodes 7 and 8). Each node of support and link has its degree of freedom as shown in Table 3. The number 1 indicates that the degree of freedom in this direction is restrained, while the number 0 is released.

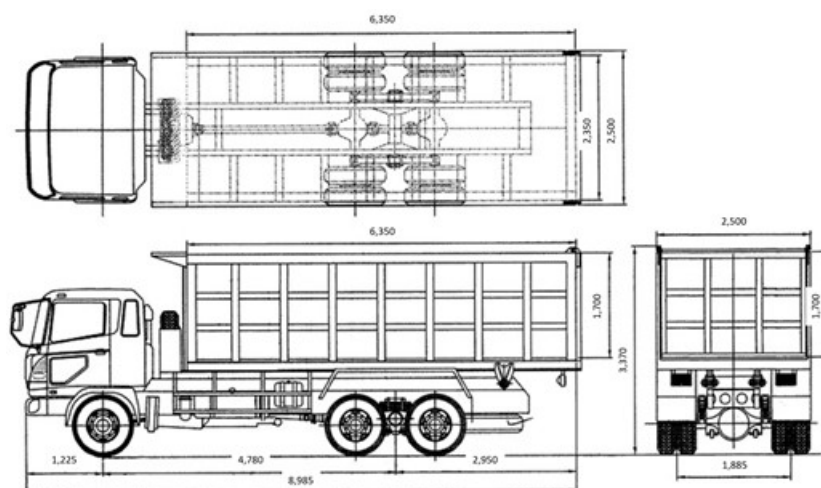
Figure 7. Dimension of truck loaded by sand.

Static testing was carried out by loading the bridge using trucks loaded with aggregates. The dimensions and capacity of the trucks used during the test are shown in Figure 7. There were five static loading schemes carried out on spans P1-P2 and P2-P3 alternately with loading stages of 60, 120, 180, 240, and 300 tons. In addition, five other loading schemes were carried out simultaneously on both spans, namely 120, 240, 360, 480, and 600 tons. The loading scheme for the P1-P2 span in the static test is shown in Figure 8, the same scheme is also applied to the P2-P3 spans, and for other schemes, the simultaneous loading was carried out on the P1-P2 and P2-P3 spans.

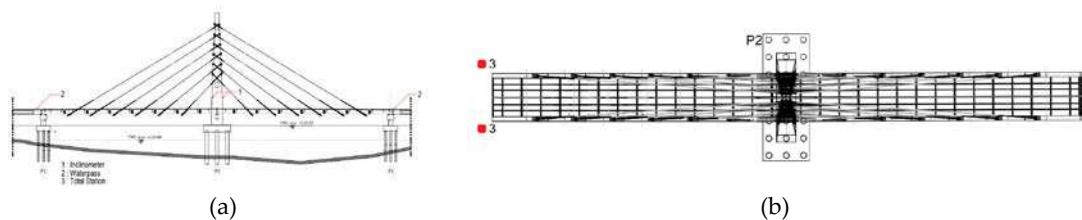
Figure 9. (a) Placement of inclinometer, waterpass, and (b) total station.

The loading was carried out in stages for both loading and unloading schemes and measuring deflection on the bridge beam using waterpass (WP) and total station (TS) measuring devices. The use of the two measuring instruments simultaneously aims to mutually validate the two results. The placement of the measuring instrument during the test is shown in Figure 9. The execution of the load test is shown in Figure 10.

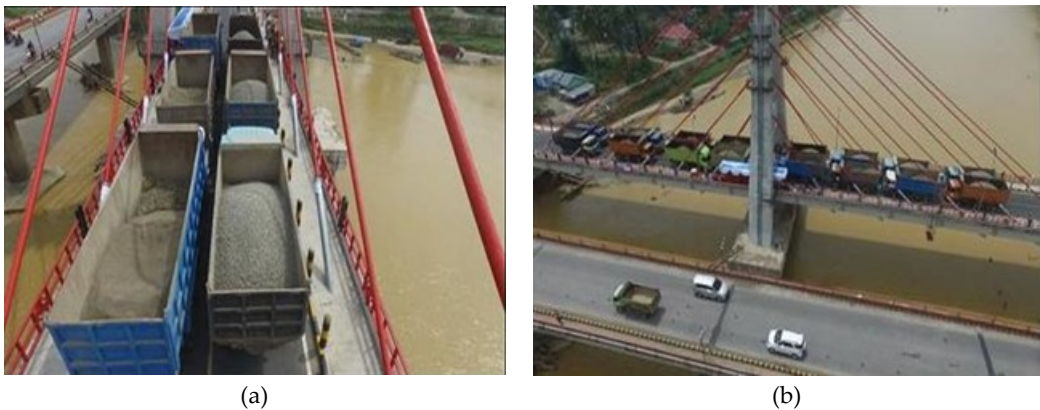
Figure 10. The execution of static load test.

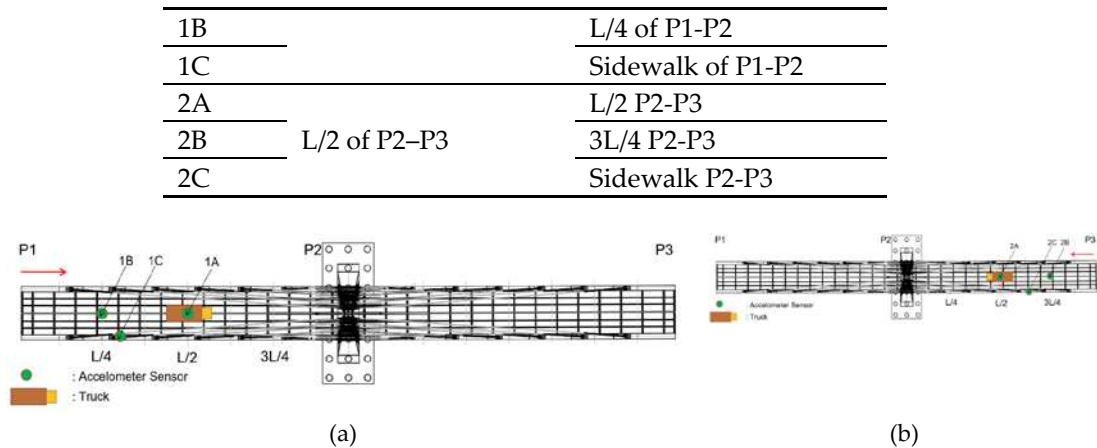
Figure 11. (a) Schematic type 1; (b) Schematic type 2.

The dynamic test was carried out by giving a sudden impact through a truck moving forward from a jumper with a certain dimension. At the same time, the acceleration of the structure was measured using accelerometers placed at several locations. The placement of accelerometers was based on the maximum response value obtained from the 3D model as shown in Table 4, Figure 11, and Figure 12.

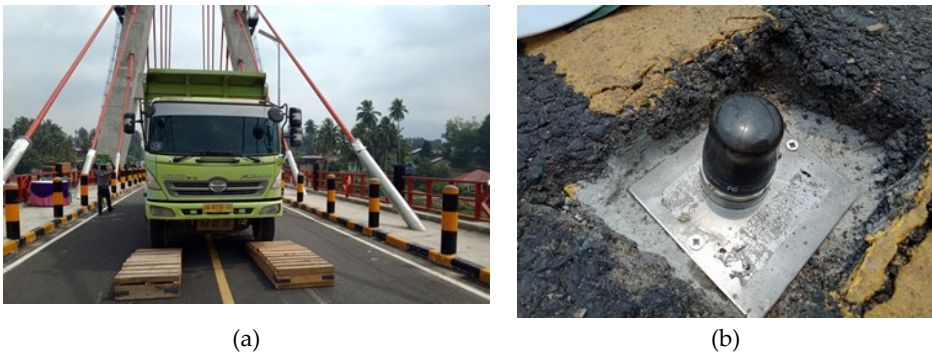
Figure 12. (a) The execution of dynamic load test; (b) The placement of accelerometer.

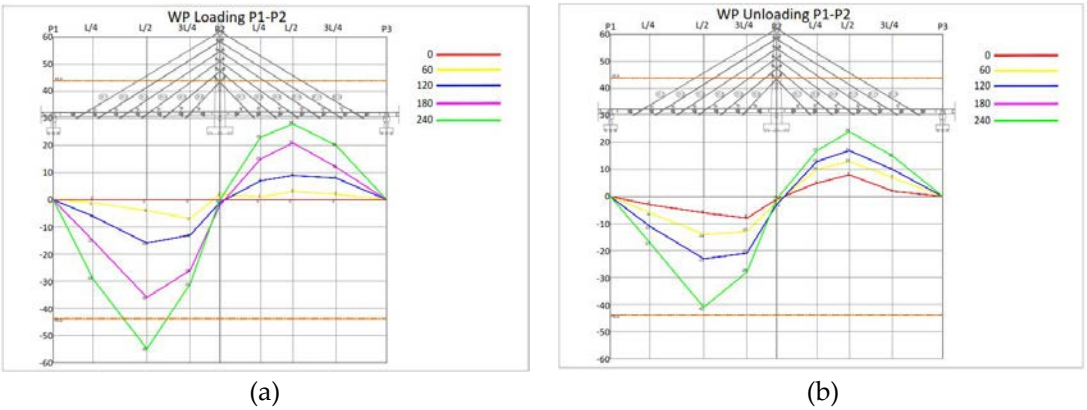
Figure 14. Graph of deflection measurement with waterpass when; a) loading and b) unloading on P1-P2 span.

Static loading and unloading at spans P1-P2 and P2-P3 measured the beam deflection by using waterpass and a total station device. Figures 13 to 16 show the deflection that occurs in the P1-P2 and P2-P3 spans due to truck loading on the P1-P2 span. The deflection that occurs in the fifth stage of loading with a load of 240 tons is 55 mm which exceeds the allowable deflection of 44.90 mm. At the same time, there was a loud clanging sound from the ST2-X1 cable and a large vibration of the bridge. This caused the Indonesian Bridge and Road Tunnel Safety Commission to decide not to continue loading up to 300 tons. In addition, the amount of deflection at zero loading and unloading has a different value, meaning that the floor of the bridge did not return to its original position after the unloading stage where all loads had been removed. Based on field observations, the beam returned to its original state after 24 hours.

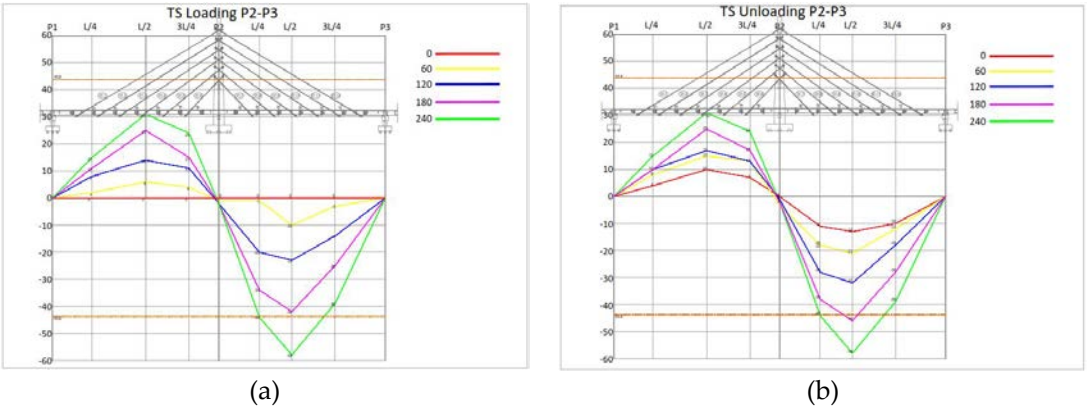
Figure 15. Graph of deflection measurement with total station when; a) loading and b) unloading on P2-P3 span.

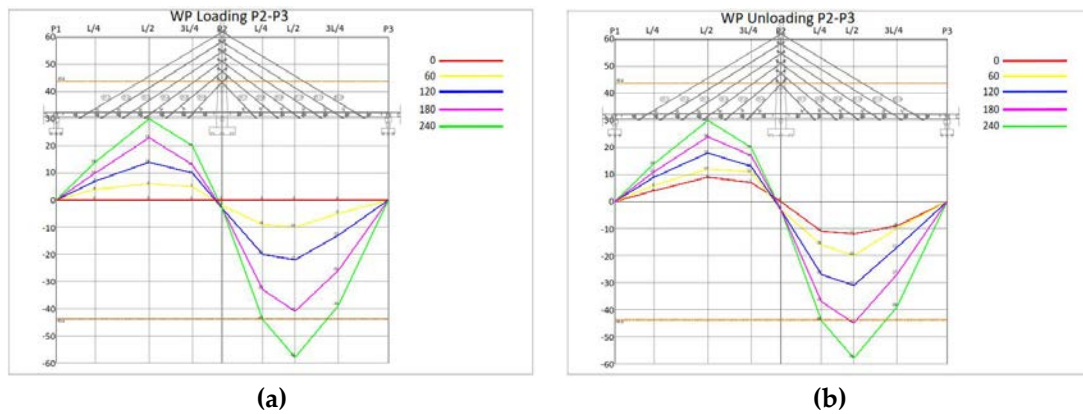
Figure 16. Graph of deflection measurement with waterpass when; a) loading and b) unloading on P2-P3 span.

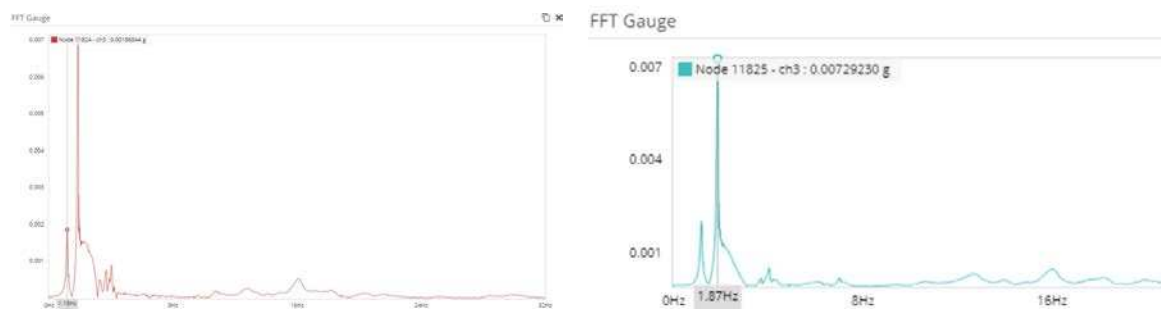
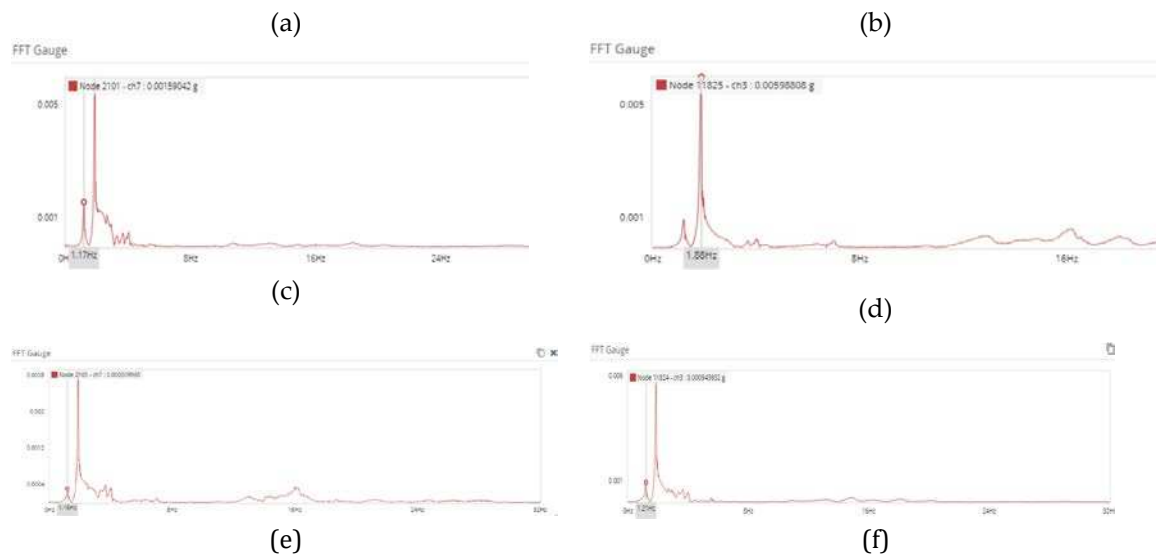
Figure 18. Graph of Fast Fourier Transform, a) vertical 1A ($f=1.18$ Hz); b) vertical 1B ($f=1.87$ Hz); c) vertical 1C ($f=1.17$ Hz); d) vertical 2A ($f=1.88$ Hz); e) vertical 2B ($f=1.18$ Hz); f) vertical 2C ($f=1.12$ Hz).

Among the results obtained from dynamic testing is a graph of the acceleration versus time (time series) which is converted into the frequency domain with a fast Fourier transform (FFT) as shown in Figure 18. Based on one of these measurement results, it is known that the natural frequency of the structure is 1.18 Hz. Furthermore, the dynamic test results are compared with the theoretical frequency of the 3D modeling results as shown in Figure 19. It can be concluded that the structural model created on Midas Civil aligns with the test results obtained in the field. The natural frequency value in the first mode is determined to be 1.19 Hz.

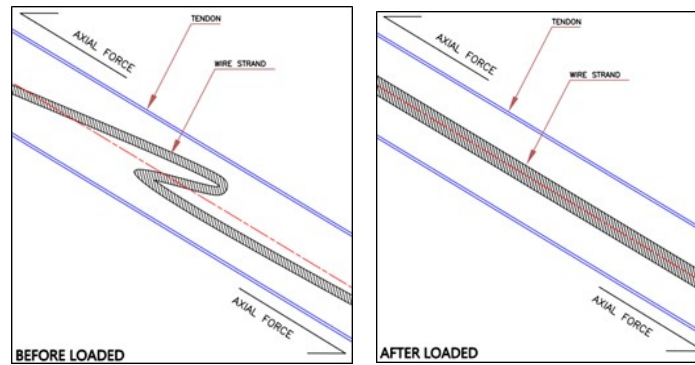
Figure 20. Condition of the strand before and after being loaded by a 240-ton truck.

As in the previous description, it is known that during the loading of the 240-ton truck, a loud clanging sound was heard. Based on field observations, the sound comes from the stay cable. This sound is caused by an imperfect pulling of the strand during the construction period which causes the cable to stay in the tendon to fold. When the bridge is loaded, the strand is stretched so that what was originally folded straight back. The following is an illustration of this phenomenon as in Figure 20. It should be noted that the condition of the cable is already wrapped, which makes it impossible to measure the extending cable or even the restressing as shown in Figure 21.

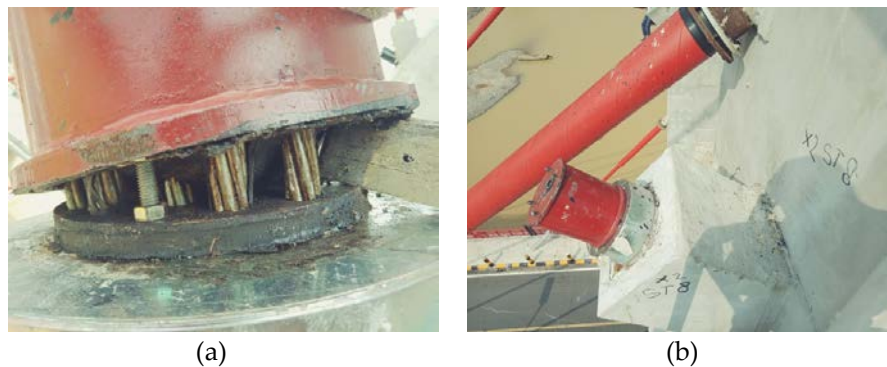
Figure 21. Condition of end anchor on pylon that has been wrapped.
