Extreme Serum Titanium Concentration Induced by Catastrophic Acetabular Cup Failure: Unveiling a Unique Scenario of Titanium Alloy Debris Accumulation

Abstract: The majority of contemporary total hip arthroplasty (THA) implants are constructed from Ti-alloys, which are generally believed to generate fewer adverse local tissue reactions (ALTR) compared to CoCr-alloys. This study presents a case of unusual primary THA failure where a substantial release of Ti-alloy debris was observed. A 52-year-old active male underwent THA after posttraumatic aseptic necrosis of the femoral head in 2006. Seventeen years after the procedure, the patient presented with groin pain and restricted range of motion. X-rays revealed protrusion of the alumina ceramic head through the Ti₆Al₄V acetabular cup. Trace element analysis indicated significantly elevated levels of serum Ti, Al and V. CT and MRI confirmed Ti-alloy cup failure and severe ALTR. During revision surgery, the worn-out ceramic head was in direct contact with the acetabular cup, having protruded through the central hole it created over time. Histological analysis of tissue samples showed wear-induced synovitis with areas of multinucleated

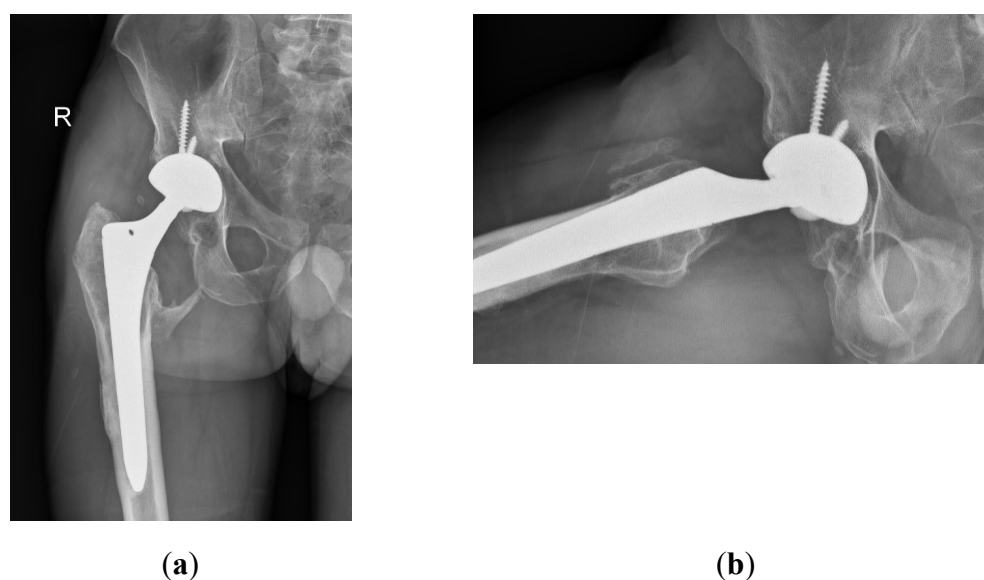
Figure 1. Radiographs of the patient's right hip 8 years after primary THA. (a) Antero-posterior view; (b) Lateral view.

Despite the absence of pain, the patient reported unusual sounds in the hip during weight-bearing, linked to the ceramic-on-ceramic (CoC) bearing. Standard radiographs of the right hip were deemed normal, as depicted in the first available postoperative X-ray (**Figure 1**). Therefore, no further evaluation or specific treatment was advised for the patient.

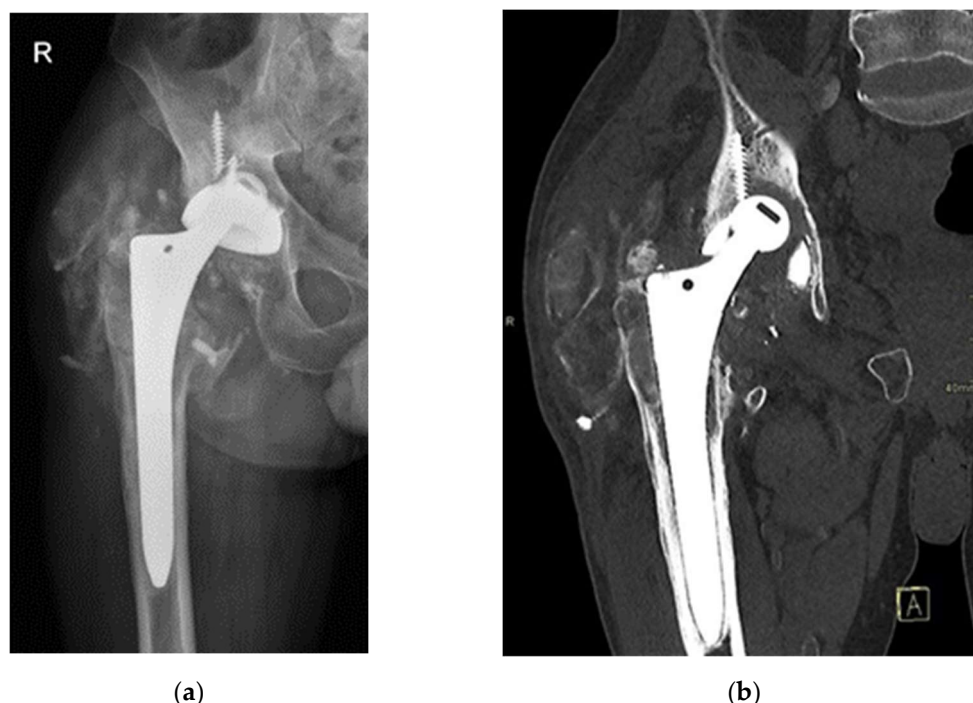
Figure 2. Radiographic imaging of the patient's right hip 17-years after primary THA. Note alumina ceramic femoral head protrusion through the acetabular cup, extensive calcifications in the soft tissues and osteolysis. (a) Antero-posterior X-ray; (b) Computer tomography (CT) scan with coronal reconstruction.

Becton Dickinson, Franklin Lakes, NJ, USA). Serum levels of titanium, aluminium, and vanadium were determined at the nationally accredited laboratory (Clinical Institute for Clinical Chemistry and Biochemistry, Ljubljana, Slovenia) for trace element analysis. X-rays and computer tomography (CT) evaluation revealed protrusion of the alumina ceramic head through the Ti6Al4V acetabular cup (Figure 2), prompting scheduling for an early THA revision.

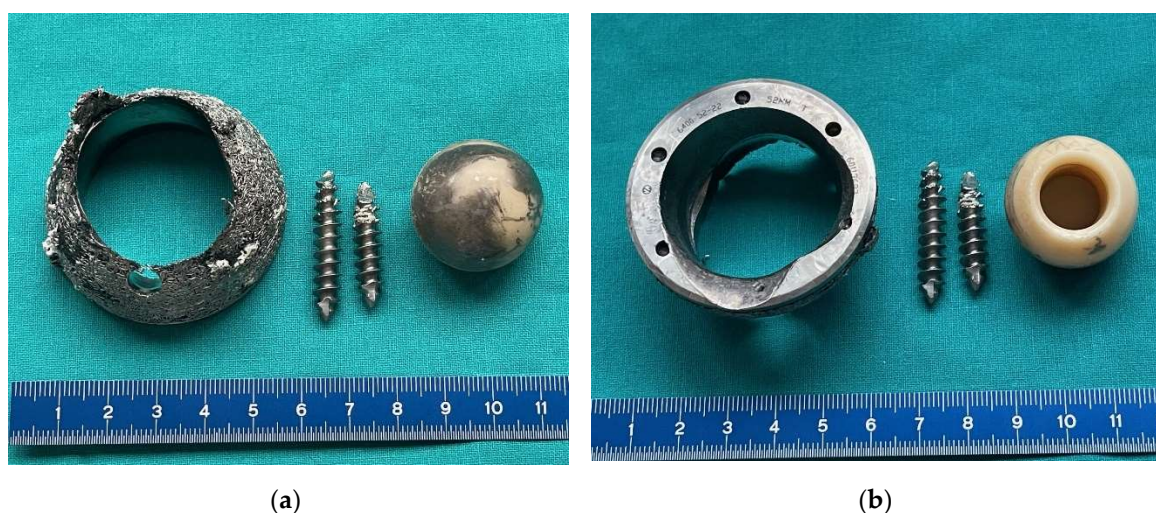
Figure 3. A photograph of the removed Ti6Al4V acetabular cup showing a central hole which was created by the alumina ceramic head. (a) Cranial view; (b) Caudal view.

During the revision surgery, the absence of an acetabular liner was noted, and the worn-out ceramic head had directly contacted the acetabular cup, protruding through a central hole formed over time (Figure 3). Pseudo-tumours in soft tissue and severe metallosis near the implant were excised, with tissue samples sent for histological analysis and cultures. Acetabular screws underwent sonication. The stable femoral stem with an intact Morse taper for femoral neck-head coupling necessitated only the exchange of the acetabular component and femoral head. A 58-mm Ti6Al4V press-fit acetabular cup (Delta-TT, Limacorporate, Udine, Italy) with an aluminum oxide matrix composite ceramic liner (BioloX Delta, CeramTec) was inserted and secured with three screws. A 36-mm aluminum oxide matrix composite ceramic revision femoral head with a Ti6Al4V sleeve (BioloX Delta Option, CeramTec) was attached to the original femoral stem, followed by repositioning (Figure 4).

The etiology behind the catastrophic failure of the titanium-alloy acetabular cup remains elusive. Although the original manufacturer's sticker, containing all pertinent data of the implant, was located in the patient's medical records, no evidence of the acetabular liner was discovered during revision surgery. Additionally, despite employing various radiographic procedures (X-rays, CT, and MRI),

we were unable to identify fragments or remnants of the ceramic liner. It is plausible that the entire acetabular liner was ground into tiny and fine-grain debris; however, such debris was not identified in histological samples obtained during revision surgery. Furthermore, the absence of larger pieces of alumina ceramic liner, which would likely have eluded the grinding process between the intact alumina ceramic femoral head and the dome of the acetabular cup, speaks against this hypothesis. Conversely, it would be highly unusual for an orthopedic surgeon not to insert the acetabular liner into the acetabular cup. In such a scenario, over the years, the harder ceramic femoral head would inevitably create a void in the softer titanium-alloy acetabular cup, particularly in a young and physically active patient.

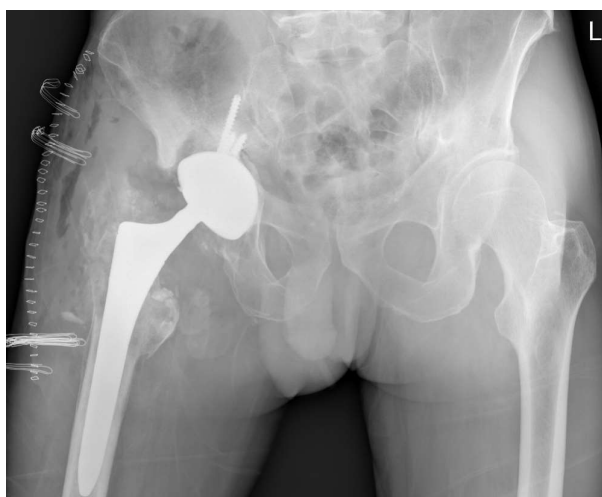
Figure 4. A radiograph of both hips depicting patient's right hip immediately after revision.

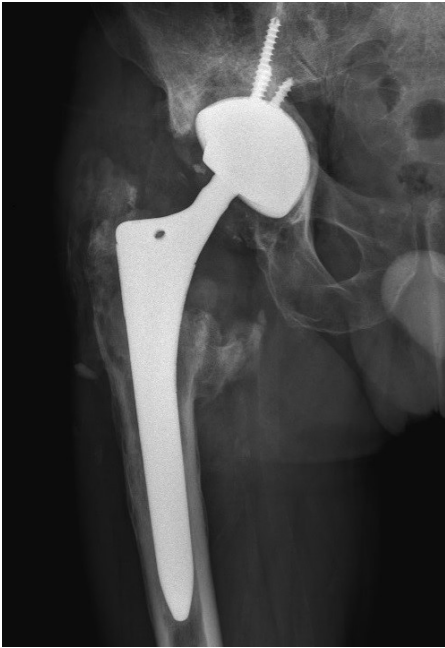
Figure 5. X-ray of the patient’s right hip 6 months after THA revision.

well as ESR and CRP level, were within normal limits. The radiograph of the patient’s hip depicted stable THA construct without additional osteolysis (**Figure 5**).

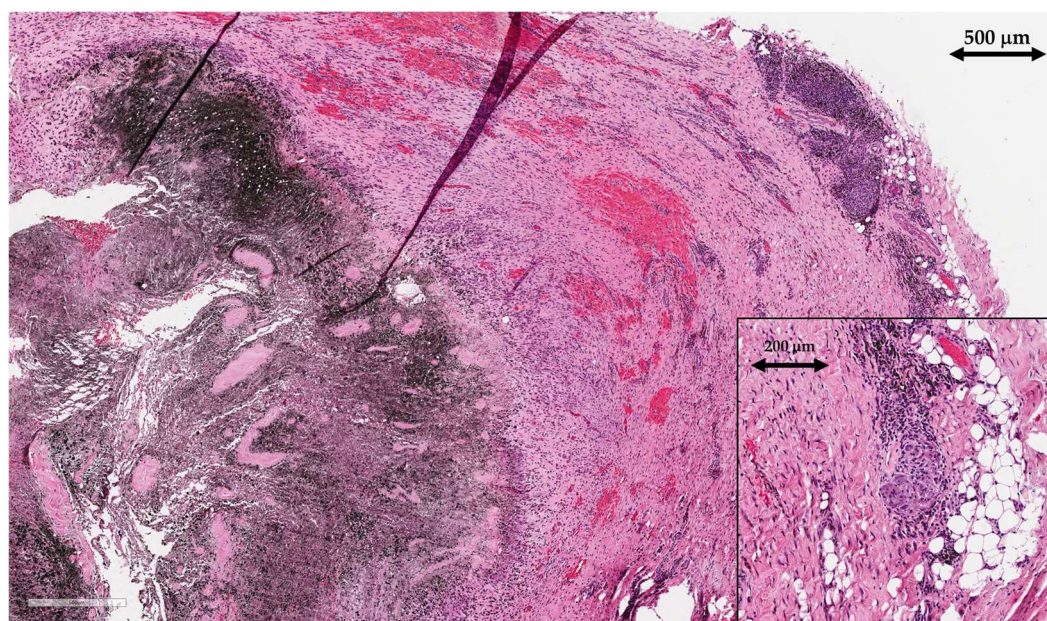
Figure 6. Histopathological findings of synovial-like interface membrane (SLIM), including areas of necrosis with abundant deposits of metallic micro and macroparticles (left), surrounded with layers of macrophages. Areas of haemorrhage (middle) and granulomatous inflammation with foreign-body giant cells (upper right corner, magnified in lower right corner) are also present (scale is written on each part of the image).

Tissue samples of periprosthetic soft tissue, that gave a macroscopic impression of pseudotumors were sent to the pathology lab for histological analysis. Tissue samples were of irregular shapes, soft, greyish brown to black color and up to 4 cm in size. Microscopic examination showed areas of necrotic tissue and fibrin depositions admixed with abundant metallic microparticles (Figure 6). There was extensive infiltration with predominantly macrophages, containing metallic

micro and macroparticles as well as areas of granulomatous inflammatory reaction with foreign-body giant cells. Lymphoplasmacytic infiltrate was present but there were no granulocytes, indicating the absence of acute inflammation and therefore excluding infection.

After joint replacement surgery, regenerated synovial tissue and the periprosthetic membrane are referred to using the term “synovial-like interface membrane” (SLIM). Histological findings of SLIM pathology are classified into groups that aid the recognition of underlying pathophysiological mechanisms leading to implant failure. Based on the International Expanded SLIM Consensus Classification, the patient had a wear-induced synovitis/SLIM, leading to adverse local tissue reaction to implant wear particles (type VI) with a predominantly macrophagic pattern with absent or minimal lymphocytic response [13]. The patient did not meet criteria for periprosthetic joint infection (no neutrophils present in the tissue).

Based on Histological particle algorithm, proposed by Perino et al., microparticles in tissue samples were mostly likely conventional non-ferrous metallic particles due to implant-wear [22]. Described micro and macro particles were greyish to intensively black, which is consistent with metal. Ceramic particles could also be present in blackish color if oxidized and can also be abundant but usually present only as microparticles except in cases of prosthesis fracture, where larger microparticles were described as well. Other implant wear-particles and endogenous particles (such as hemosiderin) differ from metal particles in shape, size, color, or are birefringent.

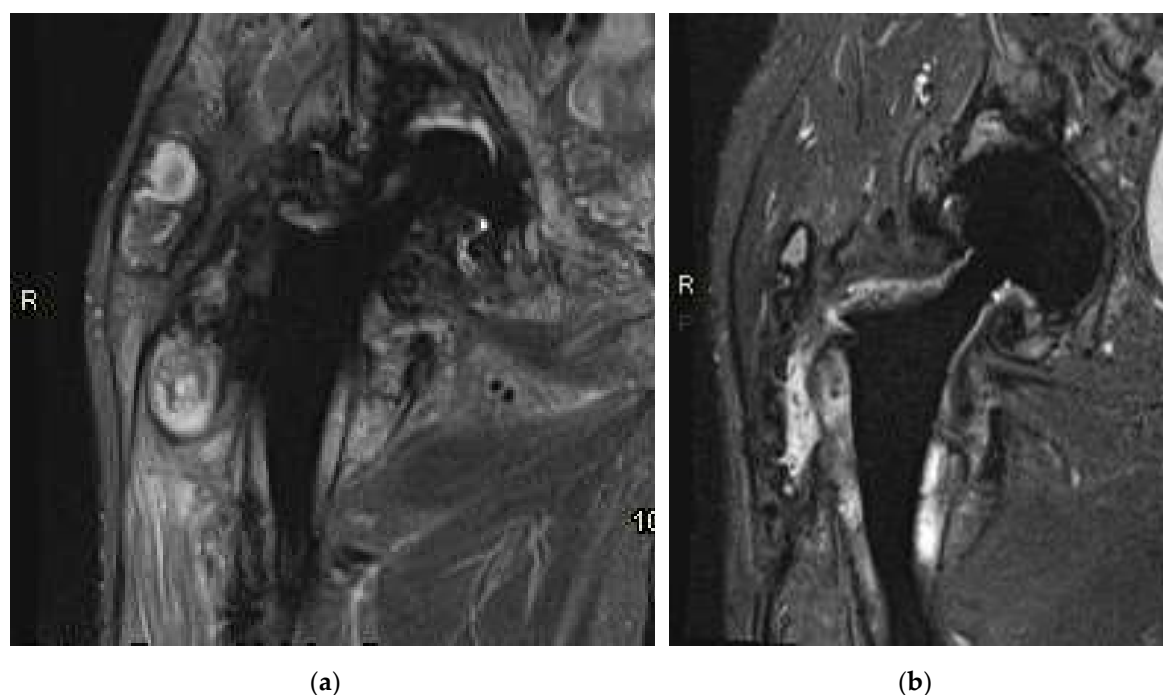
Figure 7. Magnetic resonance imaging (MRI) of the right hip in coronal plane. (a) Before revision; (b) Six months after revision surgery.

Prior to the revision surgery, MRI revealed substantial soft tissue alterations around the endoprosthesis, particularly in the muscles proximal to the greater trochanter of the femur. Primarily, these changes manifested as solid chronic granulation with a smaller cystic component that was partially calcified. In both the described soft tissue changes and the periprosthetic osteolytic regions, minute hypointense inclusions of metal microparticles were observed (Figure 7a). Six months post-revision surgery, the previously extensive granulation changes in the surrounding soft tissues were diminished. There was reduced soft tissue edema, and indications of local irritation had also decreased. The presence of slightly increased fluid around the endoprosthesis indicated residual seroma following the surgery (Figure 7b).
