A HBIM Approach for Structural Diagnosis and Intervention Design in Heritage Structures: The Case of the Certosa Di Pisa

Keywords: Certosa di Pisa; Architectural heritage; H-BIM; 3D modeling; safety assessment

A HBIM Approach for Structural Diagnosis and Intervention Design in Heritage Structures: The Case of the Certosa di Pisa

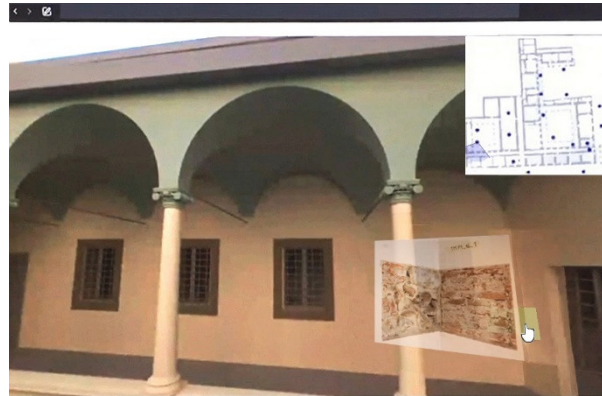
Figure 10. Screenshot of a virtual tour on the Granduca Cloister.

A virtual tour implemented in an HTML environment not only allows designers to navigate smoothly within the model and explore its geometric features, but also enables them to access and read the information contained within the model. This not only enhances the perception of space but also activates sensitivity towards the structure’s static behavior. Figure 10 showcases a screenshot of the virtual tour on the Granduca Cloister, highlighting a hotspot that enables visualization of the results of an on-site test with plaster removal, allowing exploration of the underlying masonry texture.

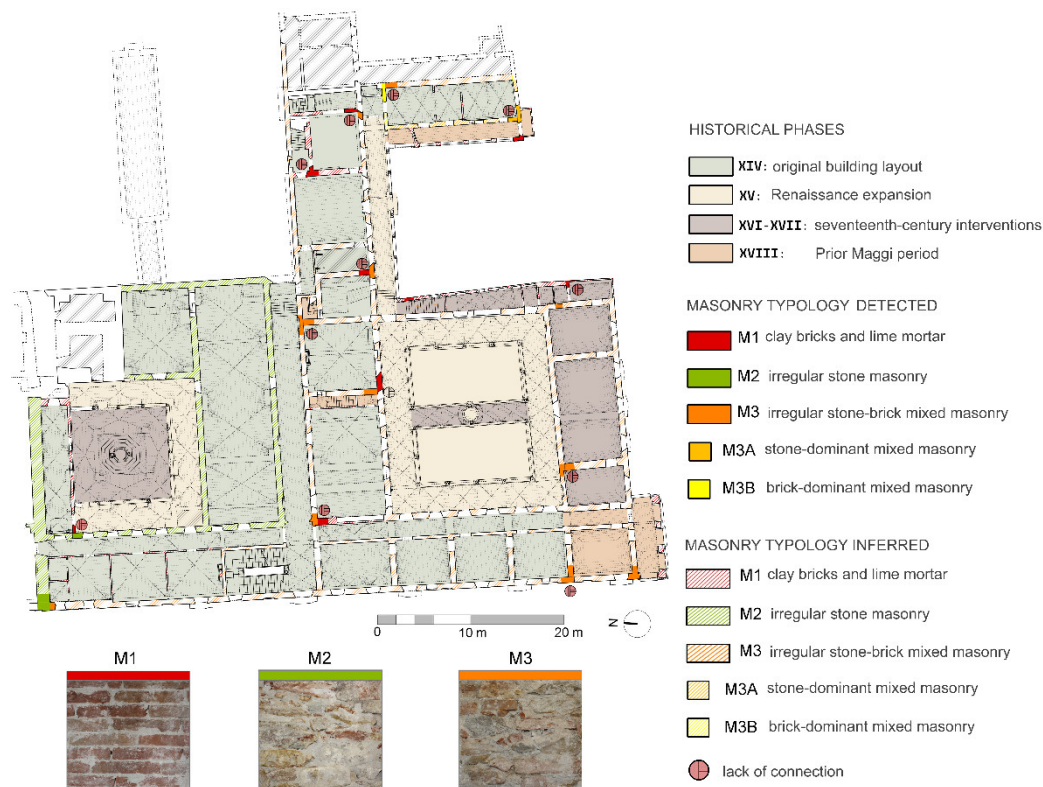
Figure 11. Map of wall macro-categories - first floor plan of the study area.

In this study, masonry was classified into three main categories, M1, M2, and M3, along with subcategories, based on the constituent materials of the units and their arrangement. The initial phase of the structural diagnosis of the south-west portion of the Certosa heavily relied on this outcome. It was supplemented by information concerning issues affecting the structures, materials, and decorative elements. In this context, the model showcases its capability to visualize the crack pattern in three-dimensional mode, displaying them on both faces of the walls through the transparency option.
