Structural Analysis and Load Test of Railway Bridge

Abstract: The BH 25 railway bridge, located in Indonesia, consists of three spans: 9.5 m (span-1 girder type), 21.9 m (span-2 truss type), and 9.6 m (span-3 girder type). Despite the initial plan for camber, it was not achieved, leading to the installation of temporary support on span-2. To assess the level of damage and determine the necessary steps, static and dynamic tests were conducted using a CC206 locomotive. The maximum deflection was recorded at -4.60 mm for span-1, -11.30 mm for span-2, and -3.42 mm for span-3. The dominant frequency in the vertical direction of span-2 was found to be 14.65 Hz. Due to the inability to achieve the planned camber and the subsequent removal of temporary support, external prestressing will be implemented, resulting in a camber of 11.82 mm. This change in prestressing also affects the dominant frequency of span-2, which becomes 17.07 Hz.

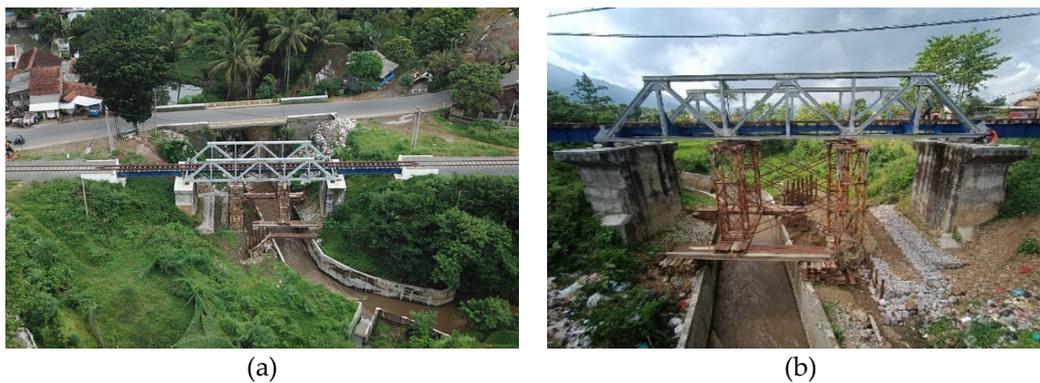
Figure 2. (a) Aerial View of the Bridge (b) Steel Structure of the Bridge.

The bridge is currently located in Garut City, West Java Province, Indonesia. Figure 1 displays a map of the Cibatugarut railway line. Figure 2a is an aerial view of the bridge, while Figure 2b provides a detailed look at the steel frame structure. The bridge has a total length of 41.055 meters, as depicted in Figure 3.

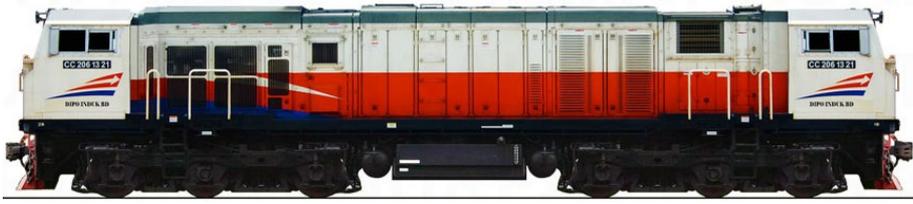
Table 2. CC206 Locomotive Specifications.

Locomotive	CC 206 13 21
Power Source	Diesel Electric
Model	GE CM20EMP
Wheel Specifications	
Whyte Notation	0-6-6-0

AAR Wheel Setup	C-C
UIC Classification	Co'Co'
Dimensions	
Track Width	1.067 mm (3 ft 6 in)
Length	15.849 mm (17 yd 1 ft 0 in)
Width	2.743 mm (3 yd 0 ft 0 in)
Maximum Height	3.695 mm (4 yd 0 ft 0 in)
Axle Load	15 ton (15 ton length; 17 ton short)
Weight	
Empty Weight	88.2 ton (86.8 ton length; 97.2 ton short)
Ready Weight	90 ton (89 ton length; 99 ton short)
Performance	
Maximum Speed	160 km/h (44 m/s) Original Speed; 120 km/h (33 m/s) Operational Speed
Engine Power	1.680 kW (2.250 hp)
Tractive Force	248 kN (56.000 lbf)

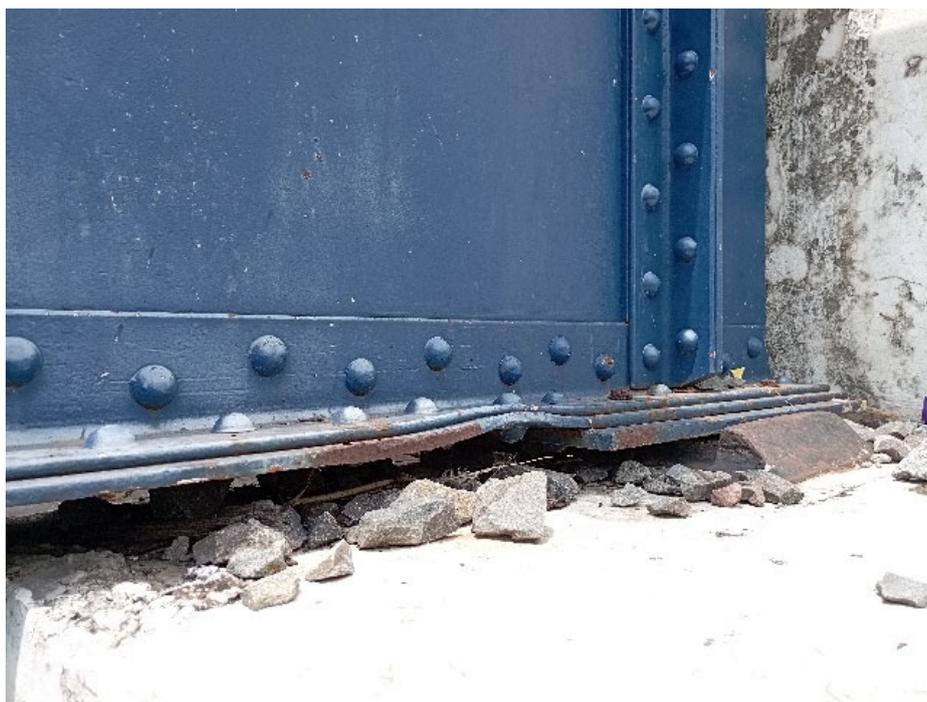
One of the failure modes in steel structures is buckling. In general, buckling is induced by axial forces or forces acting on the principal axis of the structural section. Buckling is a phenomenon in which a structure is unable to maintain its original shape, leading to a change in shape to establish a new equilibrium. Local buckling is observed in the lower flange area of the longitudinal girder structure of span-1 in the bridge. This is attributed to tensile stress surpassing the capacity of the section to bear tensile stress. Additionally, the slender/thin shape of the steel section makes it more susceptible to buckling failure. Slenderness is defined as the ratio of length to thickness, and the longitudinal section of span-1 falls into the category of non-compact slenderness. Buckling does not necessarily result in the complete failure of the structure, but it can diminish the structural performance and lead to more significant damage.

Figure 22. Local Buckling in the Flange Section.
