Structural Behaviour and Strength Evaluation of a Venetian Church through Finite Element Analysis

Abstract: Evaluation of structural behaviour of a masonry Venetian Church with pointed vault, is presented in this paper through an analysis following the necessary steps of a monument study. Having a detailed geometric model and the material estimation, the finite element method was used in order the influence of specific structural parts of the structure like masonry butresses and walls connections to the structural behaviour are examined. The comparison of the eigenfrequencies which are estimated by in situ measurements and finite element modal analysis is used to model identification. The response spectrum analysis, the static analysis for subsidence of some parts and the transient analysis of a specific seismic excitation are used to evaluation of the church strength. Comparison of modal analysis results with the structural pathology is helpful to this research about the structural behaviour of the church.

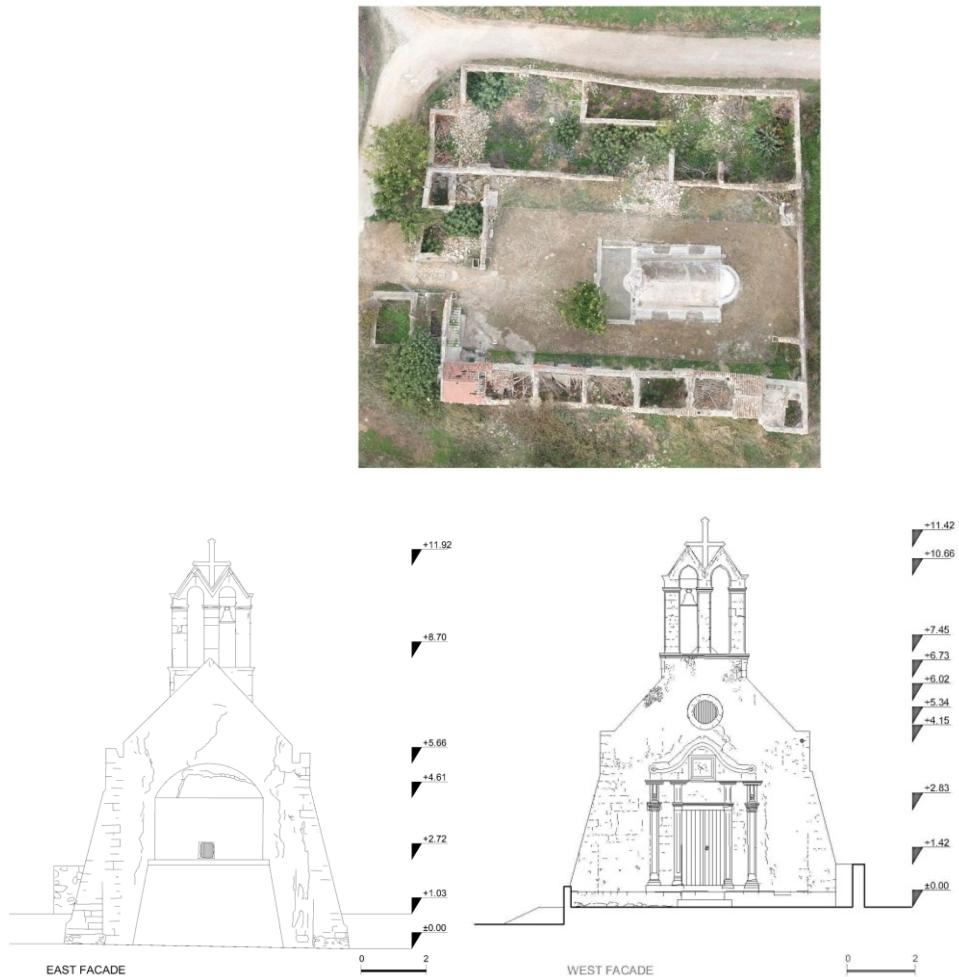
Figure 1. Plan of Mormori's Saint George ecclesiastical glebe – metochi, East and west façade of church.

The church of Saint George is categorised as a small single room church with a pointed vault roof cover and located at the center of ecclesiastical glebe's complex as shown in Figure 1. The external measurement of the plan is 9.60m by 6.24m long. The walls have been constructed with ashlar limestones and uncut stones. The main entrance is placed on the west facade and a semi-circle nook is directed to the east (Figure 2).

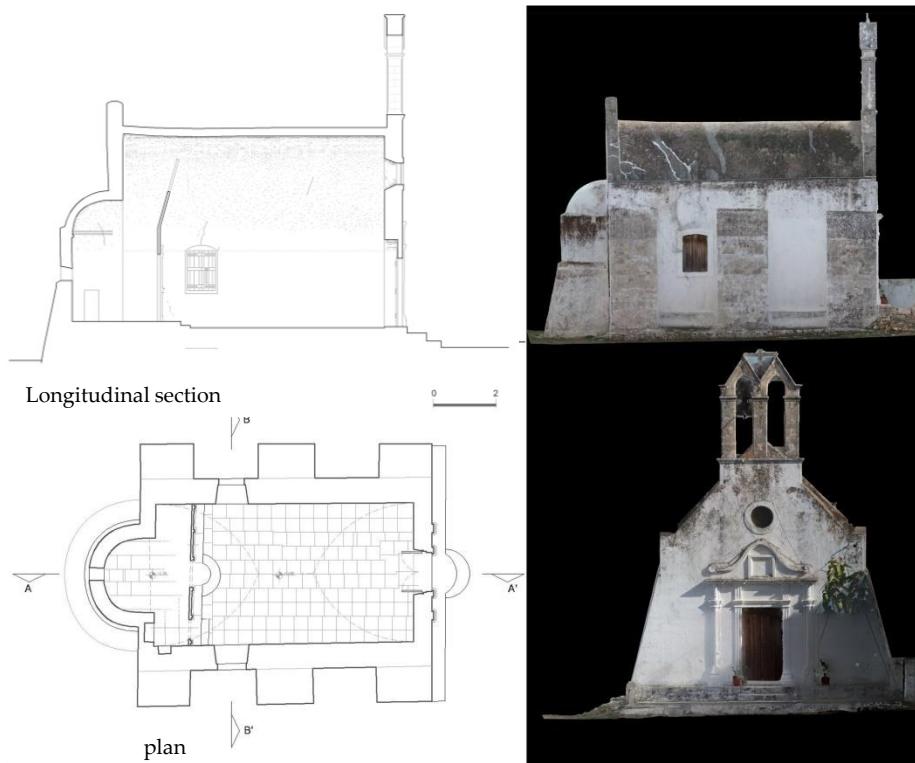
Figure 2. Longitudinal section, north facade (orthophoto), plan & west facade(orthophoto).

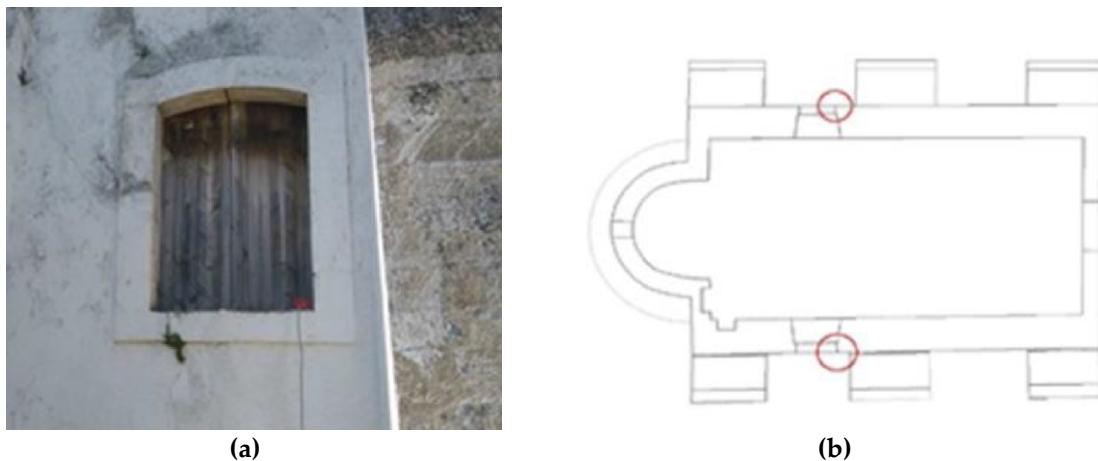
Figure 3. The position that the sensors were placed.

The equipment used was the SYSCOM company's acceleration measurement system of Applied Mechanic Laboratory at Technical University of Crete. In the present study, two recording units and two sensors were used to carry out the measurements. The location where the acceleration sensors were placed is shown in Figure 3, next to the two windows on the south and north sides of the church. The sensors were synchronized to start recording at the same time, and the duration of field recording was 10 minutes.

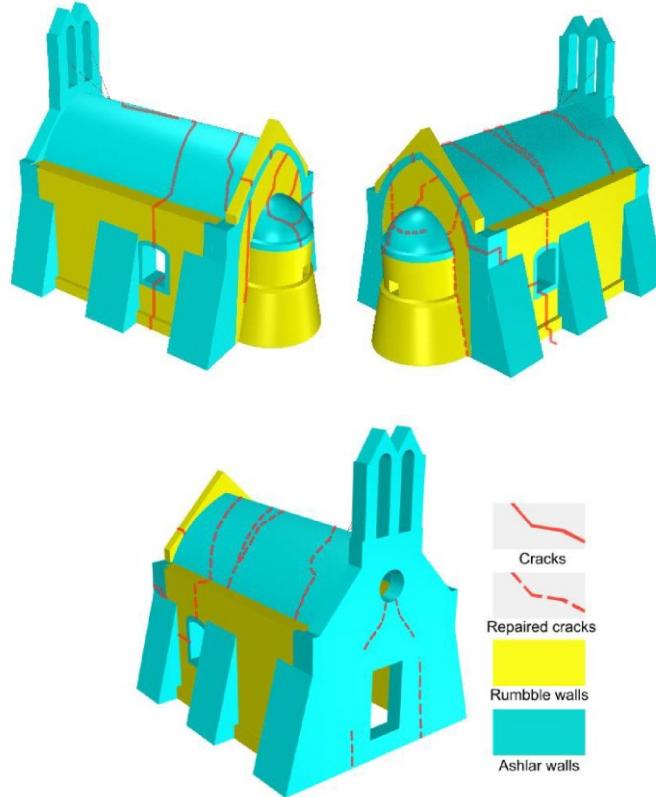
Figure 4. Perspective diagram of materials and damages.

From the in-situ observations, two main ways of structuring the stone masonry of the church were found (see Figure 4). The pseudo-isodome ashlar limestone masonry, measuring approximately 50x25x20 cm each part, and random rubble masonry. The masonry has a maximum thickness of 80 cm, the domes about 26 cm thick and the west face is 58 cm.

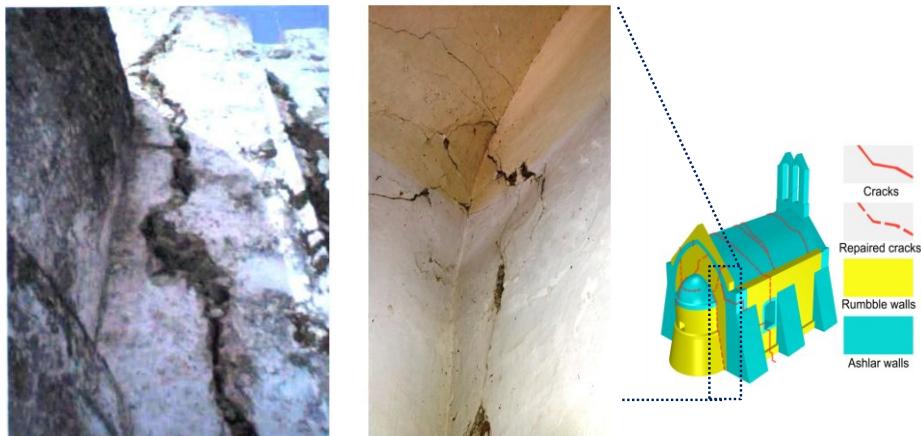
Figure 5. External (photo from 28th Ephorate of Antiquities of Chania, 2007) and internal damage on the north-east corner of church (2022).

- The north-east corner along with the buttress is almost detached with a range of cracks from top to foundation as shown in Figure 5. The mechanism which is active seems to be a combination of ground subsidence and seismic excitation with a simultaneous overturning tendency. In addition, the failure of the mortar of the gutters causes the accelerated corrosion of the masonry since the water flows into the joints and the local cracks.

To study the influence of the masonry buttresses to the dynamic behaviour of the structure two models were analyzed. From the contour plots of maximum principal stress, the reduction of tension because of the buttresses is shown in Figures 17–19 for both earthquakes. In addition, the stress concentration relates with some of the existing cracks special to the eastern wall (Figure 5).

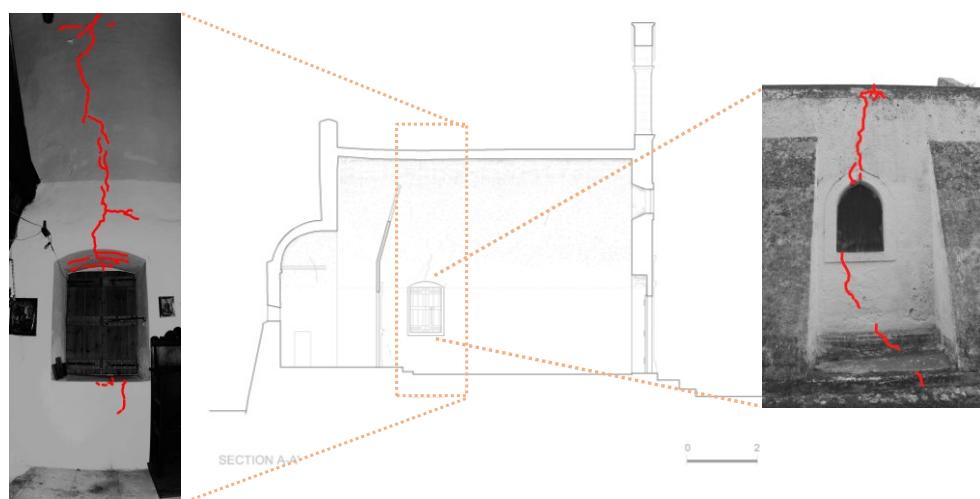
Figure 6. Internal and external damage on the south side of church (2022).

- A tendency also to cut off the eastern half of the church in a direction towards the north-east corner is indicated through continuous cracks as shown in Figures 6–8.

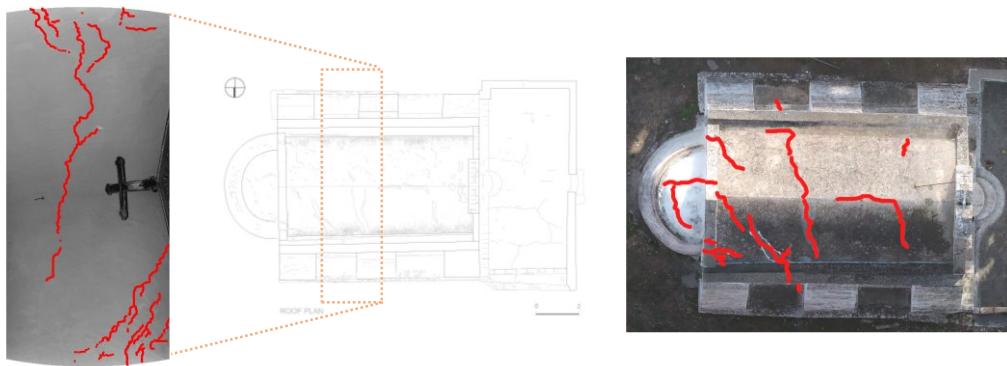
Figure 7. Continuous crack on the vault (2022).

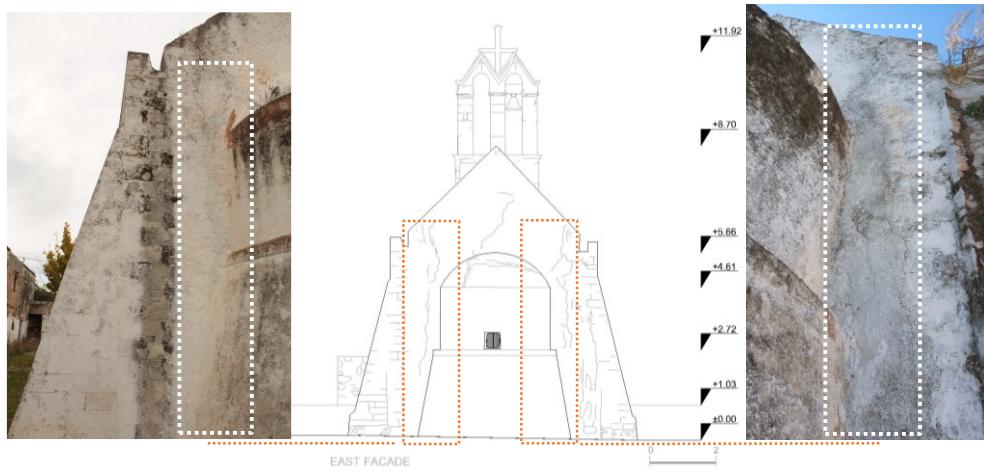
Figure 9. Damage on the east side of church (2022).

- Cracks and curvature of eastern masonry indicate that the failure mechanism in the present case is also combinatorial. The seismic loads in the masonry during the time and the east-facing dome which finds an obstacle in the nook. The result is the vertical faulting of the eastern face with the simultaneous action of subsidence in the north-eastern buttress corner (Figure 9).

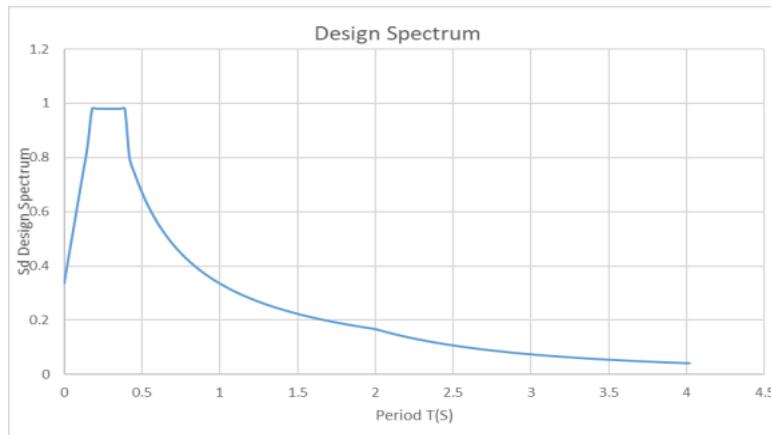
Figure 10. Design spectrum, Horizontal axis Time(s) and Vertical axis design spectrum.

The design spectrum for structural analysis was based on the technical guidelines of the KADET 2022 regulation (Figure 10) [16]. The soil category was assumed to be A, meaning that the structure was founded on rock soil. In addition, the significance class of the building was chosen to be IV as the building has a monumental character [16].

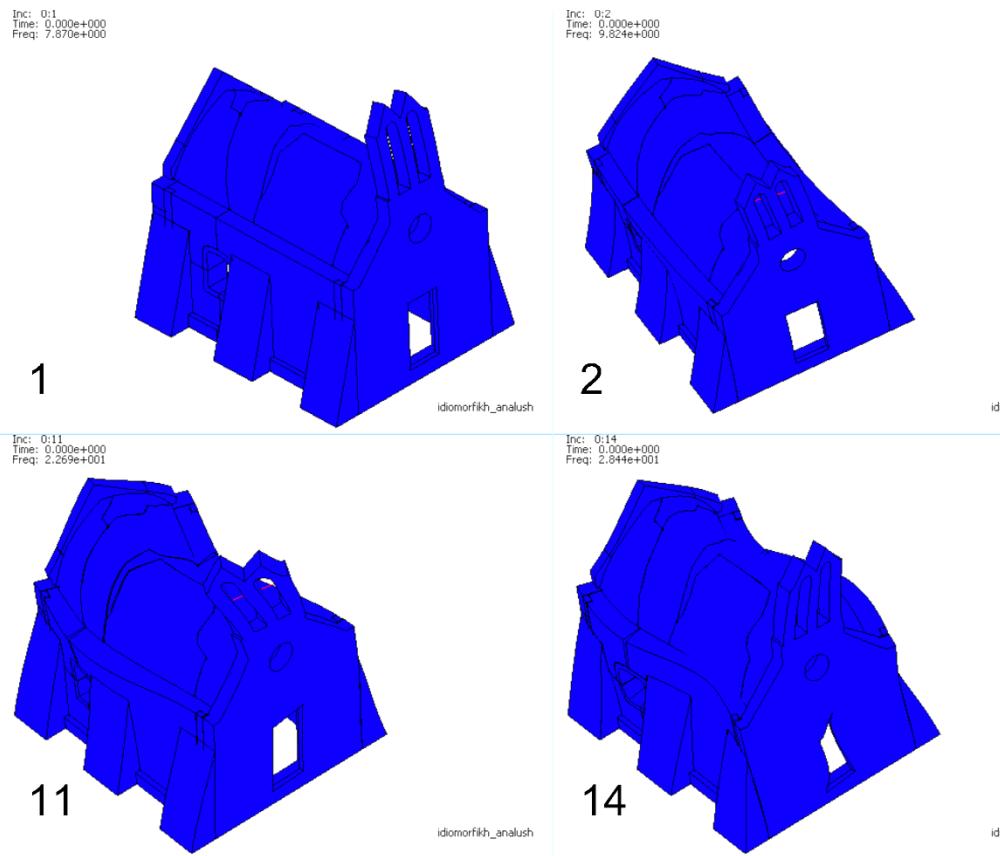
Figure 11. Eigenmodes of the temple for the frequencies 7.87Hz (shape 1), 9.82Hz (shape 2), 22.69Hz (shape 11) and 28.44Hz (shape 14).

As a result of the modal analysis, the most characteristic eigenfrequencies and eigenmodes of the church were calculated. Especially, the 1st eigenfrequency (7.82Hz), the 2nd (9.82Hz), the 11th (22.69Hz) and the 14th (28.44Hz) were also recorded by in situ measurements with little deviation. Table 2 summarizes the data from the experimental data and those calculated from the finite element model and indicative modes are shown in Figure 11.

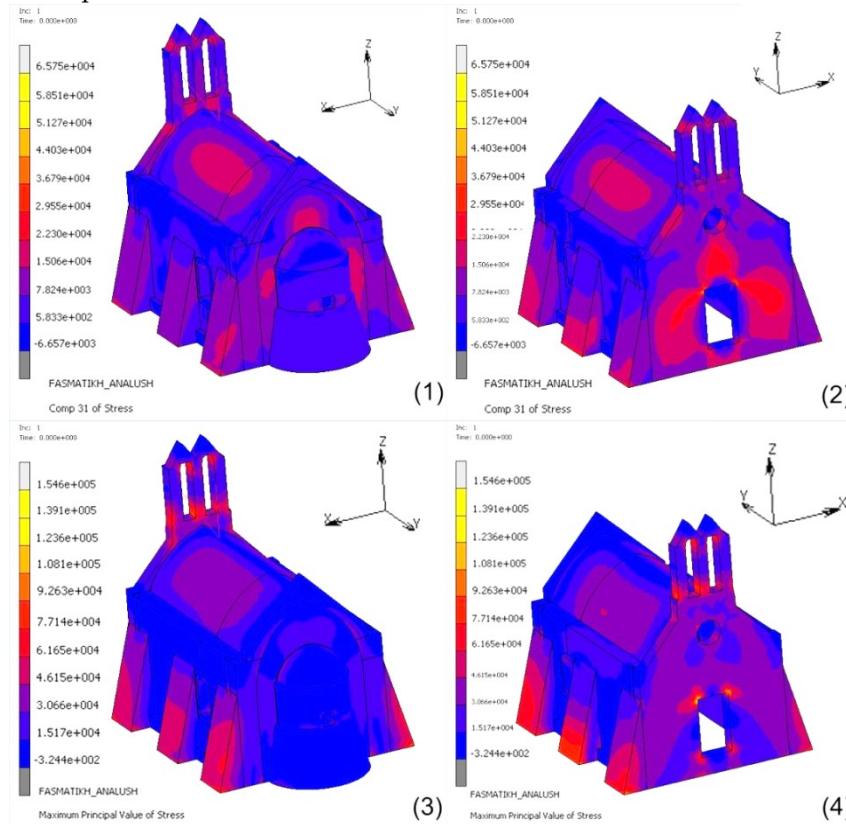
Figure 12. Response spectrum analysis results (Case $1.0*Ex+0.3*Ey$) the shear stress Szx (1-2), and the maximum principal tensile stress (3-4) (in Pa).

The response spectrum analysis was calculated by importing the design spectrum into the finite element model and taking in each combination a different percentage of action of the seismic component. Four dynamic load combinations: $(1.0*Ex+0.3*Ey)$, $(-1.0*Ex-0.3*Ey)$, $(0.3*Ex+1.0*Ey)$ and $(-0.3*Ex-1.0*Ey)$ were used. The results of first combination $(1.0*Ex+0.3*Ey)$ correlate with the pathology of the structure. Indicative results of the analysis are presented in Figure 12.

Stress concentrations are presented at points where the structure has been cracked. Most stresses on the dome as shown in Figure 12, are tensile stresses. The west facade of the dome is stressed in tension and shear also. The stresses are concentrated at the points where the facade has been cracked. Finally, on the east elevation shear stresses are concentrated at the corners of the masonry as well as at the bottom of the pediment.

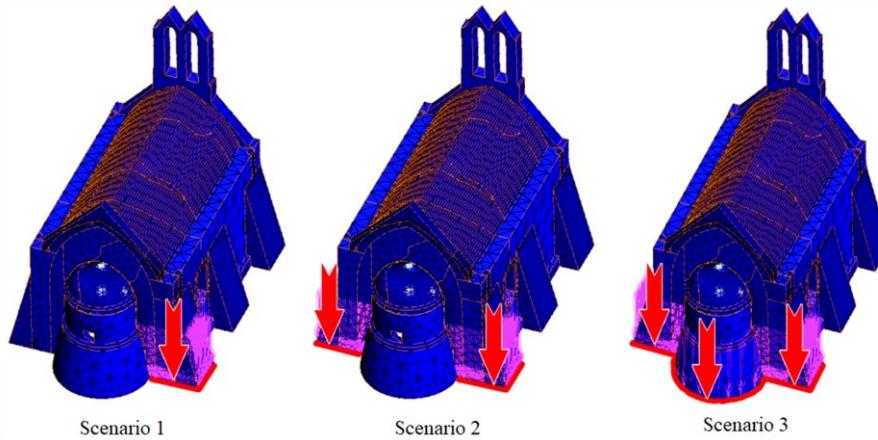
Figure 13. Scenarios of Sedimentation.

Three different cases of subsidence were studied: a) subsidence only on the northeast side of the church (scenario 1), b) subsidence on both corners of the east side of the church (scenario 2) and c) a total subsidence on the entire east side of the church (corners and dome, scenario 3) (see Figure 13). In all scenarios the subsidence was set equal to 2cm.

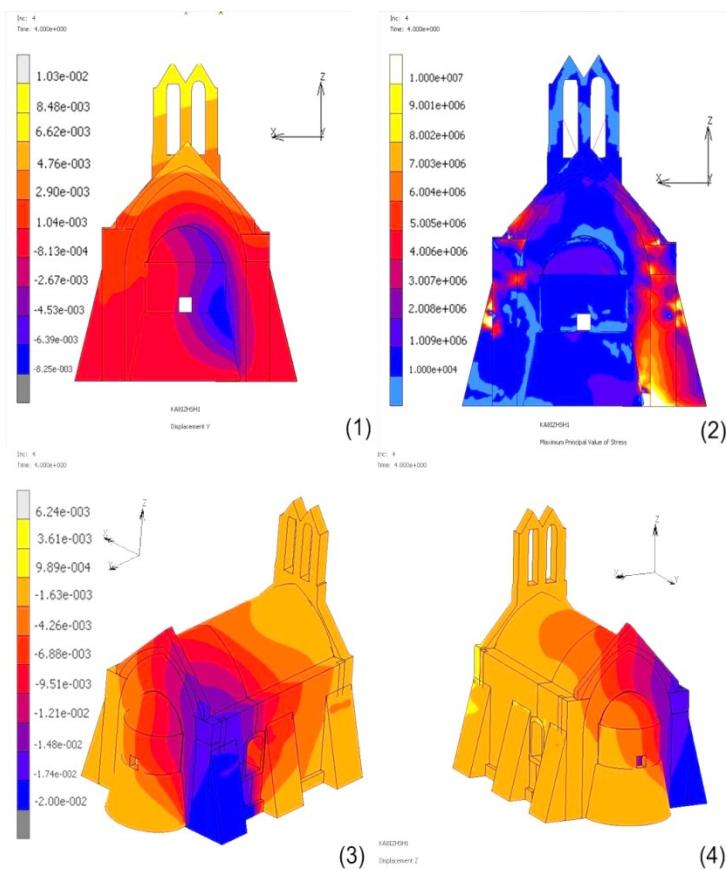
Figure 14. Analysis results for loading scenario 1.

Indicative results of the examined scenarios are presented in Figures 14–16. In each figure in 1 the out-of-plane movements of the dome are presented (in m), in 2 the distribution of maximum principal tensile stresses on the eastern face of the church (in Pa) and in 3,4 the vertical movements of the church (in m).

From a comparison of all the scenarios analyzed, the most likely scenario to have taken place is scenario 2. This scenario presents such a deformation profile which indicates the concentration of stresses at points close enough to where damage has occurred in the church.

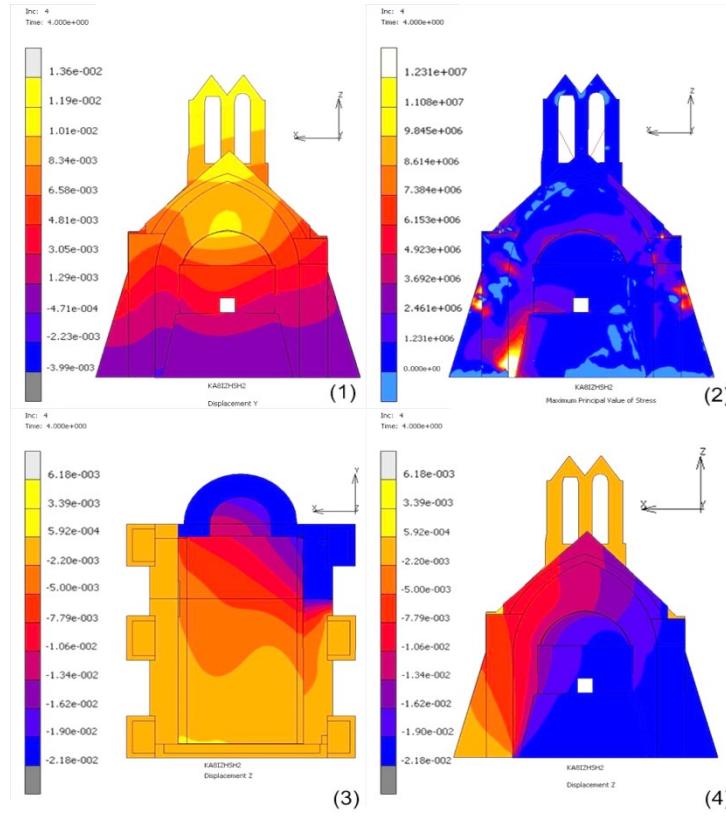
Figure 15. Analysis results for loading scenario 2.

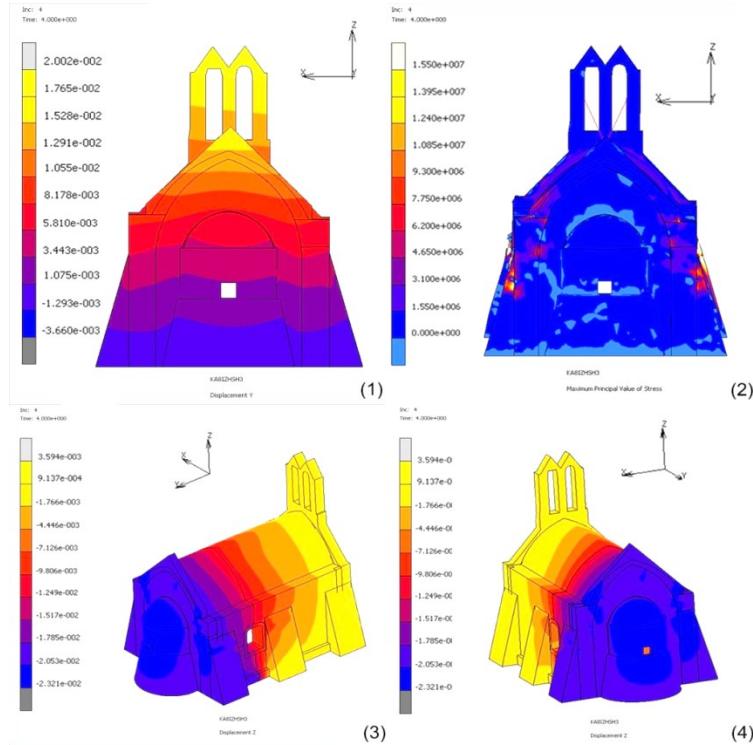
Figure 16. Analysis results for loading scenario 3.

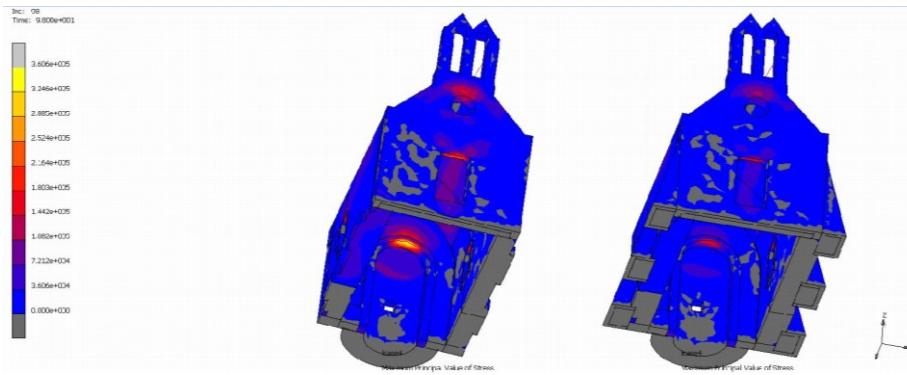
Figure 17. Maximum principal tensile stress for Arkalochori earthquake transient analysis (in Pa) (left without and right with buttresses).

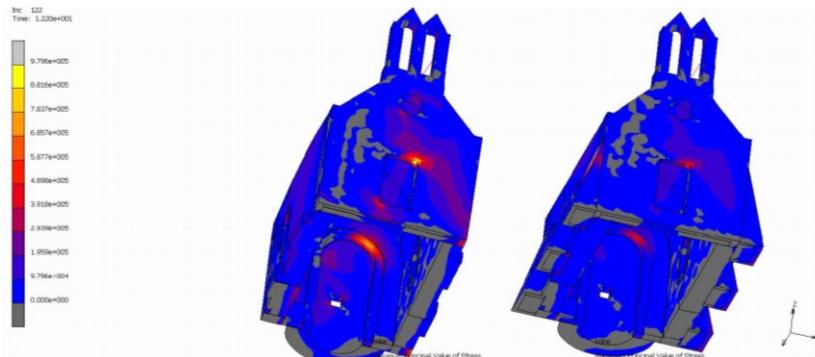
Figure 18. Maximum principal tensile stress for Kobe earthquake transient analysis (in Pa) (left without and right with buttresses).

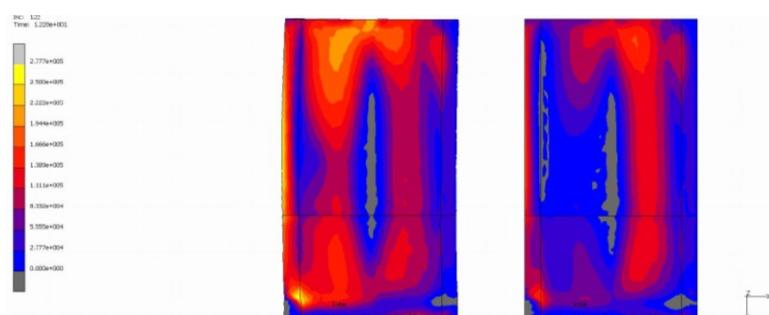
Figure 19. Maximum principal tensile stress for Kobe earthquake transient analysis (in Pa) (vault top view) (left without and right with buttresses).
