Improvement Accuracy of Debonding Damage Prediction Technology at Composite Blade Joints for 20 kW Class Wind Turbine

Keywords: artificial neural network; composite blade; debonding; machine learning; modal analysis; natural frequency

The blade used to predict the debonding damage was the blade model for 20 kW-class wind turbines developed in Kunsan National University by reflecting the spar cap and shear web, which are the structural characteristics of large composite blades [22]. This model is shown in Figure 1 and the specifications are listed in Table 1.

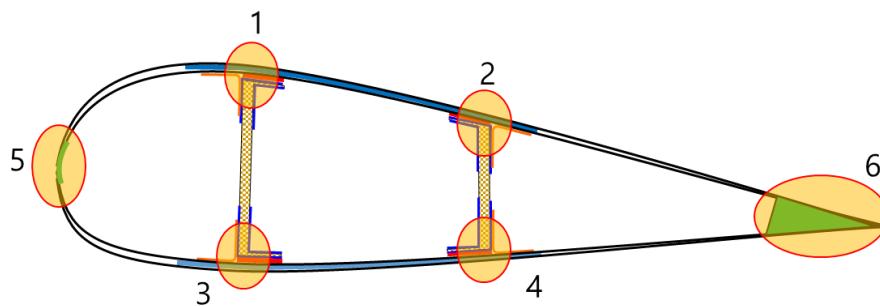
Figure 2. Blade cross section.

In this study, debonding damage that may occur at six blade joints (Figure 2) was classified based on the damage type, damage start position, and damage size, and 7,132 damage data were selected. First, as shown in Figure 3, the damage type was classified into three types. Type 1 has one damage in a single web while type 2 has two damages in a single web. Type 3 has one damage in each of the two webs. The damage start position includes points that are 18% away from the root of the blade where debonding damage has the greatest impact on the safety of the blade, and the points 0.5 m, 1.3 m, and 2.1 m away from the root were selected to consider all the shear web-spar cap joints. The damage size was selected differently depending on the type to examine changes in the natural frequency for the entire range of damaged joints as shown in Figure 4a–c. For type 1, 0.2 m-sized damage began at the damage start point of the joint and increased by 0.2 m to 1.8 m. For type 2, 0.1 m-sized damage began at the damage start point and increased by 0.1 m to 0.5 m. In type 3, the maximum damage size was selected differently depending on the damage start point to express the occurrence of one debonding damage at each of the two joints. At the 0.5 m point from the root, 0.2 m-sized damage began and increased by 0.2 m to 1.8 m. At the 1.3 m point from the root, 0.2 m-sized damage began and increased by 0.2 m to 1.6 m. Finally, at the 2.1 m point from the root, 0.2 m-sized damage began and increased by 0.2 m to 0.8 m.

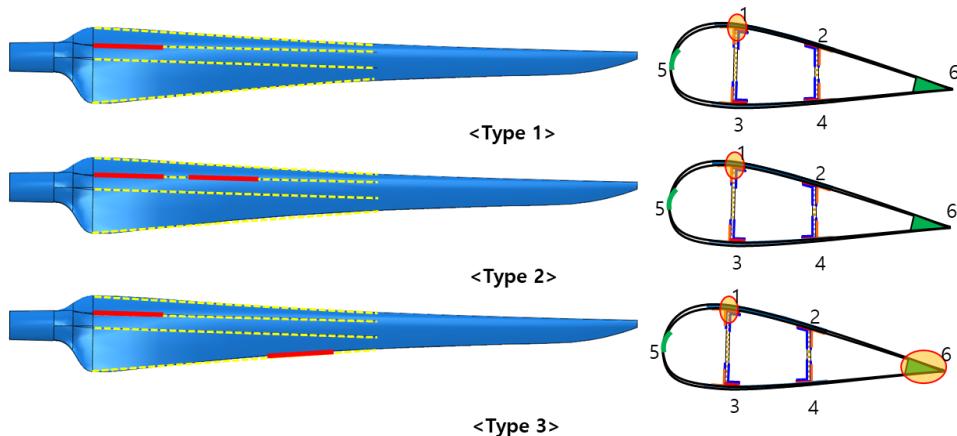
Figure 3. Blade damage type.

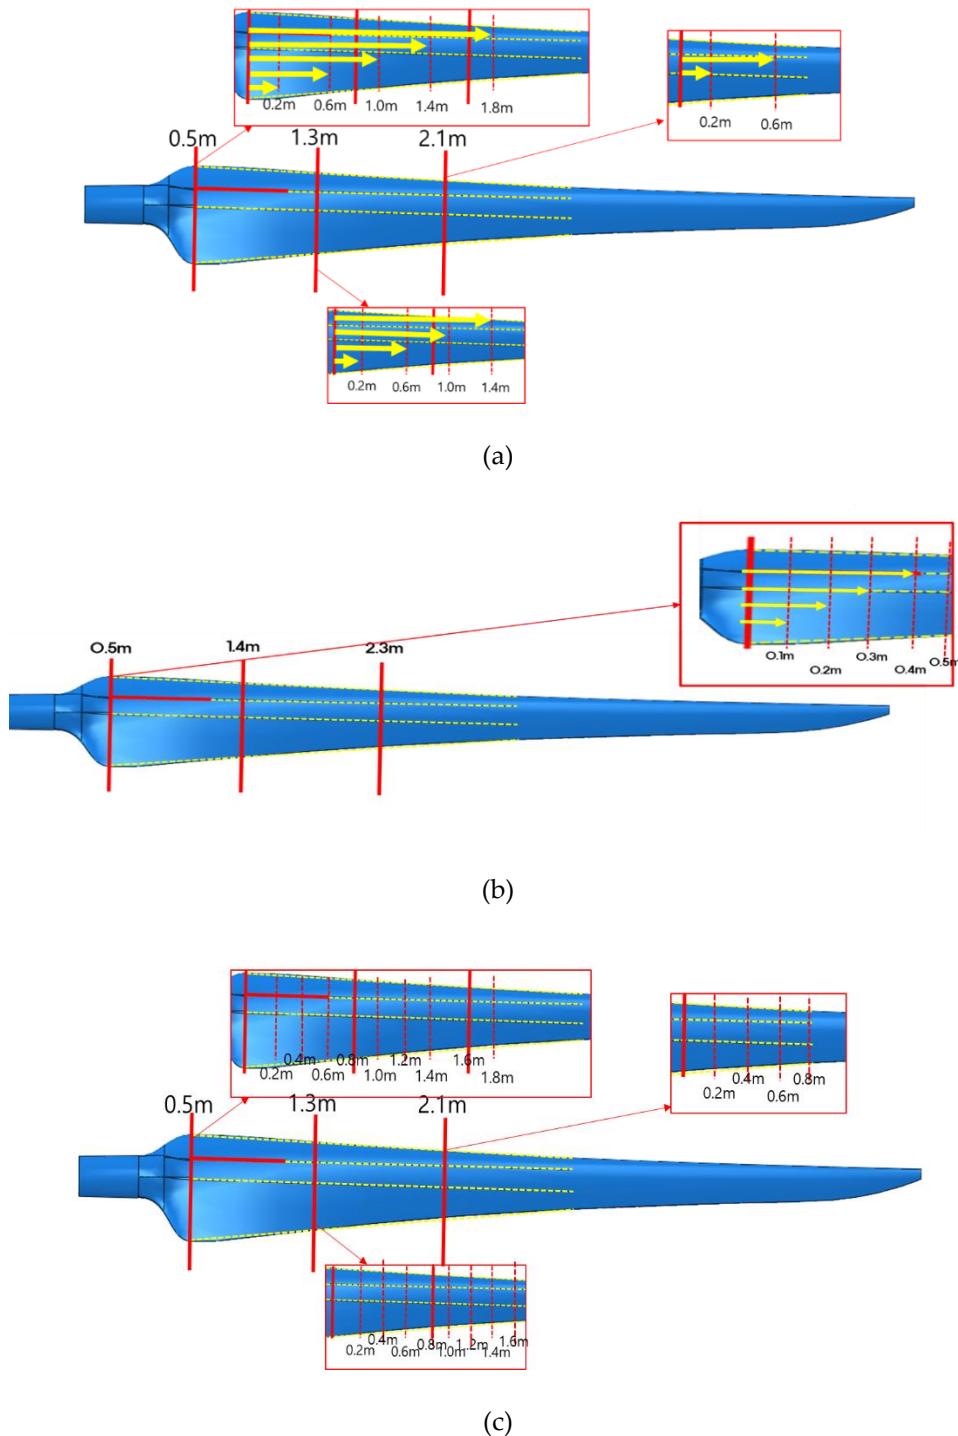
Figure 4. Damage selection criteria by type.

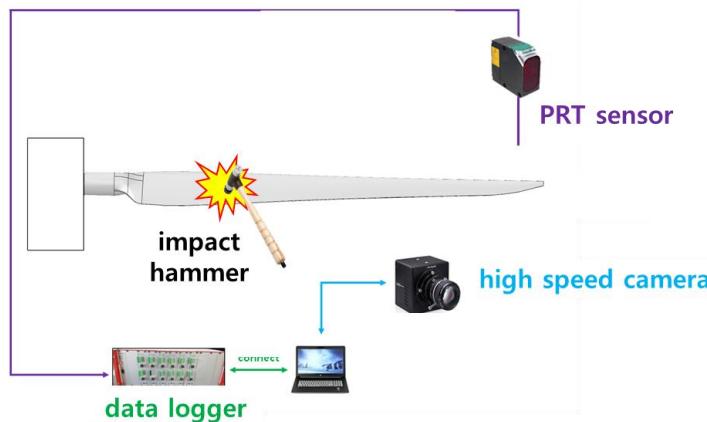
Figure 5. Schematic diagram of modal test.

To acquire and analyze the vibration characteristics of the composite blades, a fixing jig and a blade were combined and an impact was applied to the blade using an impact hammer. Vibration response and natural frequency data were then acquired using a non-contact sensor. Table 3 lists the specifications of the PRT sensor and high-speed camera used for measurement. Vibration response

data were measured at a point 2.7 m away from the root because of the measurement range limit of the sensor. The related contents are shown in Figures 5–7.

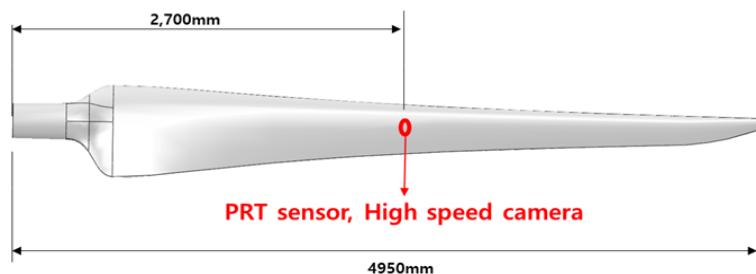
Figure 6. Position of PRT sensor and high speed camera.

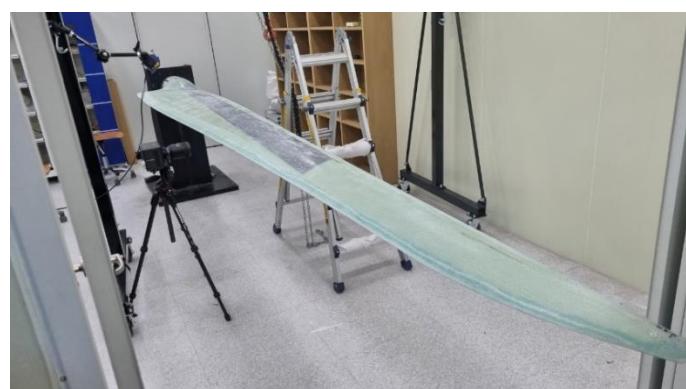
Figure 7. Composite blade modal test.

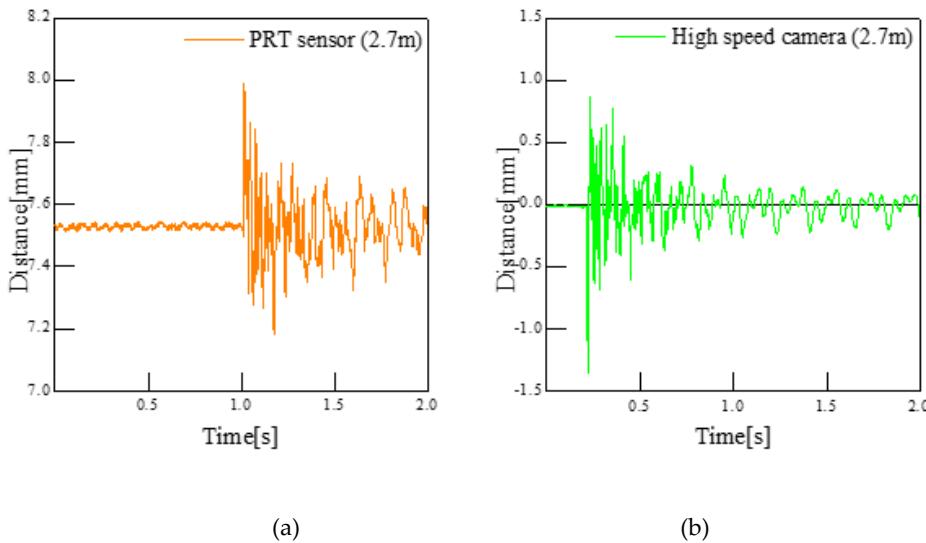
Figure 8. Vibration response data using (a) PRT sensor and (b) high speed camera.

Natural frequency data were acquired by conducting the test described in Section 3.3 and constructing a model without damage. Figure 8 shows the vibration response data and natural frequency data while Table 4 lists the modal test results.

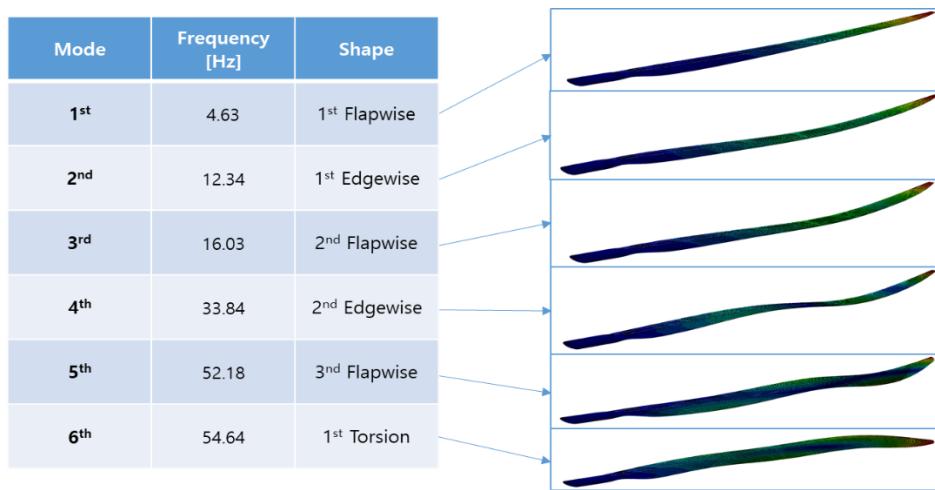
Figure 9. Blade modal analysis results and motion.

The blade model was synchronized so that the error from the results in Table 4 could be less than 5%. The modal analysis of 7,132 blade damage models was then conducted using the method described in Section 2.2. Figure 9 shows the first to sixth natural frequency results of the blade without damage and the corresponding behavior.

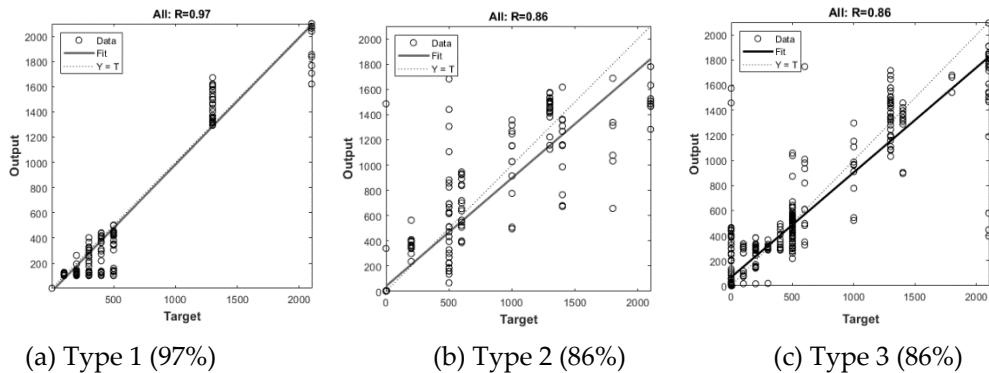
**Figure 10.** Damage prediction accuracy by type

The debonding damage prediction accuracy was examined using the ANN technique based on the natural frequency data acquired through modal analysis. The input data were the first to sixth natural frequency data, and the target data were set to predict joints subjected to the debonding damage, damage start position, and damage size. Tables 5 and 6 list the information on the input and target data. The number of hidden layers was set to two considering the forms and numbers of the input and target data as well as the learning time. Each hidden layer contained 100 neurons. Figure 10 shows the damage prediction results by type. The x-axis represents the target damage information to be predicted while the y-axis indicates the damage information predicted through machine learning. As shown in Figure 10a, the damage prediction accuracy of type 1 was found to be 97%, whereas the damage size from 200 to 1,800 mm was not completely distinguished. Figure 10b shows that the damage prediction accuracy of type 2 was 86%. Unlike type 1, 1,800 mm damage was predicted even though the maximum damage size was set to 500 mm. Finally, as shown in Figure 10c, the damage prediction accuracy of type 3 was 86%, and it was found that the damage size was not completely predicted owing to the large difference from the diagonal values obtained using a regression equation caused by complex changes in the natural frequency depending on the damage.

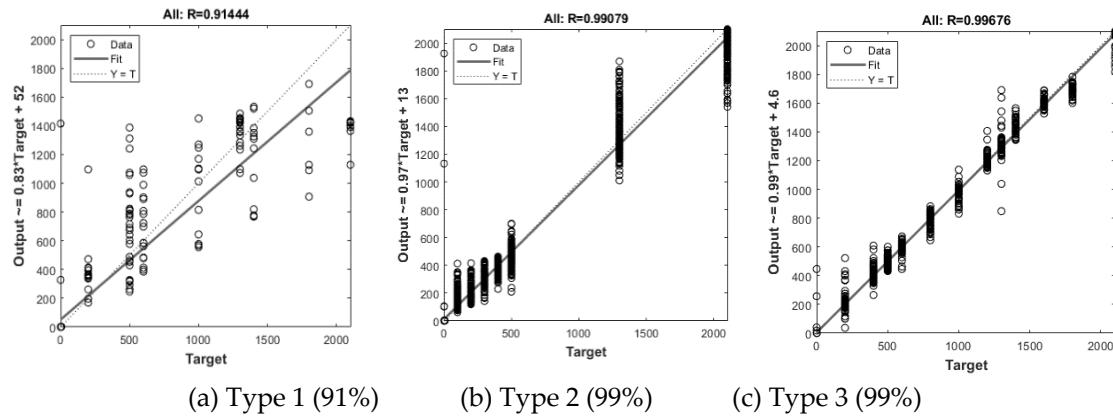
Figure 11. Damage prediction accuracy by type through learning model improvement.

To supplement the results that failed to accurately predict the damage information from the complex changes in the natural frequency caused by changes in the damage factors, a secondary learning model was established by raising the weight of the first to third natural frequencies, which exhibited larger changes in the event of debonding damage, and increasing the number of hidden layers to five for more complex forms of data prediction despite the increased learning time. The prediction accuracy of the model was examined. As shown in Figure 11a, the damage prediction accuracy of type 1 was found to be 91%, and the damage size from 200 to 1,800 mm was predicted unlike the prediction results before the improvement. As shown in Figure 11b, the type 2 damage prediction accuracy was improved to 99%, and the damage start position and damage size were predicted within the selected range. Finally, Figure 11c shows that the damage prediction accuracy of type 3 was improved to 99%, and predictions were performed within the selected range. For all the types, the damage prediction results were distributed according to the damage selection criteria compared to the results before the improvement. These results confirmed the accuracy improvement of the debonding damage prediction model based on the natural frequency of composite blades.

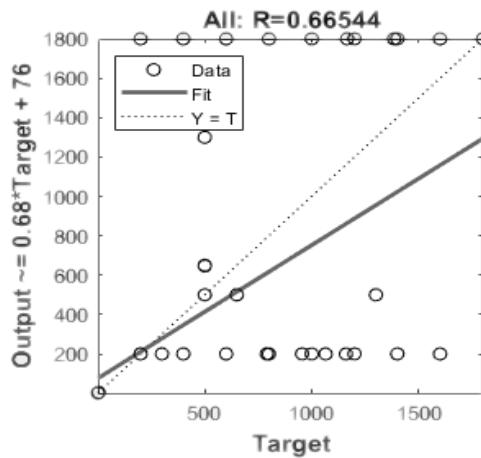
Figure 12. Damage prediction accuracy of manufactured blades.

To verify the performance of the improved algorithm, the natural frequency data of the blades with debonding damage were measured and the ability of machine learning to obtain the debonding damage information was examined. Figure 12 shows the damage detection accuracy of the manufactured blades. The damage prediction accuracy was found to be 67%, but no damage prediction tendency was observed. This appears to be because there was a difference between the damage prediction algorithm based on the modal analysis results and the damage characteristics of the manufactured blades. To address this problem, the algorithm was improved by examining the detailed damage information of the manufactured blades and performing further training with 1,000 sets of similar damage characteristics. Figure 13 shows the accuracy of the improved algorithm based on the manufactured blade data. The damage prediction accuracy was found to be 86%, and a damage prediction tendency was observed unlike in the initial model. This indicates that the damage prediction algorithm for composite blades requires the development of a learning model using the dataset based on the FEA of the target blade and the improvement of learning using the dataset based on the actual environment.

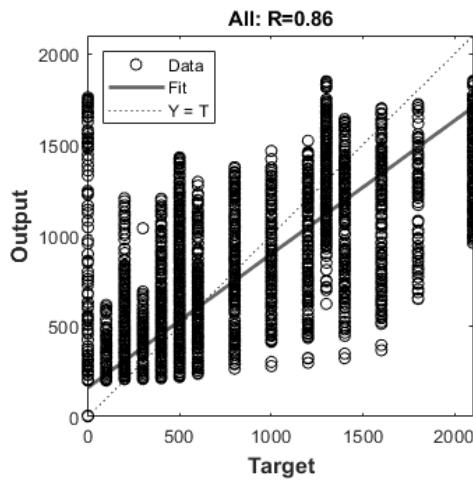
Figure 13. Damage prediction accuracy improvement model.
