# Integrated Application of Innovative Technologies for Oil Spill Remediation in Gran Tarajal Harbor: A Scientific Approach

**Abstract:** This study examines the recovery efforts at Gran Tarajal Harbor following a significant oil spill, employing innovative technologies. Initial response efforts were hampered by inadequate contingency plans and bureaucratic delays, underscoring the need for improved preparedness. Cleanup operations utilized advanced methods such as enhanced absorbent sponges, absorbent granulates, bioremediation with allochthonous species, and a combination of barriers and sponges. These technologies proved effective in minimizing environmental impact, reducing hydrocarbon concentrations in sediments from nearly 60,000 mg/kg to less than 1,600 mg/kg in seven months. Heavy metal analysis revealed lead and copper concentrations associated as well as with routine port activities, while mercury levels linked to the spill decreased over time. Tissue analysis indicated minimal contamination in local organisms, suggesting limited impact from the spill, and evaluation of the biological communities in sediments suggest an ecological recovery. Study underscores the importan

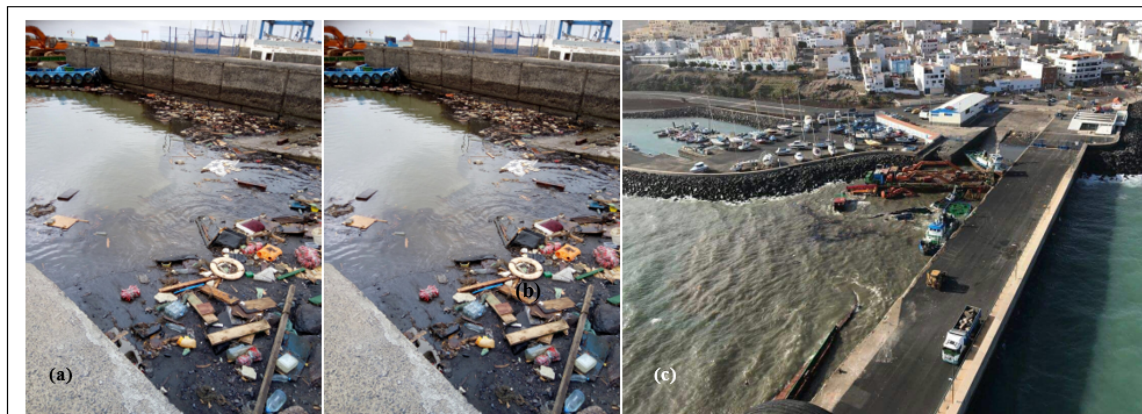
Figure 3. Consequences. In (a) the final situation of wrecks where only the blue pontoon have not sunken. Picture (b), shows the harbour interior beach. Picture (c) shows the scenario in the end of the funnel where the color of water evidence the mixture between oil, water and suspended solids.

The aftermath is depicted in Figure 3, where the vessels broke their moorings and collided with each other, gradually descending towards the bottom of the funnel where a small black sand beach is situated. Figure 3B illustrates the condition of the beach adjacent to the ramp, revealing not only the presence of oil but also a substantial accumulation of solid waste and seaweed debris dislodged by the storm. Figure 3 (c) presents an aerial image captured shortly after the incident. The wind and wave forces propelled surface oil and floating debris towards the beach and ramp at the funnel's base. Meanwhile, agitation mingled the oil with water and suspended particles, leading to emulsification, a process known as Marine Oil Snow Sedimentation and Flocculent Accumulation (MOSSFA). This process transports oil from the surface to the port's bottom, retaining a significant amount in the mid-water region (water column). [21,22,23,24]. (Video-2, MOSSFA Images).

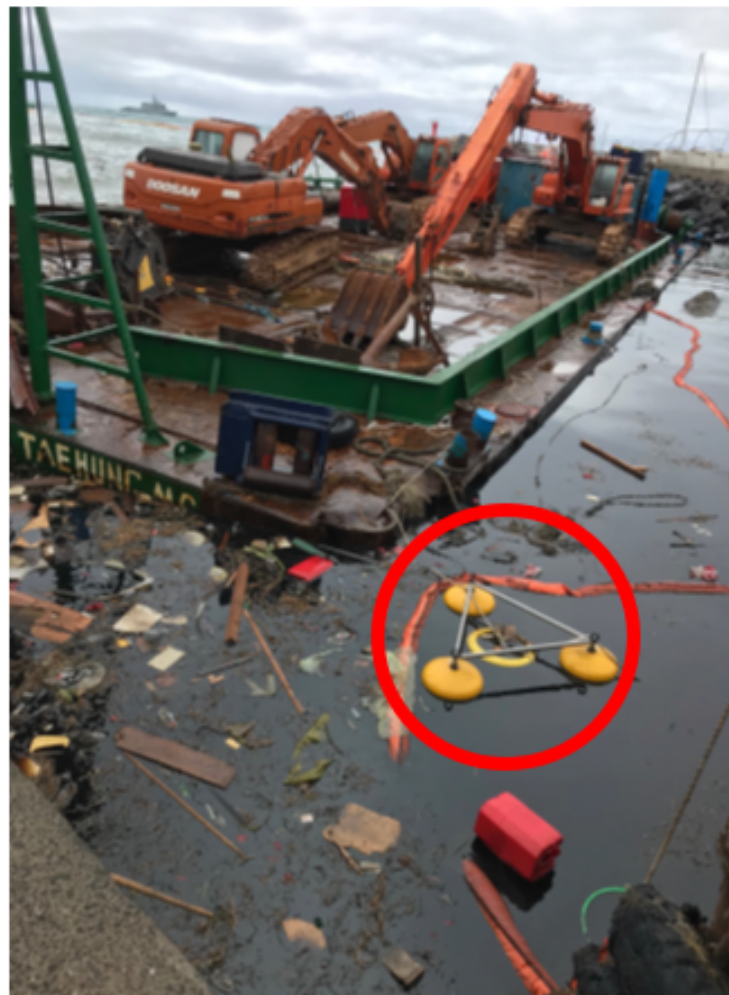
Figure 4. Standard Skimmer working (red circle)

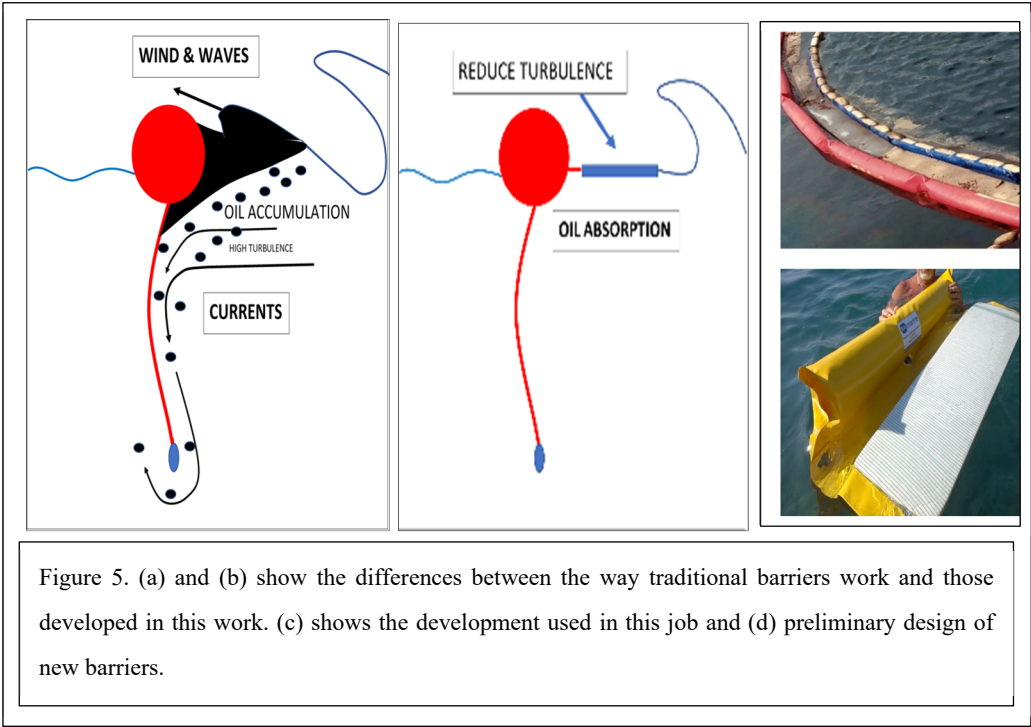
By integrating these two systems, the barriers supplemented with sponges successfully prevented the passage of any oil type for the first time, effectively trapping it within the sponge. Subsequently, in collaboration with a small barrier manufacturer, a new barrier design was developed with an adaptation to accommodate the sponge, ensuring it remains floating at water level and attached to the barrier (refer to Figure 5).

This innovative design not only enables the effective surface containment of oil, subsequently absorbed by the sponge, but also facilitates the rapid attachment and removal of sponges. This allows for the periodic renewal of sponges to remove absorbed oil accumulated during their deployment in the water.

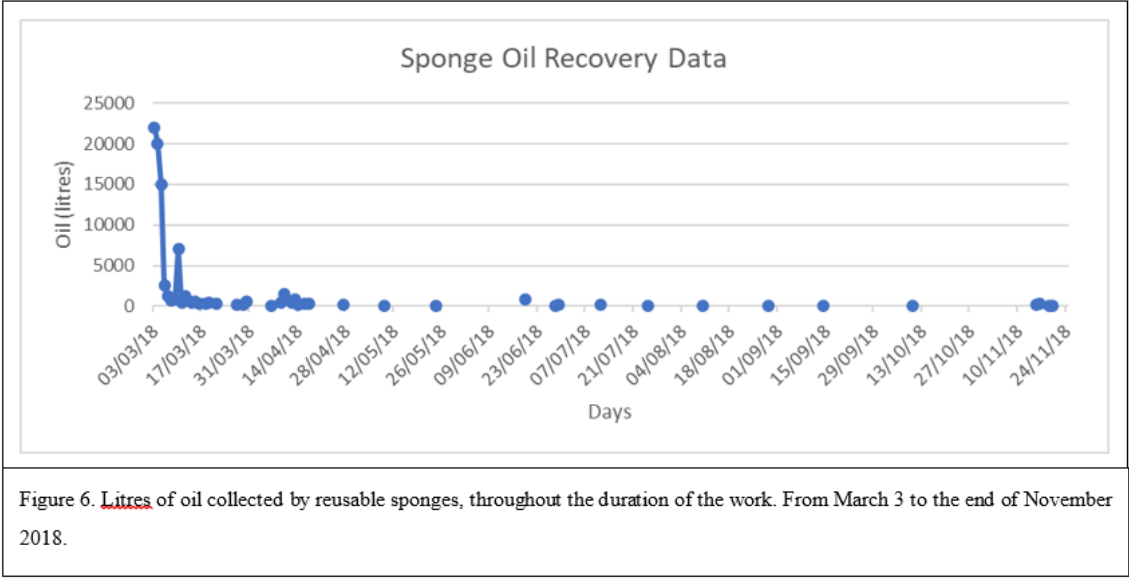
Figure 6 illustrates the progression of hydrocarbon collection during the dock cleaning activities. Notably, until the end of November, sponge absorbents were employed extensively, both directly on spills and by draining the sponges adhered to the booms, which had also absorbed oil.

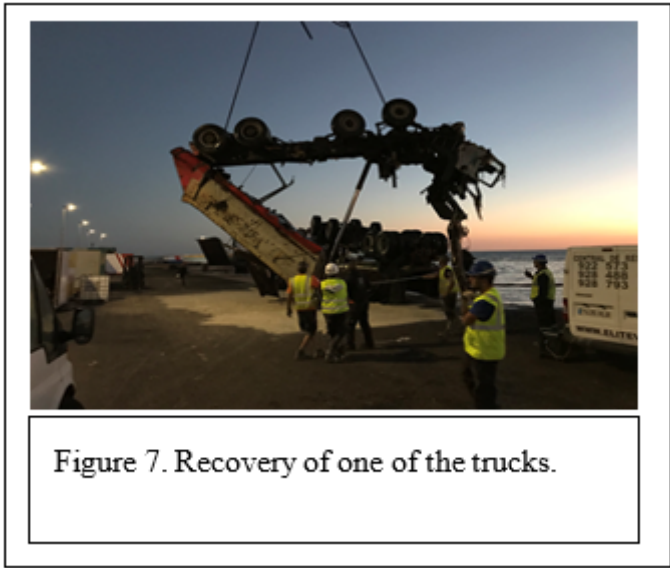
Furthermore, the cut segments of the vessels and heavy machinery (See figure 7) contained residual hydrocarbons, posing a risk of spillage upon deposition in the port. These hydrocarbons, when mixed with water, could contaminate again the water, soil the port floor, and impede operations, endangering workers. This challenge was addressed with the introduction of another innovation in oil spill response: absorbent granules.

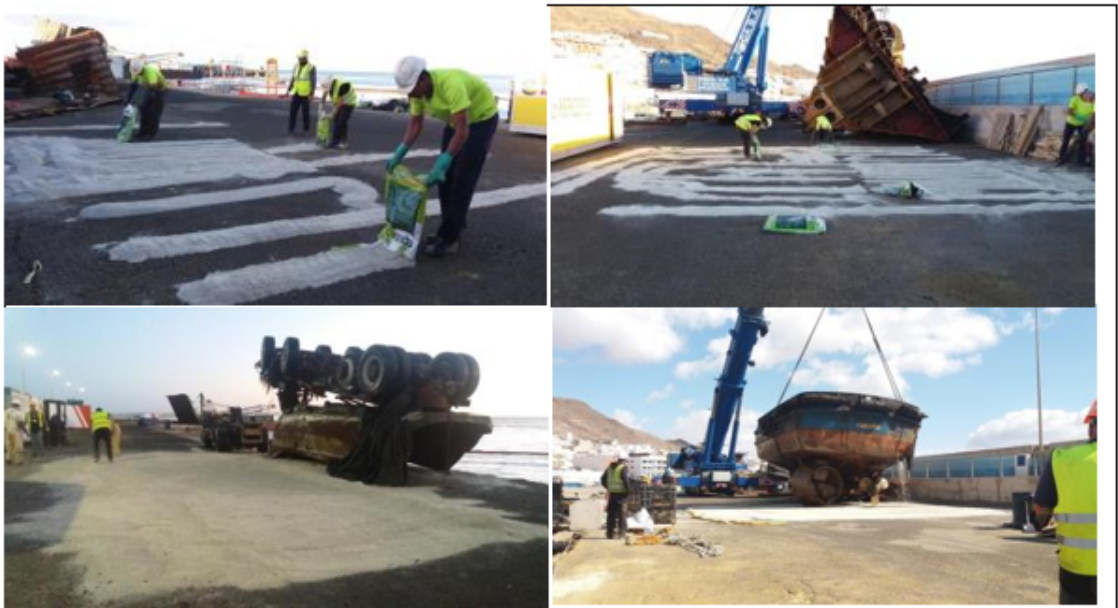
**Figura 8.** Sequence for the preparation of a bed of oleophilic and highly water-repellent absorbent granules to protect the port soil and prevent water contamination.

Figure 8 illustrates the sequence for preparing a granulate bed to prevent soil and water contamination in the event of an oil leak from a ship's cut part.

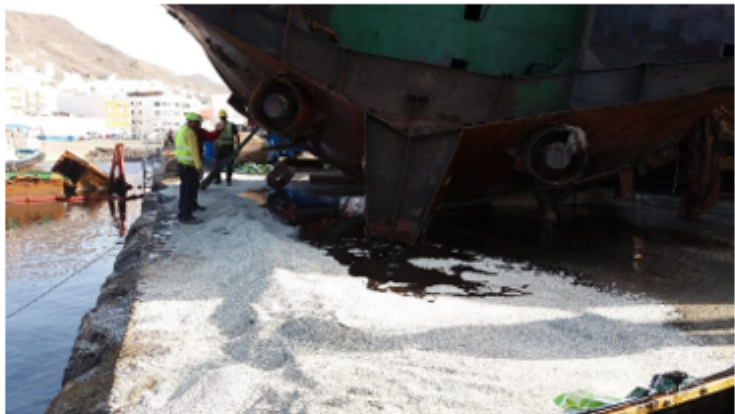
Figure 9. Significant fuel oil spill near the edge of the dock, retained with the combination of granulates and sponges.

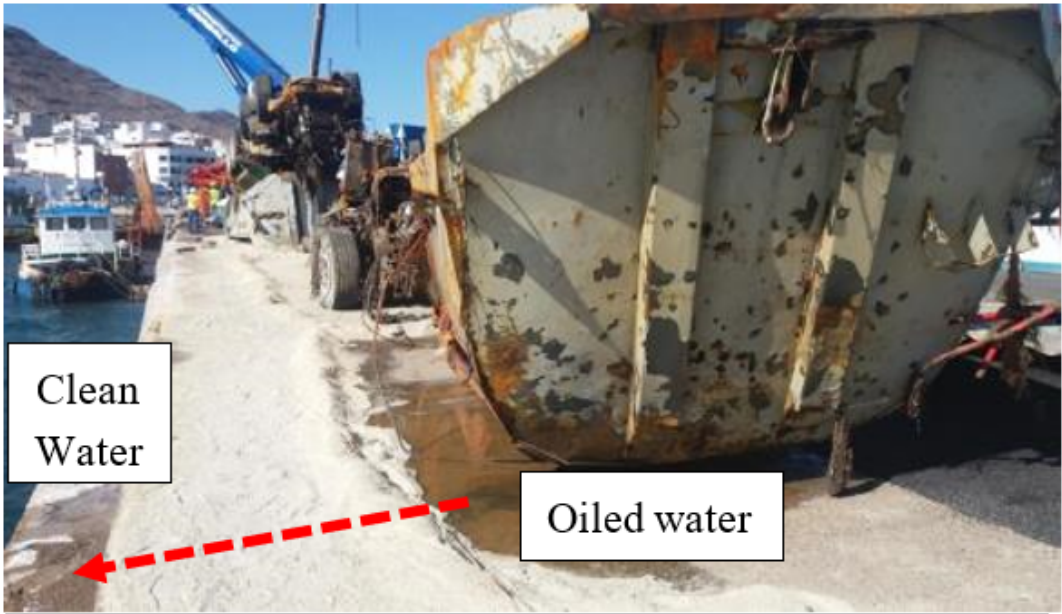
Figure 10. Filtering process for Oiled water before reached the water harbor again.

This barrier was particularly effective when dealing with water containing hydrocarbons, as the hydrophobic granulates allowed water to pass through while retaining the hydrocarbon, as shown in Figure 10.

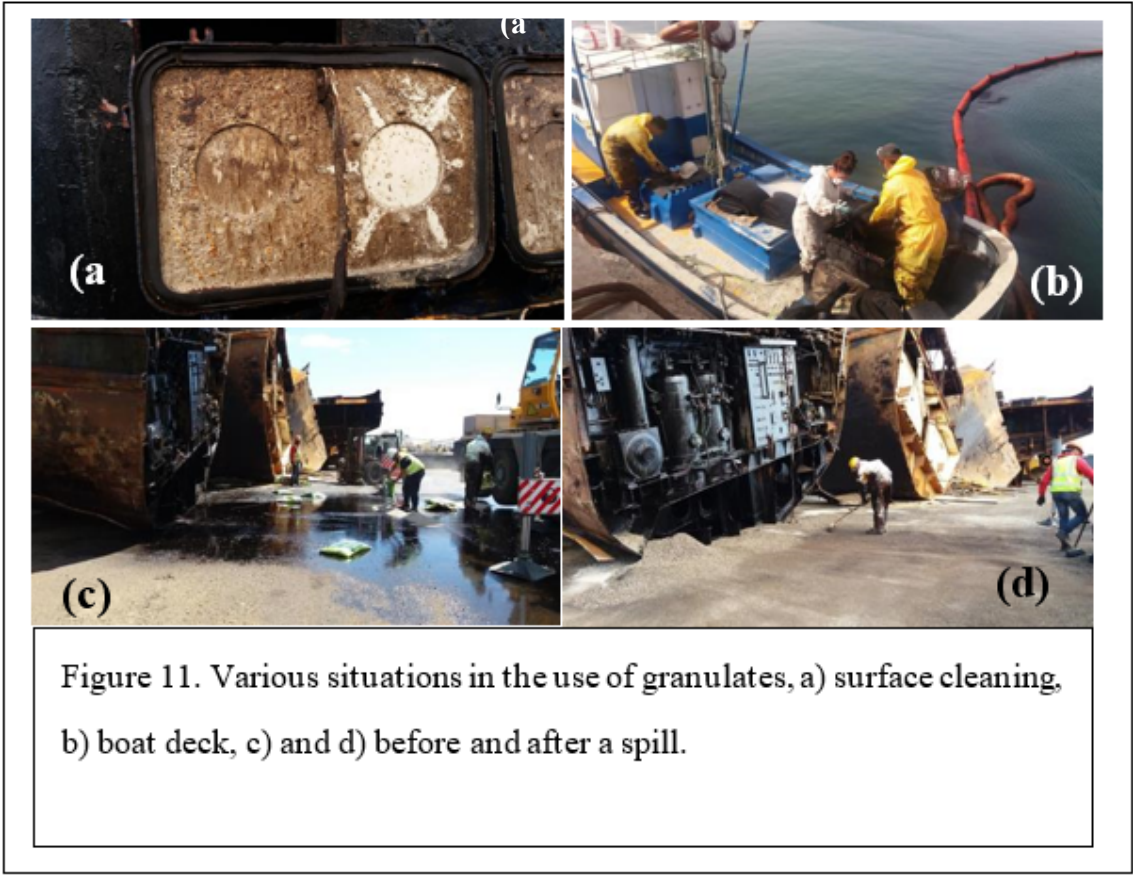
Figure 11 depicts various scenarios demonstrating the utility of granulates in enhancing safety: (a) showcases their capacity to clean various surfaces, even dry fuel oil; (b) demonstrates safe deck conditions, preventing slipping by removing oil from boot soles and the floor; and (c) and (d) depict asphalt floor cleaning before and after granulate use, without causing damage.

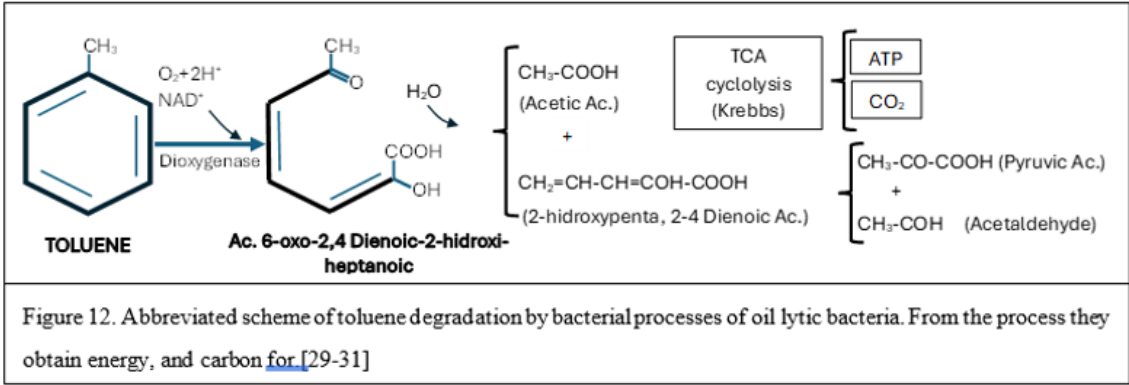
Another significant advantage of using specialized bacteria is their ability to degrade hydrocarbons completely, converting them into final products that provide energy and carbon sources for bacterial growth (see Figure 12).

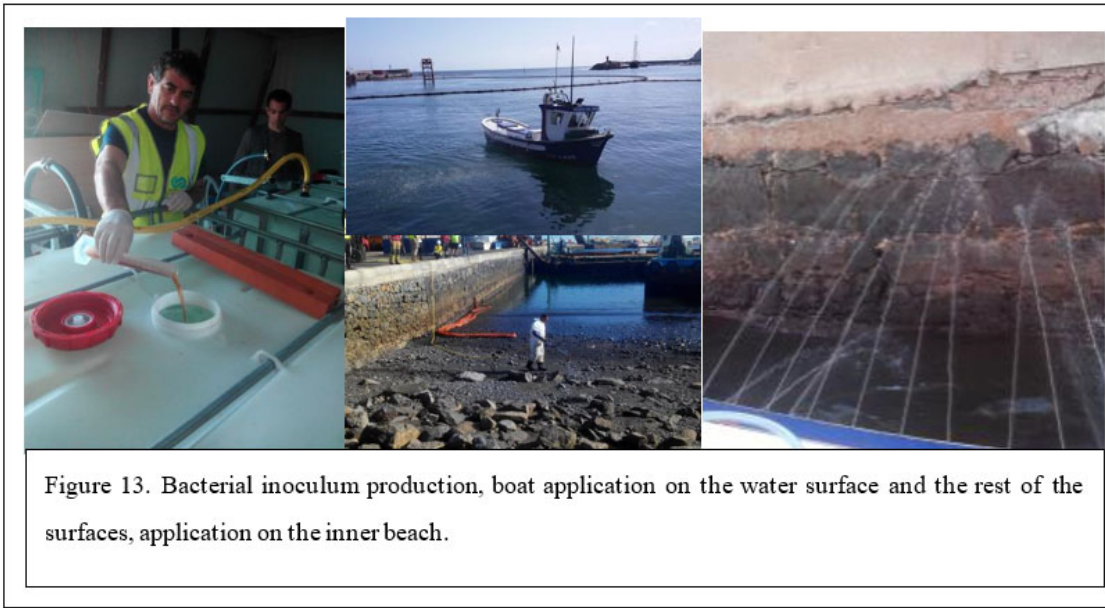
Figure 13. Bacterial inoculum production, boat application on the water surface and the rest of the surfaces, application on the inner beach.

Figure 13 illustrates how this feature of the fishing vessels was utilized to apply the inoculum over large areas affected by contamination. During the application, the aim was to cover as much area as possible and ensure that the inoculum reached every affected surface. This method proved highly effective for irrigating breakwaters, quay walls, and the water surface uniformly and relatively quickly. Other systems were also employed from the land to treat the sand of the inner beach of the port, which had been significantly affected, as any spill, in addition to the initial spill, ended up in the bottom of the sack forming the beach.

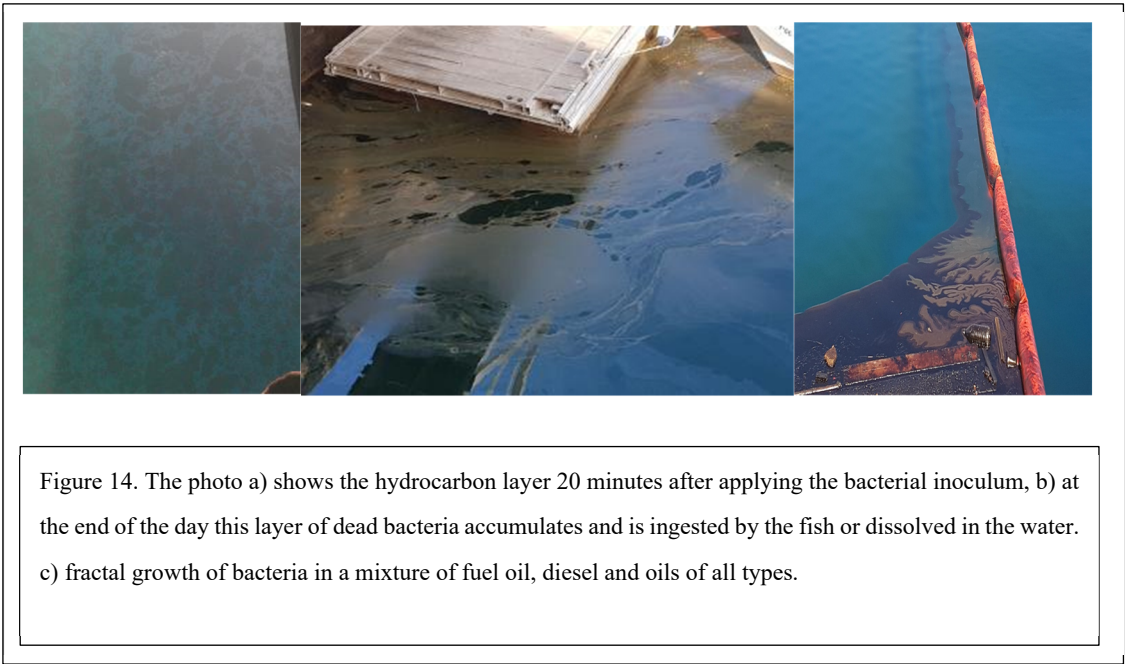
The effect of the inoculum was visibly noticeable in less than 20 minutes when the surface of the oil began to crack (Figure 14.a), indicating the degradation process as the oil lost its physical characteristics, particularly viscosity and surface tension. The oil degraded until it formed an orange

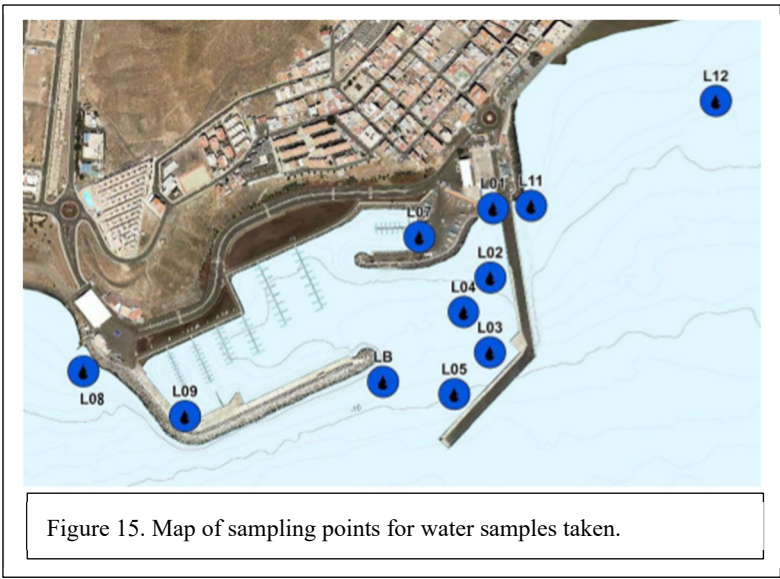
Surface water sampling was conducted from a boat. At all stations, a single sample was collected at the surface of the water column (approximately 25 cm from the surface), except for the station

located at the mouth of the harbor (station LB), where three additional samples were taken at depths of 3m, 5m, and bottom using a Niskin oceanographic bottle. Figure 15 illustrates a map of the port with the water sampling points.

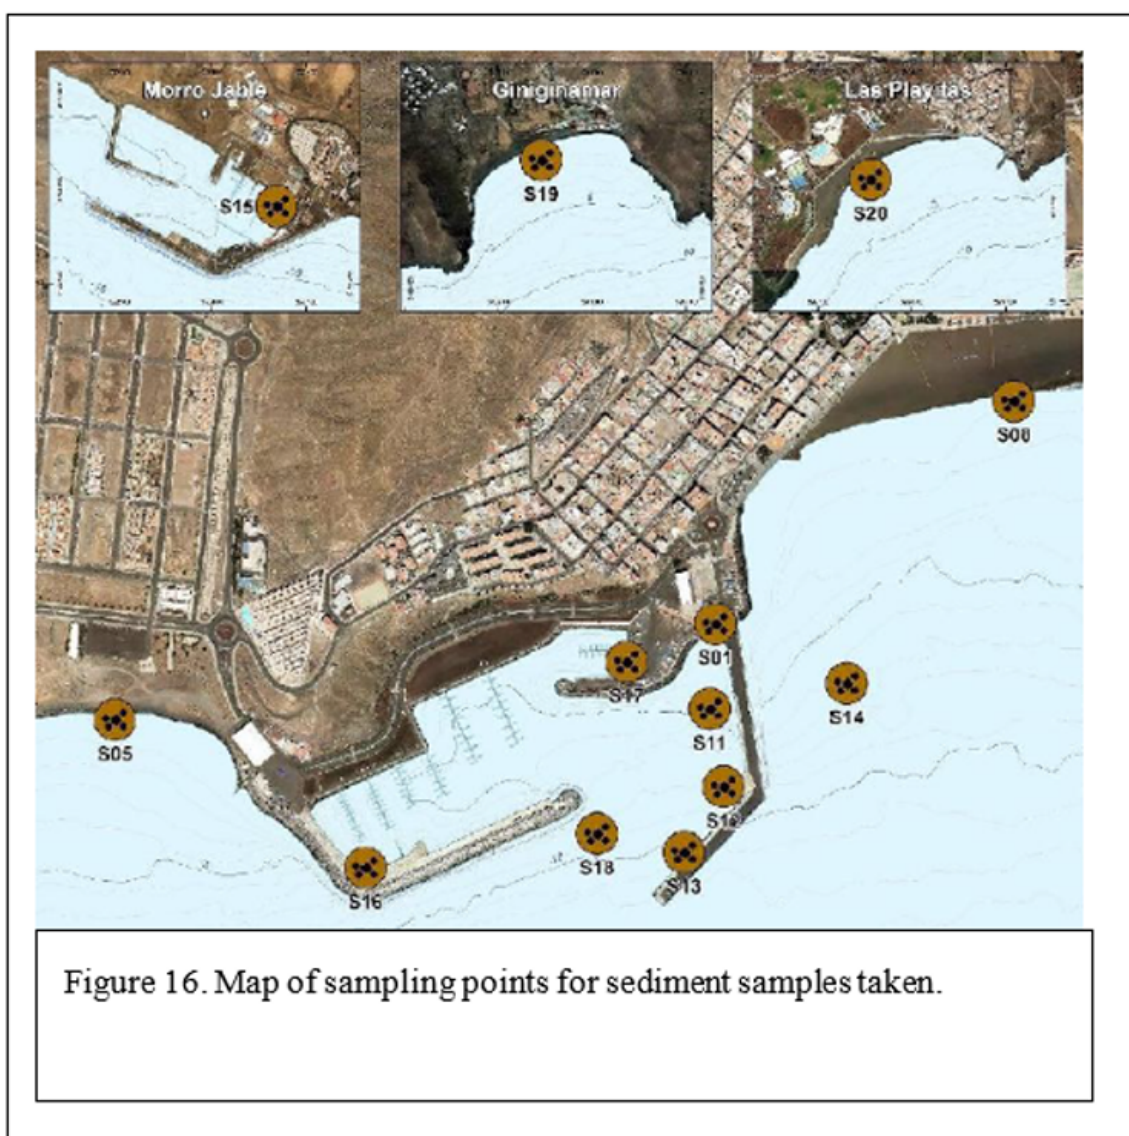
For toxicity bioassays, three sampling points were selected: two within the port and one outside, as depicted in Figure 17.

Sediment ecotoxicity tests revealed no significant toxicity, except for point S16 (See Figure 17) during the April sampling, situated within the marina where the accumulation of floating substances is common due to prevailing north-northeast winds. Positive ecotoxicity values were observed at this point, unlike others which remained below the criterion value.

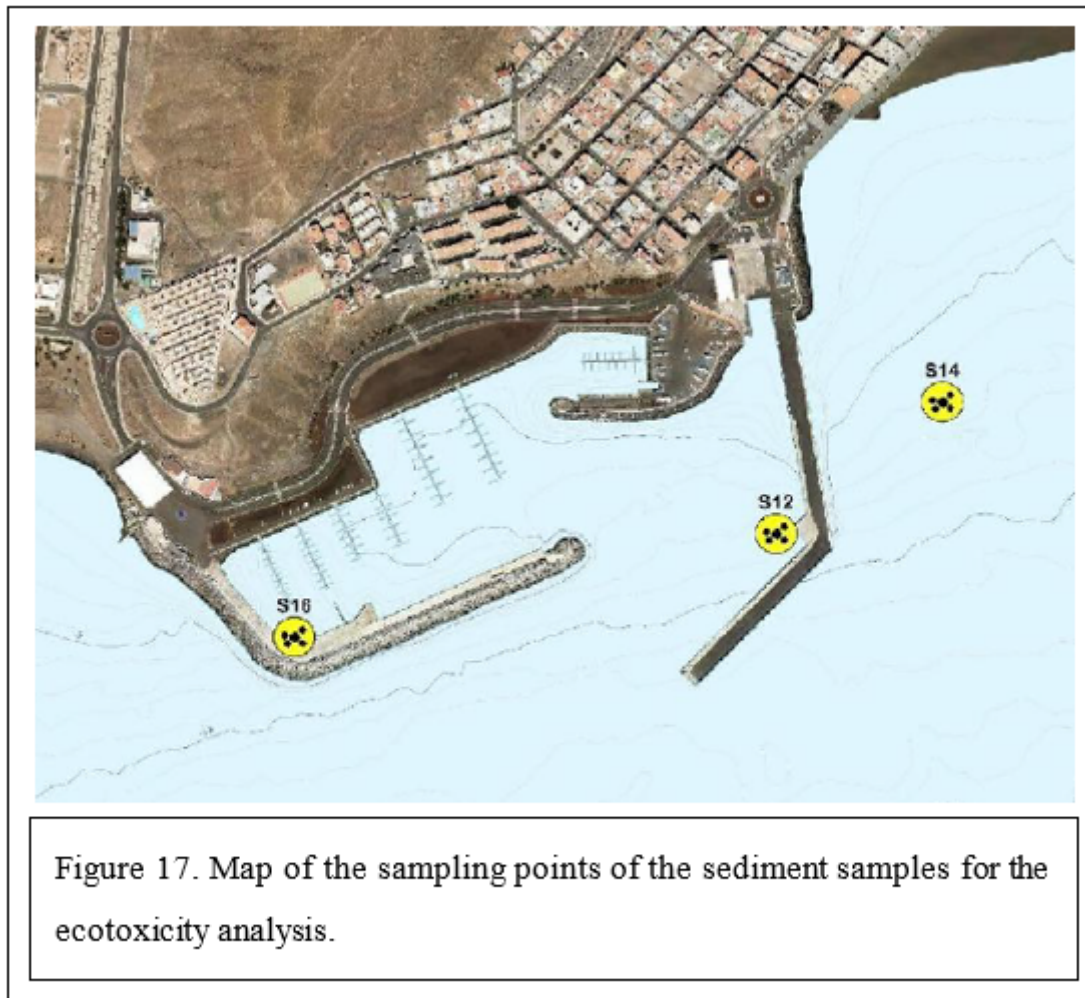
In the March sampling, high values of cadmium (Cd) were measured, above the EQS. From April onwards, this element disappeared from all stations, although a notable natural signal persisted, except at station L05 where values were nearly undetectable (Figure 18).

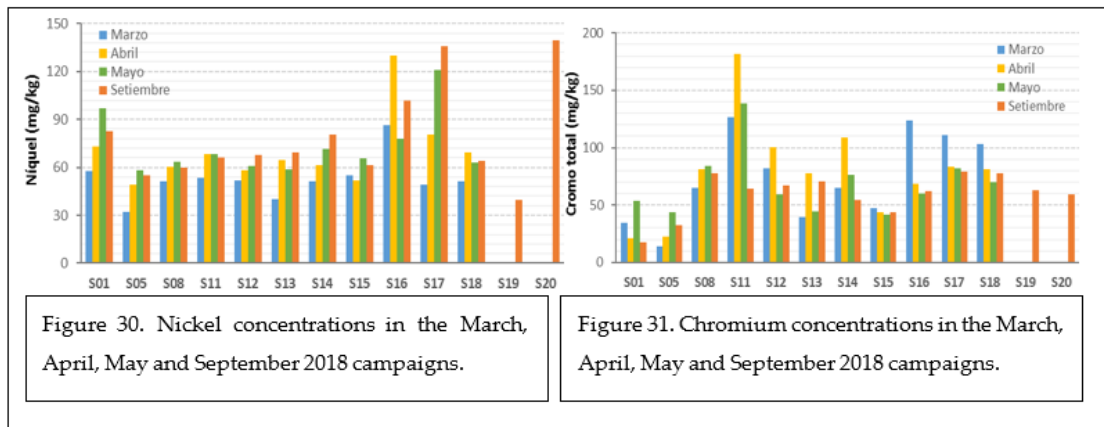
Figure 31. Chromium concentrations in the March, April, May and September 2018 campaigns.

Overall, chromium (Figure 31) concentrations showed a slight increase during the April sampling but decreased during the May and September samplings, except at station S11 during the April sampling, where a significant amount of material from the accident accumulated. This parameter also reflects the significant natural influence of the area, as the values at comparison stations (S19 and S20) are comparable to those obtained in the port.

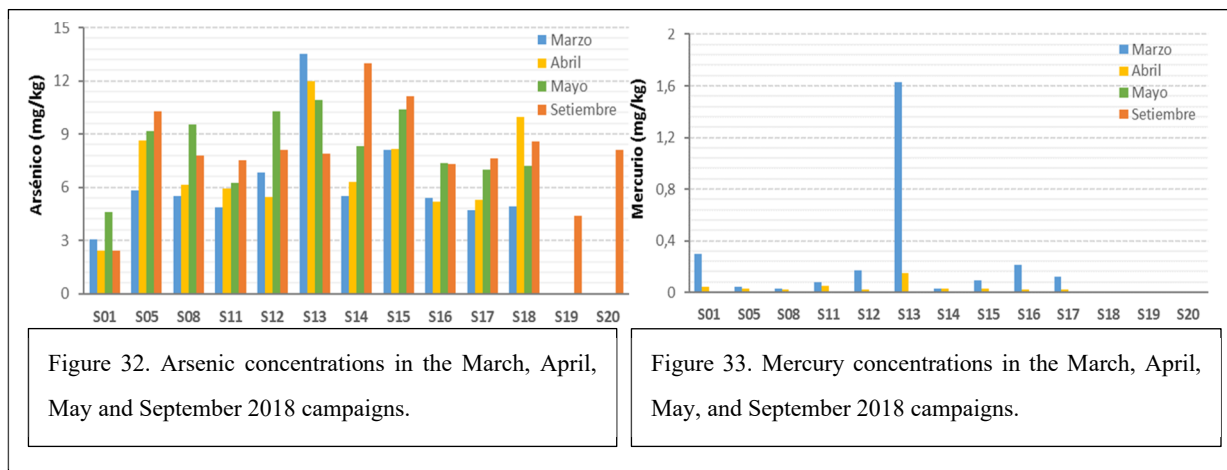
Figure 33. Mercury concentrations in the March, April, May, and September 2018 campaigns.

Mercury concentrations experienced a drastic decrease in the April campaign compared to the March campaign (91% reduction), particularly at station S13, which was approximately 11 times lower (Figure 33). In the May and September campaigns, this metal was not detected. Except for station S13 during the initial sampling, the remaining values are below 0.3 mg/kg, after which this parameter falls below detection limits. Its likely association with the accident suggests accumulation in the port area where granulometry is lower, indicating sedimentation as the cause of the peak concentration in that specific point.

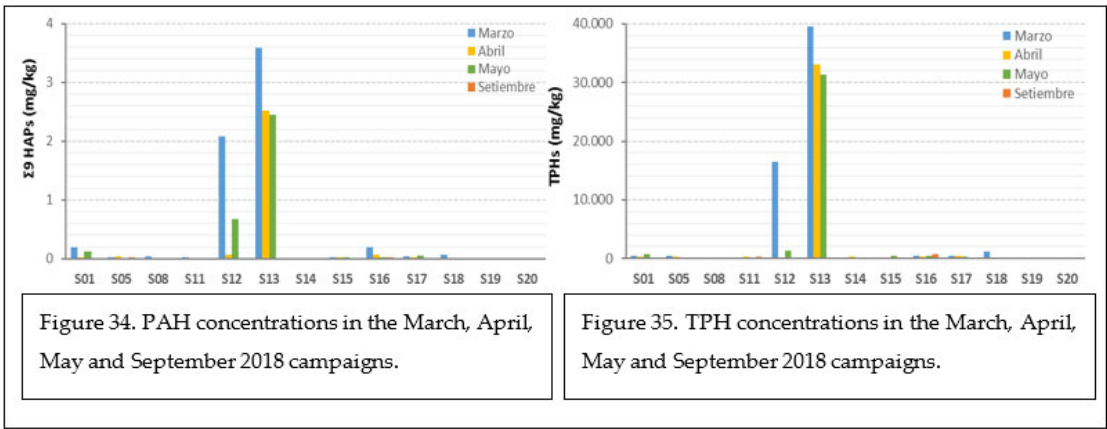
In the March campaign, concentrations of polycyclic aromatic hydrocarbons (PAHs) and total hydrocarbons remained relatively constant for all stations, (Figures 34 and 35) except for S12 and especially S13, which showed high peaks of these substances. This pattern was repeated in the April and May campaigns, although only one peak was recorded at station S13, with slightly lower concentrations than in the March campaign. In the September campaign, the presence of PAHs was not detected, and the values of total hydrocarbons were much lower than in previous campaigns. Once again, the significant sedimentation in the areas of S13 (see video 1) and S12 is identified as responsible for the accumulation of hydrocarbons in the sediment, highlighting the significant difference compared to the other stations. The formation of MOSSFA during the accident confirms

the transport capacity from the water column to the sediment of various pollutants, especially hydrocarbons.

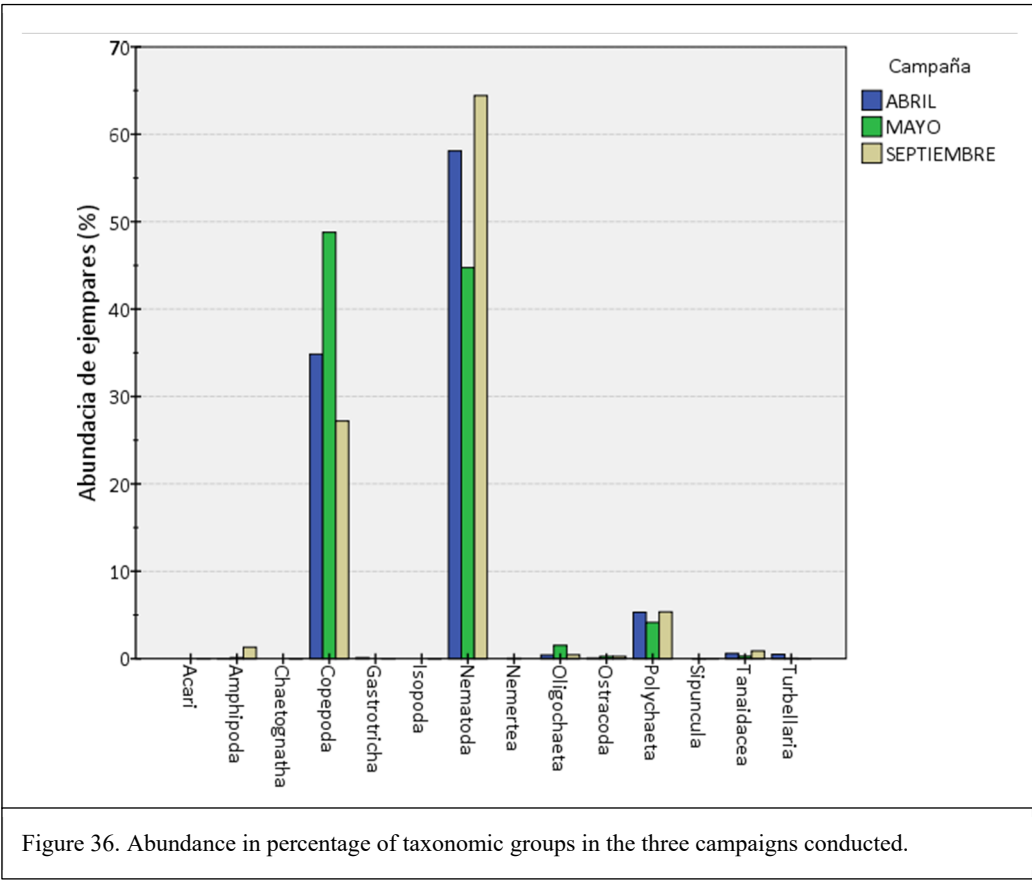
Upon analyzing data from the three campaigns, certain patterns emerge. Overall, the community structure remains consistent across the campaigns (Figure 36), characterized by a dominance of two taxonomic groups: *Nematoda* (comprising 58%, 45%, and 64% of the community in the April, May, and

September campaigns, respectively) and *Copepoda* (accounting for 35%, 49%, and 27% in the April, May, and September campaigns, respectively).

The *Polychaeta* group represents a smaller proportion, comprising 5%, 4%, and 5% in the April, May, and September surveys, respectively. Other taxa are present in minimal percentages across all three campaigns.

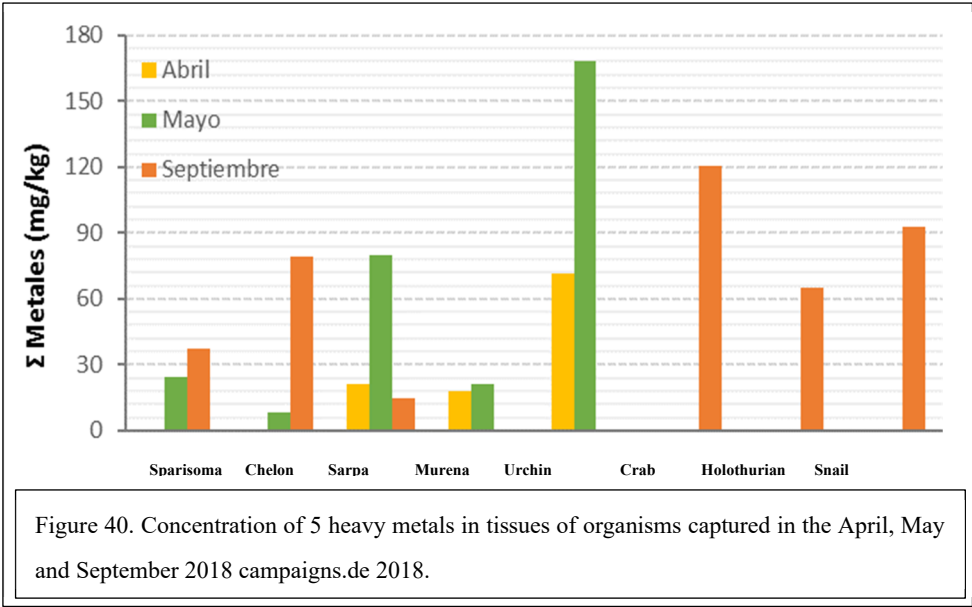
Sea urchins exhibited the highest bioaccumulation of contaminants in April and May campaigns, whereas crabs took precedence in September (Figure 39).

Linear hydrocarbon concentrations remain relatively uniform (Figure 43). Figure 39 does not show a clear trend of accumulation over time, but it does demonstrate the affinity of organisms to accumulate more or less metals, likely influenced by their nutritional characteristics or the specific traits of each organism. Although limited data are available, it can be inferred that the moray eel species does not accumulate significant levels of metals, even among the selected metals, such as zinc.

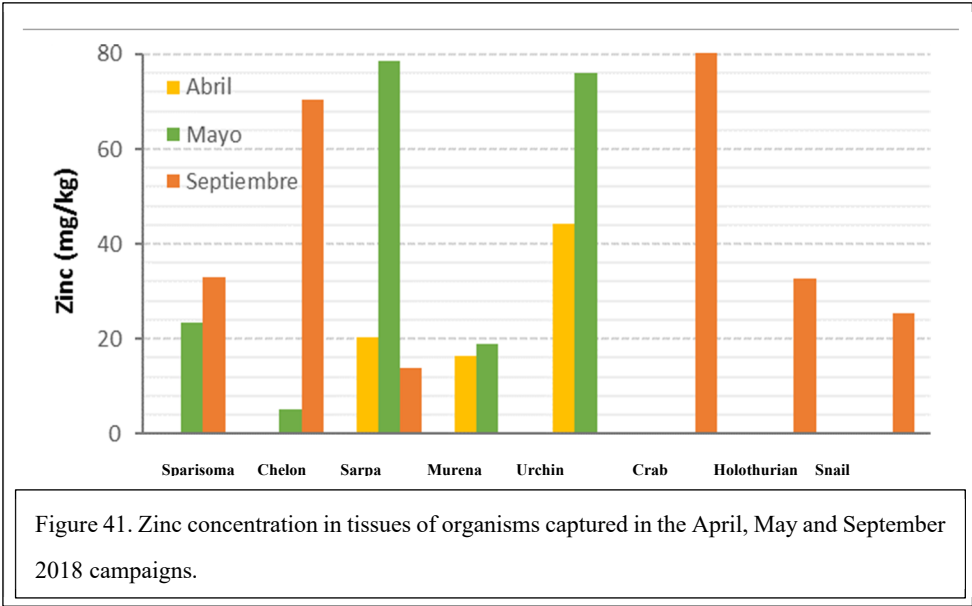
There is a general increase in the concentration of heavy metals in all organisms (Figure 40), especially zinc (Figure 41) and to a lesser extent copper (Figure 42).

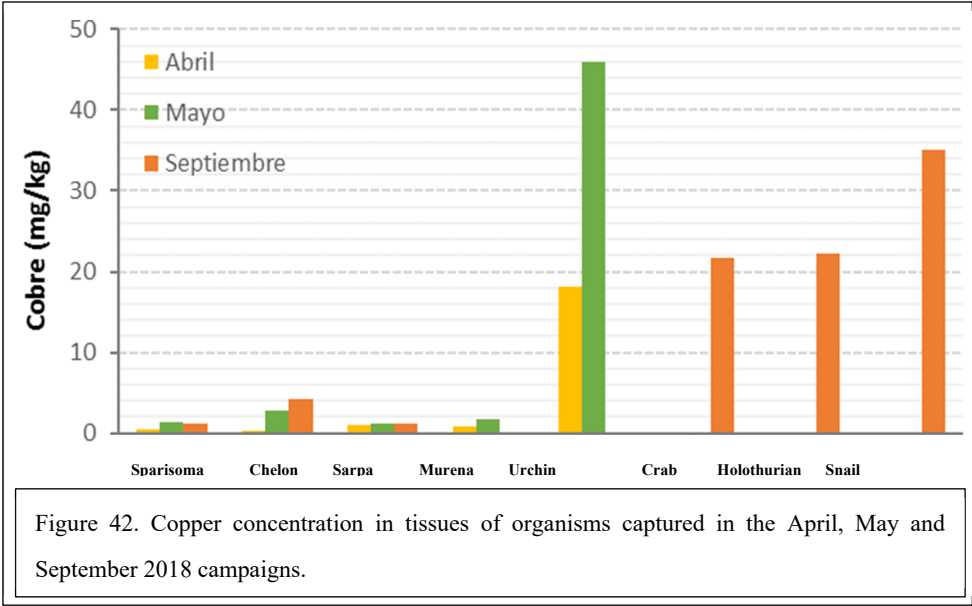
Figure 41 illustrates the presence of zinc in organisms within the port, primarily attributed to the natural concentration of zinc in the port environment, influenced by the quality of volcanic materials in that area of the island. It is challenging to discern a clear trend that could indicate the incorporation of this element into the trophic chain of the port, independent of contamination stemming from the accident.

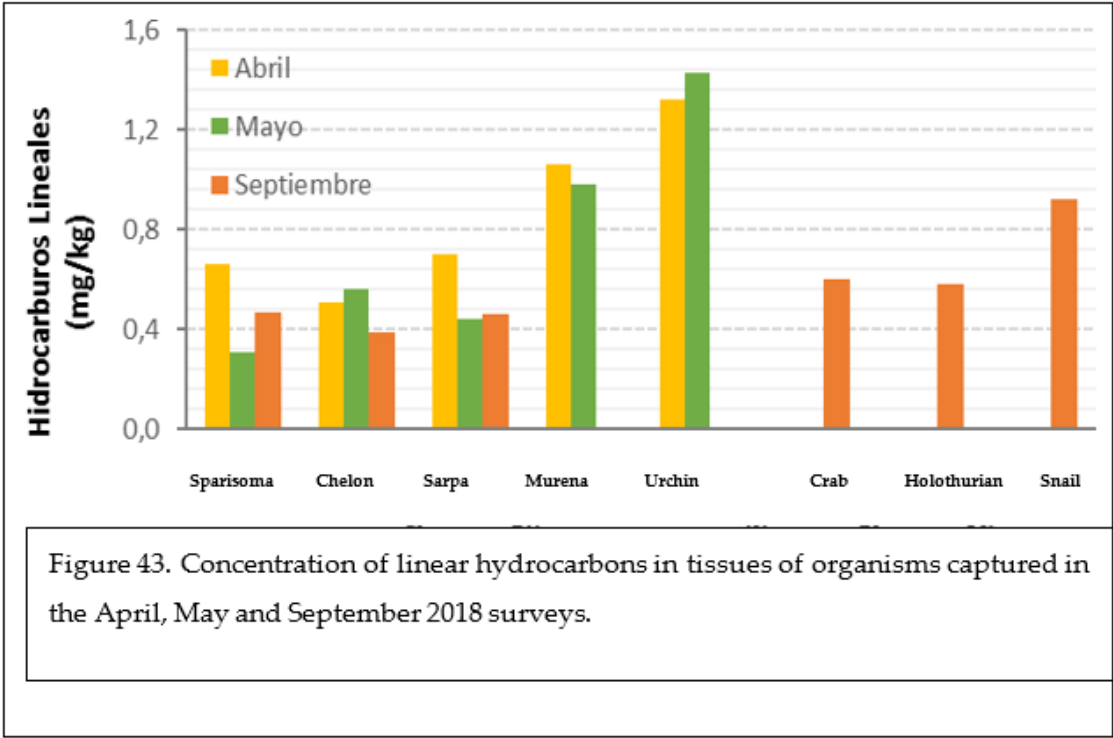
Cadmium, which was detected only in sea urchins during the April sampling, was not found in any of the organisms sampled in the May campaign (Figure 44).

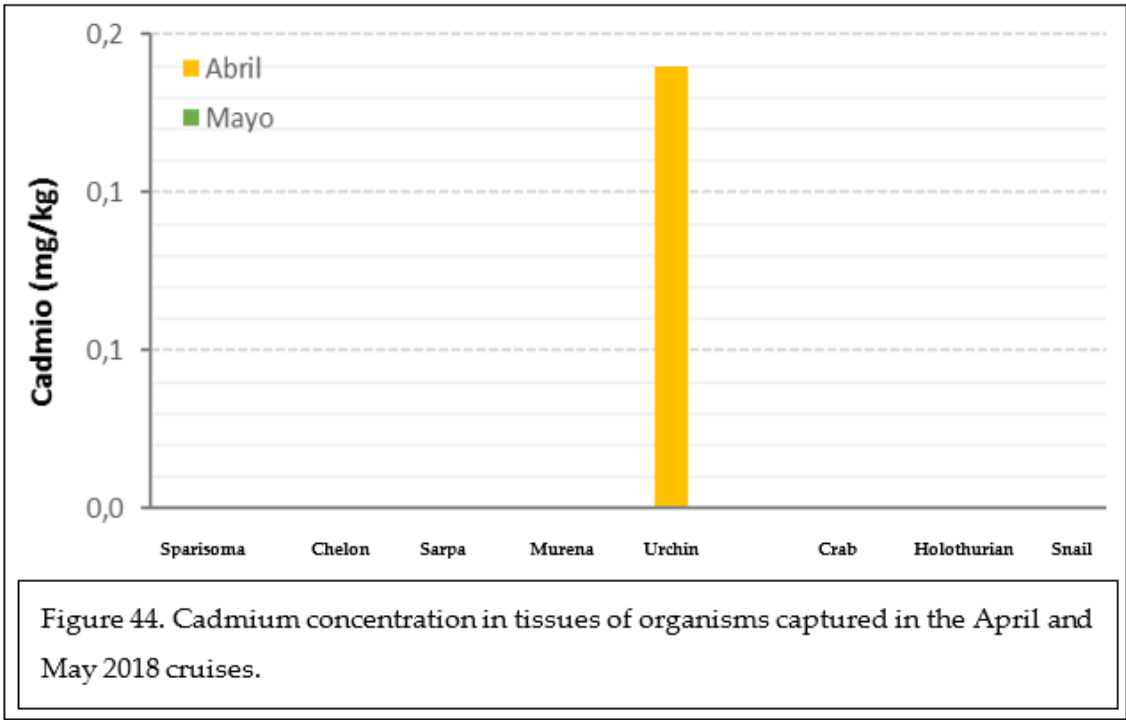
In the initial two surveys, lead was solely detected in sea urchins, showing a fourfold increase in concentration during the May sampling. In the September sampling, concentrations of this metal were measured in all the organisms analyzed, although no sea urchins or moray eels were found in September (Figure 45).

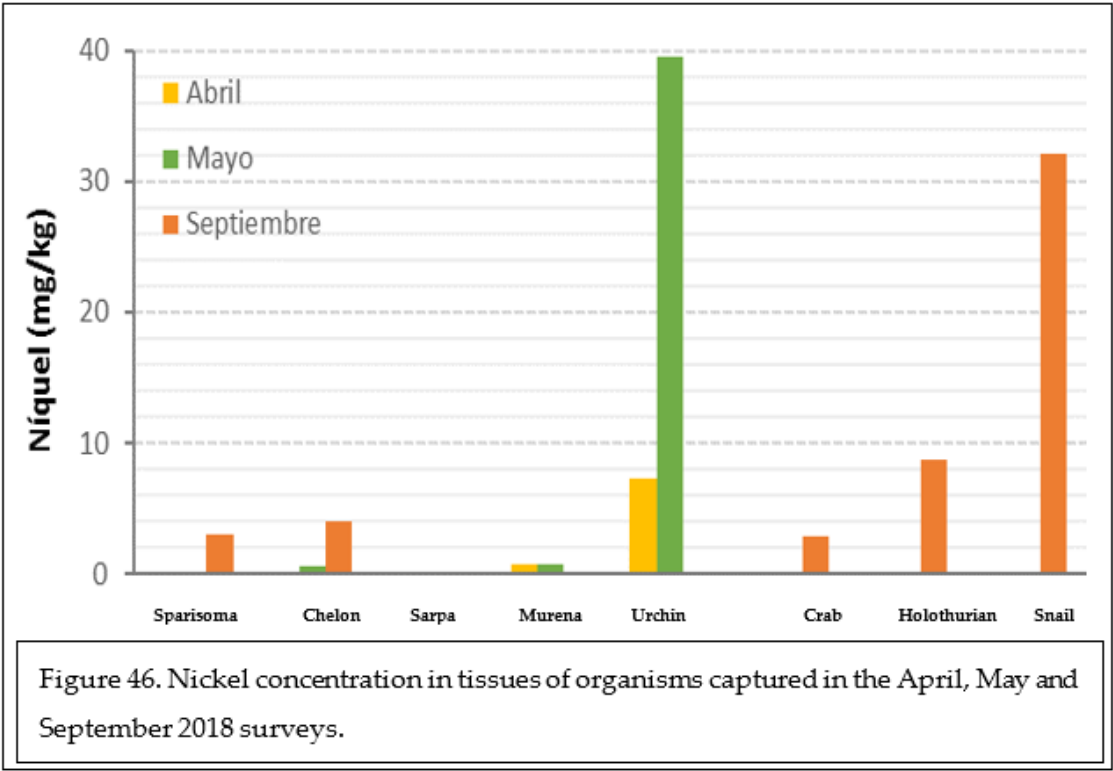
Nickel concentrations were generally very low or absent in the April and May campaigns across all organisms, except for sea urchins, which exhibited high values, particularly during the April sampling, where they increased fivefold. In the September campaign, concentrations of this metal were measured in all the organisms analyzed, with the exception of salema fish, (Figure 46).
