Inspection of Architectural Heritage and Ancient Structures Using Aerial Thermography

Rubén Rodríguez Elizalde

Universitat Oberta de Catalunya; rrodriguez@uoc.edu

Keywords: aerial thermography; drones; inspection; heritage preservation; joints and efflorescences

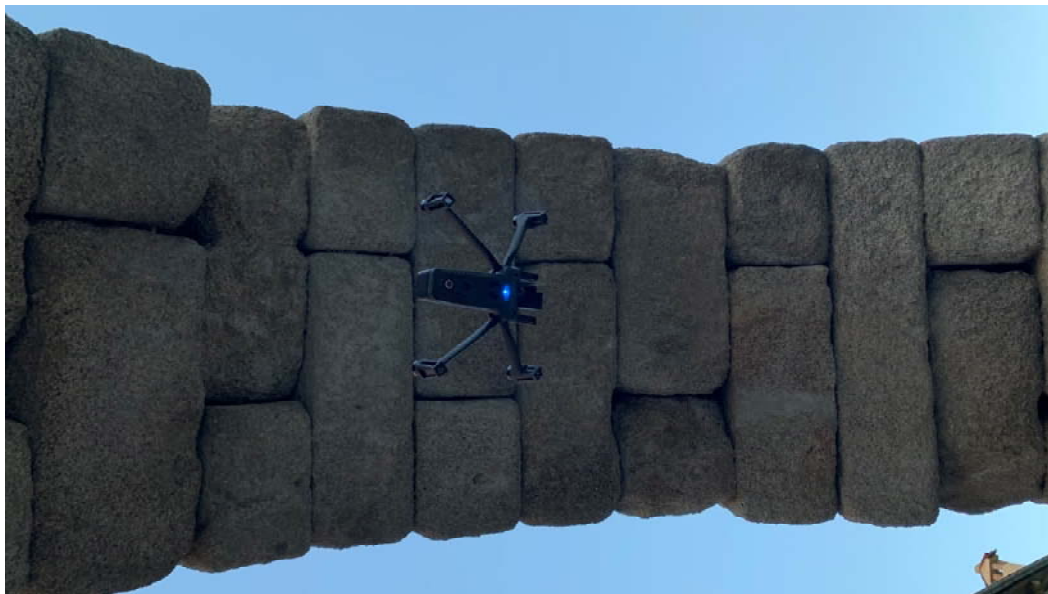
Figure 1. General view of the four-rotor drone with a thermal imaging camera used in one of the inspections, that of the Segovia Aqueduct, at a time when it was inspecting the ashlars and voussoirs that make up one of the arches, on the inside of the monument (photograph by the author).

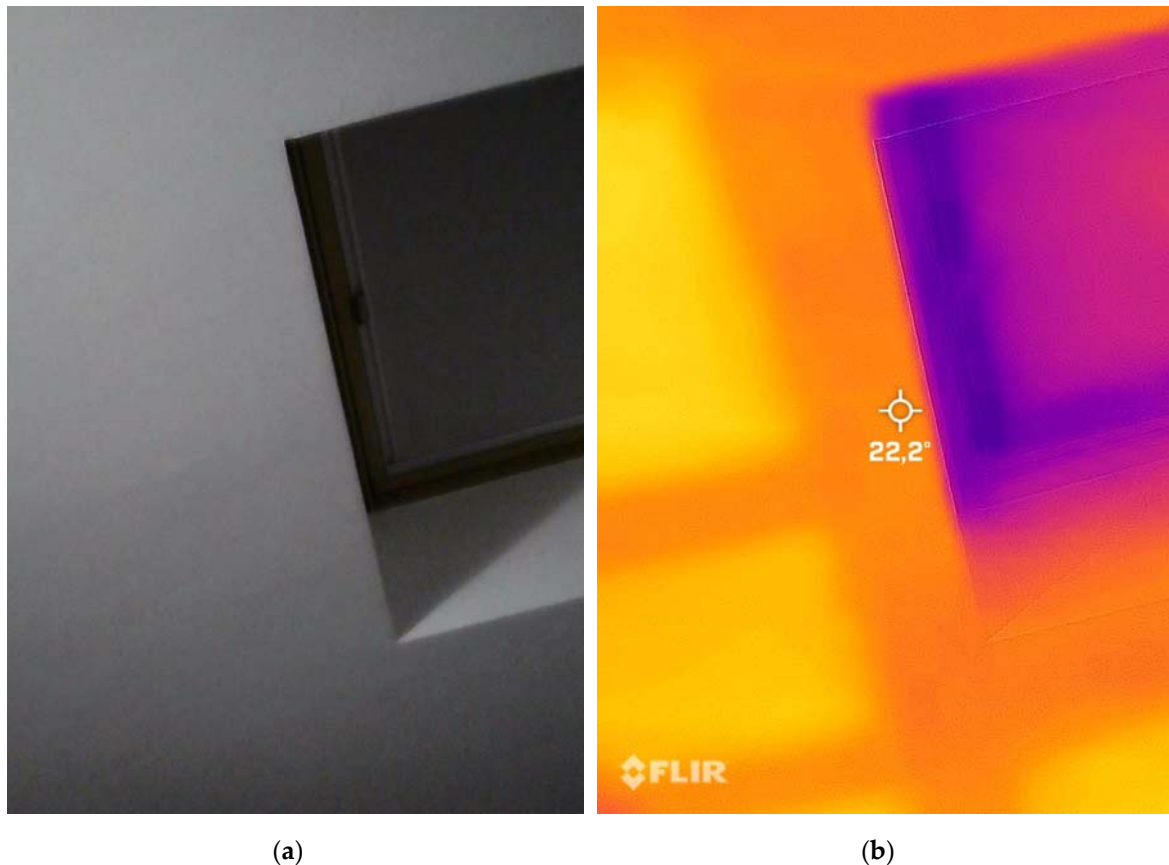
Figure 2. View from below of a top-floor dwelling with a skylight: (a) image captured by a camera; (b) Thermographic analysis in Figure 2 (a), to locate hidden beams and battens and heat losses in the skylight (photographs by the author).

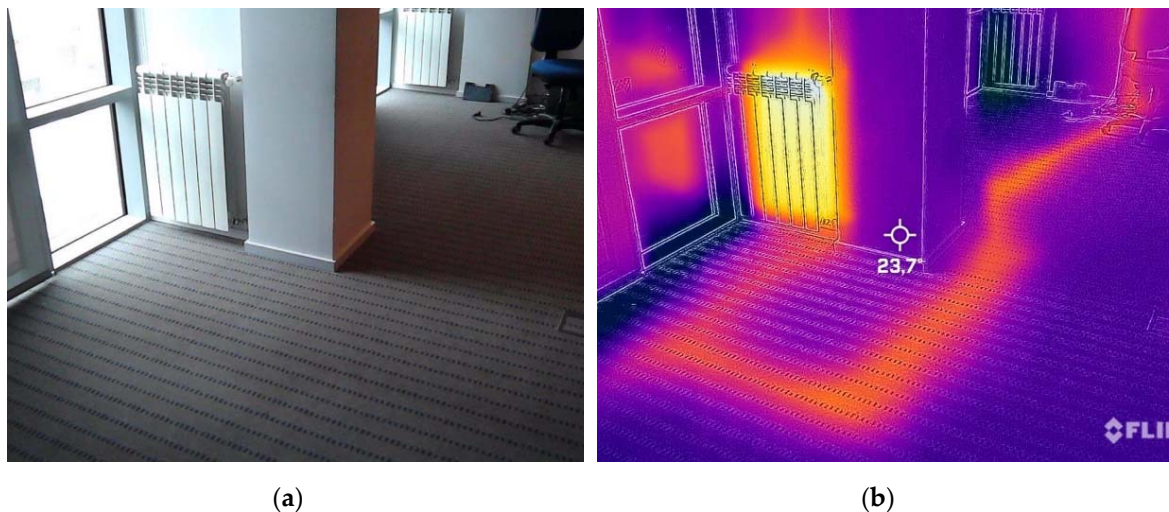
Figure 3. General view of a corner of an office building: (a) image captured during operation of the air conditioning equipment; (b) thermogram showing the location of the heat conduction supply to the heating radiator, in the image shown in Figure 3 (a) (photographs by the author).

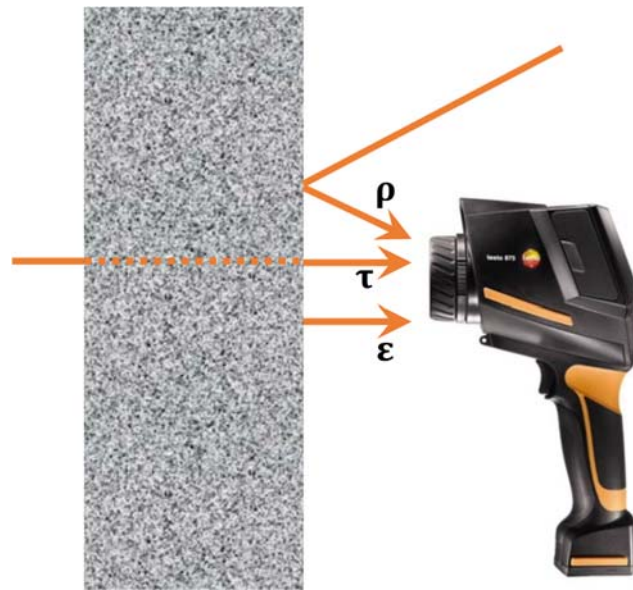
The radiation recorded by a thermal imaging camera is the result of the sum of the emitted radiation (ϵ), the reflected radiation (ρ) and the transmitted radiation (τ), originating from the objects that are present in the field of view of the camera [12] (Figure 5).

Figure 5. Radiation emitted (ϵ), radiation reflected (ρ) and radiation transmitted (τ) from an object, recorded by a thermal imaging camera (diagram by the author).

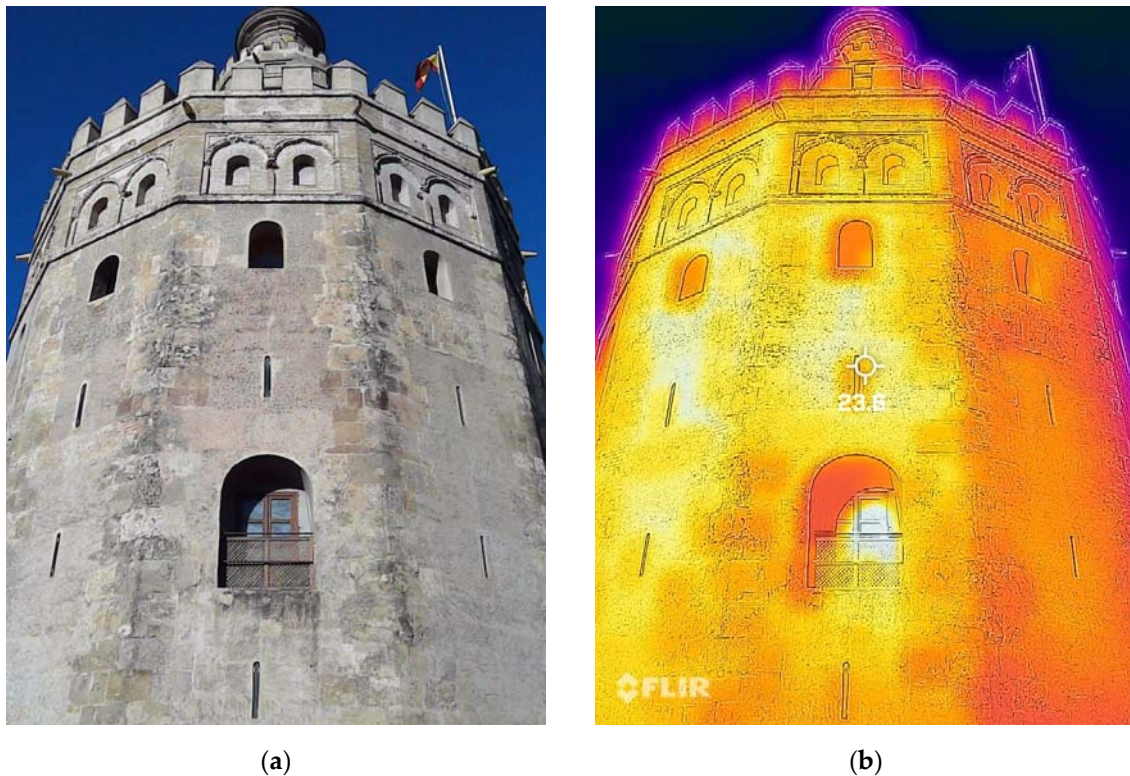
Figure 6. The Torre del Oro, in Seville: (a) photographic image of the south façade; (b) thermogram superimposed on the photograph in Figure 6 (a), where the different types of materials used can be seen (photographs by the author).

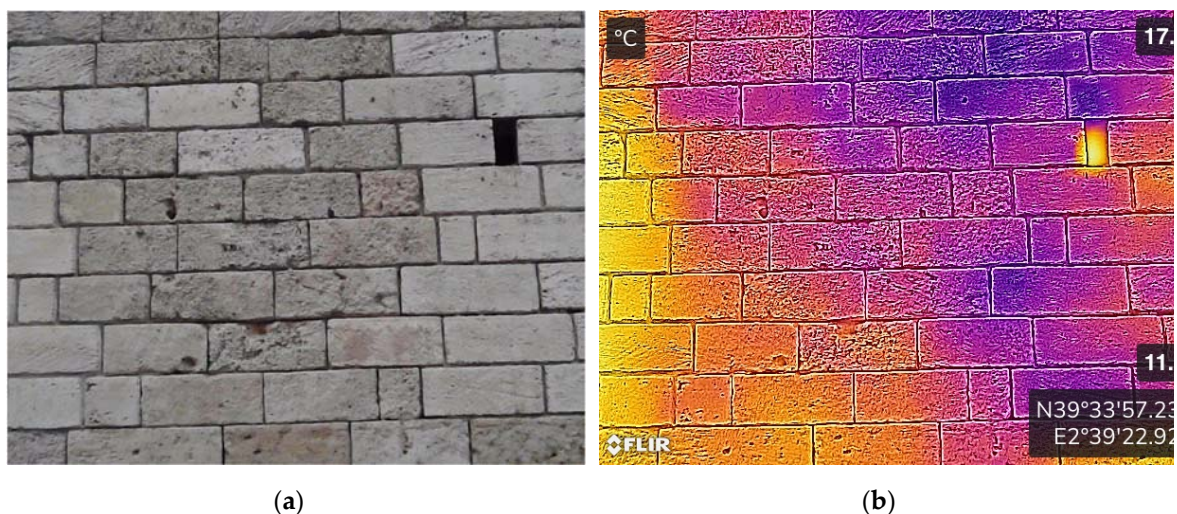
However, experience shows that the above observation cannot be extrapolated to all materials and situations: an example is the enclosure walls of Palma Cathedral (Mallorca, Spain). There, a camera is able to distinguish, by their chromatic and textural differentiation, the youngest ashlar of the Marés sandstone from the oldest ones (Figure 7 (a)), in which there are also signs of alveolisation [10]; however, in the thermogram this distinction is not so evident (Figure 7 (b)). The opposite case can be observed in the granite ashlar of the protective envelope of the Roman lighthouse of the Tower of Hercules [14], in which the differentiation is much more evident in the thermogram (Figure 8 (a)) than in the image captured by the photographic camera (Figure 8 (b)).

Figure 7. Detail of the southern enclosure wall of the Cathedral of Palma de Mallorca: (a) image captured by a camera, where different ashlar of Marés can be seen; (b) thermogram on the photograph in Figure 7 (a), where the differentiation between the different ashlar is practically non-existent (photographs by the author).

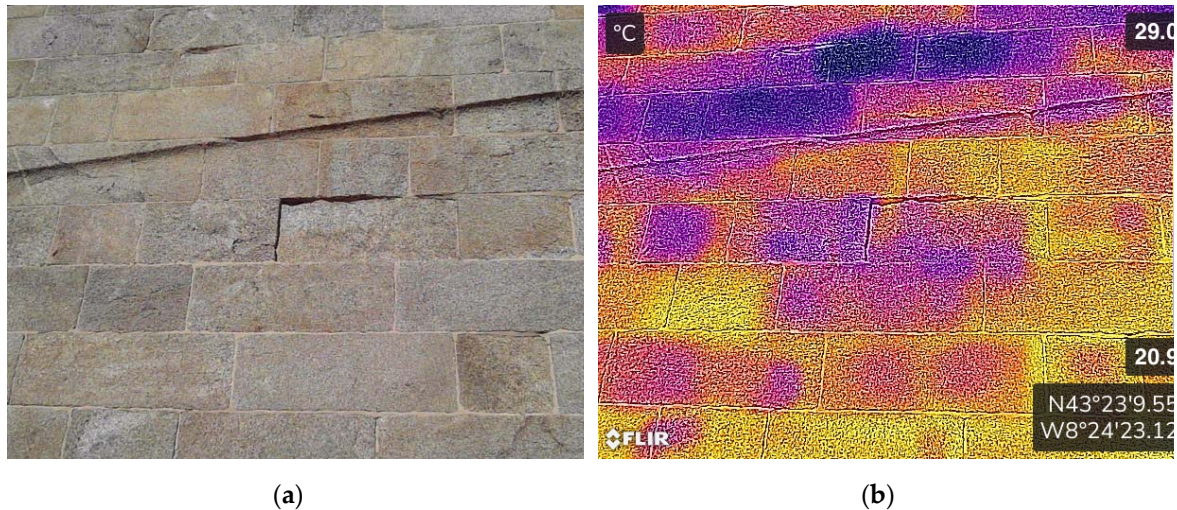
Figure 8. Detail of the western enclosure wall of the Tower of Hercules: (a) image captured by a camera, where the constituent materials can be observed: granite with mortar; (b) thermogram where the differentiation between the different ashlars of the wall can be clearly observed.

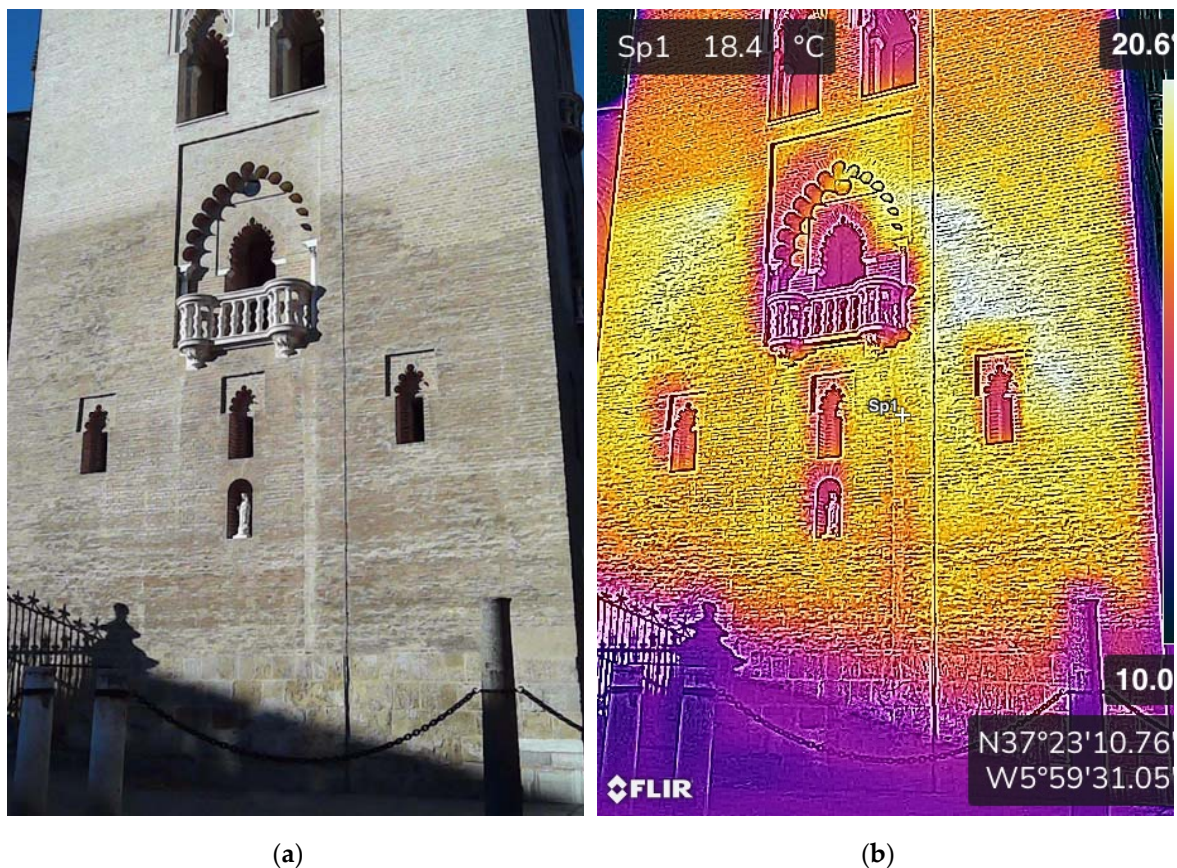
Below, we can also see the lower part of the east façade of the Giralda, the tower that serves as a bell tower for the Cathedral of Seville. Despite its recent restoration [15], the problems of the constituent fabric (especially the brick) linked to moisture are still present, as can be seen with the naked eye in the image captured by a photographic camera (Figure 9 (a)). Analysing the same image captured by a thermographic camera, we can see even more clearly the areas of moisture in the perimeter wall. According to the functioning of thermography as an auscultation technique, it is logical to think that the damp areas must be warmer than the dry areas [16], due to evaporation loss, as shown here (Figure 9 (b)).

Figure 9. Detail of the east facade of the Giralda tower, bell tower of the Cathedral of Seville: (a) image captured by a photographic camera, where moisture can be observed; (b) thermogram on the photograph in Figure 9 (a), where the thermographic camera has been able to capture the different degrees of moisture in the brick (photographs by the author).

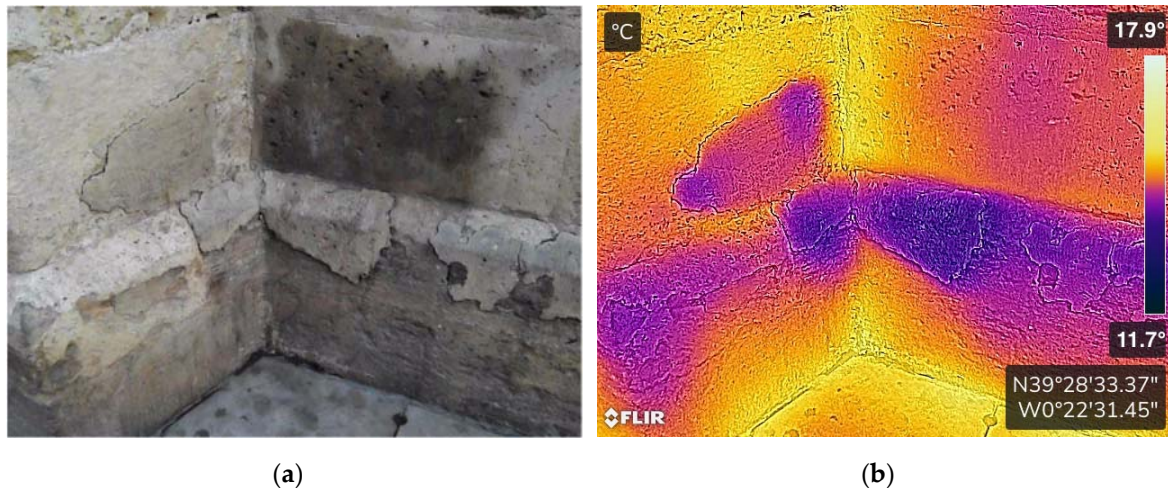
However, this is not always the case, as sometimes the thermal history can mask the signals that are truly useful for this purpose, as is the case with the example of the first courses of the bell tower of the Cathedral of Valencia, the Miguelete Tower (Figure 10 (a)). There, these first ashlar serve as a base: the unfortunate restoration actions, using unsuitable materials, result in different degrees of wetting, which the thermal imaging camera is able to capture (Figure 10 (b)).

Figure 10. Detail of the enclosure wall at the base of the southeast façade of the Miguelete Tower, bell tower of the Valencia Cathedral (a) with diverse materials and in different states of deterioration; (b) detailed thermographic analysis of the constituent materials, where the thermographic camera is able to capture the differences between them (photographs by the author).

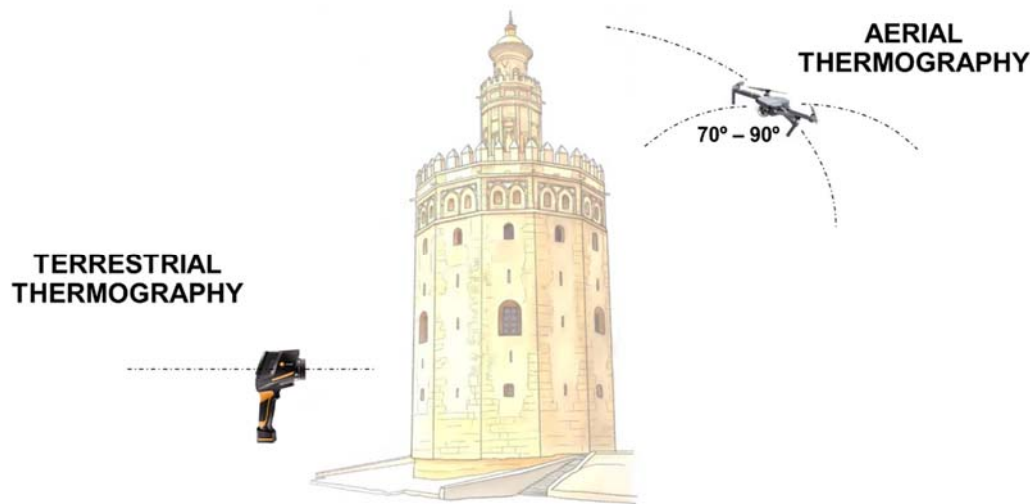
Due to the small size and low weight of current thermal imaging cameras, any multirotor drone is now capable of carrying a thermal camera. This is how aerial thermography was born: the combination of thermography and aerial piloting of the drone allows for obtaining specific information from a thermal camera from viewpoints that are very difficult to obtain manually. Thus, for example, for an adequate analysis of any thermal anomaly, it is recommended that the thermal imaging camera be positioned with a viewing angle of between 70° and 90°, measured with respect to the surface being analysed. If a manual camera were used, it would be very difficult to meet this condition; however, a drone with a thermal camera is able to meet this condition with ease (Figure 11).

Figure 11. Comparative analysis between the rigidity of terrestrial thermography and the flexibility of aerial thermography (diagram by the author).

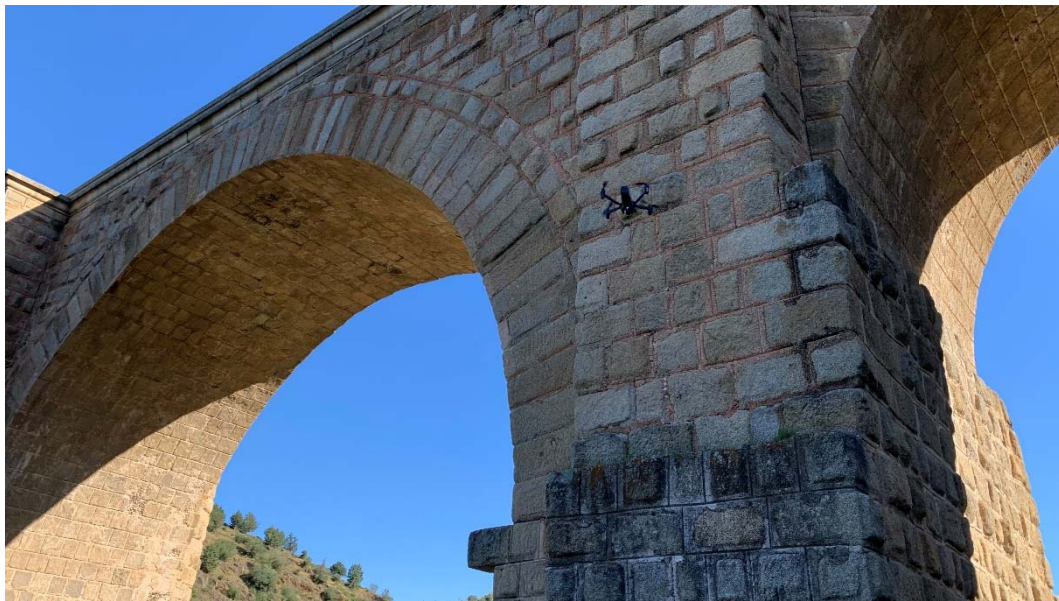
Figure 12. General view of the quadcopter drone with a thermal imaging camera used during the inspection of the first pier of the Alcántara Bridge, on its west side (photograph by the author).

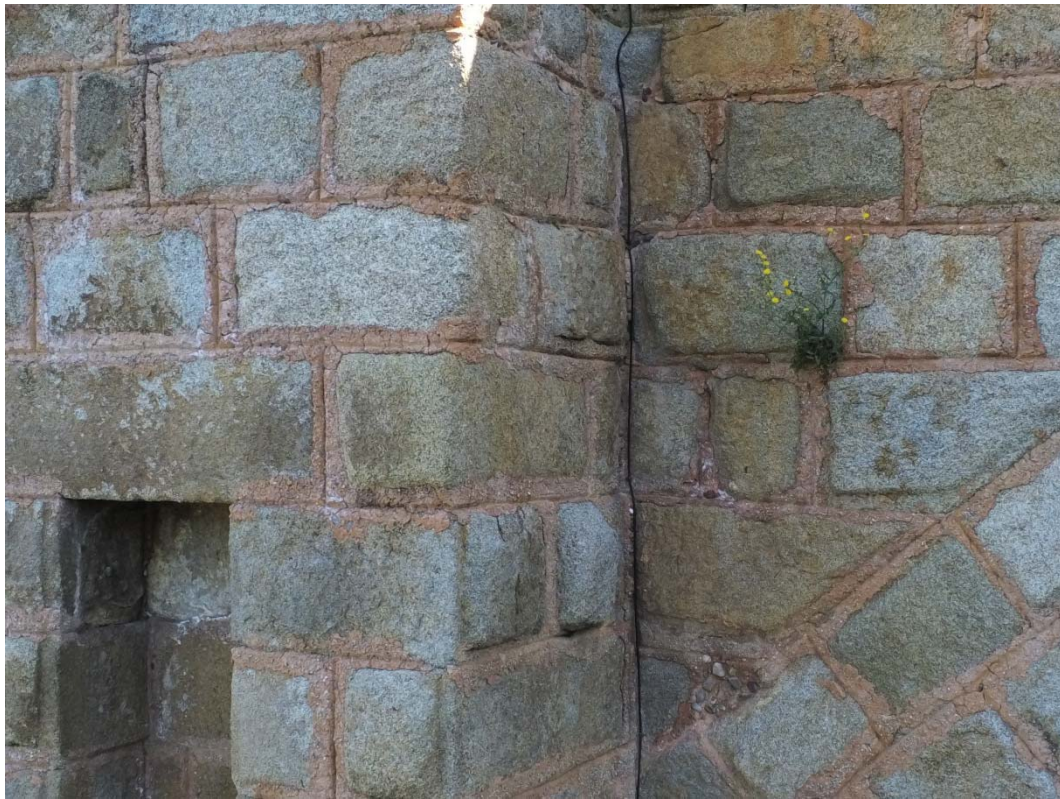
The main deficiencies diagnosed were linked to the use of lime mortar in previous restoration works [21], to fill the joints between ashlar (Figure 13). It is interesting to observe, in the analysis of the thermograms, the difference in temperature that can be observed between the ashlar and the mortar of the joints: while the most exposed faces of the ashlar register the lowest temperatures (Figure 14 (b)), the mortar joints register the highest temperatures (Figure 14 (a)), and only the remains of runoff water on the ashlar allow them to reach a temperature similar to that registered by the mortar joints.

This value reached by the runoff water mark, together with the vegetation that has taken root in some deteriorated joints (Figure 13) and the temperature record that locates the thermogram on the

Figure 13. Photographic image captured by the drone during the flight, ascending 15 m above the position shown in Figure 12, where the lime mortar joints and the presence of organic matter and vegetation can be observed (photograph by the author).

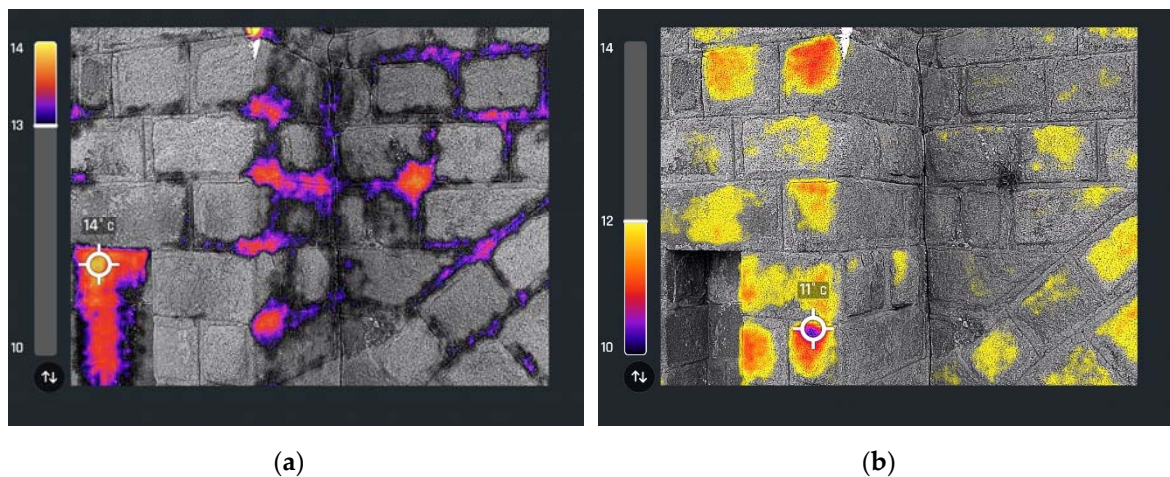
rooted plant (Figure 14 (a)), leaves no doubt that moisture is the fundamental cause of this thermal difference.

Figure 14. Thermogram of the previous photograph (Figure 13): (a) location of the maximum temperature values; (b) location of the minimum temperature values (photographs by the author).

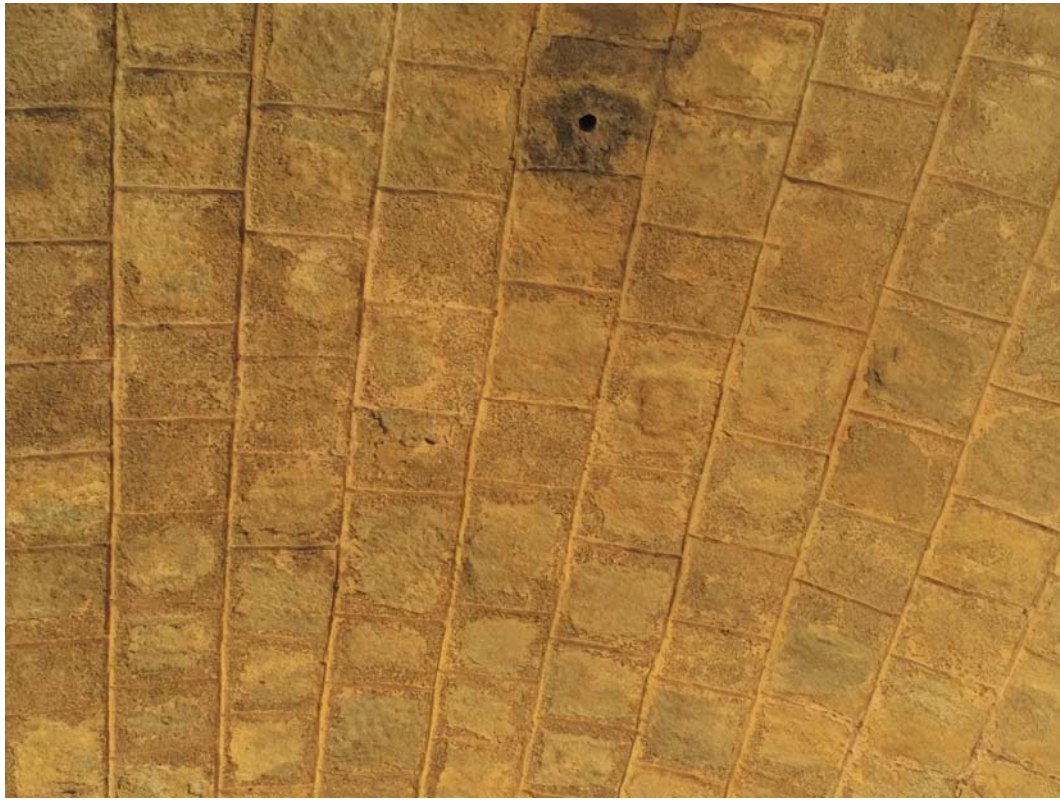
Also linked to moisture is the slight proliferation of efflorescence that was diagnosed during the visual inspection carried out months ago on the intrados of the vaults (**Figure 15**). Indeed, efflorescence usually appears around areas where there is a high concentration of moisture.

Figure 15. View of the intrados of the first vault, in a photographic image taken with the drone, where some minor runoff and a black crust were located around its drainage point (photograph by the author).

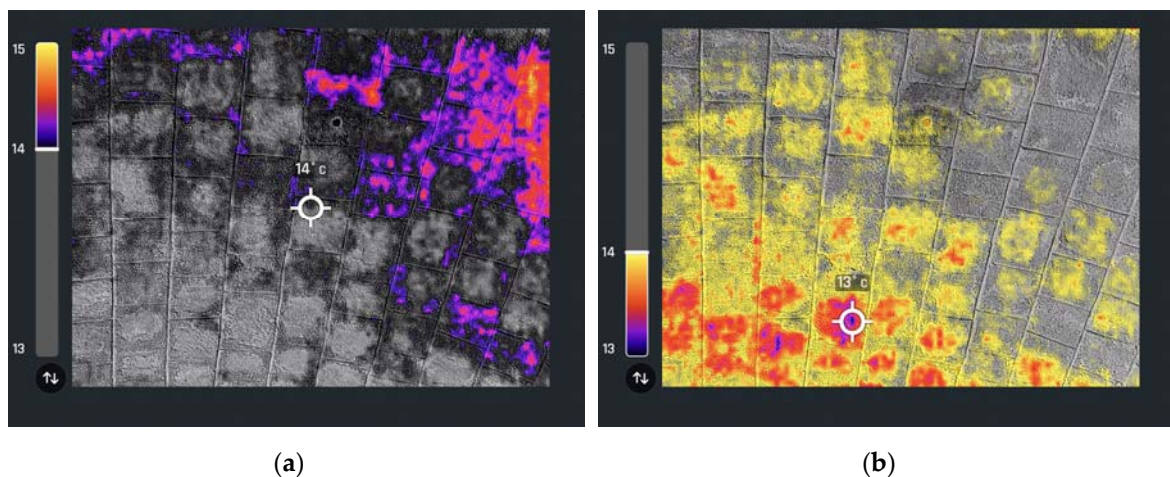
As this is a bridge spanning a river with considerable flow, it is in a location with high moisture. Thermographic analysis of the intrados of the vaults allowed us to confirm this, although it was

important to bear in mind the differential effect that this implies, for the establishment of maximum (Figure 16 (a)) and minimum (Figure 16 (b)) temperature values, since the upstream side is elevated east (east side), while the downstream side is elevated west (west side).

Figure 16. Thermogram of the previous photograph (Figure 15): (a) location of the maximum temperature values; (b) location of the minimum temperature values (photographs by the author).

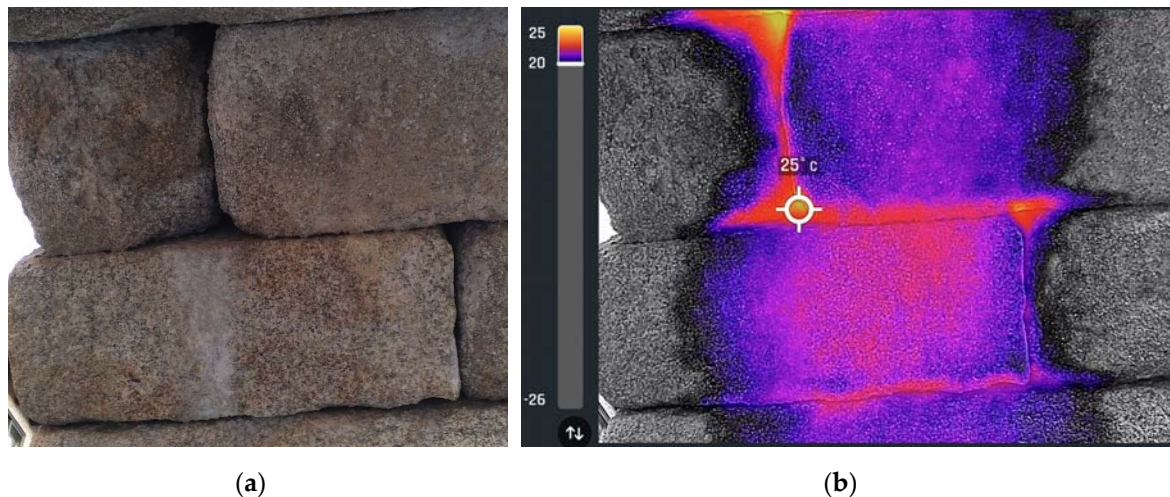
For the thermographic auscultation, the observations made in the visual inspection a few months before were taken into account, as well as the information obtained by the thermograms in the thermographic auscultation of the Alcántara Bridge. Fortunately, here we have a construction of large granite ashlar, practically lacking mortar in its joints [23]. This, together with the absence of a river (therefore, less moisture), makes the location of an efflorescence less probable (Figure 17 (a)) but, when found, it can be much more worrying. Once again, the thermogram showed a coincidental observation: the joints show the maximum temperature values, this value being especially high in the joints between ashlars where, precisely because of the absence of mortar, cavities are recorded (Figure 17 (b)). However, it should be noted that the exteriorization of the efflorescence is not recorded on the thermogram.

Figure 17. View of a group of voussoirs forming an arcade, where efflorescence was observed: (a) photograph; (b) thermogram corresponding to this photograph, where the point where the highest temperature was recorded can be observed (photographs by the author).

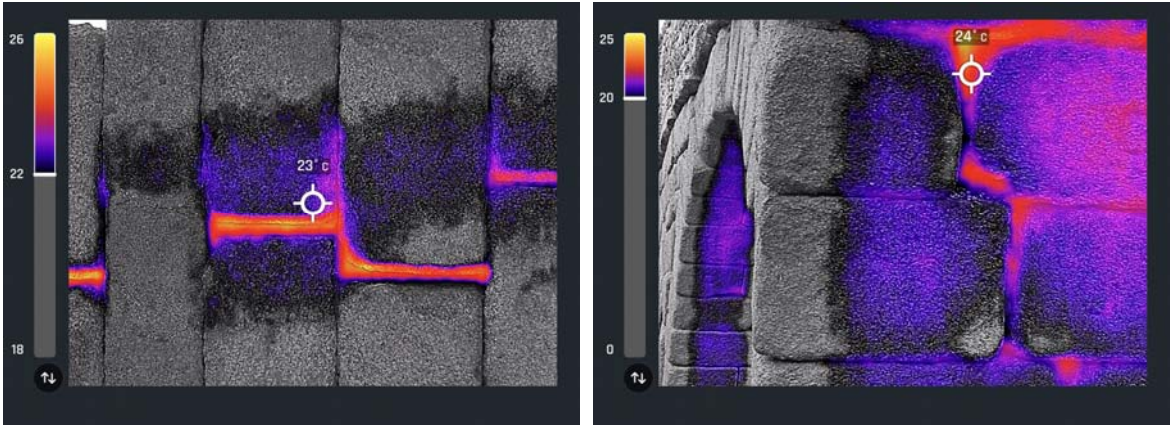
Regardless of the observation of other possible efflorescences in similar points, the usual pattern of the seven arches examined confirmed the above: the maximum temperature values are always recorded in the joints between the voussoirs or the ashlars (Figure 25 and Figure 26). As occurred in the Alcántara Bridge, the minimum values are recorded on the most exposed exterior face of the ashlar (Figure 28 and Figure 30), while the joints always show the maximum temperature inside (Figure 27 and Figure 29). The cause, once again, is related to moisture.

Figure 18. Location of the maximum temperature values between the interior ashlar of an arcade of the Aqueduct, at two different points (photographs by the author).

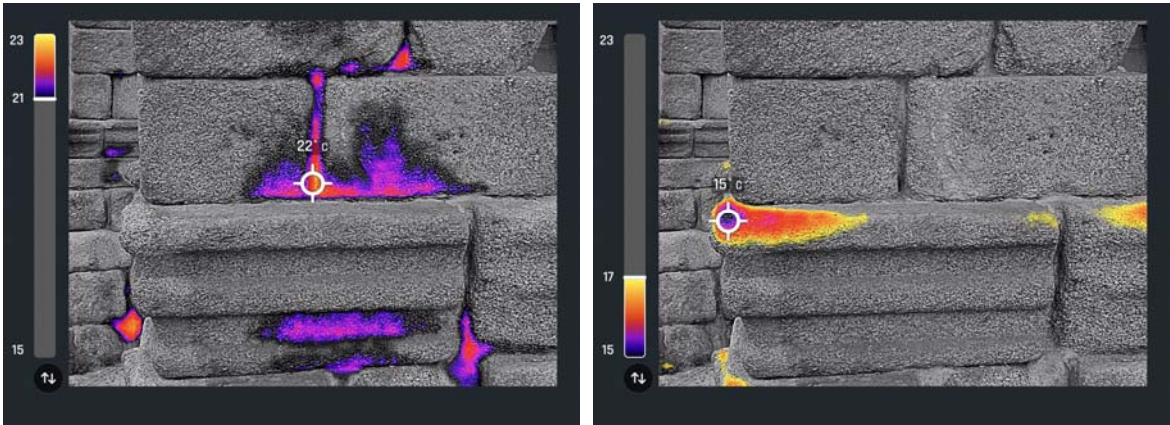
Figure 20. Location of extreme temperature values between the inner ashlar of a starting support: (a) maximum values and (b) minimum values (photographs by the author).

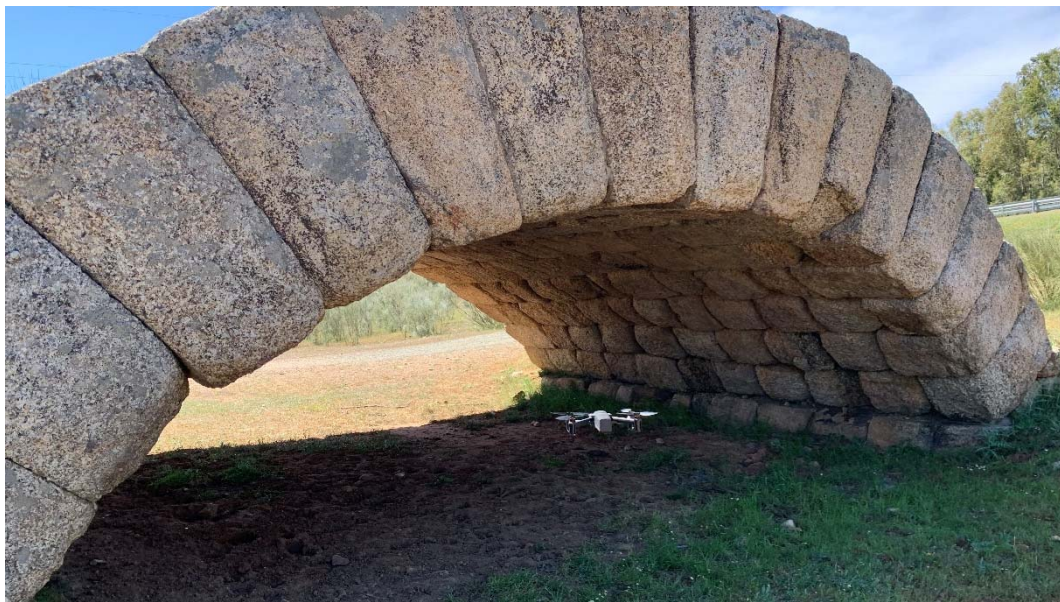
On this occasion, it was also decided that the drone would enter those first two vaults (Figure 21) and, once inside, proceed to the reconnaissance analysis of the intrados. Obviously, the photographic camera corroborated the observations made in the previous inspection (Figure 34), but the thermal camera provided a very interesting result: as in the other two monuments analysed, the thermograms of the interior of the vaults also found extreme temperature values in the joints between ashlar and on the outer face of the ashlar. However, here the location of the maximum and minimum values was reversed with respect to the other two monuments: while in the Alcántara Bridge and in the Segovia Aqueduct the maximum values were recorded in the joints between ashlar, in Alconétar the minimum values were recorded in the joints between voussoirs (Figure 36). Similarly, contrary to the two earlier inspections, in Alconétar the maximum temperature values were recorded on the outer face of the ashlar (Figure 35).

Figure 21. Quadcopter drone with thermal imaging camera used in the inspection, entering the first vault for the inspection of its intrados (photograph by the author).

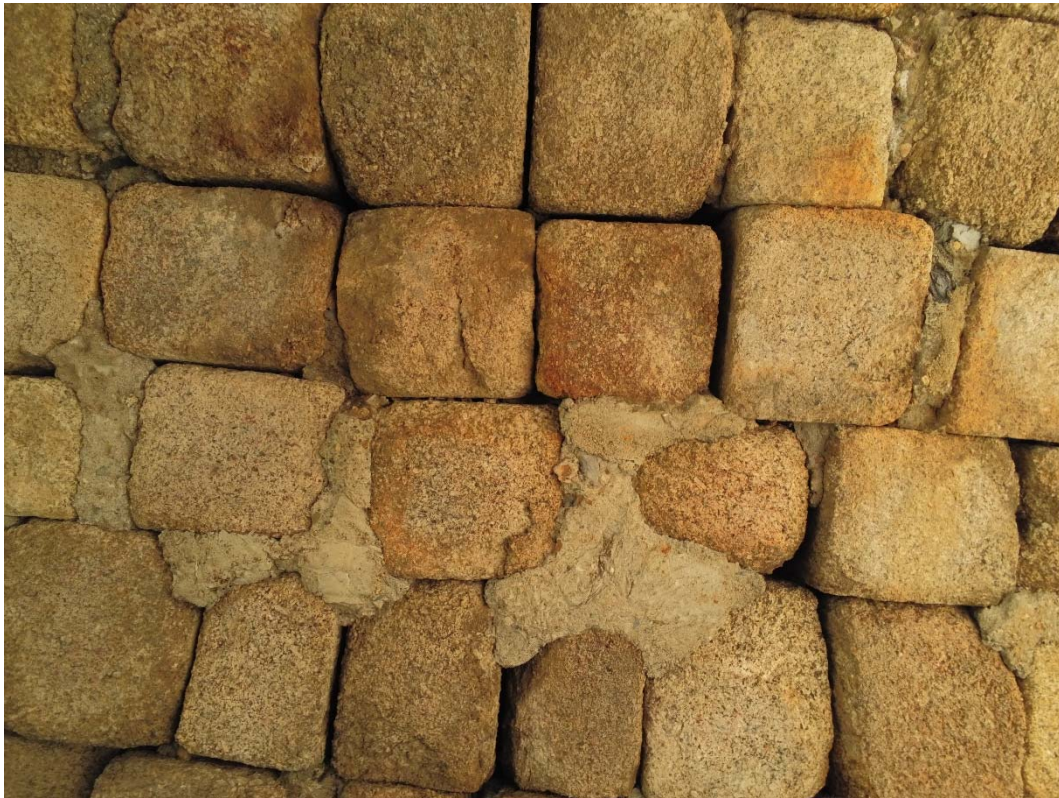
Figure 22. View of the intrados of the first lowered vault, in a photographic image taken with the drone, where altered granite elements and remains of cement mortar were found (photograph by the author).

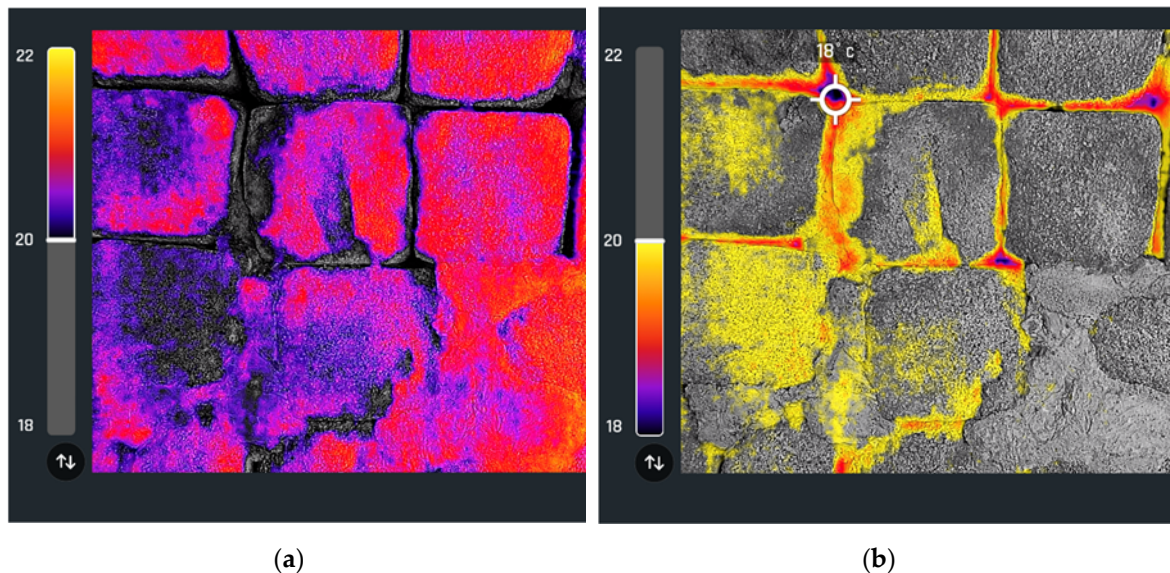
Figure 23. Location of extreme temperature values on the photograph in Figure 22: (a) maximum values and (b) minimum values (photographs by the author).

This was undoubtedly due to the lack of exposure to the elements (and therefore to solar action) for the intrados of these vaults, given their geometric characteristics, in contrast to the vaults and walls of the Alcántara Bridge and the supports and arches of the Segovia Aqueduct.

In any case, it is undeniable that, although in an inverted manner, the extreme values are recorded at the same points, and this constitutes a risk in the face of phenomena such as the crystallization of salts or the freezing and thawing of interstitial water within the constituent material, which also demonstrates the great utility of exploring the monument with a thermographic camera.
