# Development and Evaluation of New Visible Index on Remote Sensing for Estimating House Damage and Sediment Runoff in Disasters

[Haruhiro Shiraishi](#)<sup>\*</sup> and [Yuichiro Usuda](#)<sup>\*</sup>

Risk and Resilience Engineering Degree Program, Graduate School of Systems and Information Engineering, University of Tsukuba

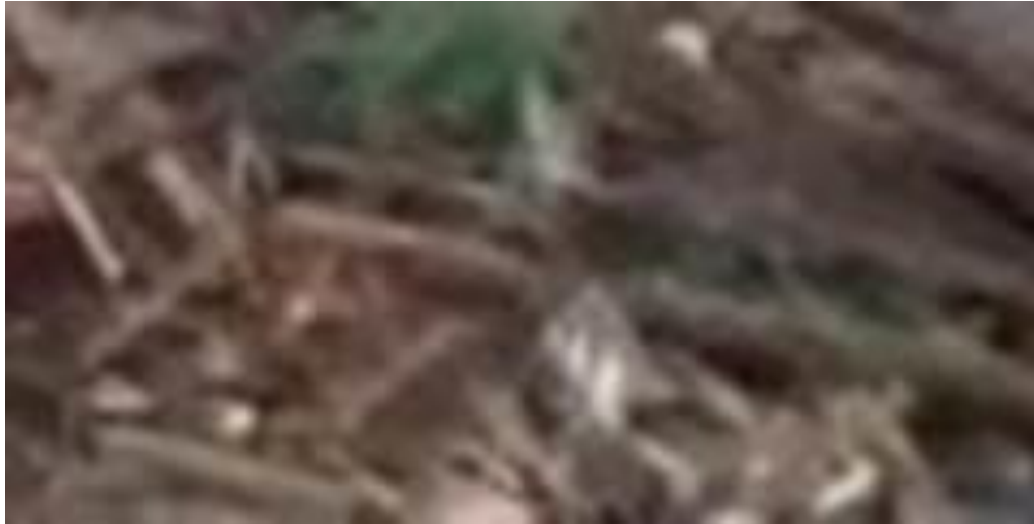
**Figure 3.** Example of debris used for calibration.

was used as D<sub>Ical</sub>, and if the pixel value of the target image was within the range from the average value of the D<sub>Ical</sub> to the value  $\alpha\sigma$  away from it, then the pixel was considered to be a "damaged pixel". As shown in Equations (4) and (5),  $\mu$  and  $\sigma$  are the mean and standard deviation of all pixels of the calibrated debris color (D<sub>Ical</sub>). Also,  $\alpha$  indicates an arbitrary number. The image used for calibration in this paper is shown in Figure 3. This image can be selected arbitrarily by the experimenter.

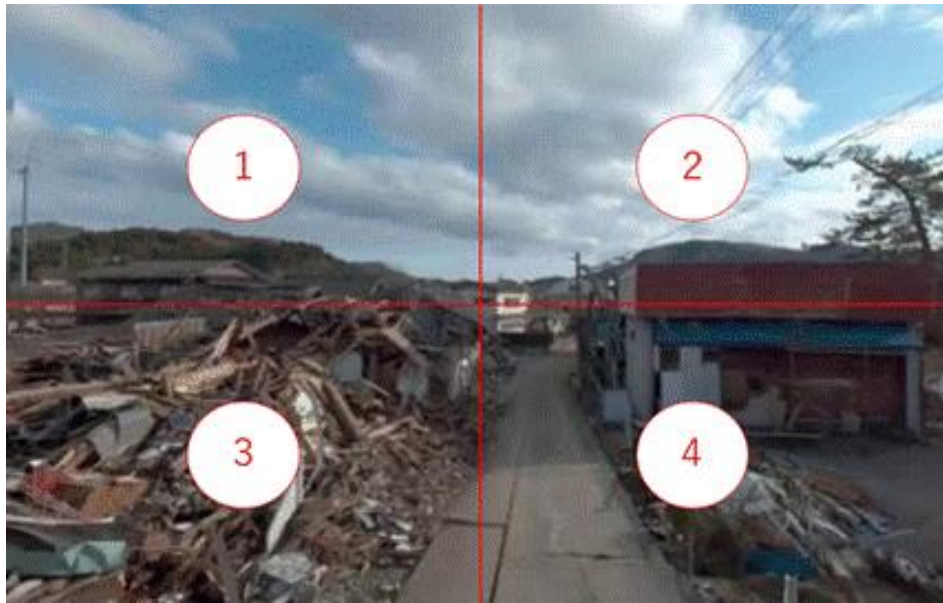
**Figure 4.** Image of the affected area divided into top, bottom, left, and right.

As shown in Figure 4, in images taken from the roadway, the upper half, i.e., in the areas (1) and (2) in the image, points to the distance or sky. Therefore, it is conceivable that the upper half may be removed when photographing the vicinity. By dividing the image into the lower left and right halves, i.e., (3) and (4), we decided to consider the image as a "damaged image" if the DI had a significant impact on one of the left and right halves. This is to ensure accurate judgment when comparing an image in which a house has collapsed on only one side and an image in which a house has collapsed on both sides. This delimitation method was applied in both the calculation method by average and by area.

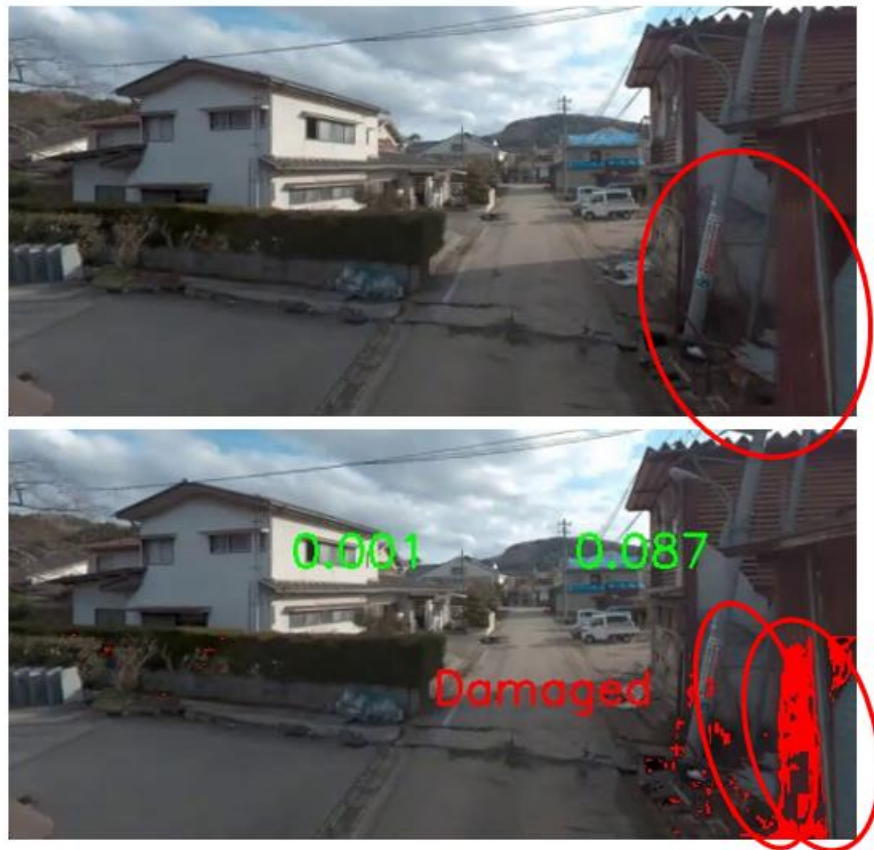
**Figure 5.** (Top) Value calculated by the average of DI (The red area should indicate the area with the most damage, but in fact it is not shown correctly.) (Bottom) Image calculated by the percentage of DI area after calibration (The red area is the damaged area and is shown correctly. If the value exceeds a certain level, it is considered "damaged".)

No criteria exist for evaluating the scale of damage by the average value per pixel of the DI. Therefore, to solve this, calibration of the DI is a prerequisite; as indicated in the methodology, photographs of runoff sediment and timber for that land/weather condition were used to calibrate the DI. This allows for standardization of the scale of damage for that soil/weather condition. The "damaged" pixels (A) were determined to be "damaged" pixels if the DI value was close to the calibrated image, and "undamaged" pixels (B) if it was far away, in relation to the overall percentage, and the percentage of "damaged" pixels (A) in the total number of pixels (A+B) was calculated to The scale of damage was determined by calculating the percentage of "damaged" pixels (A) in the total number of pixels (A+B). This enabled the scale of damage to be calculated with high accuracy and quantitative values to be shown. For example, in the image shown in Figure 5 before calibration, it is necessary to show the partially damaged part of the house on the right, but it was not calculated well. On the other hand, in the post-calibration image, the percentage of "damaged pixels" to the area of the lower left portion is 0.001 (0.1%), and the percentage of "damaged pixels" to the area of the lower right portion is 0.087 (8.7%), indicating quantitative criteria, and the accuracy of "damaged The accuracy of the "damaged pixels" is also high.

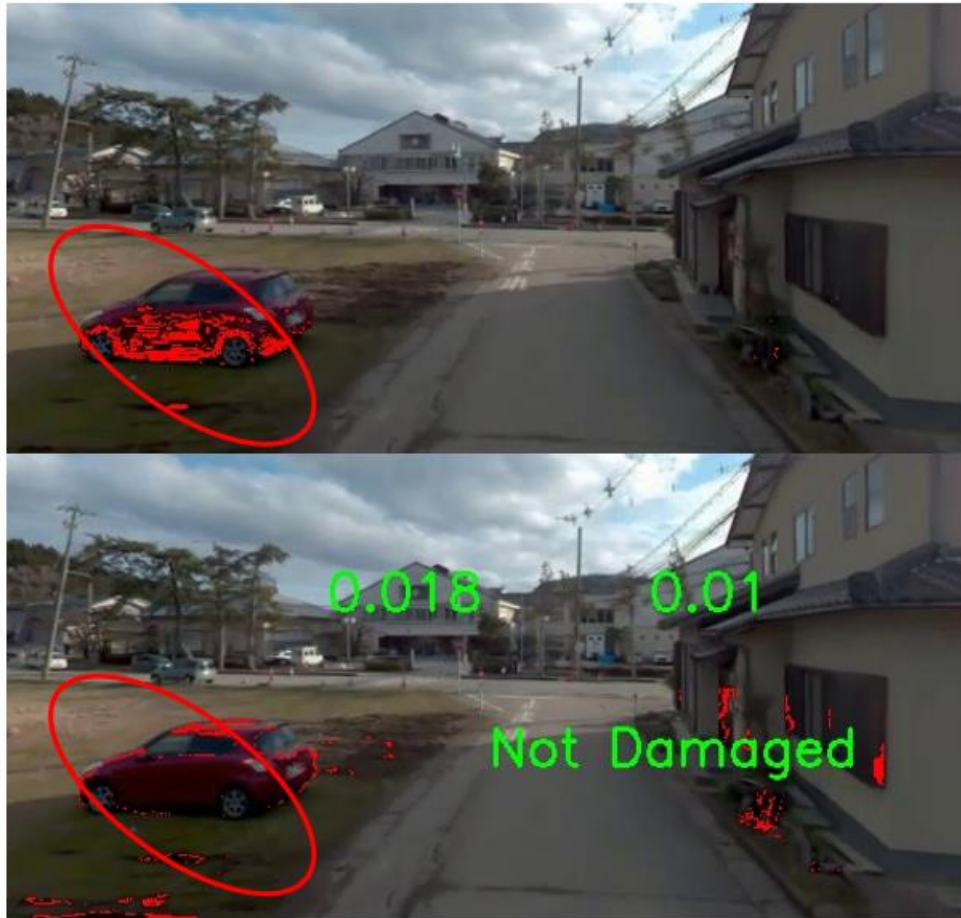
**Figure 6.** (Top) Example of misidentification as "damaged" by the average of DI (Bottom) An example of correctly identifying "Not Damaged" by the percentage of DI area calibration (the soil in the lower left was misidentified but recognized as "Not Damaged" because it was a small percentage of the total area.).

In calculations using DI averages, the problem was that there were many cases of misrecognition of damage conditions. Even if the accuracy of recognition is improved by calibration, there are still cases of misrecognition. For example, the case shown in Figure 6. The car on the lower left is red, resulting in misrecognition by the DI. On the other hand, the indicator that was calibrated and showed a percentage of the total area could be correctly recognized as "no damage," although it was recognized.

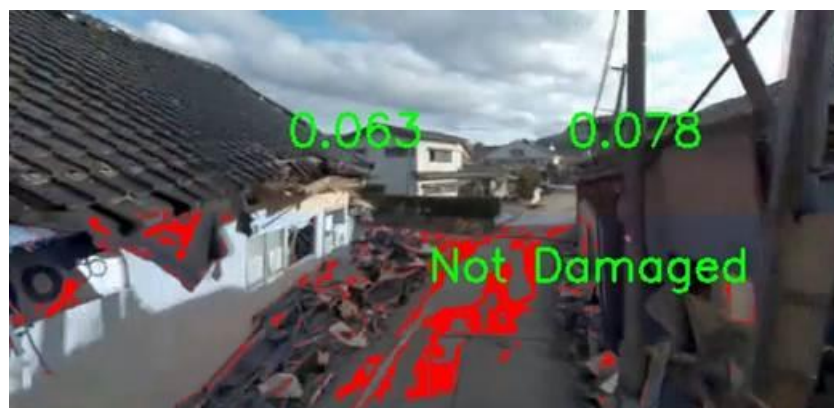
**Figure 7.** Example of significant loss of accuracy when calibrating with unrelated images.

considered "damaged". When an image of sediment completely unrelated to the affected area was used for calibration, the accuracy was found to be significantly lower, as shown in Figure 7. A value of 8% (0.08) or more is appropriate for a  $0.1 \sigma$  deviation, but if the color range is expanded to  $0.2 \sigma$  or  $0.3 \sigma$ , the value is calculated according to the coefficient of standard deviation using the normalized standard deviation table.
