# The Role of Architectural Restoration in Preserving and Rehabilitating the Grand Throne Hall at Al-Jawhara Palace-Salah al-Din al-Ayyubi Citadel-Cairo-Egypt

**Abstract:** this paper focuses on a scientific study of the restoration, rehabilitation and reuse of the great throne hall, the most important hall in al-jawhara palace. it also aims to study the most important factors and forces of damage that affected the great throne hall, natural, biological, and human, and the resulting damage. field tests were performed, laboratory tests to determine fracture stress, liquidity and spandex limits tests, chemical analysis on soil samples and geoelectrical testing of the soil, and the results did not show caves or voids in the ground until a depth of 10.00 m, construction materials were studied and tested using x-ray, (xrd), mechanical tests (tensile, shear, compression), and a study of the effect of seismic loads on the walls; the results showed horizontal and vertical cracks; based on the study and analysis of these cracks, it was possible to present modern techniques in restoration and reinforcement methods, and in conclusion, the researcher's recommendations.

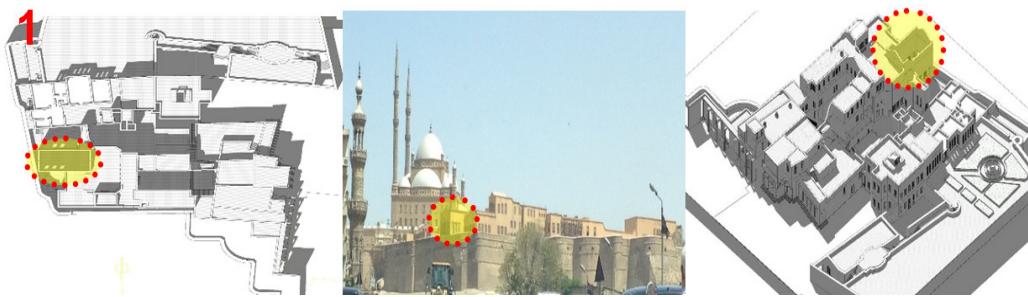
**Figure 1.** the location of the great throne hall of al-jawhara palace.

see a good view of cairo; the fustat and the pyramids [3,44,49]. the entrance of the room is a double door located on the west side of the main reception hall. it is a rectangular area of 16.30 m. in length and its width is 11.20 m [3,49]. the room's western wall has five windows which overlook the outside. likewise, its south wall has three windows overlooking a courtyard. the wall panels in this hall are divided into rectangular panels with various decorations that go beyond the painted trompe loiselle technique [3,42,49]. the ceiling no longer exists as the throne room was badly damaged by the 1972 fire. most of the wall decorations are gone and the wooden ceiling is burnt out. only the remains of one wooden truss remain and they can greatly help in the restoration of this hall. **Figure 1 And 2** general planning of al jawhara palace [3,42,49].

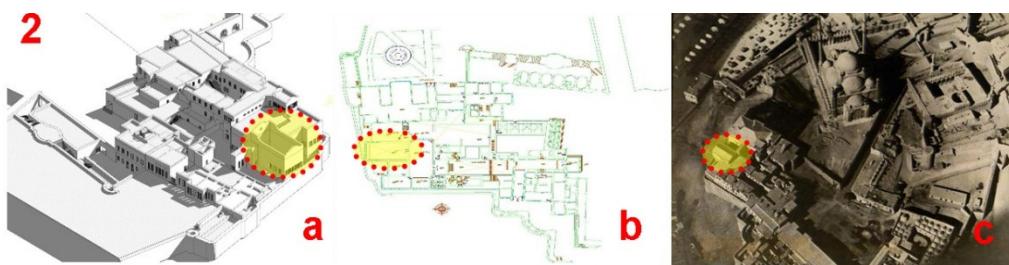
**Figure 2.** **a.** a perspective of the current state of al-jawhara palace shows the absence of a trussable ceiling for the great throne hall. **b.** the horizontal projection of al-jawhara palace and the great throne hall on the western side. **c.** an aerial photograph before the 1972 fire of al-jawhara palace shows the presence of the trussable ceiling of the great throne hall.

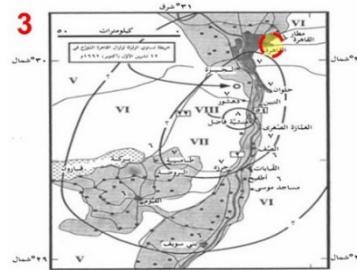
**Figure 3.** map of the 1992 earthquake and its impact on the great throne hall.

earthquakes, winds, soil subsidence, as well as biological factors. Figure 3.

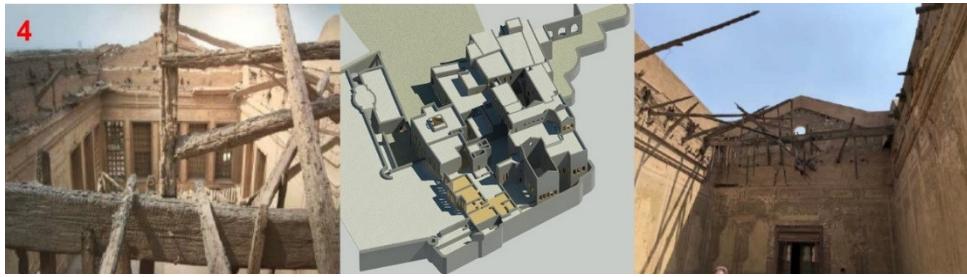
**Figure 4.** the fire of the truss roof of the throne hall in 1972.

- the fire in 1972 that destroyed the truss and the false ceiling **figure. 4**.
- deterioration of the means of drainage and nutrition, which leads to water leakage.
- pollution from workshops, factories, car exhaust, and encroachment of buildings near the castle.
- inconsistency between the agencies supervising the historical buildings.

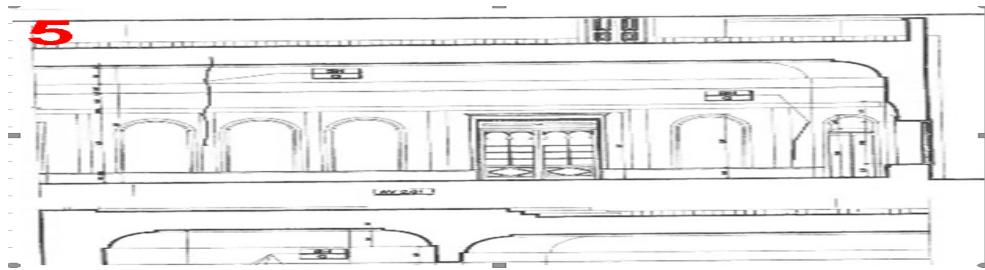
**Figure 5.** damage to the wall of the door of the great throne hall from the outside.

carved limestone was used in the construction of the walls and foundations [52], in courses stacked on the load-bearing walls system, and bricks were used in the construction of the upper parts [35]. the observed cracks are limited to the crushing of the adhesive mortar for stones of different types (mud mortar, gypsum mortar, lime mortar, and tile due to natural and atmospheric factors and the effect of humidity and rain [32], as well as the occurrence of erosion and erosion of parts of the

stones due to the deposition of salts on them by the influence of weather factors such as rain [31], wind and dust in addition. to the emergence of vertical, horizontal, and inclined cracks in the walls and their locations were limited [3].

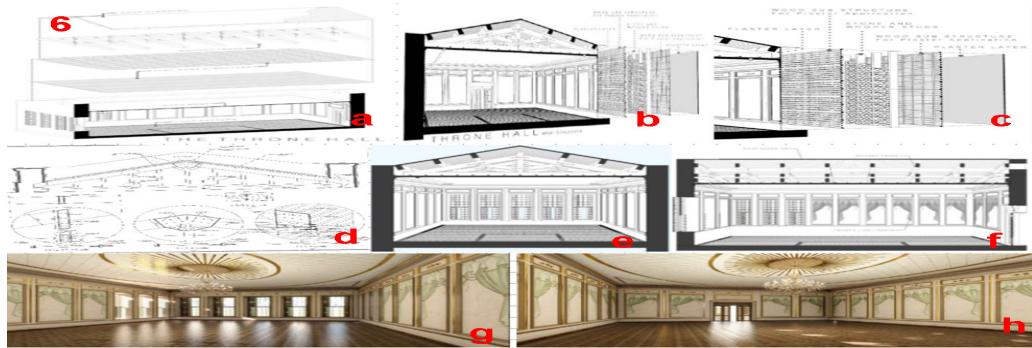
**Figure 6.** a. it shows the method and layers of rebuilding the ceiling of the throne room.

- b. reconstruction of the wall shows layers. the app as an example of the throne room.
- c. sectional perspectives showing the reconstruction of the ceiling of the throne hall and the baghdadli ceiling below.
- d. longitudinal sectional perspective showing the reconstruction of the throne room.
- e. reconstruction sketch of the windows facing the throne room.
- f. reconstruction drawing of the great throne hall truss.
- g. reconstruction sketch of the throne room for the entrance wall.
- h. reconstruction sketch of the throne room facing the entrance.

wooden ceilings in which insect infestations appeared. the restoration process for wood is summarized in the following steps: removing the floor layers to replace the wooden beam, steel the ceilings around the beam to remove the loads from the beam in need of restoration, remove the parts that need restoration and clean them well, the wood is fumigated to ensure that any decay or insects is removed from the inside, the wood is painted with epoxy materials that protect the surface of the wood without affecting its natural properties or its archaeological appearance so as not to block the ventilation pores of the wood, the truss of the great throne hall is being re-implemented with the same original sectors [48,52], according to the structural design with the attached panels **figure's. 6 and 7**.

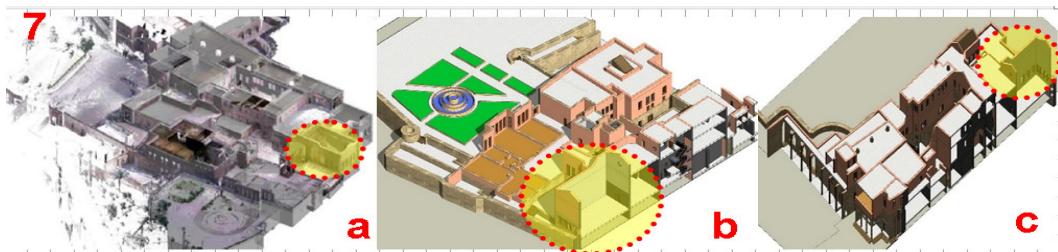
**Figure 7.** a. 3d model of al-jawhara palace and the great throne hall.

- b. longitudinal sectors of a perspective passing through the throne room, the guesthouse, and the entrance block from the north (marine) side.
- c. longitudinal sectors of perspective passing through the throne hall, the guesthouse, and the entrance block from the south (the tribal) side.

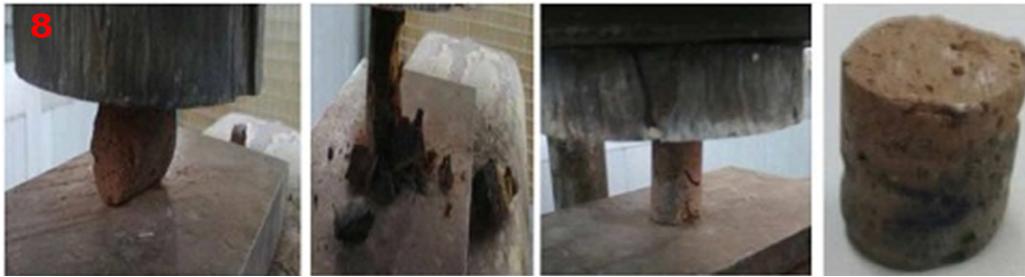
**Figure 8.** devices used in tensile, compression and shear testing on the bricks used.

each sample was separately placed in a shear test device to determine the extent of the resistance to shear stress that it could be exposed to. the effective force was gradually increased until collapse or fracture, and the result was as follows: maximum load 3110 newton, shear force 4.6 n/mm<sup>2</sup>. **Table 3 and figure. 8.**

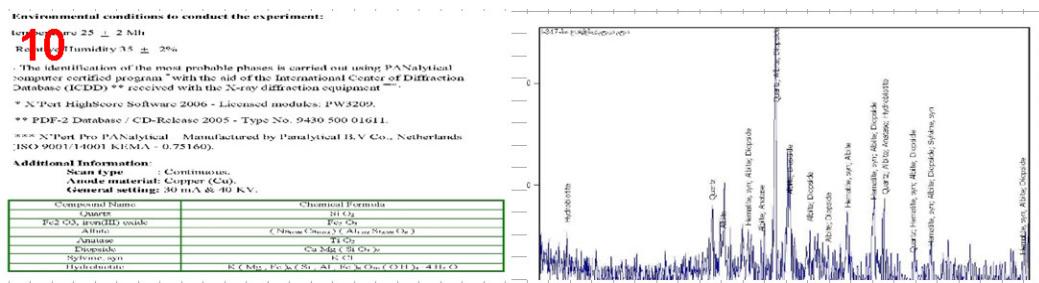
**Figure 10.** the result of the xrd polarized microscopy test on the bricks used.

the brick sample consists of quartz crystals, and the sample floor consists of iron oxide and some other minerals such as diopside and sylvine, syn, as it appeared by examining the sample. and there are no traces or evidence of visible damage to the sample of the studied bricks **figure. 10.**

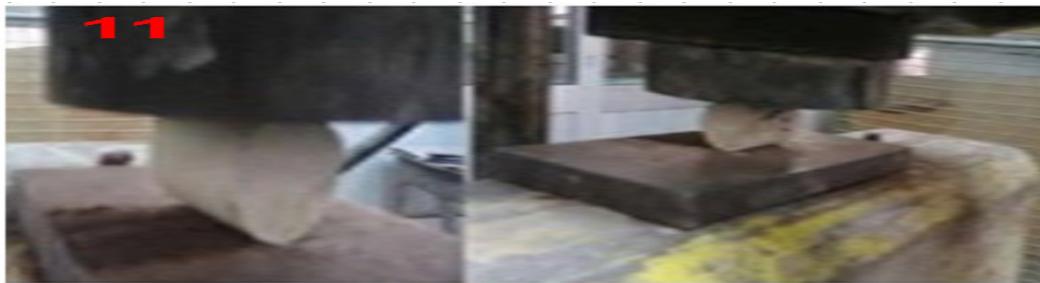
**Figure 11.** devices used in tensile testing on the limestone used.

each sample was placed separately in a tensile test device and the effective force was gradually increased indirectly until collapse or fracture, and the result was as follows: the maximum load is 3790 n, the tensile force is 0.98 n/mm<sup>2</sup>. **Table 5 and figure. 11.**

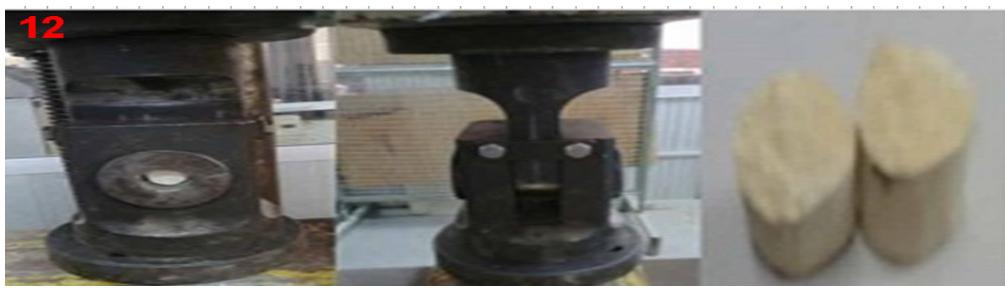
**Figure 12.** devices used in the pressure test on the limestone used.

each sample was separately placed in a shear test device to determine the extent of resistance to shear stress that it could be exposed to. the effective force gradually increased until collapse or fracture, and the result was as follows: maximum load 16300 newton, shear force 12. 4 n/mm<sup>2</sup>. **Table 6 and figure. 12.**

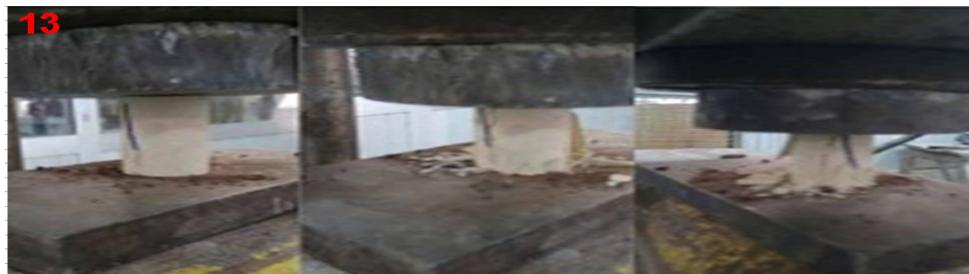
**Figure 13.** devices used in the pressure test on the limestone used.

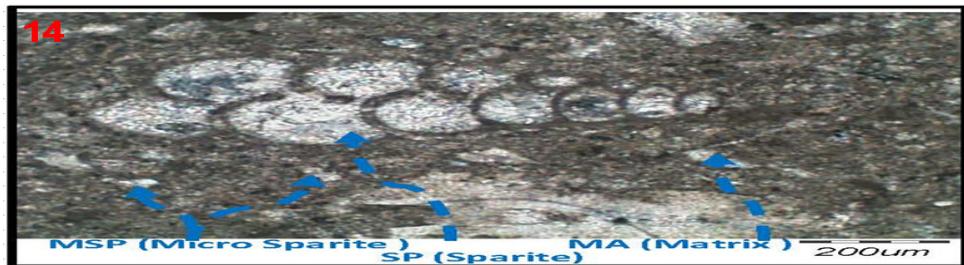
**Figure 14.** the result of analysis by x-ray diffraction of stone samples and devices used on the thin section.

it was found that it consists mainly of calcite and quartz minerals.

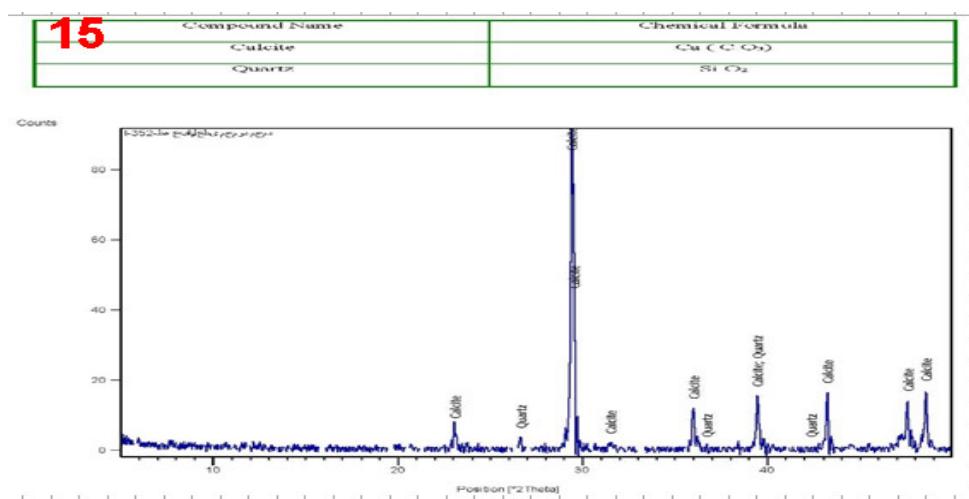
**Figure 15.** report showing the analysis by x-ray scattered diffraction on the stone used.

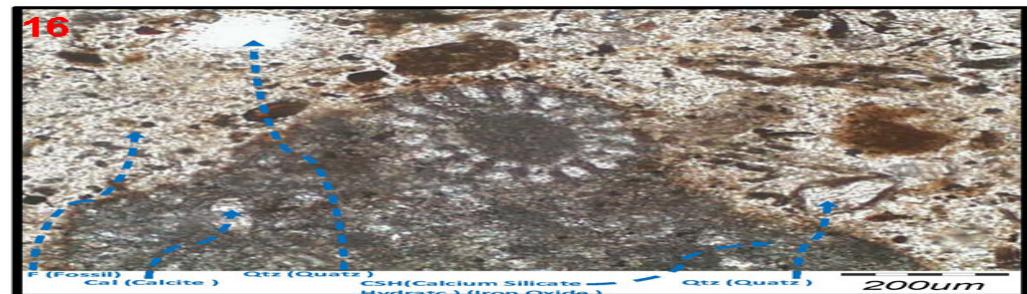
**Figure 16.** wall mortar samples used on thin section in x-ray diffraction analysis.

the sample of the limestone under study consists mainly of calcite grains, mostly of the medium-grained type (2:4um), which is called microsparite. the sample also shows the presence of fossils (> 4 um) and the size of sparite or coarse-grained calcite. the sample (matrix) of fine-grained calcite and some silt and studied limestone can be classified as fossil limestone, most of the fossil content of the sample is from foraminifera fossils (foraminifera). there is no clear evidence under the polarizing microscope of damage to the sample.

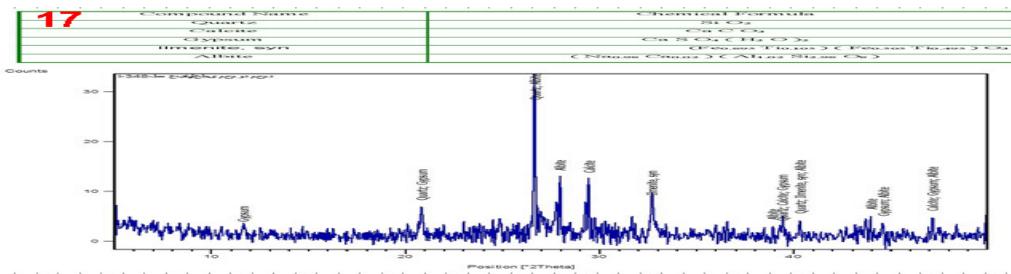
**Figure 17.** analysis by x-ray diffraction on the wall mortar used.

the analysis was carried out on a sample of mortar used in the walls of two sheets, and the results were as follows: it was found that it is mainly composed of quartz, calcite, gypsum, and albite as secondary minerals. **figure's. 17 and 18.**

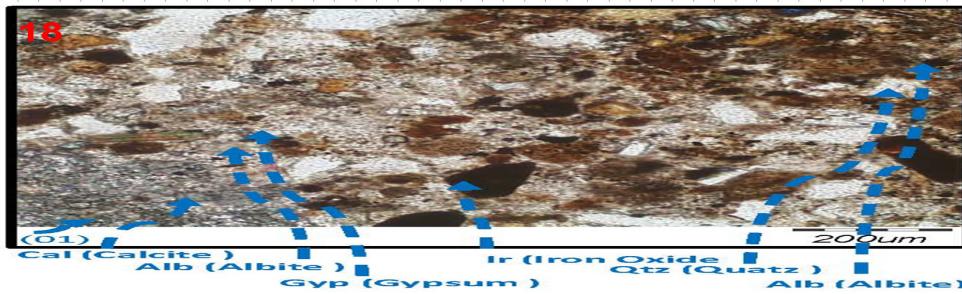
**Figure 18.** two-thin wall filler used on thin section in x-ray diffrequency analysis.

the sample consists of filler mortar of medium quartz grains, in addition to some iron oxides, which were shown by xrd. there are crystals of lite feldspar dispersed in the sample. there is a fine-grained calcite mineral in the lower left part of the picture, indicated by arrow no. (01), and some salts and minerals appear in the sample as ferrous materials. it has no visible signs of damage.

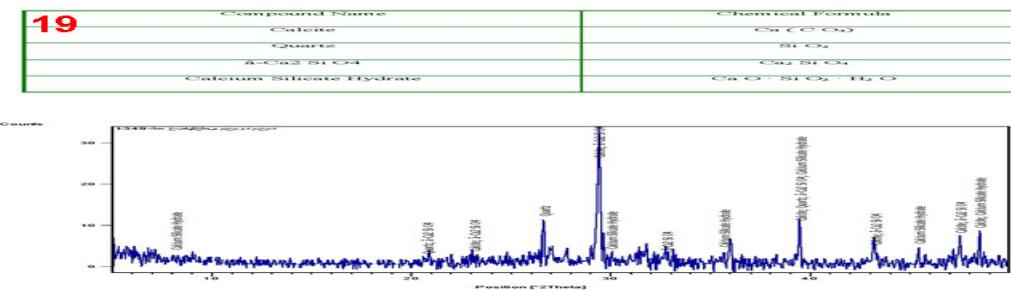
**Figure 19.** analysis by x-ray diffraction on the wall mortar used.

the analysis was carried out on a sample of arborite mortar used in two-paper walls, and the results were as follows: it was found that it consists mainly of calcite, quartz and hydrated calcium silicate as secondary minerals. **figure. 19.**

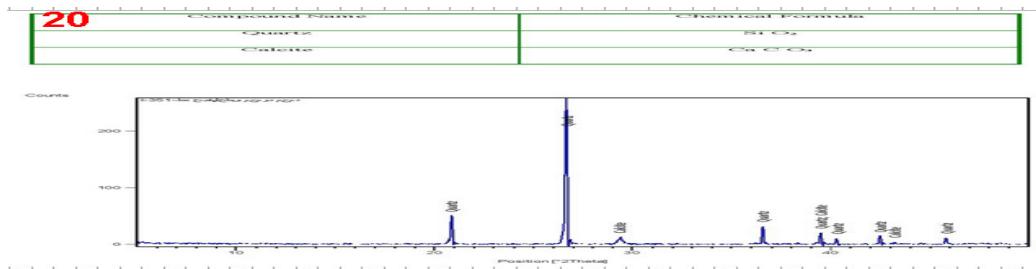
**Figure 20.** analysis by x-ray diffraction on the mortar of the wall mortar (conch) used.

it was found that it is mainly composed of quartz and calcite as a secondary mineral. **figure. 20.**

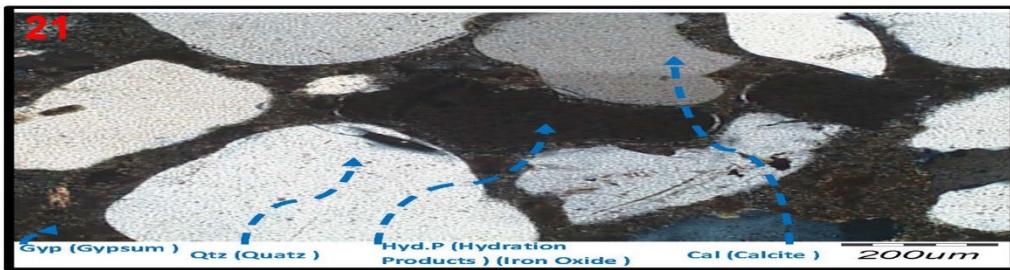
**Figure 21.** wall mortar samples (conch) used on thin section in x-ray diffraction analysis.

the study of the sample using a polarizing microscope showed that the main component of the studied mortar is quartz grains (filler) of large size with semi-circular shapes, which represent more than 75% of the studied sample. there are some traces of some evaporated minerals (gypsum). there is also a fine-grained calcite as a matrix between the quartz grains. there are some traces of formation of hydrated metabolites on the edges of quartz crystals. **figure's. 21, 22 and 23.**

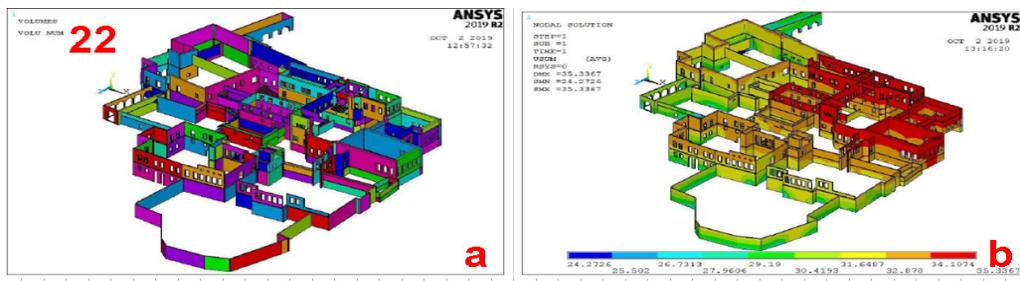
**Figure 22.** a. structural models for walls and stairs used in detailed finite element analysis. b. distorted shape of all walls (sum of the displacement vector) under the influence of static loads (mm).

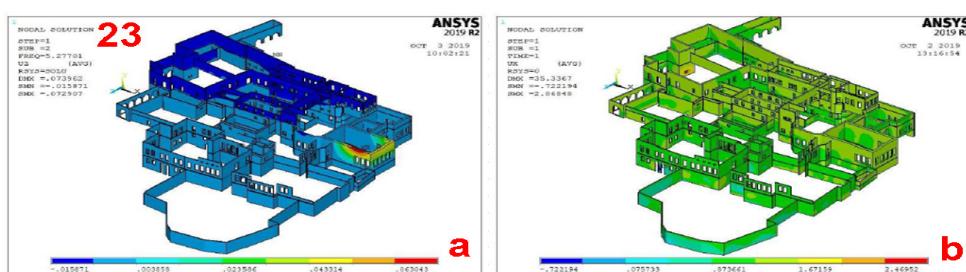
**Figure 23.** a. form horizontal deformation (z direction) under the influence of seismic loads in z direction (mm). b. form vertical deformation (y direction) under the influence of seismic loads in the z direction (mm).

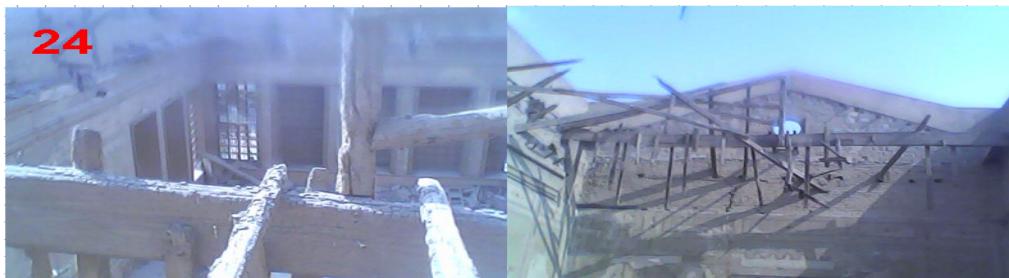
**Figure 24.** the truss wooden ceiling of the great throne hall after the 1972 fire.

it consists of wooden ceilings consisting of veins of panels and cladding of al-baghdali in the form of a truss and a borrowed ceiling from the inside. it was burnt in 1972, and what remains is clear in the pictures. inspect the roof, remove and replace the sections with new ones of the same quality with a layer of protection against decay, insects, and pests. making a layer of baghdadi wood, a layer of mortar for the ceiling and a layer of paints [3,49]. **figure. 24.**
