Smart Road Maintenance: Using Smart Technologies for Maintenance Management on Local Roads

School of Civil Engineering, Universidad Católica de Santa Maria, San Jose Urbanization, Yanahuara District, Arequipa 04013, Peru

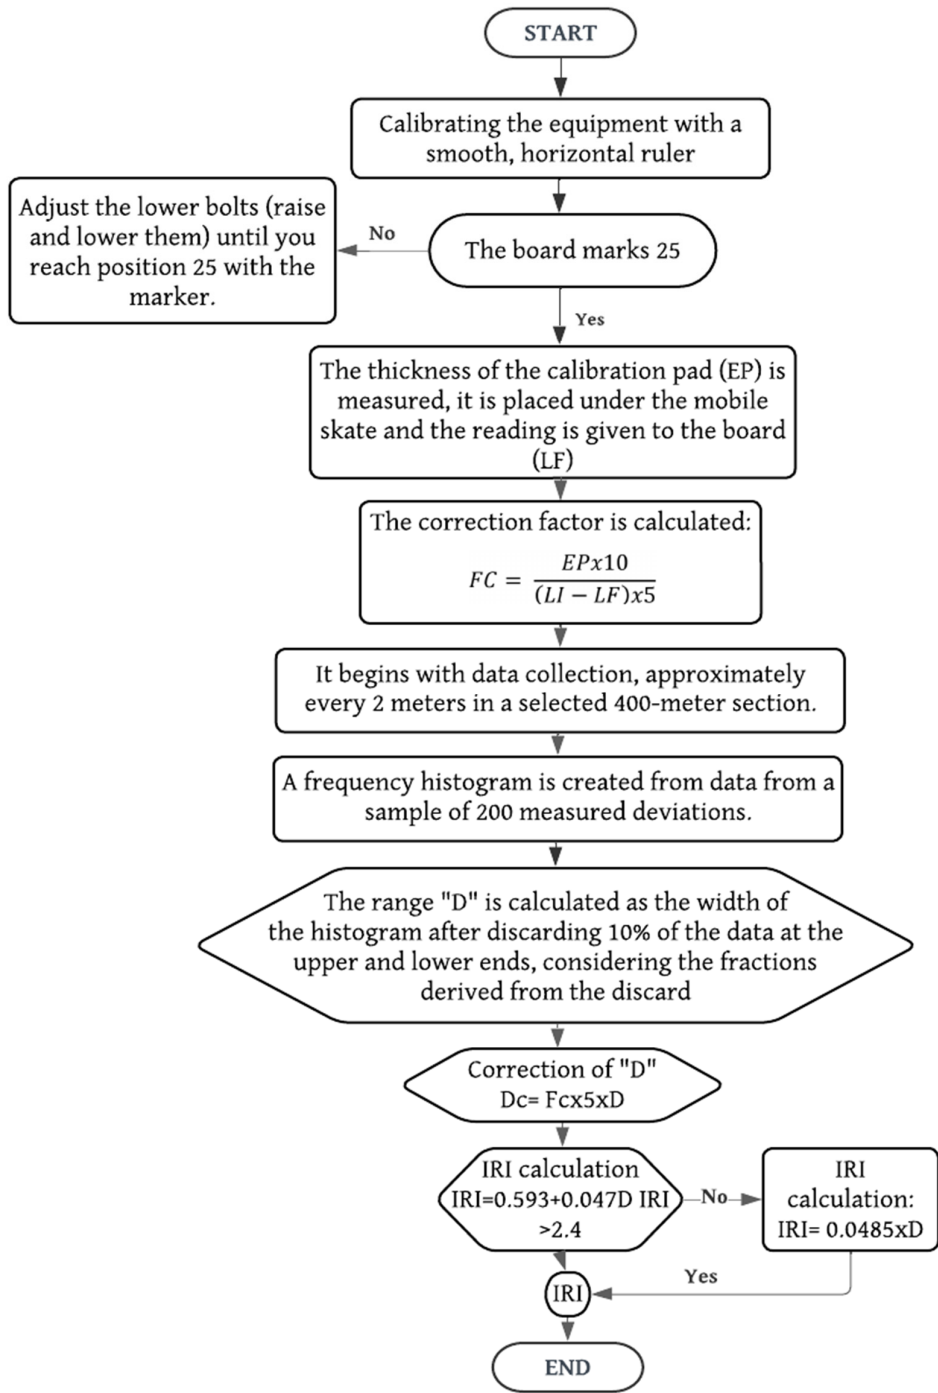
Figure 1, corresponding to the first flowchart, summarizes the methodology for determining the Pavement Condition Index (PCI) using the Merlin Roughness Meter. The procedure begins with calibrating the equipment by placing it on a horizontal surface and adjusting its support points until the pointer indicates 25. If it doesn't, the lower bolts are adjusted until this is achieved. Then, two readings are taken: an initial one (RI) and another with a calibration block under the movable foot (Rf) to determine the correction factor. Three people are required: an operator, an assistant to record the readings and a spotter. The operator moves the equipment until the wheel completes one rotation (1.98 m), places it on its three support points, and records the pointer's position in a field form, repeating the process until 200 consecutive readings are completed. The recording form has 20 rows and 10 columns, filled from top to bottom and left to right.

Figure 1. Flowchart of the Rugosimeter Merlin Equipment method.

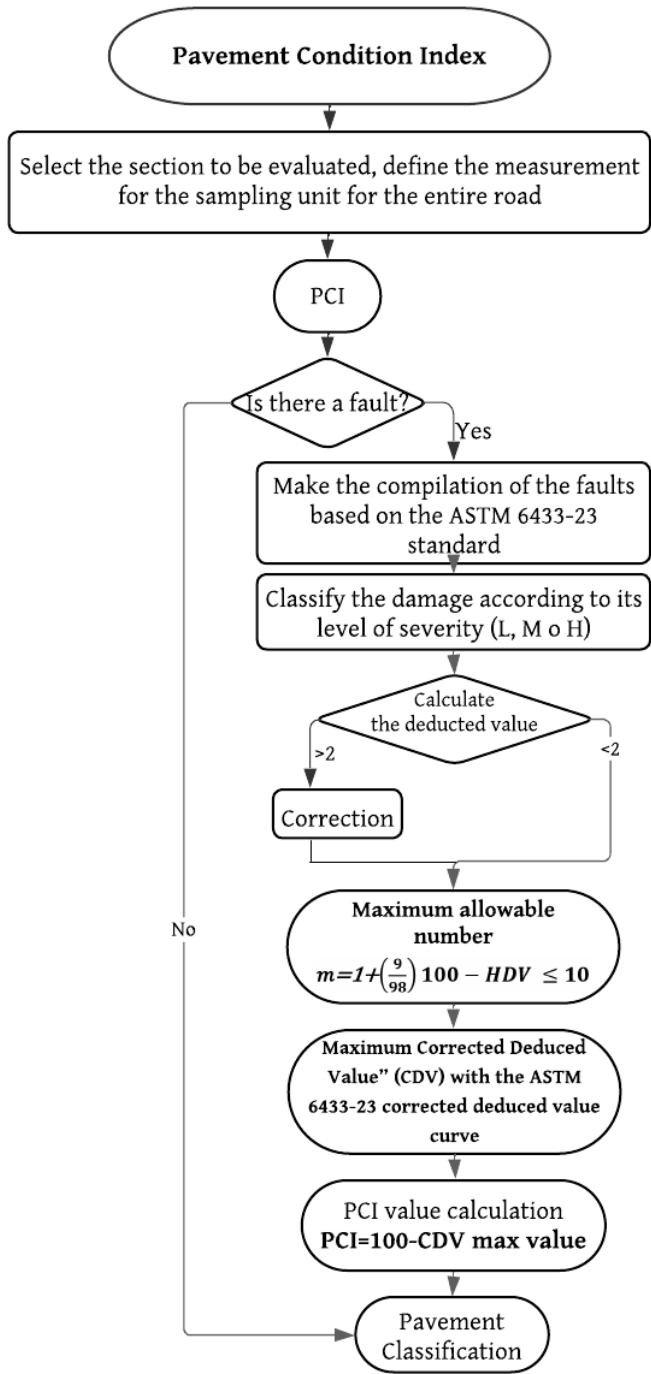
Figure 3, corresponding to the third flowchart, summarizes the procedure for measuring the PCI through visual inspection. To calculate it, the failure data obtained during the on-site inspection according to the 19 specified failures is required. These values are then subjected to the following steps: the Deduct Value (DV) is calculated by recording the sum of each type of failure according to its severity and quantity. The density of the failures is then used to determine the deducted value for each type of damage. Next, the maximum allowable deducted values (m) are calculated using an equation that takes into account the maximum deducted value for each sampling unit. The total deducted value is adjusted using a correction curve, thus obtaining the maximum Corrected Deduct Value (CDV). Finally, the PCI is calculated by subtracting the maximum CDV from 100, which indicates the pavement's condition. The PCI is classified according to various failures such as deformations, cracks, and erosion in the pavement [22].

Figure 3. Procedure for measuring PCI by visual inspection.

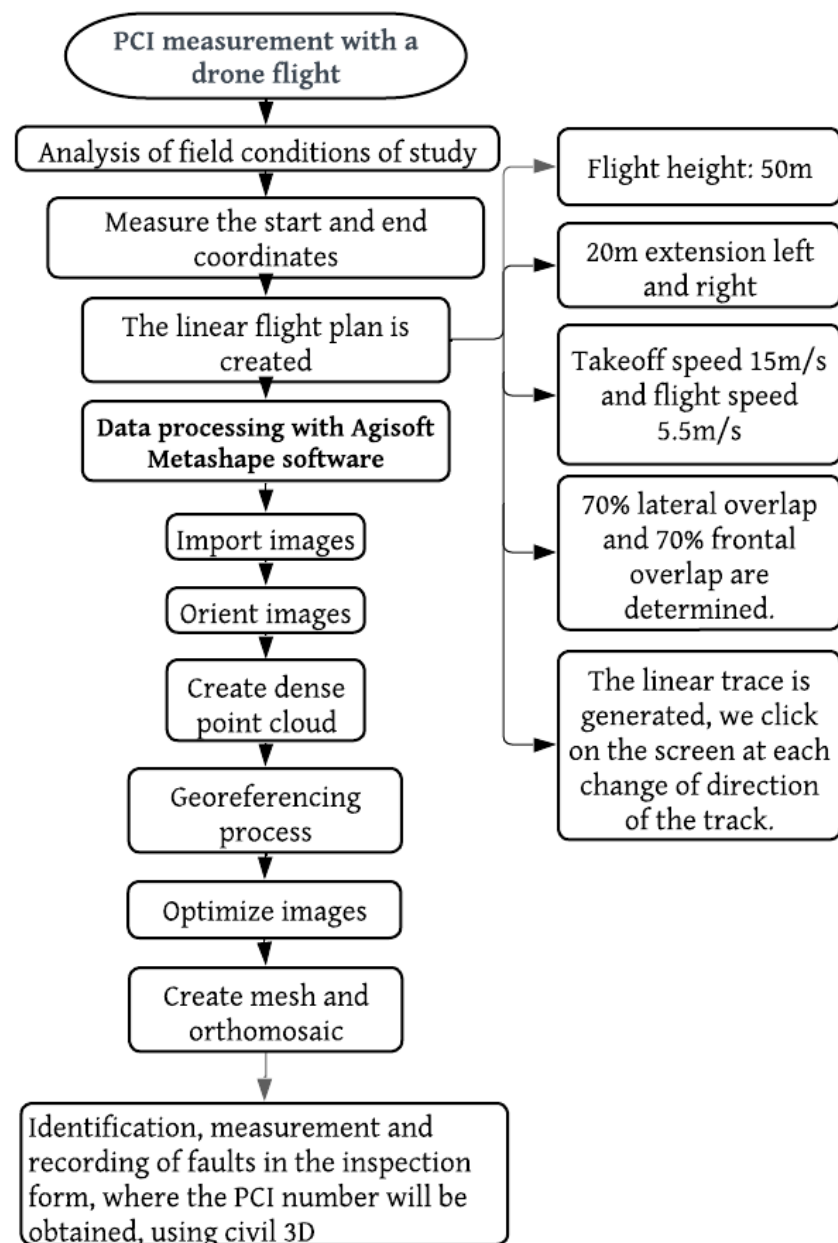
Figure 4, corresponding to the fourth flowchart, summarizes the procedure for measuring the PCI using the DJI Mavic 2 Pro drone, programmed via a mobile phone with the DJI PILOT app. The flight was conducted at 11 a.m. at an altitude of 50 meters to capture high-resolution images, taking photos every 2 seconds with a 70% overlap. A linear flight plan was generated, and the flight parameters, such as takeoff speed (15 m/s) and flight speed (5.5 m/s), were configured. The drone followed the programmed route, returning to the takeoff point for battery replacement three times. All information was stored in the drone's memory and then processed using Agisoft Metashape software, where the images were imported, oriented in high quality, and a dense point cloud was created for the final analysis.

Figure 4. PCI evaluation by flying the DJI Mavic 2 pro Drone.

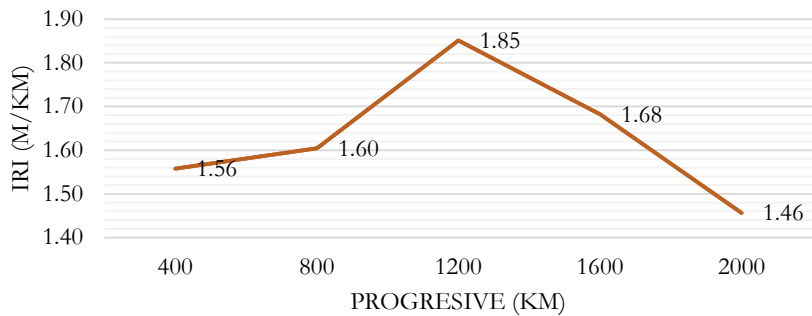
Figure 5 shows the results for the IRI for the right lane evaluated using the Merlin Roughness Meter. It can be seen that the highest IRI value, 1.85, occurs in the section from 0+800 to 1+200.

Figure 5. IRI right lane Merlin roughness tester.

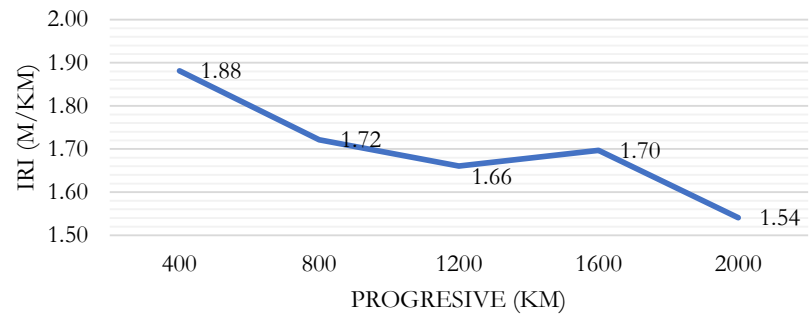
Figure 6 shows the results for the IRI for the left lane evaluated using the Merlin Roughness Meter. It can be seen that the highest IRI value, 1.88, occurs in the section from 0+000 to 0+400.

Figure 6. IRI left lane Merlin roughness tester.

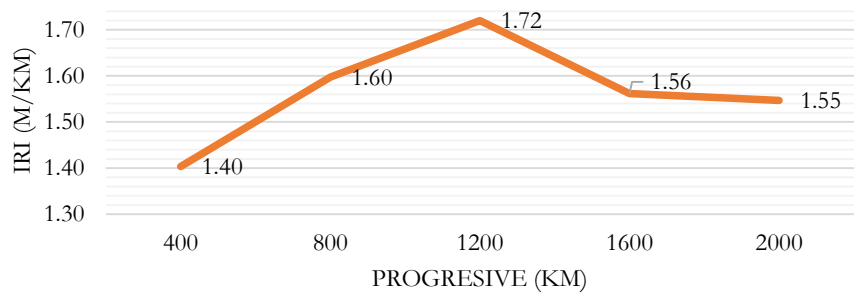
Figure 7 shows the results for the IRI for the right lane evaluated using the Roadroid app. It can be seen that the highest IRI value, 1.72, occurs in the section from 0+800 to 1+200.

Figure 7. IRI right lane using ROADROID.

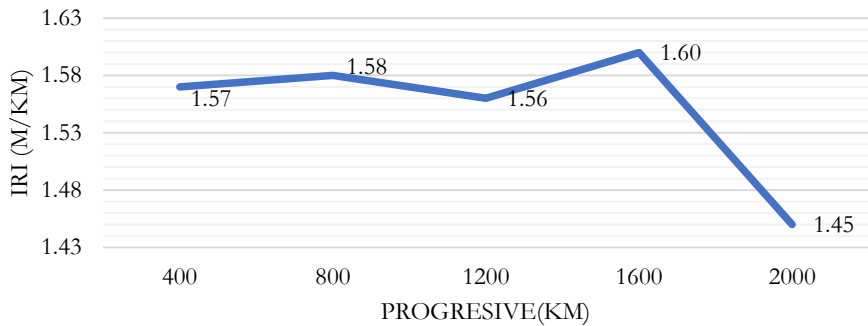
Figure 8 shows the results for the IRI for the left lane evaluated using the Roadroid app. It can be seen that the highest IRI value, 1.60, occurs in the section from 0+800 to 1+200.

Figure 8. IRI left lane using ROADROID.

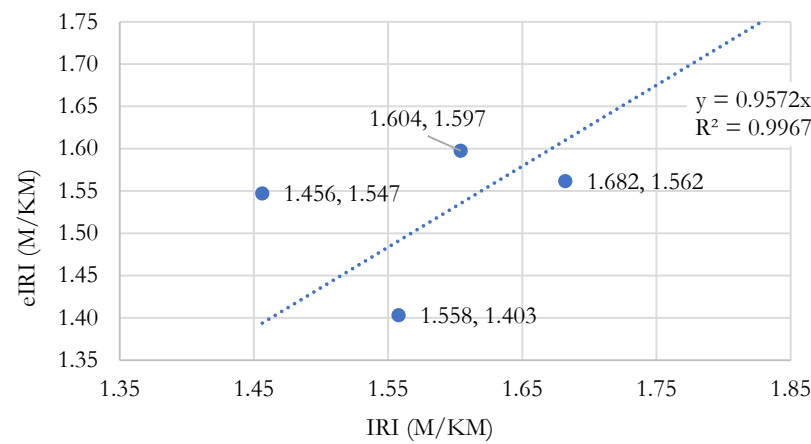
Additionally, Figure 9 shows the scatter plot of IRI vs eIRI for the right lane data. The best-fit line to the point cloud with the origin point (0,0) is displayed, with the IRI values on the “x” axis and eIRI values on the “y” axis. A coefficient of determination (R^2) of 0.9967 is obtained, indicating a high correlation (Figure 3).

Figure 9. IRI vs eIRI dispersion table—Right Lane.

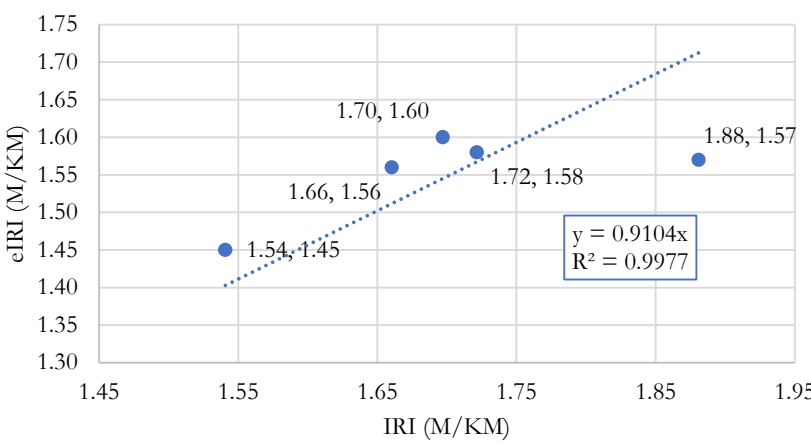
Figure 10 shows a linear regression for the left lane data. The best-fit line to the point cloud with the origin point (0,0) is displayed, with the IRI values on the “x” axis and eIRI values on the “y” axis. A coefficient of determination (R^2) of 0.998 is obtained, also indicating a high correlation.

Figure 10. IRI vs eIRI dispersion table—Left Lane.

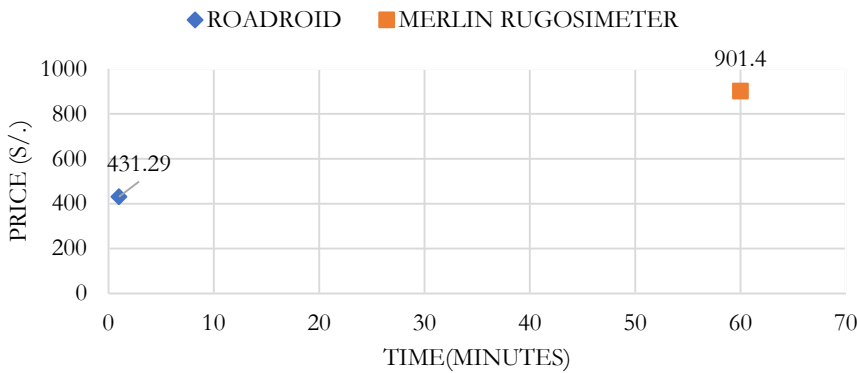
Figure 11 shows the Cost-Benefit analysis between these two methods, indicating that the Roadroid application is more efficient in terms of time and cost for measuring IRI over 1 kilometer of road, with a time of 1 minute and a cost of 681.29 soles per km, compared to 60 minutes and a cost of 901.4 soles per km using the Merlin Roughness Meter.

Figure 11. Cost Benefit in time between the Merlin Roughness Tester and ROADROID.

The Roadroid application’s performance is 1.08 km/min, as the vehicle traveled at an approximate speed of 75 km/h. In contrast, the traditional Merlin Roughness Meter has a performance of 1 km/h. This indicates that the data collection process using the Roadroid application is 60 times faster. Therefore, it is concluded that the use of the Roadroid application is not only more economical but also more cost-effective.

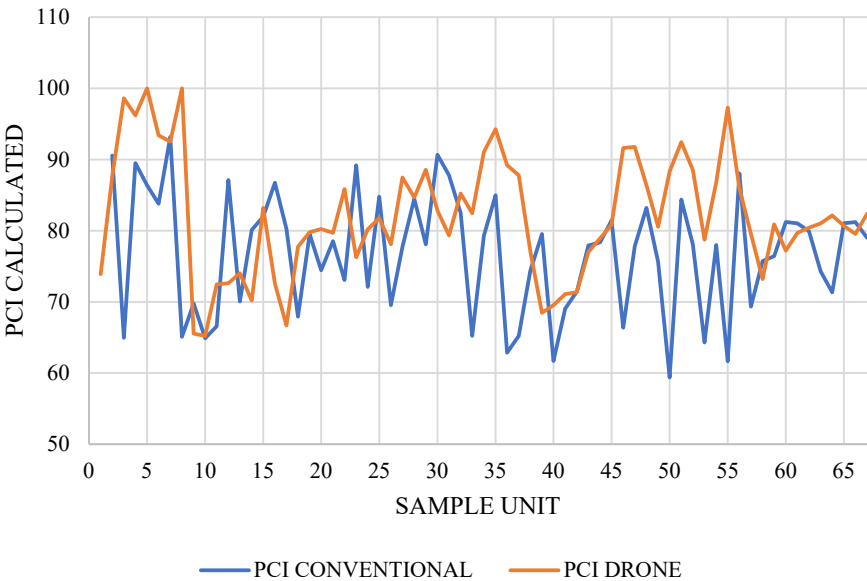
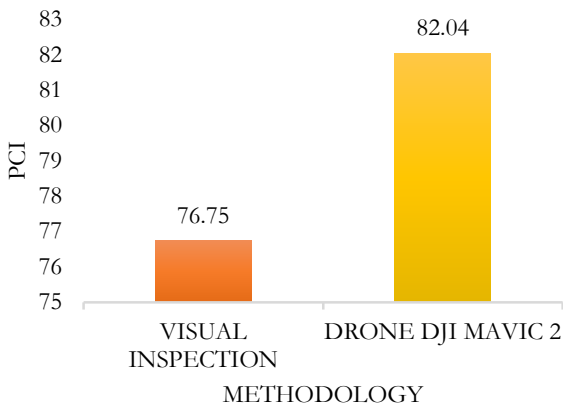
In Figure 12, PCI data for each 30 m sample unit can be visualized using both methodologies and a bar graph also represents the average PCI value for both methodologies.

Figure 12. PCI values calculated for both methodologies.

Figure 13. PCI values calculated for both methodologies.

In response to the values presented in the comparison of the PCI between both methodologies—through the conventional method of visual inspection of failures and via drone flight (DJI Mavic 2 Pro)—for the AR-780 road, the average PCI value through the conventional visual inspection method was 76.75, and for the DJI Mavic 2 Pro drone, it was 82.04, with an average variation of 6.89%.

Therefore, it can be concluded that the PCI measurement using the traditional method provides greater accuracy and detail since it is conducted in the field and yields better results for pavement failures compared to the method using the DJI Mavic 2 Pro drone. The results obtained by the drone can be optimized by complementing it with topographic leveling; the drone did not offer higher precision because it is not the appropriate equipment for z-axis measurement, which requires millimetric precision for this study. The photogrammetry performed with the drone does not have the appropriate z-axis precision.

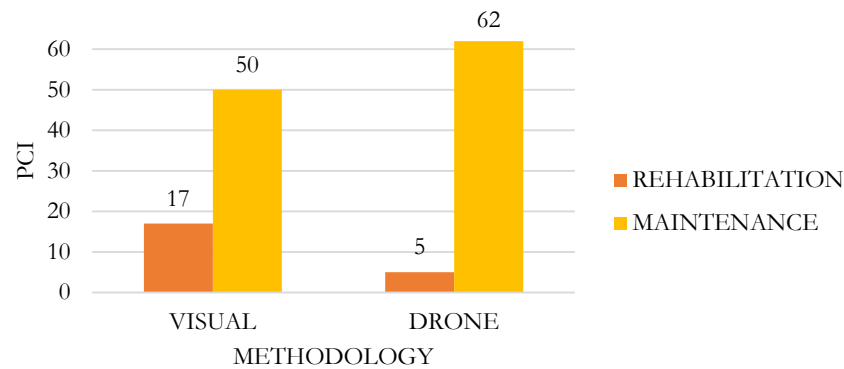
In response to the values presented in the comparison of the intervention range between both methodologies—through the conventional method of visual inspection of failures and via drone flight (DJI Mavic 2 Pro)—for the AR-780 road, the PCI of the AR-780 local road was determined through conventional failure inspection, obtaining 50 sample units that require maintenance and 17 units that require rehabilitation (2, 7, 9, 10, 12, 17, 25, 32, 35, 36, 39, 40, 45, 49, 52, 54, and 56). Meanwhile, using the drone method for PCI, 62 sample units were found to require maintenance and 5 units to require rehabilitation. It is notable that both methods coincided on 5 sample units requiring rehabilitation intervention: UM-09, 10, 17, 39, and 40; and 50 sample units suggested maintenance intervention, with 12 sample units differing in their intervention range.

Figure 14. PCI for both types of evaluation and their respective classification.

It can be concluded that PCI measurement using the traditional method provides greater accuracy and detail since it is conducted in the field and yields better results for pavement failures compared to the method using the DJI Mavic 2 Pro drone.

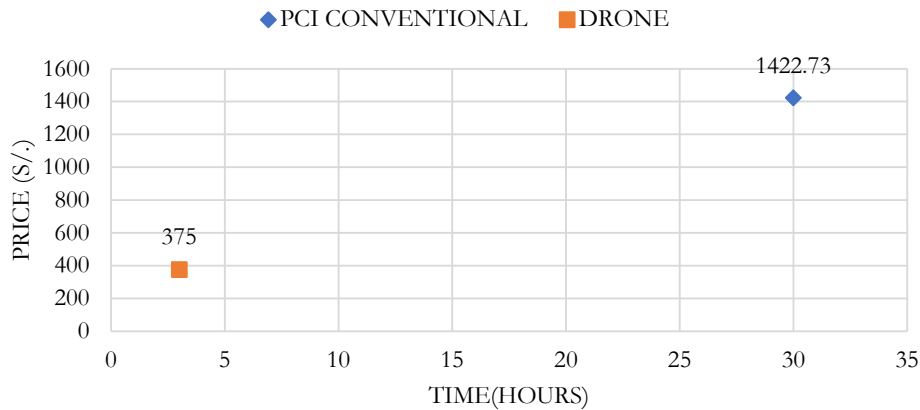
In Figure 15, a cost-benefit analysis between the traditional system and the method using a drone is observed, obtaining lower costs and time using a drone, which is 375 soles and 3 hours, compared to the traditional method, which is 1,422.73 soles and 30 hours.

Figure 15. Cost-benefit analysis between the traditional system and the method using drone.
