# Integrating Geosynthetics and Vegetation for Erosion Control Applications

Posted Date: 29 October 2024

Keywords: roots reinforcement; shear strength parameters; erosion control; geosynthetics

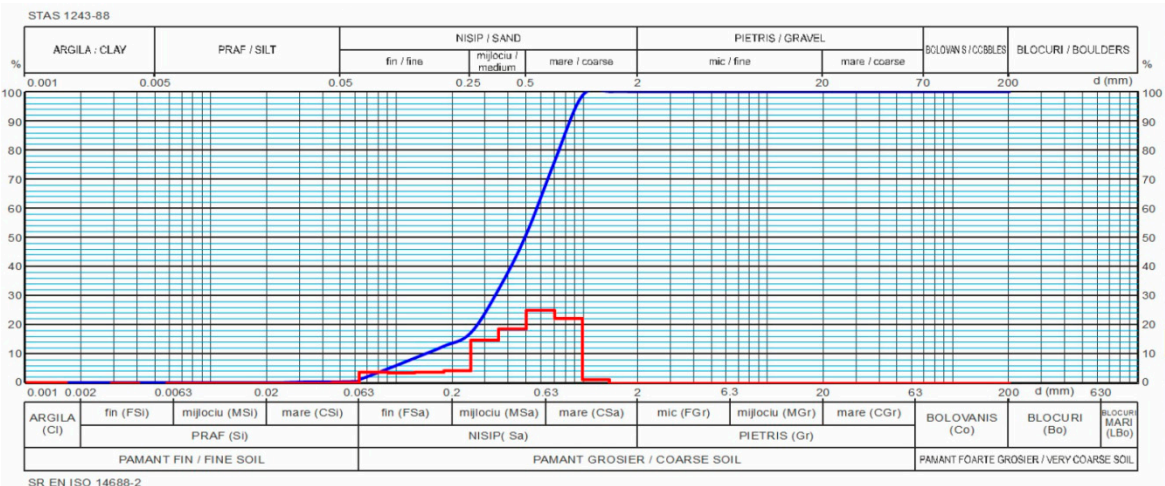
Figure 3. Grain size distribution of the sand sample.

The organic soil (OS) used in this study is a natural product commonly used for gardening, with an organic matter content ranging between 60-80% and a pH value of 5 to 7. Geotechnical characteristics of the OS are internal friction angle of 19.57° and cohesion of 36.11 kPa. The soil used in all the tests is known as very erodible soil - sandy soil. From the granulometric perspective, medium to coarse sand with poor gradation, according to SR EN ISO 14688:2-2018 [21] (Figure 3). Geotechnical characteristics of the bare sand (BS) are a specific gravity of 2.65 g/cm<sup>3</sup>, internal friction angle of 32.94°, and cohesion of 1.24 kPa.

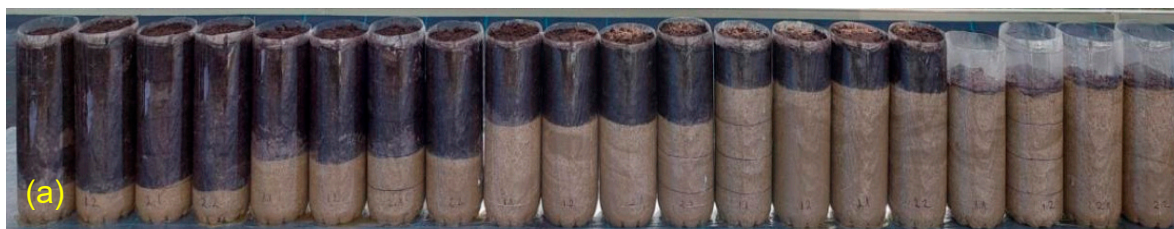
**Figure 9.** The growing plant's stages at different periods: (a) 30.09.2022 (day 0), (b) 25.10.2022 (25 days), (c) 19.11.2022 (50 days), (d) 14.12.2022 (75 days), and (e) 27.02.2023 (150 days).

From visual observations and measurements of growth parameters from 30.09.2022 to 27.02.2023 (170 days), it was concluded that in the cylinders where a double number of seeds was sown, the results are not relevant to the research project because the density of the sprouted plants is too high, causing the plants to crowd each other and preventing proper root development. It was also observed that the plants that developed in the container with 5 cm of topsoil developed roots as strong as the plants developed in thicker layers of topsoil; this led to the conclusion that a layer of 5 cm of topsoil is optimal for the development of plants and their roots.

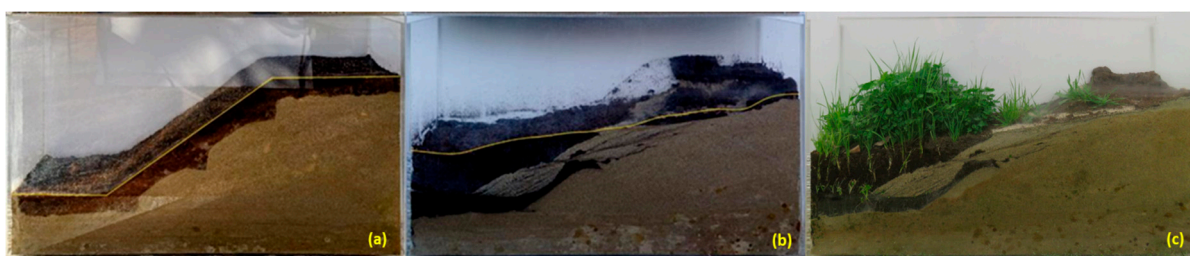
**Figure 19.** The variation in the profile of a sandy excavation protected by 5 cm of OS (with seeds) during rainfall simulation at different periods: (a)  $t = 0$  minutes, (b)  $t = 10$  minutes, and (c) after approx.—four months, during the winter.

Simulating torrential rainfall over an area where excavation had been made in sandy soil, topped with a layer of 5 cm of OS that had been seeded but where the vegetation had not yet developed, had severe effects. In the scaled model, landslides occurred, completely altering the initial profile after just 10 minutes of intense rainfall (Figure 19).

This rapid and massive shallow landslide occurred because the topsoil, without plant roots, absorbed all the rainwater quickly, increasing its weight. Since the soil beneath the topsoil layer was not saturated, a failure plane formed below the saturated topsoil layer, causing a general instability in 10 minutes. The scale model test remained undisturbed during the winter, from January 2023 until April 2023. Because during the winter of 2023-2024, there were a few days below-freezing temperatures, the seeds germinated, sprouted, and grew. It was observed that during the landslide caused by the torrential rainfall simulation, the seedlings also slid to the base of the slope.

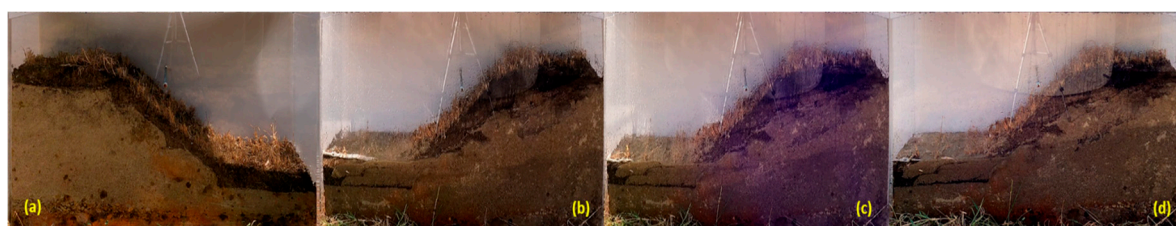
**Figure 24.** The variation in the profile of a sandy excavation protected by 5 cm of OS with dried mature vegetation during rainfall simulation at different periods: (a)  $t = 0$  minutes, (b)  $t = 80$  minutes, (c)  $t = 100$  minutes and (d)  $t = 120$  minutes.

During the rainfall simulations on the slope protected by 5 cm of OS and mature dry vegetation, it was observed that the sand was displaced on the side opposite the filmed area after approximately 75 minutes, and the camera was moved. Figure 24 shows the amount of displaced material.
