The Method for Assessing the Causes of Damage to a Bearing in a Rotary Air Preheater

[Paweł Maślak](#)* and Grzegorz Przybytek

Wrocław University of Science and Technology, Faculty of Mechanical Engineering, Department of Machine and Vehicle Design and Research, Poland

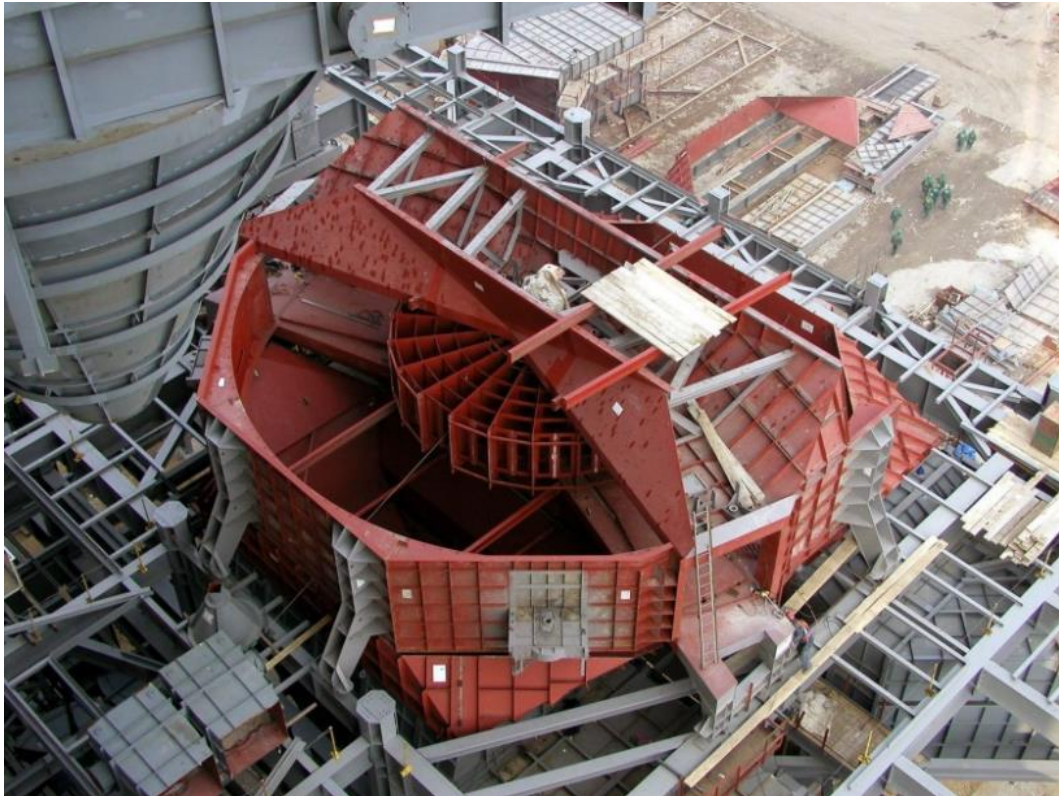
The rotary air preheater (LUVO, Figure 1) is one of the auxiliary devices of a steam generator and consists of a rotor and its drive, flanged connections, bearings, seals and a housing. Its task is to recover the temperature from the exhaust gases leaving the boiler and to heat up the air flowing in the opposite direction. The heated air is used to heat up the dust that enters the boiler through coal burners to ignition temperature. The heat is transferred through a vertical-axis rotor.

Figure 1. The installation of a rotary air preheater on the steam generator.

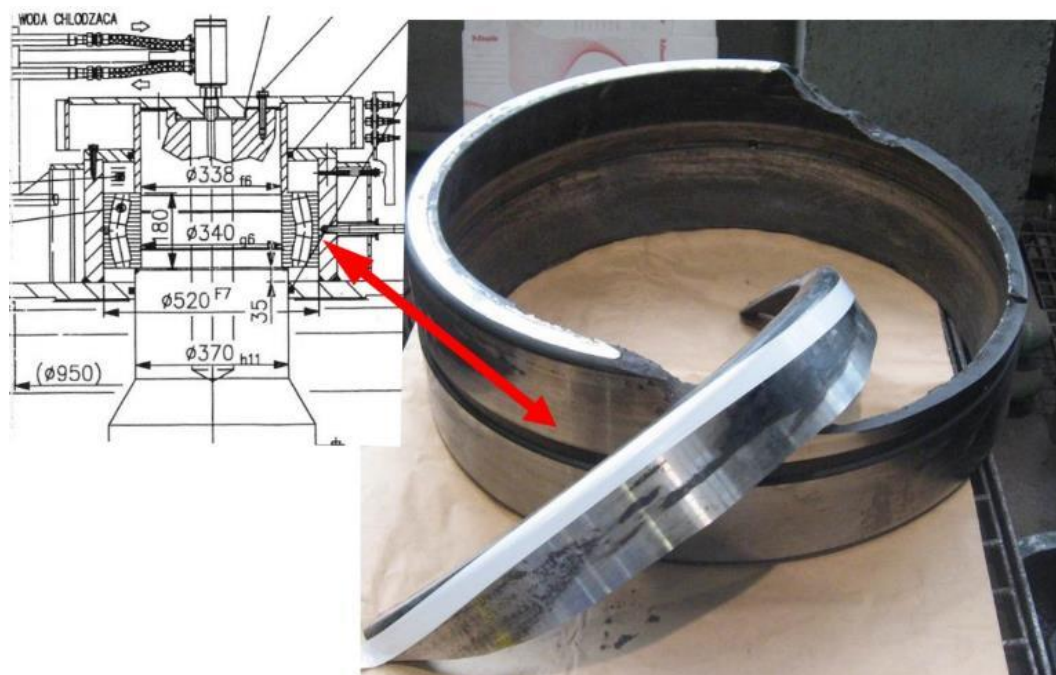
The damage to the self-aligning spherical roller bearing of the rotary air preheater is shown in Figure 2.

Figure 2. Damaged self-aligning spherical roller guide bearing of the rotary air preheater.

Bearings are critical components in various mechanical systems, facilitating smooth motion and reducing friction between moving parts. However, the integrity of bearings can be compromised due to various factors, leading to cracks and subsequent failure. In one power plant, after several years of operation there was an emergency shutdown of the preheater on a fluidized bed boiler due to damage to the top bearing.

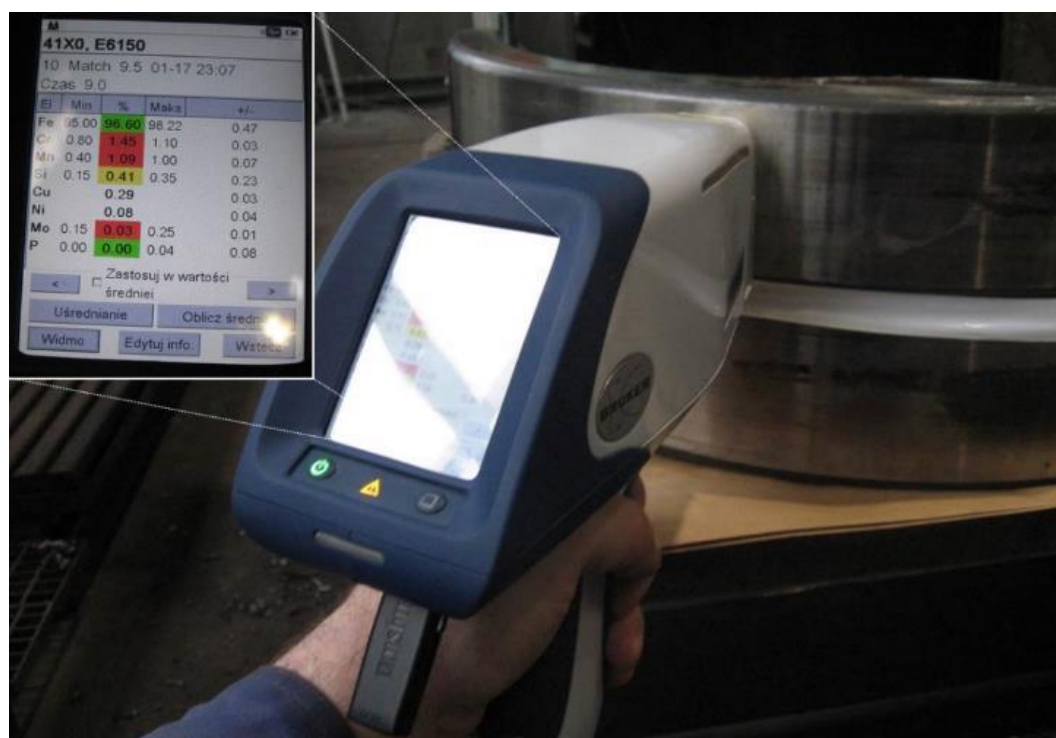
At the beginning of research, the chemical composition was analyzed with a spectrometer to determine the type of material used for the bearing [17,18]. All elements of the bearing were tested, i.e.: inner ring, damaged outer ring, spherical roller elements and cage (Figure 3).

Figure 3. Damaged self-aligning.

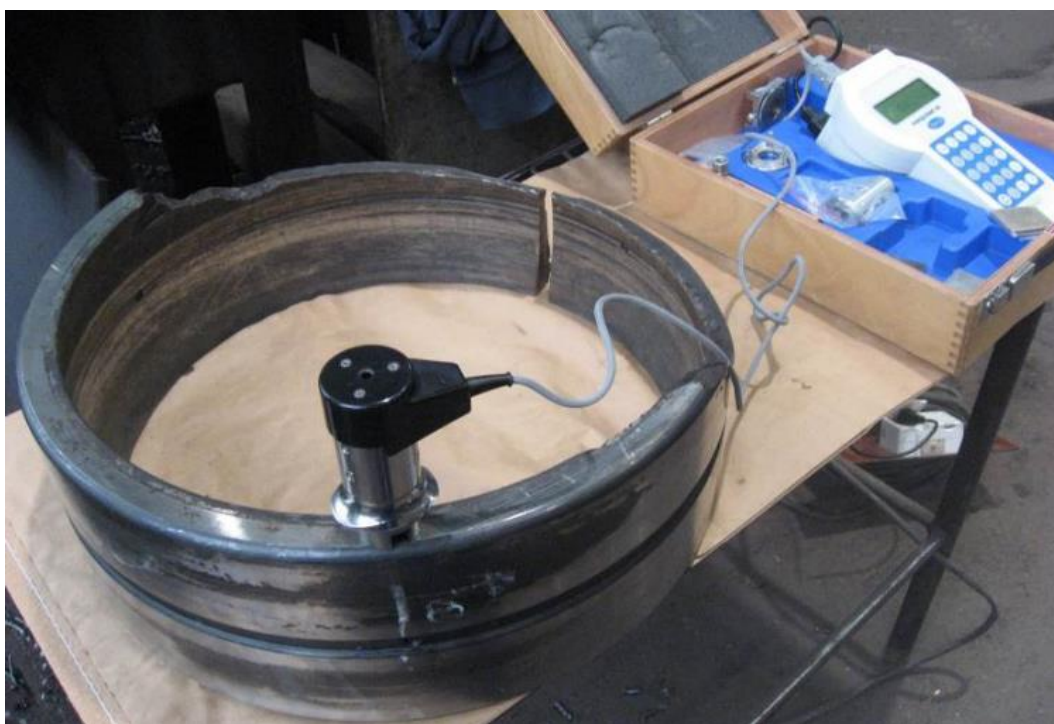
The second parameter that is important in determining the steel grade is hardness. When carrying out hardness measurements, the Vickers method was used (Figure 4). The tests were performed on two parts of the damaged ring in 10 points that were uniformly distributed along the circumference of the bearing. The number of measurements at each point ranged from 6 to 10 and the obtained hardness range was from 61.8 HRC to 62.1 HRC.

Figure 4. The measurement of hardness of the damaged outer ring of the bearing using the COMPUTEST S.C. hardness meter.

According to the literature, corrosion-resistant bearing steels are obtained through the process of hardening (820-840)°C and low tempering 180°C (1±2 h), which produces a hardness of 62.5 HRC [18]. Therefore, the measured values confirm that the outer ring of the bearing in the rotary air preheater has undergone proper heat treatment.

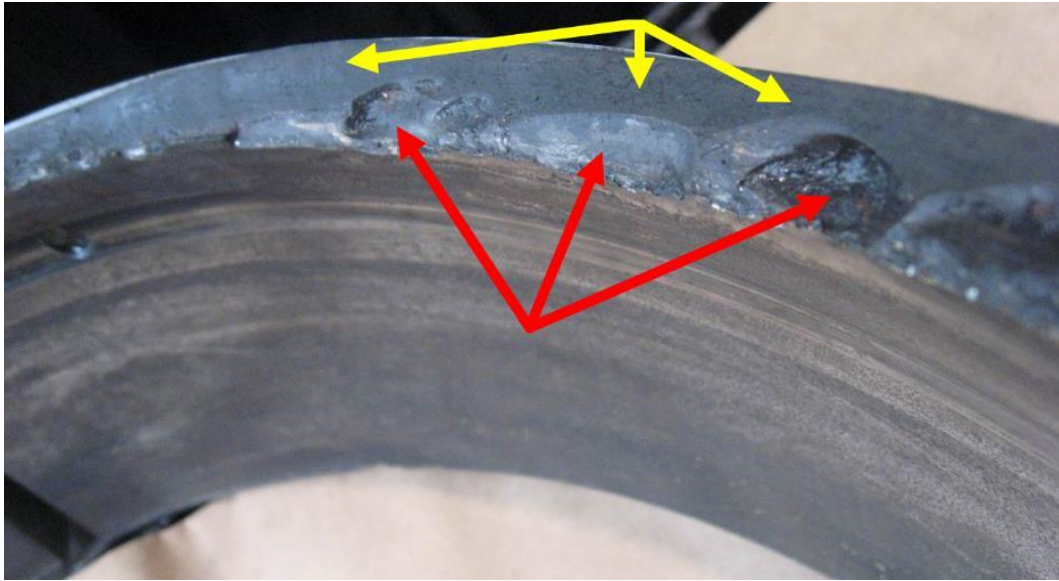
The basic method of non-invasive assessment is visual testing, which was carried out on all elements of the damaged bearing [21,22]. The visual inspection of the outer ring revealed a discontinuity in the material of the outer raceway, which passes through the oil hole and groove. The visual inspection of the fracture resulting from the separation of a fragment of the casing revealed three types of fracture surfaces:

- fatigue fracture (marked red - Figure 5),
- shear damage (marked yellow - Figure 5),
- contact pressure areas - indentations in the separated part of the ring (marked blue - Figure 6)

Figure 5. Fracture of the outer ring of the bearing. Fatigue, conchoidal zone (red arrows) and shear, residual zone (yellow arrows).

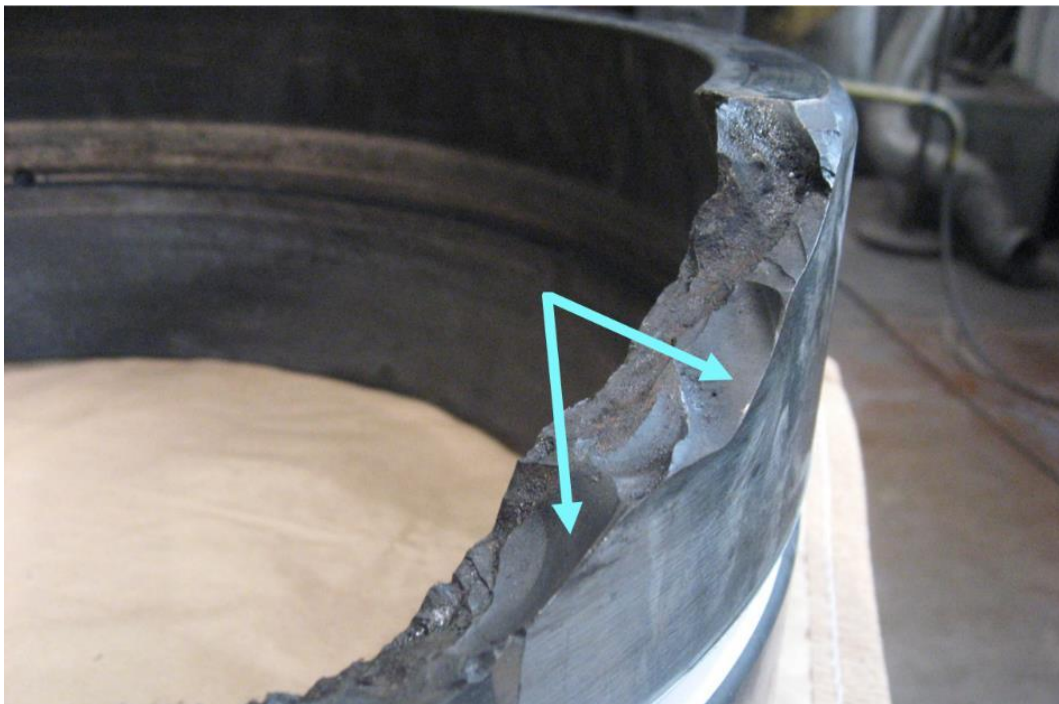
Figure 6. Zone of contact pressure between the separated part of the raceway and the rest of the raceway.

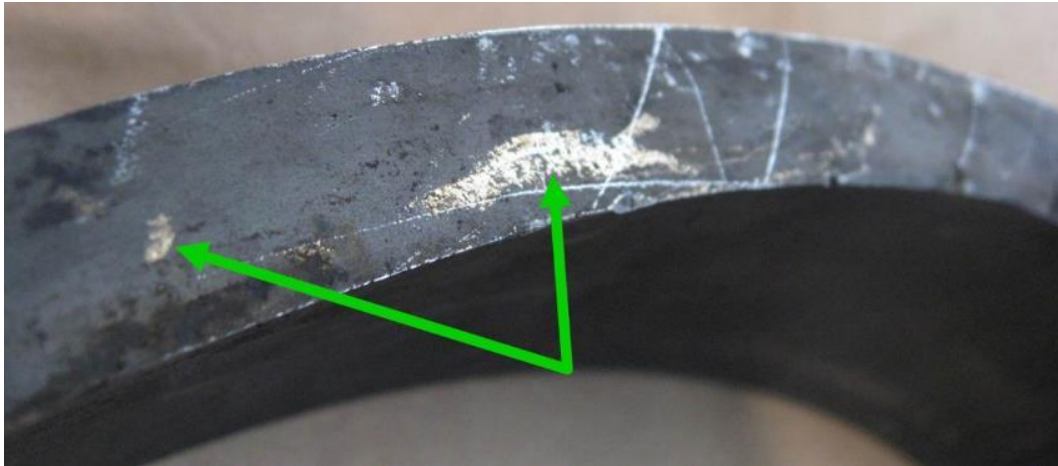
In addition, formations of non-ferrous metals were found on the fracture surface, which means that during the failure, a part of the ring must have come into contact with the cage that is made of brass (Figure 7).

Figure 7. Traces of brass which the bearing cage is made of.

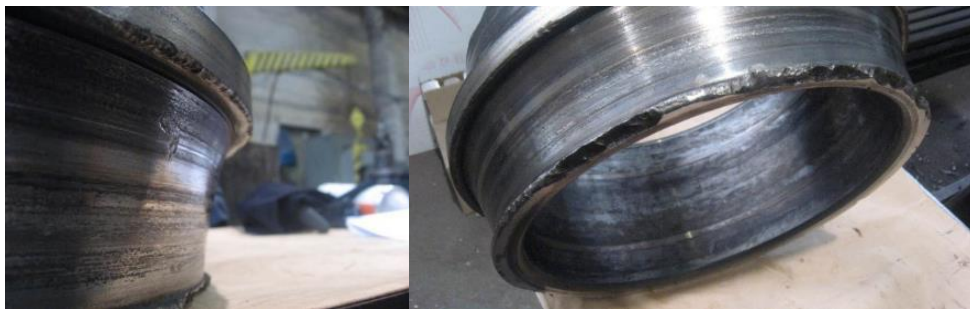
Other phenomena caused by the temporary overloading of the bearing included the flaking of material, denting in the separated fragments of rolling elements, seizures and crevice corrosion, particularly visible on the inner raceway of the bearing (Figure 8). Additionally, tests revealed damage to the side surfaces of the outer ring (Figure 9).

Figure 8. Signs of peeling and damage to the raceway and side surfaces of the inner ring.

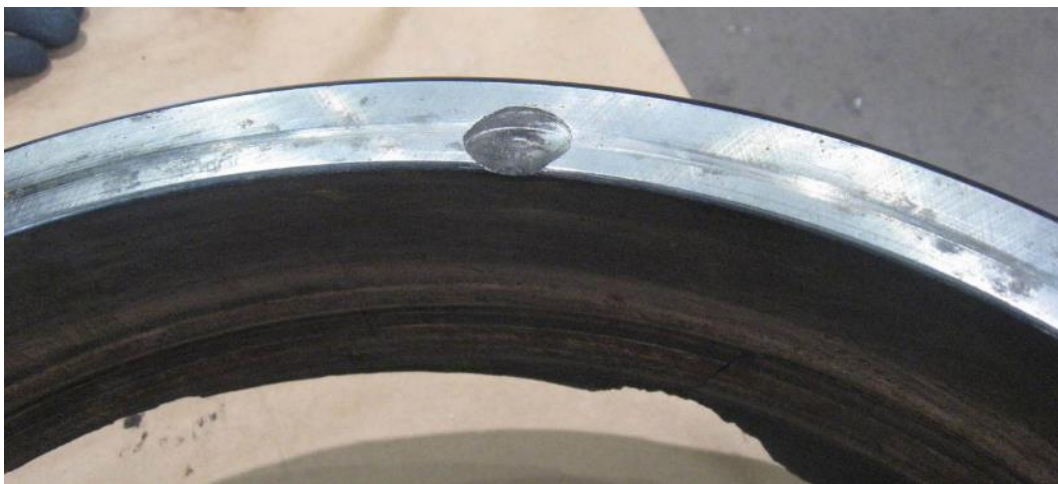
Figure 9. Signs of damage to the side surfaces of the outer ring.

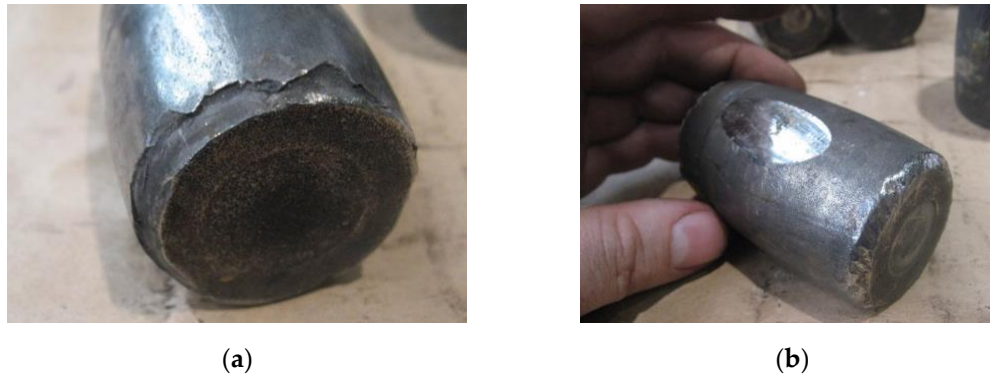
When the rolling elements of the damaged bearing were examined, most of them had cavities, chipping and spalling (Figure 10a).

The damage to the inner ring of the air preheater bearing caused by excessive contact pressures, through excessive bearing deflection, resulted in the grinding of the surface of a significant number of rollers - there are "fresh" signs of material flaking (Figure 10b).

Figure 10. Damage to the bearing's rolling elements: (a) chipped contact surface between the rolling element and the raceway, (b) chipped edge of the rolling element.

The aforementioned damage may have already started while the bearing was in operation and not as a direct result of a failure because the LUVO bearing is subject to heavy and low cycle loads.

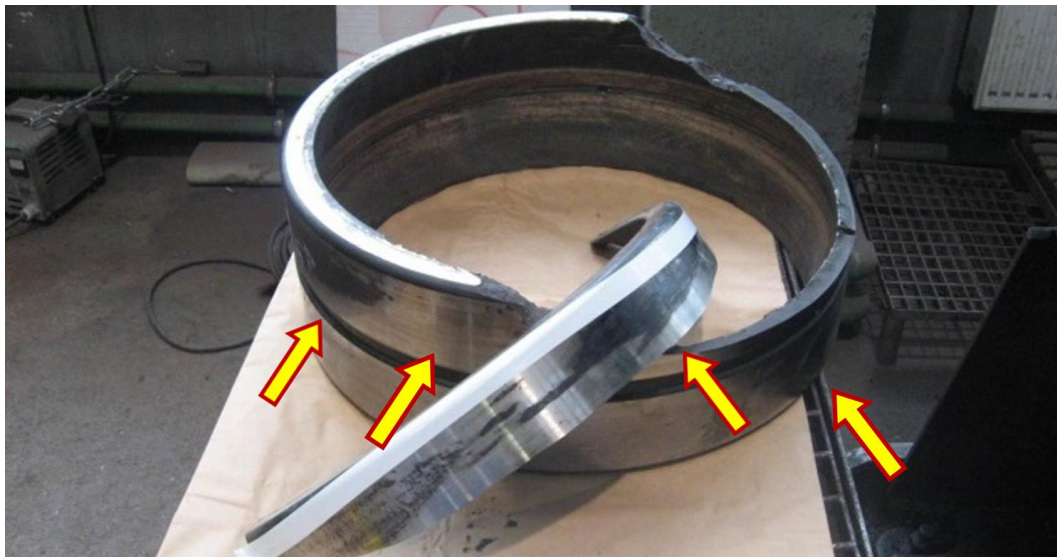
In addition, when operating in severe conditions (elevated temperatures), the bearing sustains so-called secondary damage. Figure 11 shows an example of such damage in the form of fretting corrosion on the outer ring.

Figure 11. Fretting corrosion on the bearing's outer ring mating surface.

Fretting corrosion is commonly encountered when operating conditions cause deformations of bearing seats under heavy loads. It can be black (as recorded in this case), red or reddish-brown. Over time, advanced corrosion leads to improper contact between the mating surfaces of elements and consequently to bearing damage.

The fretting, which resulted in the failure of the air preheater, could have also been caused by human error when the bearing seat was mounted.

To sum up, as a result of the performed tests, it was determined that the direct cause of failure of the rotary air preheater support was fretting, which occurred due to a design error - the fit was insufficient and/or there were manufacturing flaws - incorrect mounting of the bearing in the housing.

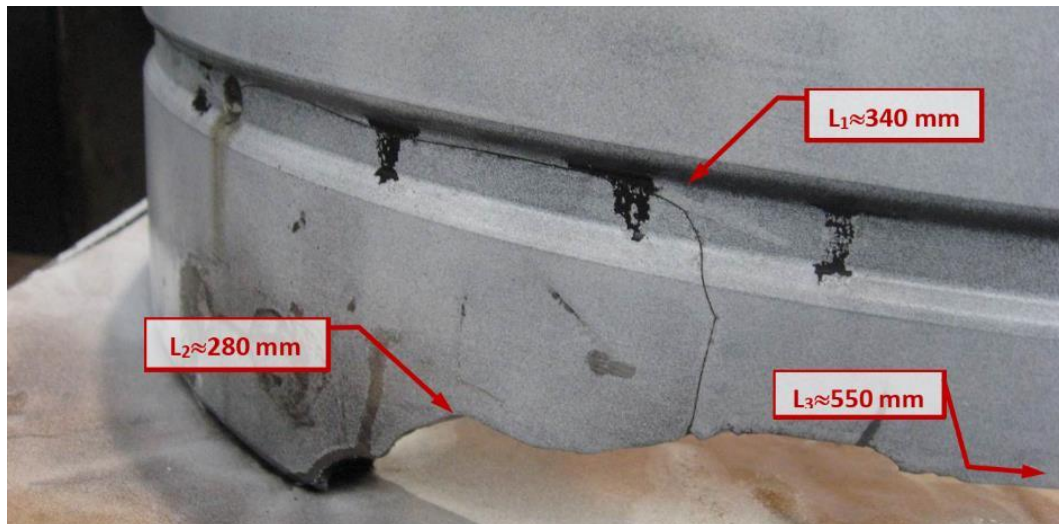
Based on the test results it was possible to determine the geometric form and the size of the crack on the outer ring of the bearing (Figure 12).

Figure 12. Size of material discontinuity.

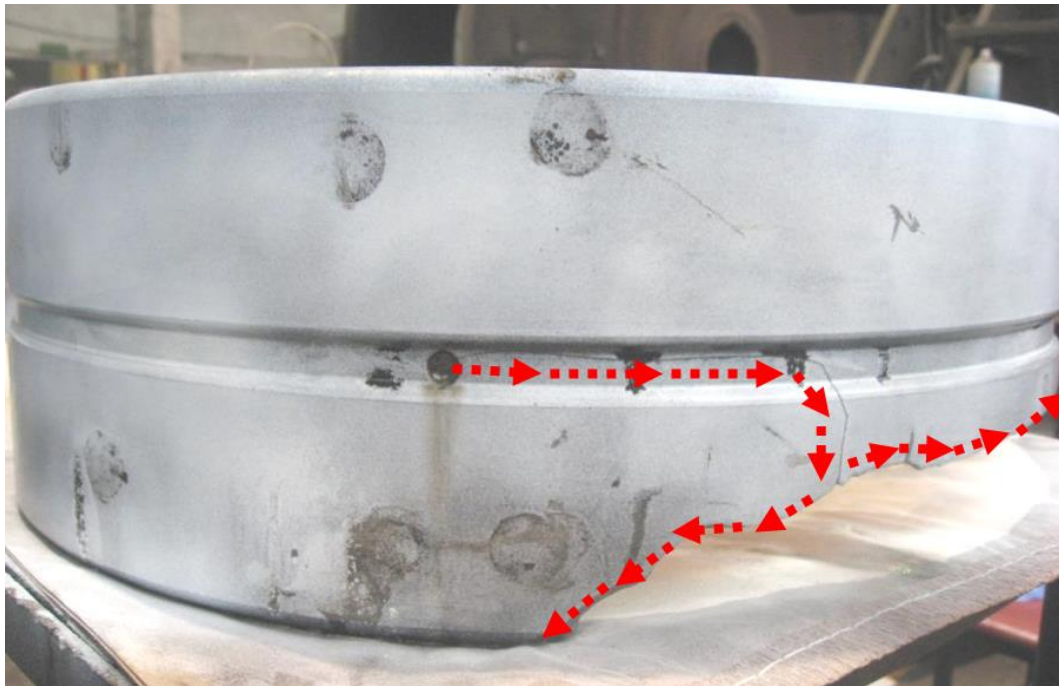
Non-destructive testing was the step in determining the cause of bearing damage. The test results identified damage in the form of a crack in the bearing's outer ring, material flaking and seizures of the inner raceway and fractures of its side surface. In addition, the visual inspection revealed the presence of fretting, which propagated during operation and became one of the main causes of damage to the rotary air preheater bearing. Fretting usually occurs when the fit is insufficient/too loose and there is relative motion between the bearing ring and housing. Relative motion is usually caused by shape inaccuracies or shaft deflection and causes small pieces of the material to split off from the surface of the seat in the housing. These pieces oxidize quickly upon contact with air. The corrosion on the outer ring (Figure 11) produces local shape imperfections on the surface of the bearing seat - the volume of iron oxide is larger than that of pure steel. The natively concave and convex bearing seat resulted in insufficient fit between the bearing ring and the seat surface along its width, which is why it deflected under load, resulting in a fatigue crack on the circumference of the ring raceway - the ring cracked at its weakest point, in the oil groove. The likely direction of propagation and the resulting loss of material integrity of the outer ring is shown in Figure 15.

Figure 15. Direction of crack propagation.
