Comprehensive Technical Inspection of a Medieval Bridge (Ponte de Vilanova, in Allariz) Using Microtechnological Tools

Abstract: Ponte de Vilanova, a masonry bridge, was built in Allariz, Galicia, in the 13th-14th centuries. It is still standing. The structure, generally well-preserved, shows minor deformations and wear signs caused by environmental factors. To conduct a comprehensive assessment without impacting the bridge's integrity, drones with thermal and underwater imaging technology were employed. Aerial inspections revealed vegetation growth and minor efflorescence (salt deposits) in some areas, while aerial thermography detected temperature variations along the stone joints, indicating moisture presence. The granite blocks comprising the bridge showed consistent quality and preservation. The underwater inspection confirmed that the bridge's piers are well-set on the riverbed, with no major damage observed, ruling out immediate repair needs. This approach allowed a thorough evaluation of submerged parts without requiring divers, enhancing safety and reducing costs.

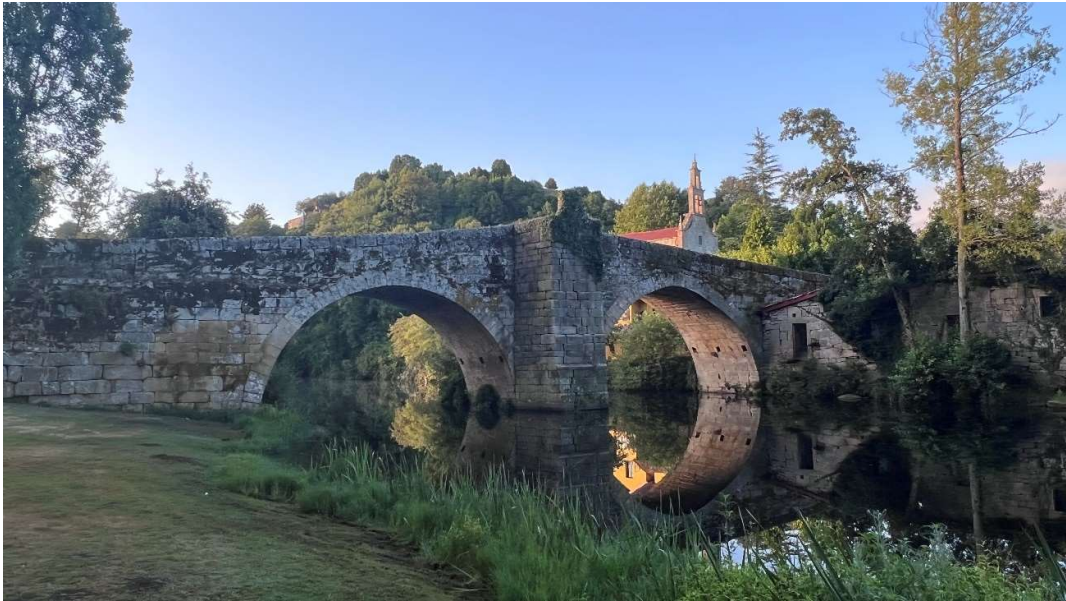
Figure 2. General view of the downstream elevation of the Vilanova Bridge (photo by the author).

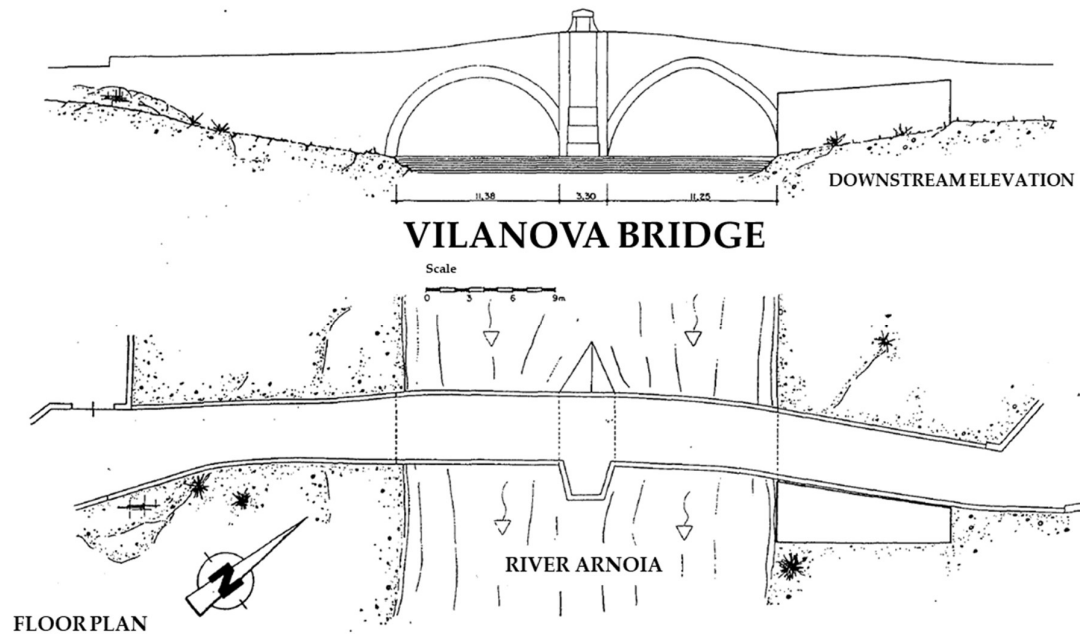
The bridge has two arches very close to the semicircular point. The spans of these arches are almost equal: 11.25 m and 11.38 m (Figure 4). The intermediate pier, the only pier the bridge has, has a pointed starling and a cutwater. The starling is on the downstream side and does not reach the level of the roadway (Figure 2). This starling is topped with a short pyramidal cap. Curiously, the cutwater does reach the level of the road (Figure 3), forming a siding. This siding over the breakwater has a trapezoidal shape when viewed in plan (Figure 4) and shows a pediment with an inscription and the coat of arms of Allariz [1,2]. The starling and the cutwater are not locked: they are attached to the bridge. This indicates that they were probably built during one of the repairs carried out on the bridge [1,3].

Figure 4. Floor plans and elevation of the Vilanova Bridge (diagram by author drawn on a plan by Alvarado, Duran and Nárdiz [3]).

The road has a useful width between parapets that varies between 3.80 and 4.40 meters (Figure 4).

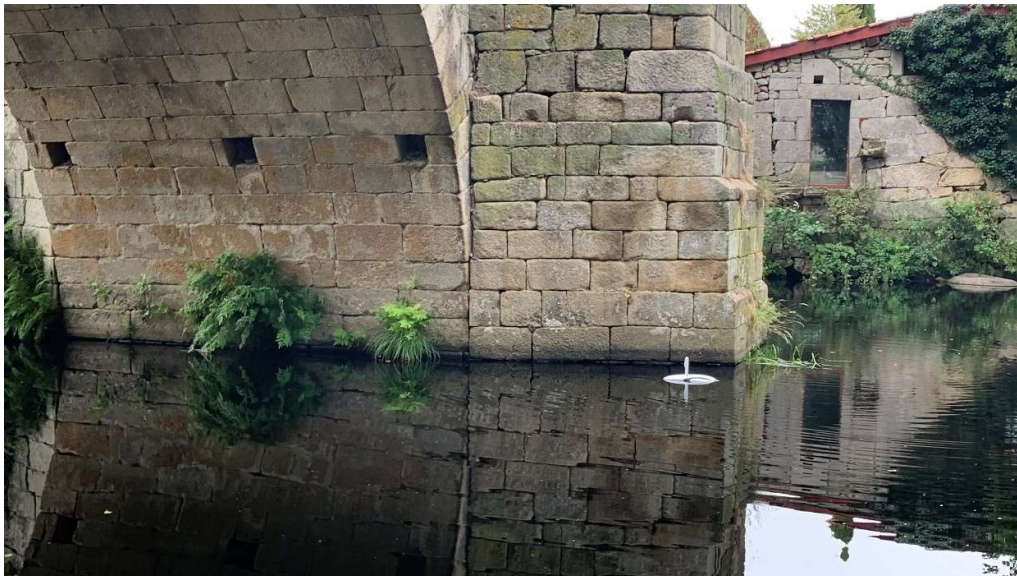
Figure 8. Underwater drone surrounding the central pier of the Vilanova Bridge from downstream/the west, inspecting the river bottom around the cutwater (photo by the author).
