# Risks Associated with Subsidence-Collapse of Sinkholes. A Case Study in the Town of Alcalá de Ebro (Zaragoza, Spain)

[Alberto Gracia](#)\*, [Francisco Javier Torrijo](#), Alberto Garcia, Alberto Boix

Keywords: collapse hazard; sinkhole mitigation; gypsum karst; Alcalá de Ebro; injections; geogrid; evaporitic rocks; topographic auscultation; results obtained

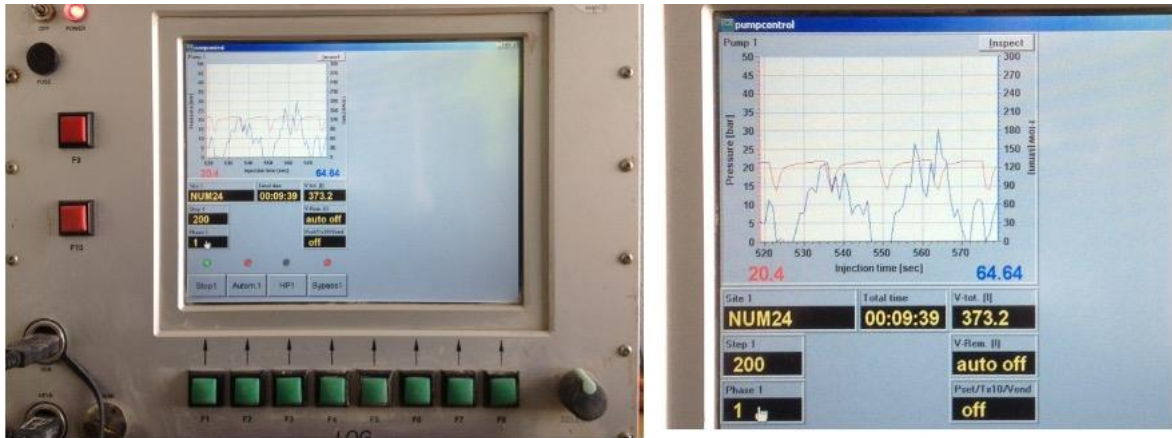
The working method has been controlled by a recording system in which, during the injection process, the volume and pressure reached in the manoeuvre can be recognized at each step (relative depth). The Figure 2 includes the monitor where the injection number (24), the relative depth (at -20 meters), the total volume injected (373.2 litres) and the pressures reached (up to 20.4 bars) are recognized.

Figure 2. Injection control equipment.

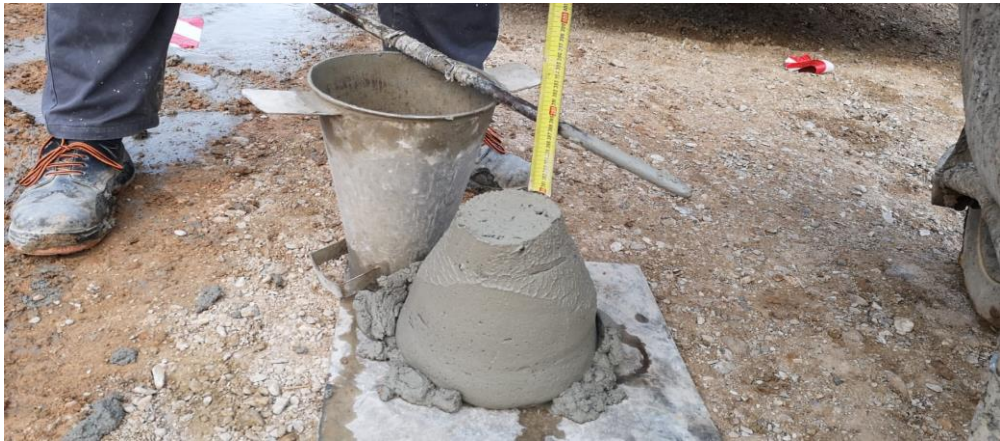
A rigorous control was carried out on the characteristics of the mortar. Specifically, its dosage to control its density and viscosity, with the intention that it remain in the environment of the application itself, generating semi-columnar structures. (Figure 3).

Figure 3. Control of the consistency of the mortar B.M. Abrams cone between 8 and 12 cm.
