Structural Performance of Exceptionally Slender Gothic Pillars: The Role of Marés Stone in Palma Cathedral

Rubén Rodríguez Elizalde *

Posted Date: 5 May 2025

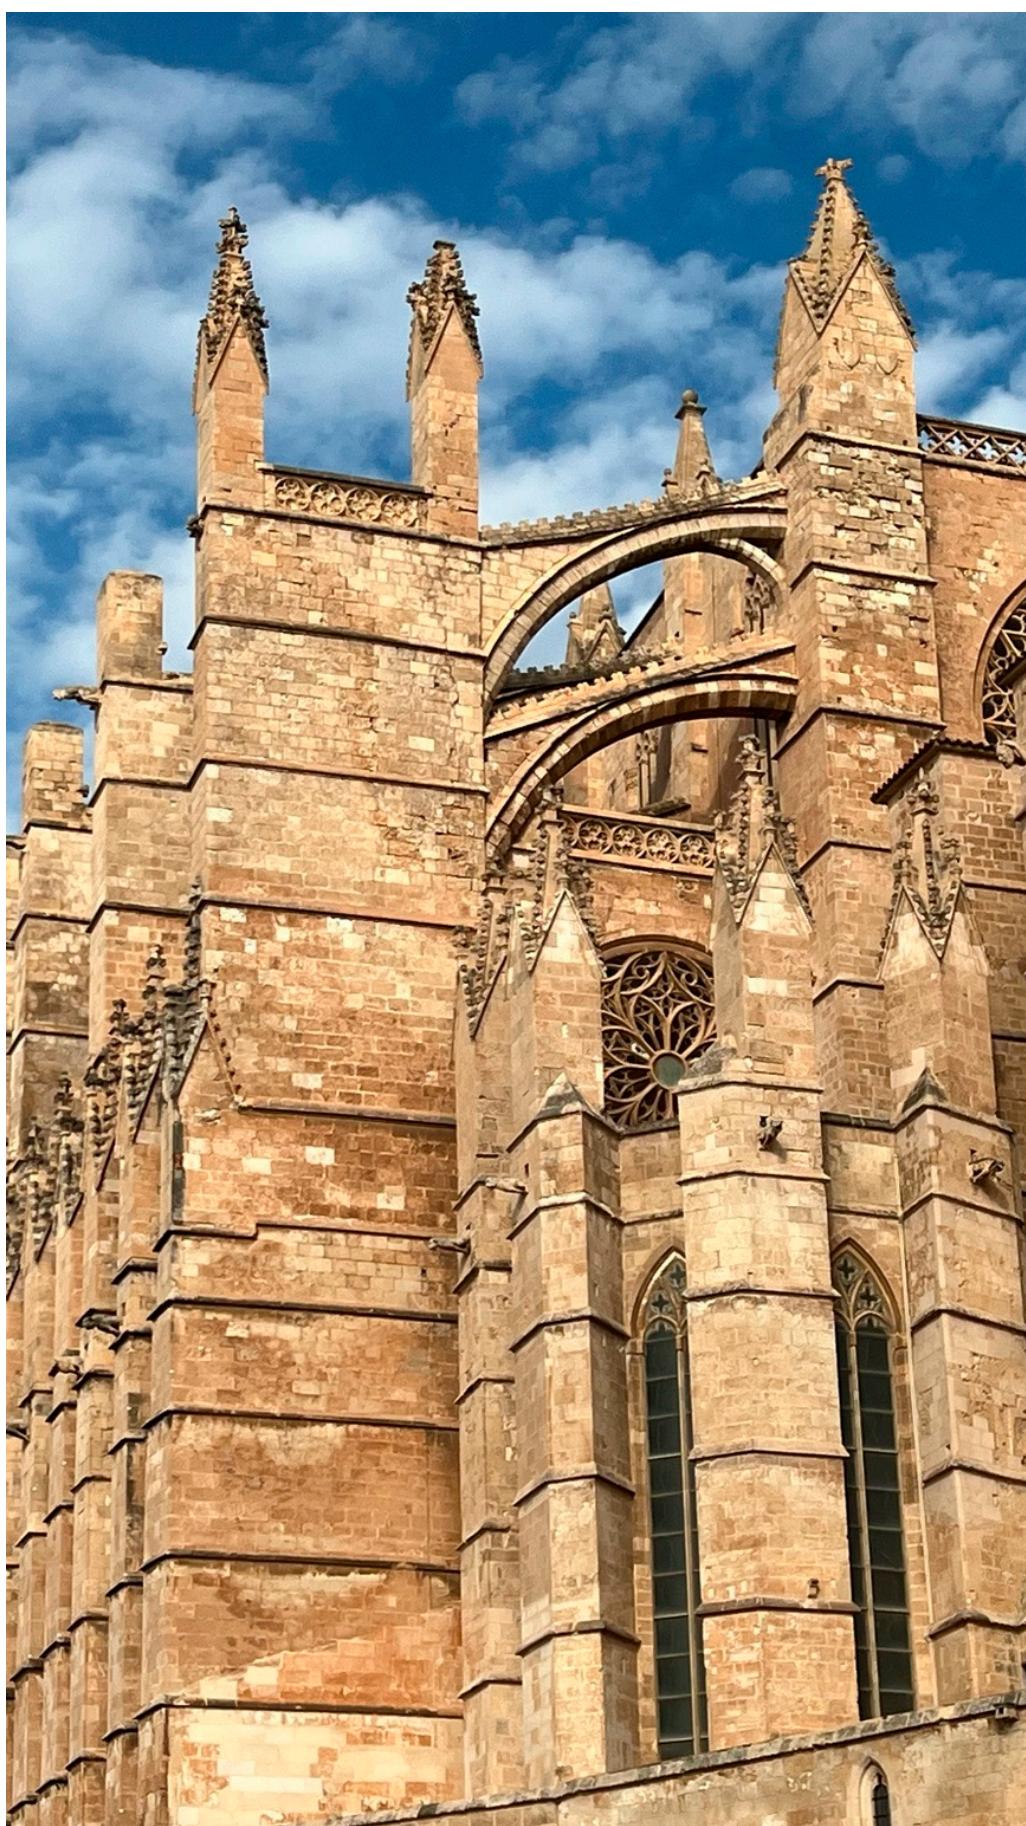
Figure 3 presents a detail of structural elements characteristic of Gothic architecture [15], all carved from marés stone. The image highlights the visual continuity of the material across structural and decorative components, as well as the chromatic variations associated [12] with differential aging processes.

Figure 3. Exterior detail view of Palma Cathedral showing buttresses, flying buttresses, and pinnacles constructed from marés stone (photograph by the author).

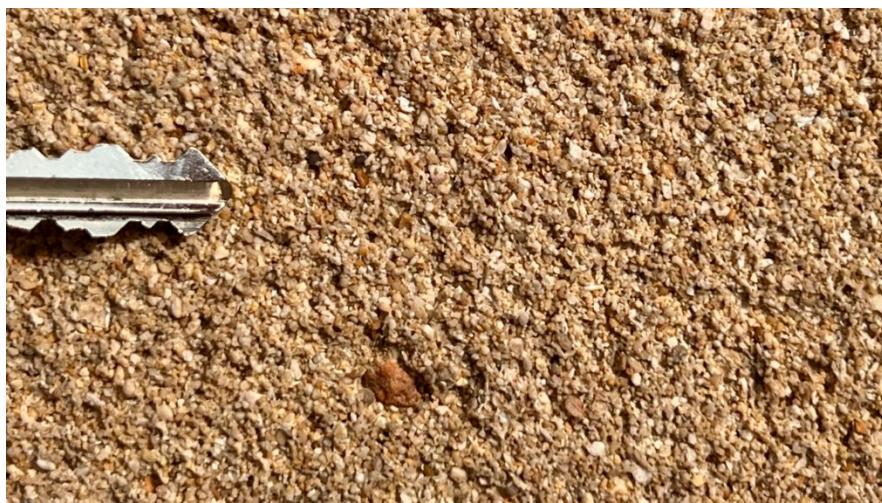
In situ observations identified several distinct textural types, both in original ashlar and in pieces that had been repaired or restored. Images obtained using a portable magnifying lens revealed wide intergranular voids, uncemented grain boundaries, and areas showing early signs of dissolution. In some cases, fine particle accumulation or incipient biological colonization was observed in the most open pores.

Figure 4. Detail of a marés sandstone sample showing its porous texture and granulometric variability. The key provides an approximate scale. The open structure is characteristic of marés sandstone from coastal quarries (photograph by the author).
