# Investigation and Identification of the Causes for the Unprecedented Accident at the "Chaira" Pumped Hydroelectric Energy Storage Plant

**Abstract:** The present study deals with an accident analysis of the "Chaira"- Bulgaria high pressure Pumped Hydroelectric Energy Storage (PHES), especially the failures of the Francis large scale Hydraulic Unit No. 4 (HU4). The causes of overloading and cracking of the stay vanes and their functionality are investigated. Despite many studies on the behavior of the runner and its safe operation the complete destruction of the system because of the stay vanes failure has not been sufficiently studied and published in the scientific literature. The aim is to assess the reasons that have led to this unprecedented accident of the "Chaira" PHES of total destructions of the stay vanes. Based on the historical data and the operating modes, as well as of the identification of the critical elements an objective assessment of the risks of damage of the stay vanes and of entire unit is proposed. A virtual prototype is built for simulation of the system behavior in working and emergency conditions. The loads, stresses and deformations are precisely calcul

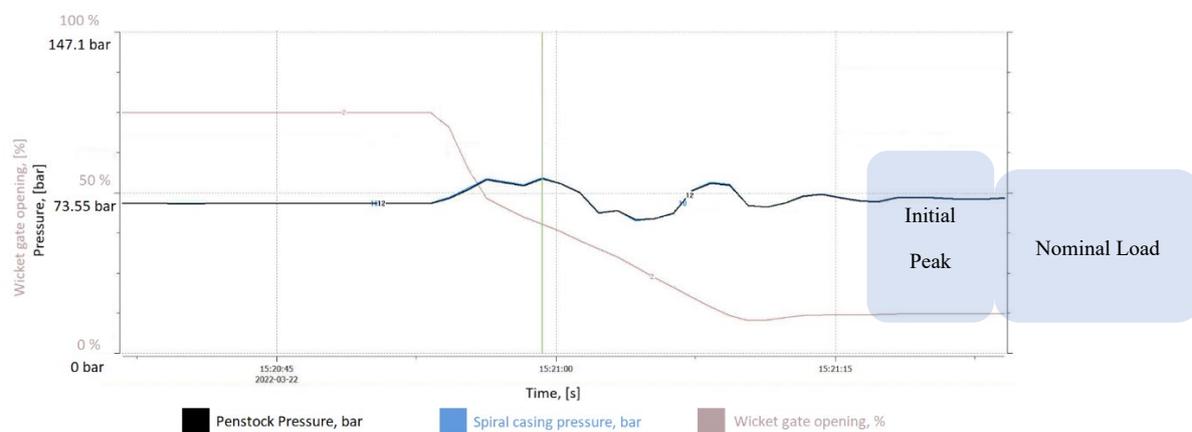
The data from the existing monitoring and control system were used to determine the pressure values at the inlet of the spiral casing in the generator mode and the pump mode. They are characterized by small peak loads in the transient modes. This is evident from the load diagram shown in Figure 6 which shows the pressure inside the penstock and the turbine spiral casing as well as the opening of the wicket gate at 75% load. Analysis of the data highlights five main modes:

- S1 – nominal generator mode;
- S2 – generator mode at peak in transient mode, pressures exceed by approximately 12%;
- S3 – pump nominal mode;
- S4 – pumped mode at peak in transient mode, the pressures exceed approximately 7% the nominal pressures for the pump mode;
- S5 – load rejection in generator mode.

**Figure 6.** Nominal and peak loads (a sample of the PHES sensors records).

An analysis of the charts provided by the Supervisory Control and Data Acquisition (SCADA) system was performed, and no significant "hydraulic shock" was detected as a result of the rapid closing of the wicket gate apparatus. All the parameters changes of the charts are within the permissible limits for cases of power load failure.

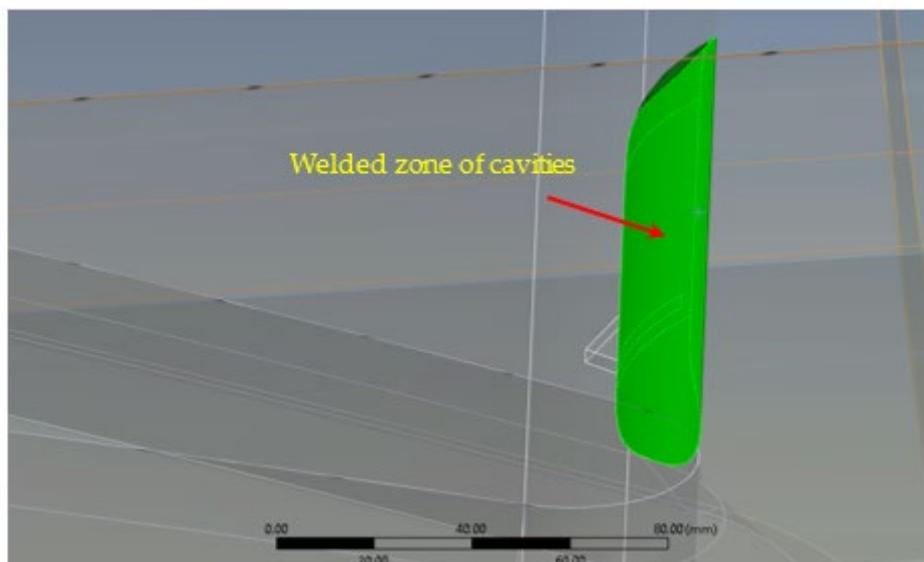
In Figure 9 the geometry model of a stay vane edge, including the welded cavity zone is shown.

**Figure 9.** Geometry model of a stay vane edge, including the welded cavity zone.

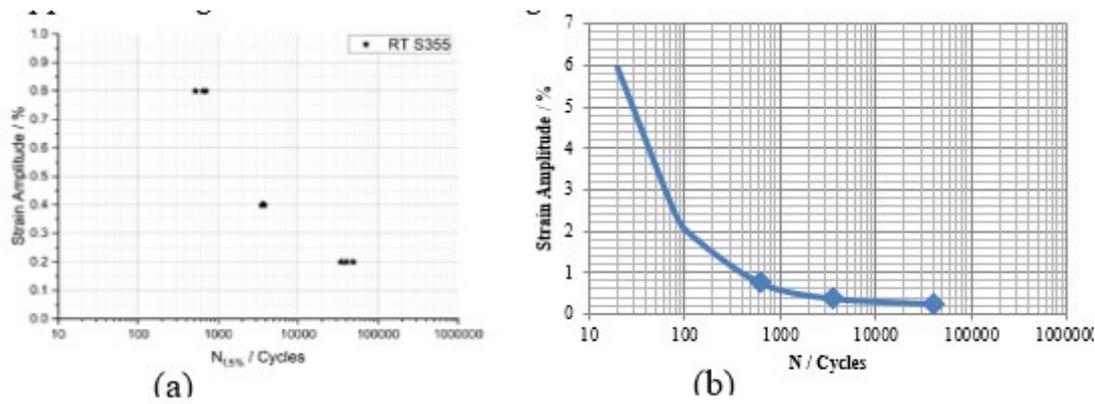
Additional data is needed on the fatigue properties of the materials, as the estimation of the fatigue and low-cycle fatigue requires the use of a dependence of the number of cycles on the deformation. The fatigue data of the materials (Figure 11, a) used in the construction of the virtual prototype was determined according to the information provided in the Materials Testing Institute University of Stuttgart, Report-No.: 904 2634 004 “Chaira” - Damage Case Unit 4, WP4: Strain-Controlled Fatigue Tests (LCF). The resulting fatigue curve is shown in Figure 11 (b). This curve is approximated by mathematical methods to the following function:

Figure 11. Fatigue data for the materials of the stay vanes: (a) measured fatigue data; (b) approximated curve.

The computational results indicate unequivocally that low-cycle fatigue of the material is expected to occur. This will lead to failure under cyclic loading at about 10,000 - 14,000 number of cycles that include: on Pump/Generator; off Pump/Generator; emergency stops. The fatigue curves of the materials in Figure 11 compared to the computational results confirms this conclusion.

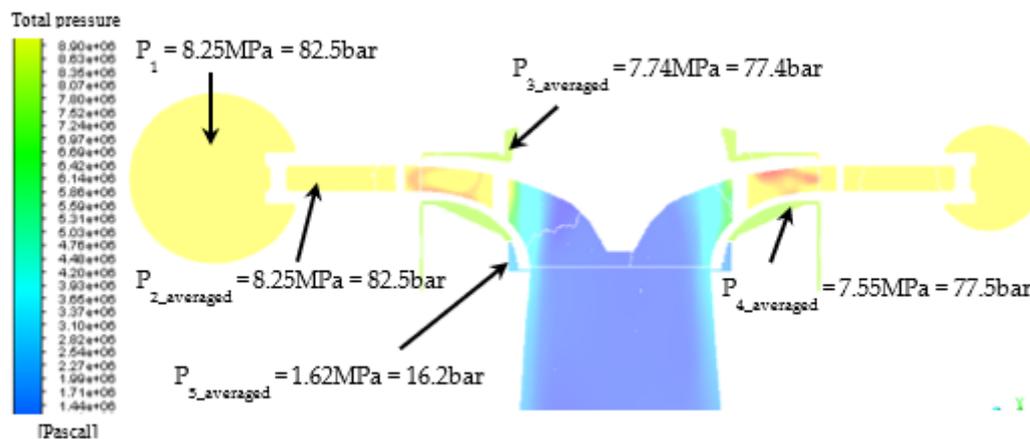
The numerical results for the total pressure for S5 mode, similarly to the S3 mode, the numerical values of the total pressure in the axial cross section of the spiral casing and the outlet tube are shown in Figure 18.

**Figure 18.** S5 – the numerical values of the total pressure in the axial cross section of the spiral casing and the outlet tube.
