# NDT Anatomy of the Medieval Masonry of the SAN Niccolò' Tower-Gate in Florence (Italy)

[Massimo Coli](#)<sup>\*</sup>, Anna Livia Ciuffreda, Costanza Stramaccioni, Giorgio Caselli, [Giorgio Lacanna](#), Emanuele Marchetti

Keywords: medieval; masonry; tower-gate; ndt; anatomy

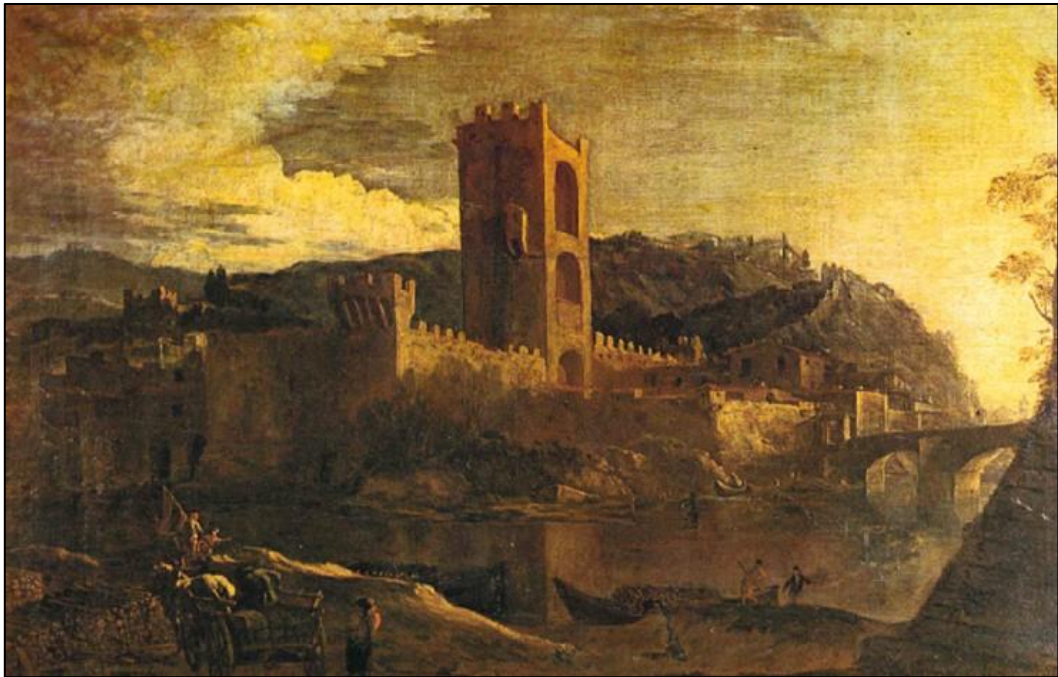
The availability in the geological database of the Firenze Municipality (<https://sigs.comune.fi.it/>) of 6 boreholes all around the site of the Tower and a historical painting (Figure 10) allowed to define that the Tower is directly founded onto the bedrock about 3 m at depth.

**Figure 10.** View of the Tower of San Niccolò in the XVII century (by *Livio Mehus*) in which the rock stratifications of Pietraforte on the banks of the Arno acting as foundation of the Tower are evident.

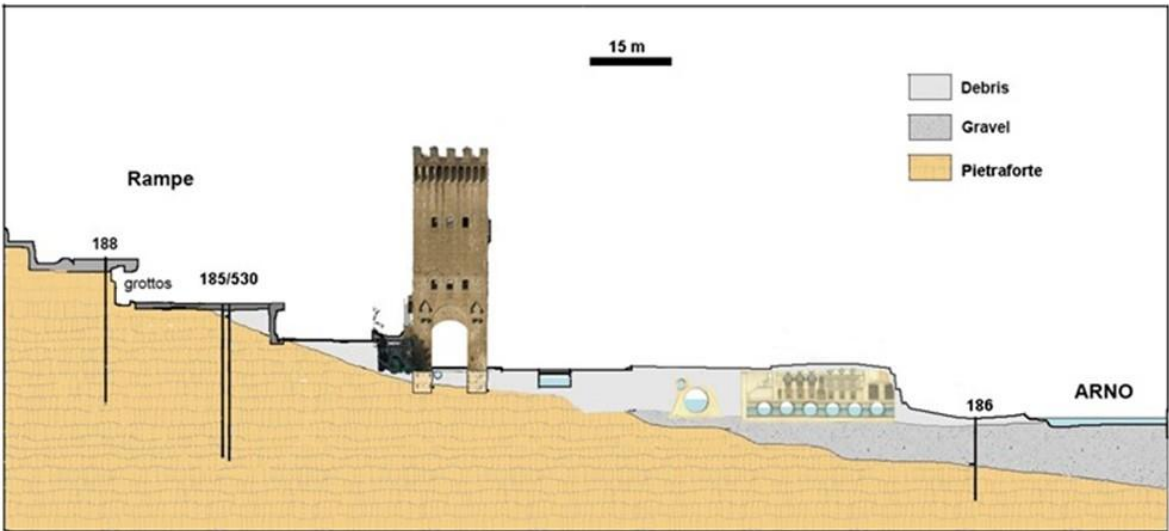
Field and boreholes data, matched with historical data of the Arno banks evolution, led to define the geological setting of the Tower slope (Figure 11).

**Figure 11.** Geological section of the area of the Torre di San Niccolò, also showing the reservoir for the Rampe waterfalls, the sewers and the structures of the old Water Factory.

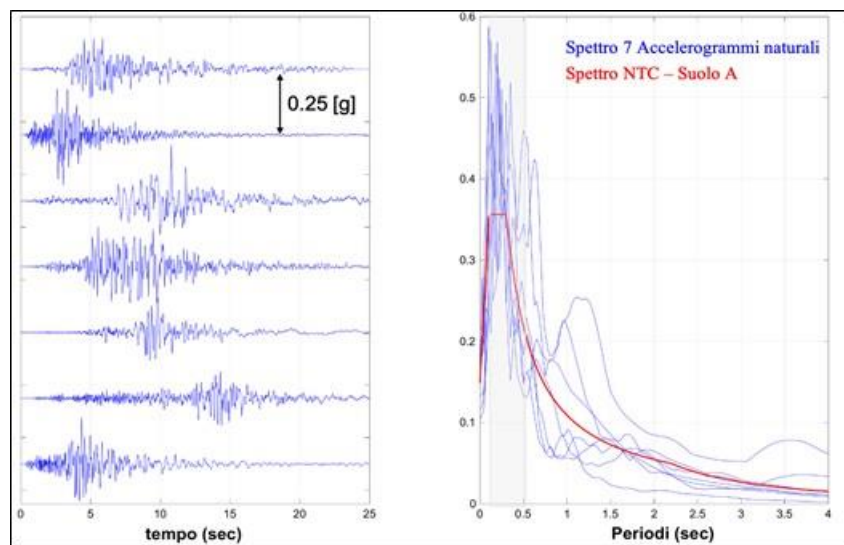
In the case history of the San Niccolò' Tower-Gate, foundations rest directly on a rigid substrate, therefore the input seismic signal for the seismic hazard assessment, as referred to a set of 7 natural accelerograms, recorded on rock and spectrocompatible for a return period of 712 years, as it is a historic-monumental building, gives a maximum acceleration equal to 0.57g; to be compared with the proper moment of the Tower (Figure 12).

**Figure 12.** Left: Set of the 7 accelerograms used for a return period of 712 years. Right: Elastic response spectra of the 7 accelerograms (blue) compared with the Italian elastic spectrum for foundation on rock (red); the structural period band of the San Niccolò Tower' is shown in grey.

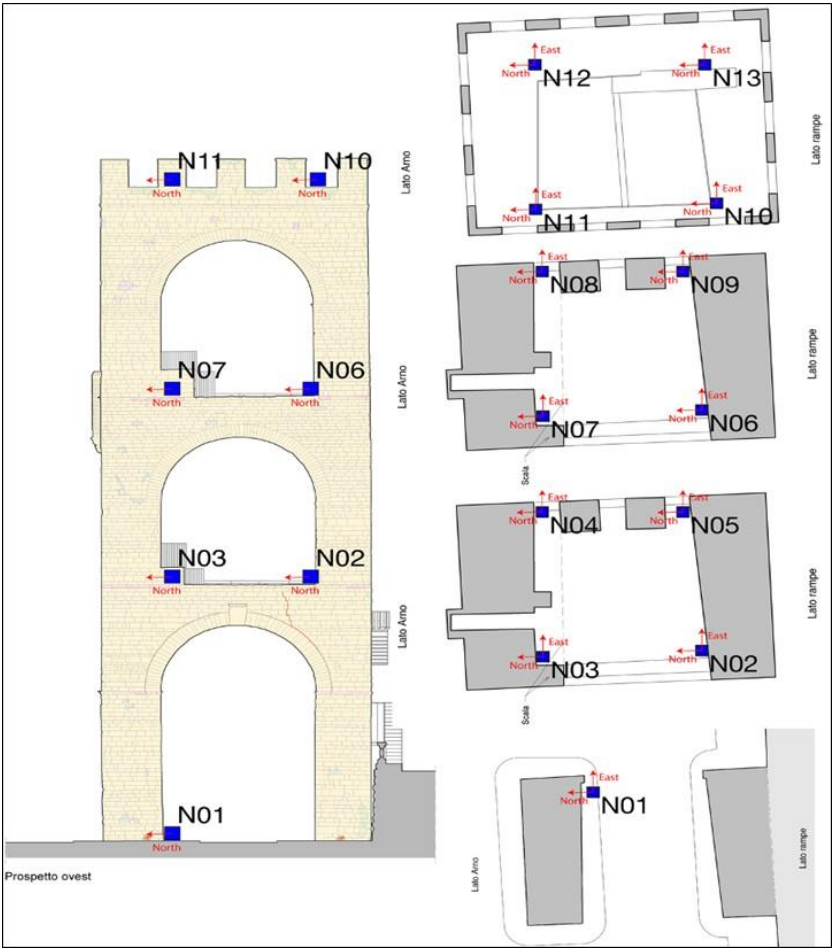
By means of a set of 13 seismometers located at different levels on the Tower (Figure 13) it has been possible, using ambient noise, to define the proper motion of the Tower.

**Figure 13.** Location of the 13 seismic stations installed on the Tower of San Niccolò, of which one sensor was placed at the base and 4 stations on each of the three levels.

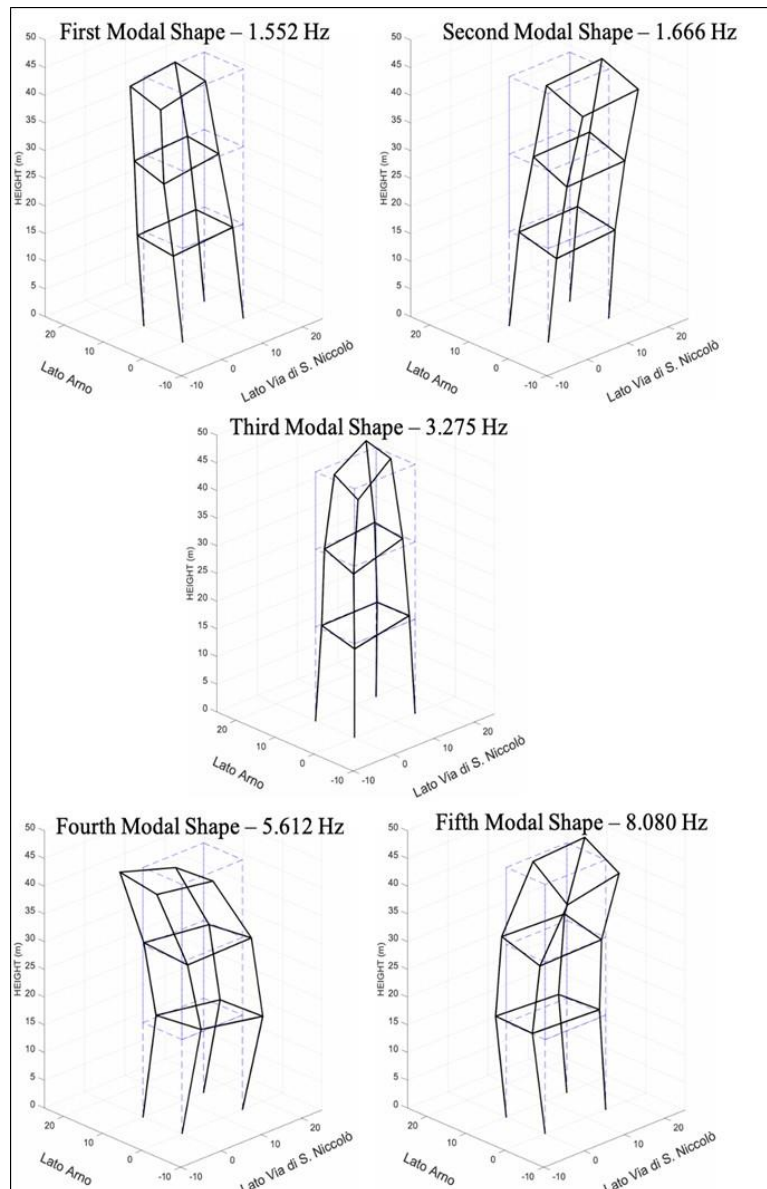
The results obtained clearly identify five modal shapes (Figure 14), with frequency peaks of 1.552 Hz, 1.666 Hz, 3.725 Hz, 5.612 Hz, and 8.080 Hz. The first two flexural modes being coupled and exhibiting a frequency difference of only 0.11 Hz. The first modal shape exhibits a north-south motion perpendicular to the second mode, which is primarily east-west. The third mode, at a frequency of 3.725 Hz, is torsional, while the fourth and fifth are flexural, with north-south and east-west motion directions, respectively.

**Figure 14.** Three-dimensional representation of the 5 modal deformations identified for the Tower of San Niccolò.
