# An Empirical Examination of the Adverse and Favorable Effects of Marine Environmental Conditions on the Durability of Optical-Fiber Submarine Cables

Yukitoshi Ogasawara

This study investigates the factors contributing to the degradation of spirally wound armored steel wires used to protect core-structured unarmored optical-fiber submarine cables, driven by coupled multi-factor corrosion mechanisms in marine environments. It also assesses the influence of physical properties of deep-sea sediments on the durability of unarmored cables. The objective is to establish a scientific basis for cable longevity by integrating theoretical insights with empirical evidence. Although the steel utilized in armor is cost-effective and durable, it remains vulnerable to corrosion. Since the inaugural practical deployment of submarine communication cables between the United Kingdom and France in the 1850s, only a limited number of studies worldwide have examined the armor's corrosion and durability. Furthermore, there is limited literature on the physical characteristics of deep-sea surface sediments that directly affect the service life of the mechanically fragile polyethylene sheath. An in-dept

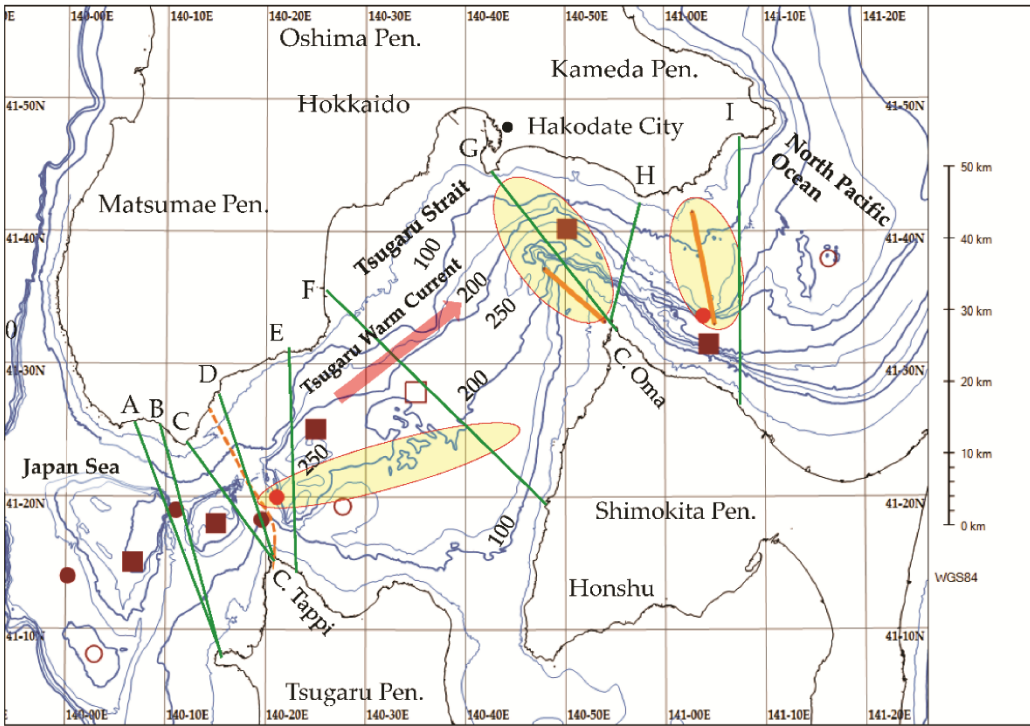
**Figure 10.** A comprehensive depiction of the Tsugaru Straits and its adjacent coastal region. Isobaths are shown as solid purple lines at 50-meter intervals, derived from digital bathymetry data (M7000 series) from the Hydrographic and Oceanographic Department of the Japan Coast Guard.

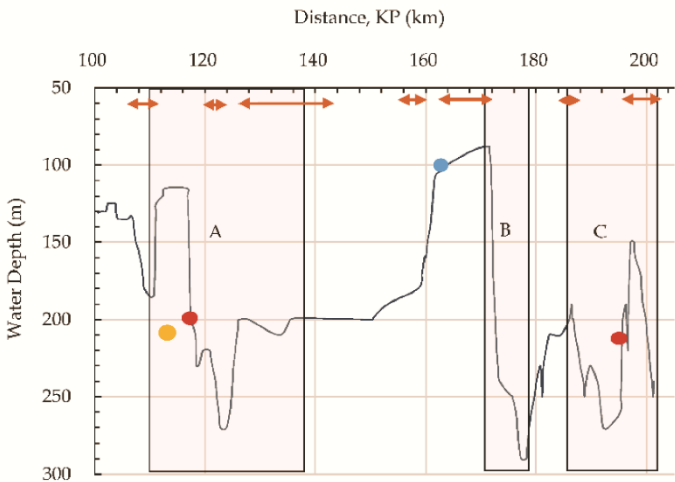
The east-west cable failure points were located within the Surface Lay area, where the cable is laid directly on the seabed. This occurred due to the steep slope and rocky seabed. On flat terrain, the cable-burying method achieved a burial rate of 52%. The failure locations coincide with regions of swift seawater flow, strongly influenced by seabed topography (see Figure 13; the nearest survey lines are E and I). Thus, rapid ocean currents and tidal streams are significant contributors to cable failure. Further analysis of these factors is presented in Section 5.

**Figure 11.** A cross-sectional depiction of the seabed along the planned route of the studied communication cable system. The regions shaded in light red (A, B, and C) signify areas of increased flow velocity. The red-filled circle designates the site of cable failure, while the orange-filled circle denotes the railway tunnel, as illustrated in Figure 10. Furthermore, the light-blue-filled circles indicate the locations where the submarine power cables intersect. The light-brown arrow points to the designated cable-burial area.

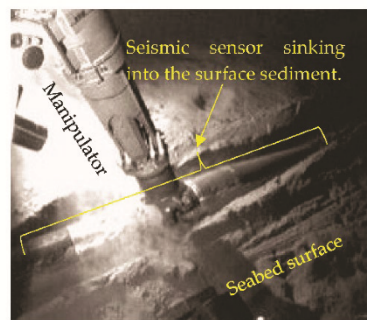
Figure 21 shows the seismic sensor installed on the seabed in the Amami Trough at a water depth of 1100 meters, north of Okinawa, Japan. Figure 22 presents its mechanical outline [29]. This example shows the seabed sediment thickness at the sensor site, which roughly matches the sensor’s outer diameter of 216 mm. Furthermore, observations of patina erosion on the surfaces of most pressure vessels of repeaters recovered from the deep-sea floor during cable maintenance suggest that the thickness of the sediments in the oceanic basin is approximately 20 cm.[23] Conversely, physical evidence indicates that sediments in the Kuril subduction zone are only 2–10 cm thick.

Figure 21. Observation of the installed seismic sensor on the seabed by an ROV.

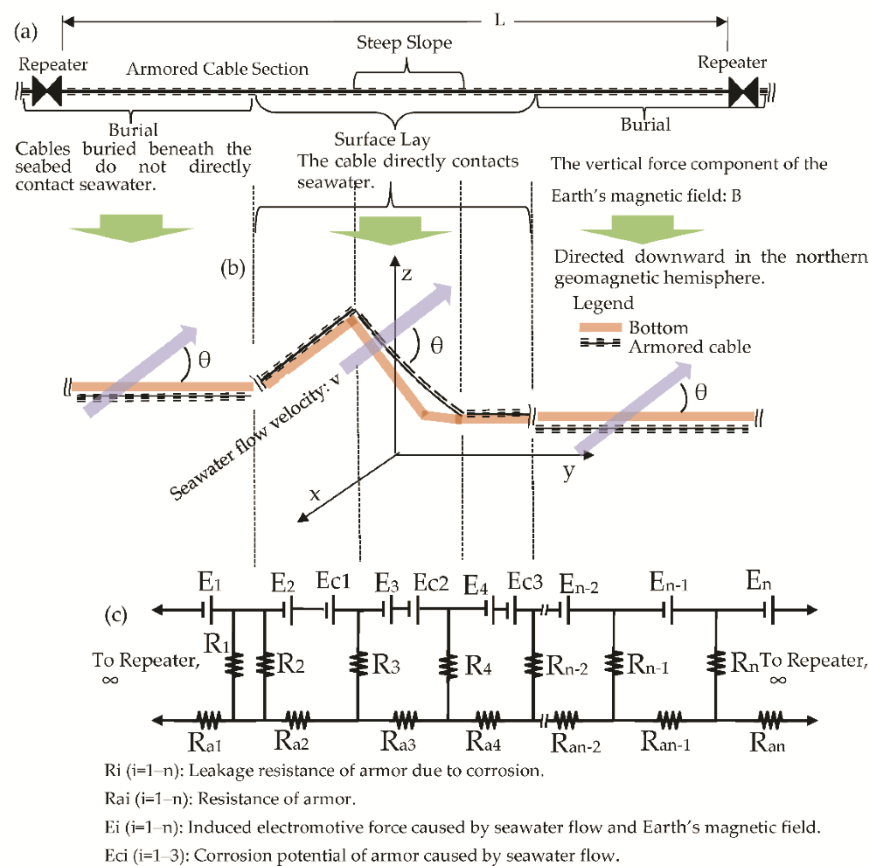
**Figure 33.** (a) Diagram of an armored cable section, (b) the cable installation including surface laying on a steep slope region, and (c) the equivalent circuit of armor between the repeaters.

The electromotive force, denoted as ( $E$ ), is generated throughout the armor of cable section between repeaters due to the interaction of seawater flow with Earth’s magnetic field’s vertical component—an effect explained by Faraday’s law of electromagnetic induction—and can be approximated using the following equation (6) [5].

Since the armor does not come into contact with dissolved oxygen in seawater due to being insulated by seabed soil,  $E_{ci} \approx 0$ . As a result, armor corrosion is significantly minimized. Consequently, the leakage resistances of armor  $R_1, R_{n-2}, R_{n-1}$ , and  $R_n$  are elevated. As a result, minimizing the corrosion current in each circuit. This analysis shows that leakage resistance is a key factor in the progression of corrosion.

Electromotive forces,  $E_i$ , resulting from seawater flow and the Earth’s magnetic field, and the corrosion potential,  $E_{ci}$ , caused by seawater flow, are induced in the armor. Furthermore, R2, R3, and R4 are approximately zero due to armor corrosion, resulting in short circuits. Furthermore, the persistent flow of corrosion current through each circuit accelerates the corrosion process.

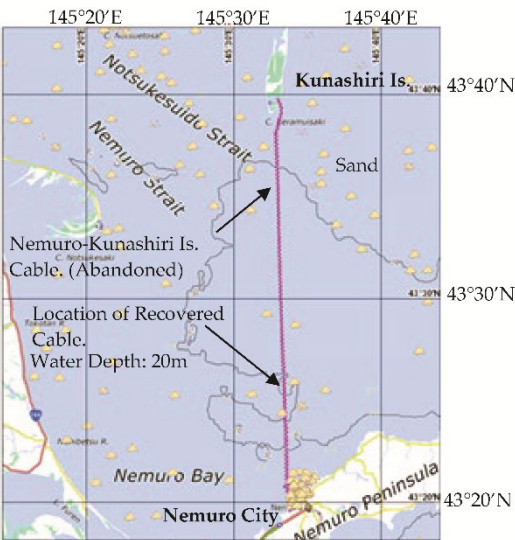
Figure 34. Route of the Abandoned Nemuro-Kunashiri Island cable [15].  
Approximate location: see to Figure 9.

The cable has a 55 mm diameter, and the armor consists of 14 steel wires, each 5 mm in diameter. Rust covers the entire surface of the armor due to corrosion. There is no evidence of mechanical wear or erosion corrosion. This is because the seawater flow velocity near Nemuro Strait, where the submarine cable in Figure 34 is located, remains below 0.5 knots year-round [42]. The seabed is flat and sandy. This suggests that the submerged cable’s weight will bury almost all of it. The gentle seawater flow likely allowed corrosive materials to accumulate on exposed armor sections, or it minimized corrosion from oxygen concentration cells. In both cases, the progression of corrosion was significantly slowed.

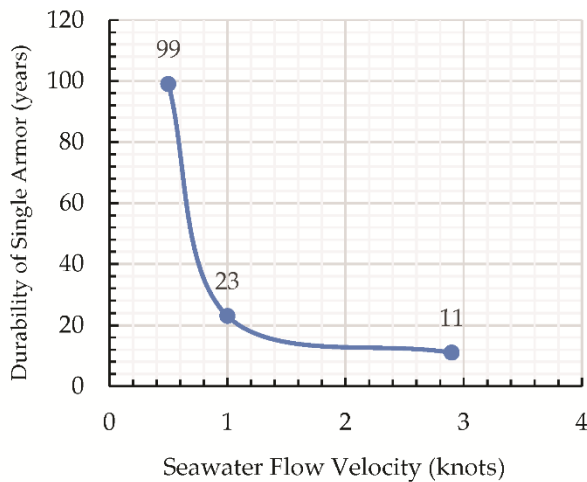
Upon analyzing armor thinning due to corrosion across three cases in the marine environment, as discussed in Sections 3, 5.4, and 5.7, it was determined that the seawater flow velocity substantially affects long-term durability. Figure 36 illustrates the relationship between the velocity of seawater flow and armor durability, as verified above. In the future, increasing the sample size will enable more accurate performance charts.

**Figure 36.** Long-term durability of single armor against seawater flow velocities, based on verification results.

components that constitute the system and does not consider environmental factors. It is challenging to forecast the external forces—such as natural disasters or industrial activities—that may influence cable failures. Based on this, when applying the ITU standard for designed lifetime to the SAM cable exposed on the seabed and considering environmental factors, it is recommended that the seawater flow velocity should be approximately 1.0 knots or less, as illustrated in Figure 36.
