# Catastrophic Failure Analysis of a Wind Turbine Gearbox by Finite Element Method and Fracture Analysis

Posted Date: 27 September 2024

Keywords: Renewable energy; wind turbine; gearbox; catastrophic failure; fatigue

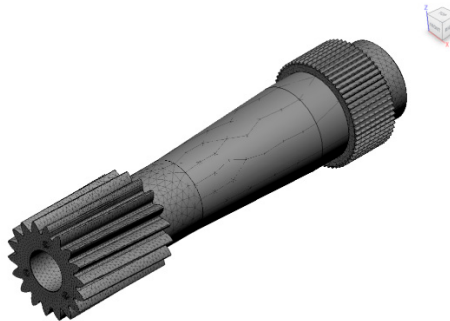
**Figure 3.** Sun shaft – first stage planet.

Figures 4 and 5 show the von Mises stresses throughout the sun shaft. The highest stress was found in the contact area of the teeth, reaching a maximum of 1,474.536 MPa.
