# Early 20th-Century Mortars from Teatro Nacional de São João (Porto, Portugal): Characterization of Degradation Mechanisms

Posted Date: 5 February 2026

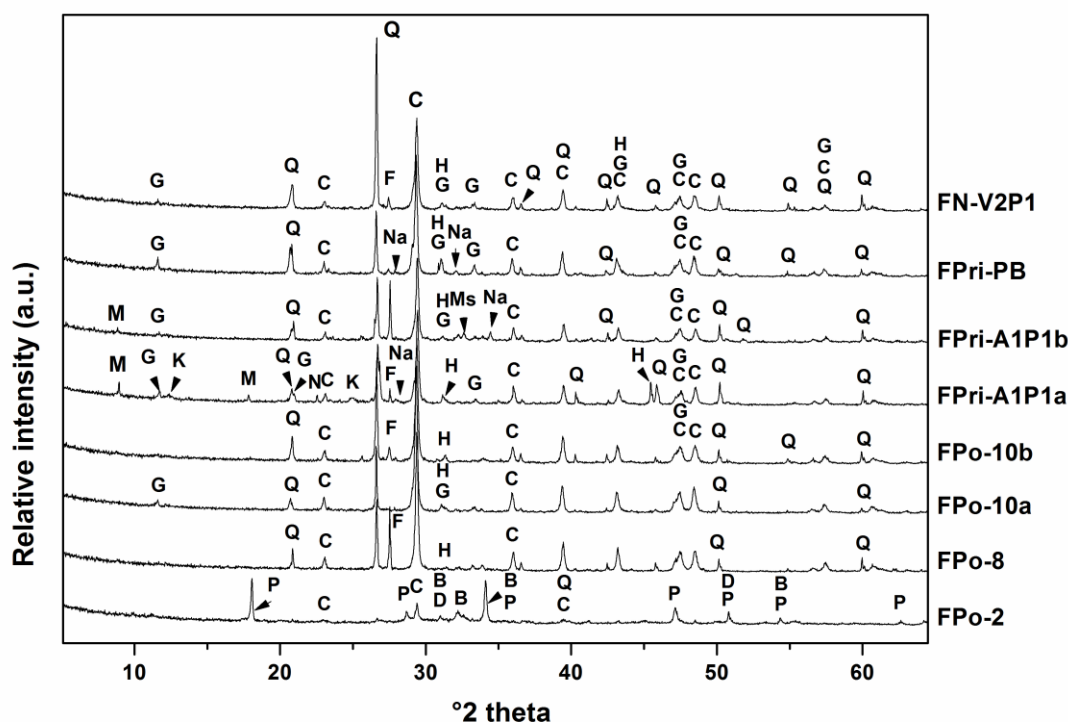
X-Ray diffraction analysis (XRD) analysis provided an insight on mineralogical composition of individual mortars (Figure 3). XRD patterns show that calcite and quartz are dominant minerals in all the samples with exception of FPo-2 mortar. Gypsum and feldspars are present in the most of the cases (FN-V2P1, FPri-PB, FPri-A1P1a, FPri-A1P1b, FPo-10a) and (FN-V2P1, FPri-PB, FPri-A1P1a, FPri-A1P1b, FPo-10b, FPo-8, respectively), while mica is identified only in case of FPri-A1P1a and FPri-A1P1b mortars and magnesite in FPri-A1P1b (Figure 3). All the samples (besides FPo-2) display the presence of halite (NaCl). Other soluble salts such as nahcolite (NaHCO<sub>3</sub>) and natron (Na<sub>2</sub>CO<sub>3</sub>·10H<sub>2</sub>O) were identified, nahcolite in the samples FPri-A1P1a,b and FPri-PB, all from the northern façade, and natron was present in FPri-A1P1a mortar. The presence of salts, sometimes quite meaningful, reveals that mortars were relatively altered from their original composition. The occurrence of natron and nahcolite is usually related to their formation in concrete or mortars under the action of sodium carbonates [15]. Current studies have revealed that the action of sodium carbonate usually results in salt crystallization inside voids in the mortar matrix, while the action of

sulphates may be more destructive, often promoting concrete delamination [15]. The presence of kaolinite in FPri-A1P1a, due to the alteration of feldspars, may be another indicator of the high degree of alteration of these mortars or simply a result of use of sand with incorporation of kaolin (Figure 3). Moreover, related to the differences between FPo-10a and FPo-10b and FPri-A1P1a and FPri-A1P1b mortars, it is noticeable that the mortars differ in their “a, b” subgroups exclusively only in the intensities of the peaks of the admixtures. Lower occurrence of gypsum in case of FPri-10b and mica, kaolinite, gypsum and natron in case of FPri-A1P1b mortar is confirmed, compared to FPri-10a and FPri-A1P1a mortars, respectively, as expected due to their distinct exposure.

**Figure 3.** XRD patterns of the studied mortars. (B-belite, C-calcite, D-dolomite, F-feldspar, G-gypsum, H-halite, K-kaolinite, M-mica, Ms-magnesianite, N-nantron, Na-nahcolite, P-portlandite, Q-quartz).

FPo-2 mortar reveals a clearly different mineralogical composition compared to the rest of the mortars, proving a dissimilar origin of this sample. The main crystalline phase in FPo-2 is portlandite, which partially carbonated into the calcite form. Other identified admixtures include quartz, dolomite and belite ( $C_2S$ ). This mortar does not contain any soluble salts (Figure 3). Existence of portlandite and  $C_2S$  and absence of soluble salts in FPo-2 confirms that this mortar was applied during the former intervention rather than during the initial building phase. Although, solely from XRD results the type of binder used remains unclear, XRD reveals similarities and distinctions between mortars and clearly identifies salts present in these samples.

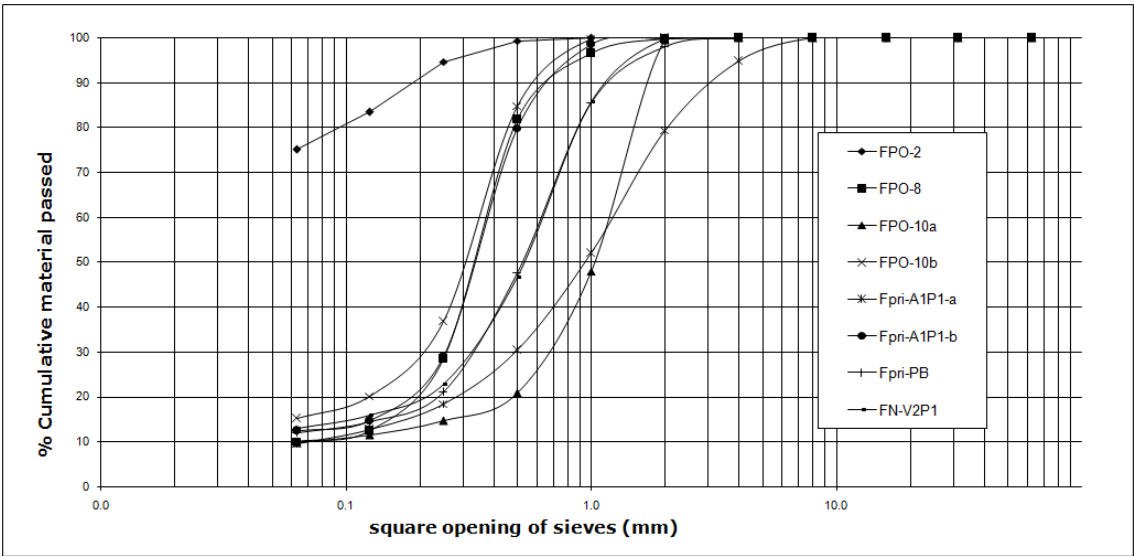
- 1) samples FPO-8, FPO-10b and FPri-A1P1b with finer particles,
- 2) samples FPri-PB and FN-V2P1 with larger particles,
- 3) samples FPO-10a and FPri-A1P1a, with distinct particle size distribution compared to the rest of samples. FPri-A1P1a mortar is the one with coarsest particle size (Figure 4).

Figure 4. Particle size distribution of mortars aggregates.

A similar sand, with distinct particle size distribution was used for the remaining mortars. Considering particle size distribution, the same aggregate was used in the composition of mortars FPo-10b and FPri-A1P1b and FPo-8. The same conclusion may be applied to samples FPri-PB and FN-V2P1 (Figure 4).

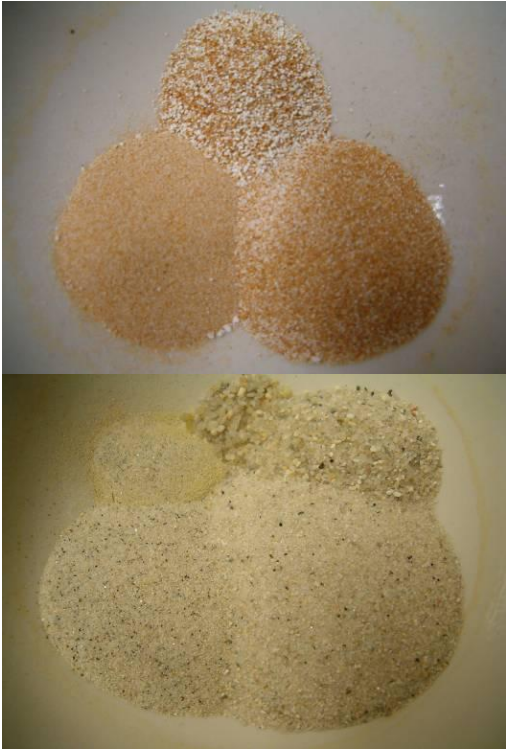
Fig 5a- FPO2,5b- FPO8

**Figure 5.** Insoluble fraction of individual mortars obtained after acid dissolution (a) FPo-2, b) FPo-8, c) FPo-10a, d) FPo-10b, e) FPri-A1P1a, f) FPri-A1P1b, g) FPri-PB, h) FN-V2P1.

Distinct character of FPo-2 is noticeable also in the fineness and color of its aggregate, composed of fine brownish sand in comparison to the river sand aggregate used in the other mortars.

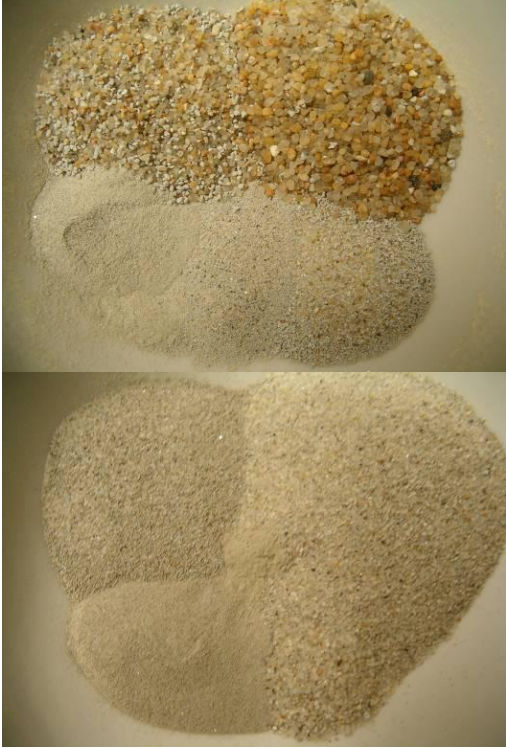
Fig 5c- FPO10a, 5d – FPO10b

From the obtained results and coupling with XRD data, it is possible that FPri-A1P1a and FPriA1P1b mortars together with FPo-10a and FPo-10b were prepared and used at the same period, with the specific aim of fulfilling two layers, as the basis of aggregate of individual set is the same accompanied by coarser grains (Figure 5).

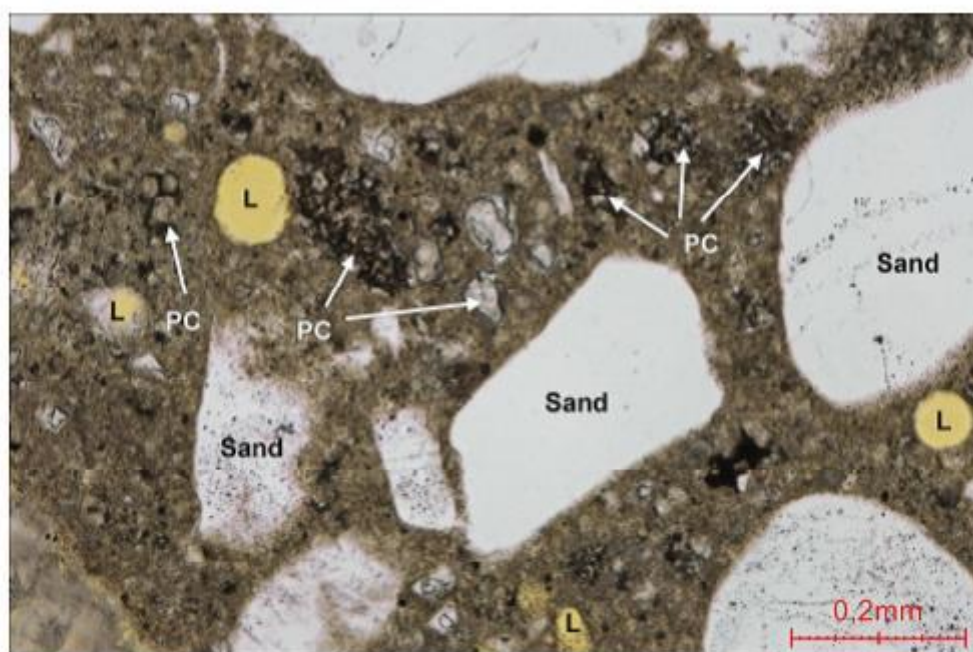
Optical microscopy revealed clear evidence of cement grains, composed by alite ( $C_3S$ ), belite ( $C_2S$ ) and ferrite ( $C_4AF$ ) as displayed in Figure 6, confirming that this binder was actually used in the mortars of Teatro Nacional de S. João facades.

**Figure 6.** Thin section of FPo-10 mortar. (PC- cement, L-lime) [18].
