Critical Failures in Aviation Components: The Role of Hydrogen Embrittlement

Kadir Kaan Karaveli ^{1,2}, Mete Kalaycioglu ¹, Burak Bal ² and Tamer Saracayakupoglu ^{1,*}

¹ Turkish Aerospace Industries, 06980 Ankara, Türkiye; kadirkaan.karaveli@tai.com.tr (K.K.K.); kalayciolu@yahoo.com (M.K.)

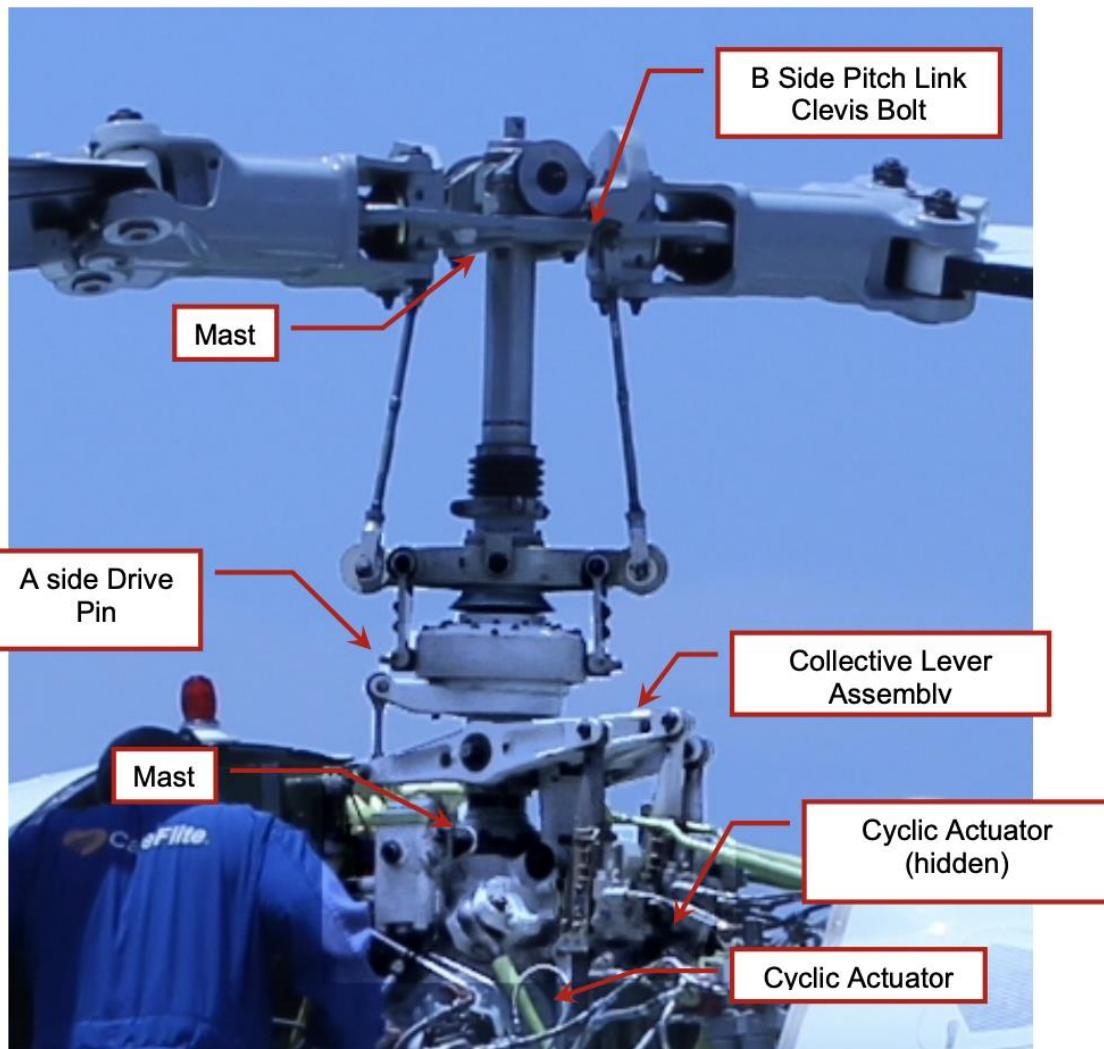
Prior to the incident, the rotor components of the helicopter were reported as fully operational. **Figure 9** shows the rotor head assembly of the Bell 222U helicopter before the accident, with key components such as the A-side drive pin, B-side pitch link, and cyclic actuators clearly labeled.

Figure 9. Image showing the rotor head of the Bell 222U helicopter before the accident, with critical components identified [65].
