# Drones as a Tool for the Sustainable Conservation of Heritage Metal Structures

The Requejo Bridge, also known as the Pino Bridge, is an impressive engineering work that spans the Duero River. The bridge is located in the province of Zamora, Spain (Figure 1), with its exact position defined by the following coordinates:

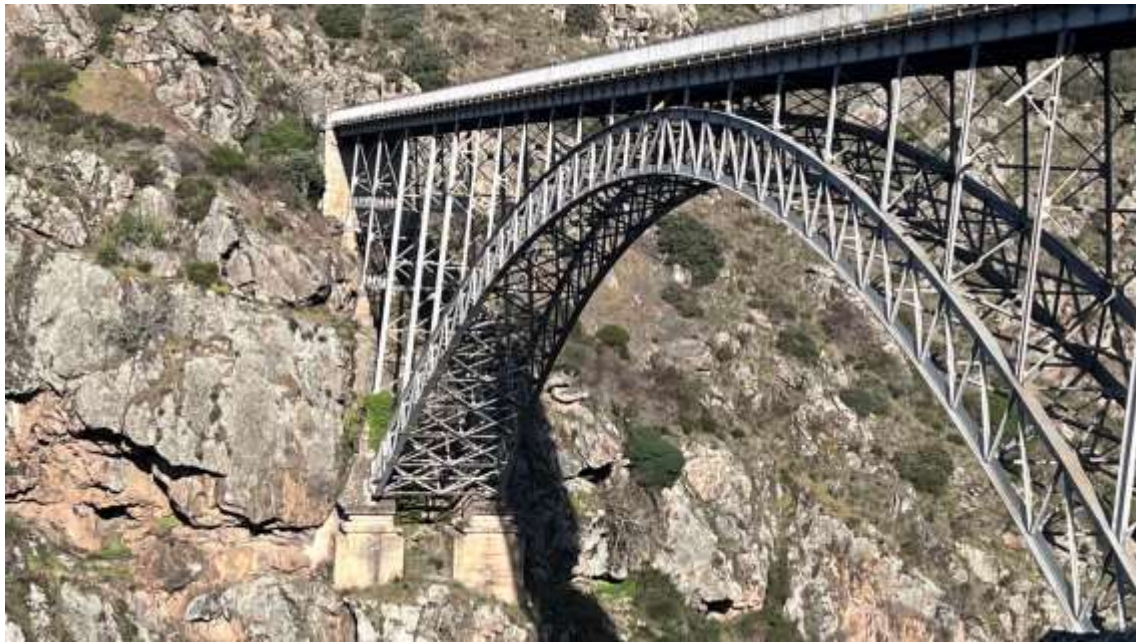
**Figure 7.** Partial view of the bridge from the southern side (upstream side), showing the main arch and, in the background, the second abutment with its corresponding support trestles (photograph by the author, taken with a drone).

Stains produced by the discharge of water and other liquids through the drainpipes were also observed. At the time of the visit, these pipes were not long enough to discharge water away from the arch (a pipe can be seen in the center of the arch in Figure 7 and Figure 17).

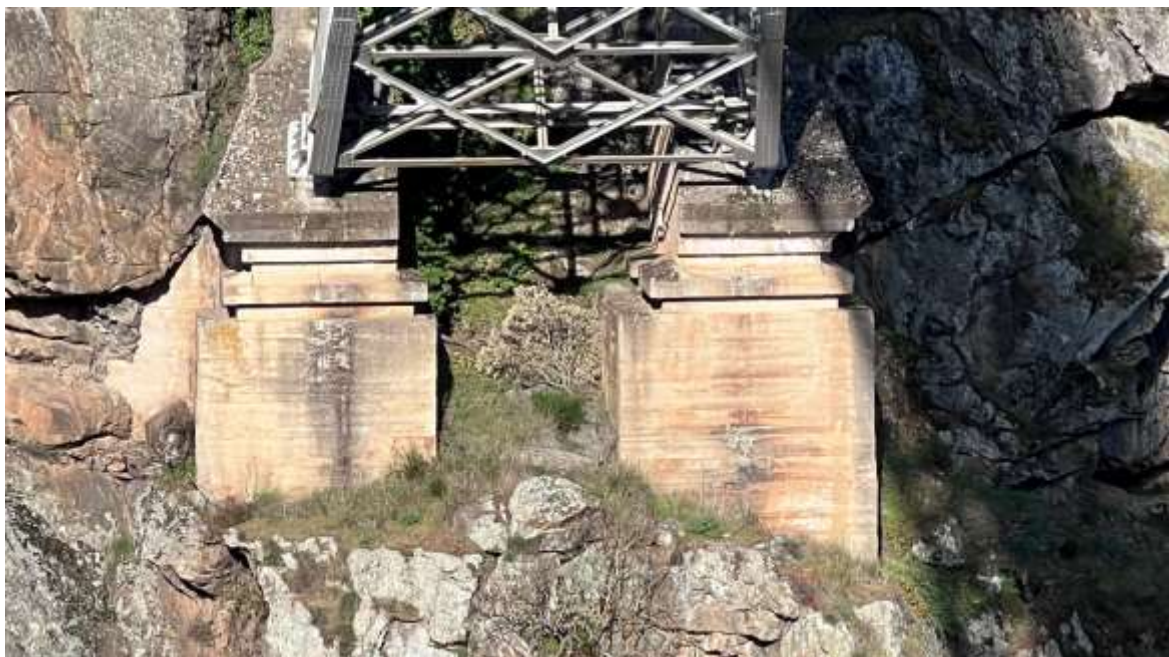
**Figure 8.** Arch supports on direct concrete foundations near the second abutment (photograph by the author, taken with a drone).

Previous observations (Figure 8) had already indicated that, despite its century-old age, the concrete foundation elements presented a generally acceptable state of conservation, showing slight deterioration related to the material's durability, particularly due to runoff water. The action of runoff water was also the primary pathology observed on the abutment walls, where stains associated with moisture caused by the continuous process of surface runoff sliding down the wall face were detected (Figure 12).

The hinged bearings of the arch displayed an excellent state of conservation, both in terms of the joints and the anchorages. Meanwhile, the roller bearings on the deck exhibited corrosion on the bearing plates, although the rollers themselves showed no significant deterioration, aside from slight corrosion on the body of some of them.

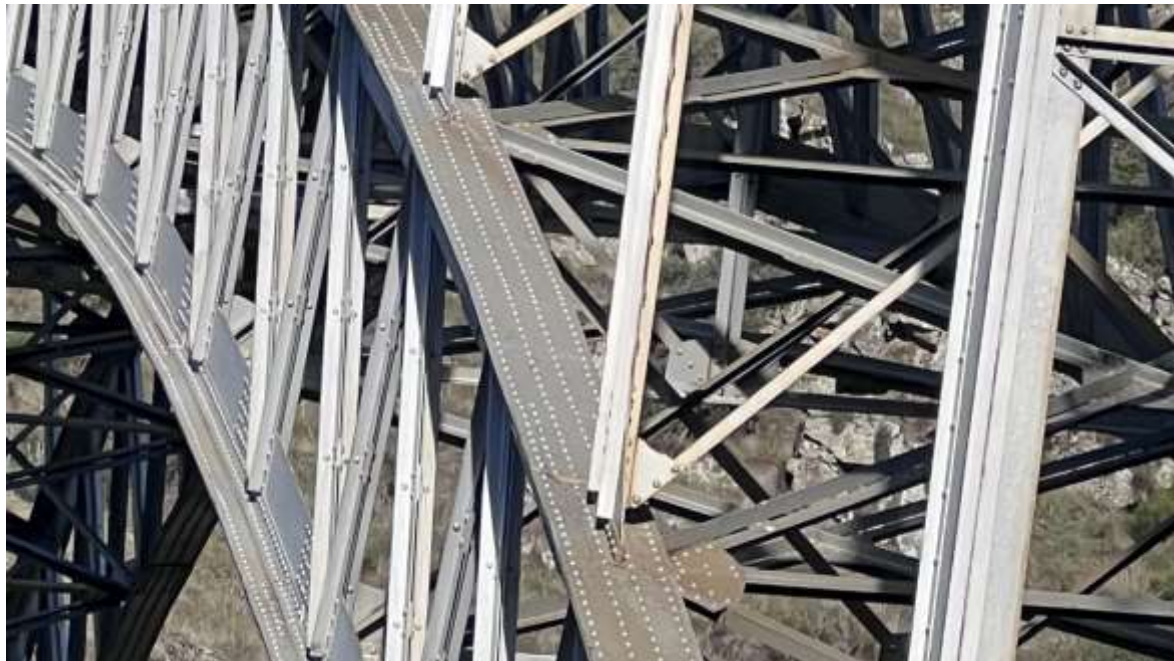
**Figure 9.** Examples of upright supports on the arch, using gusset plates fastened with bolts, on the upstream side (photograph by the author, taken with a drone).
