Hydrogen Embrittlement in Aviation Components: An Incident Based Overview and Analysis

4.1. Failure of the Bell 412EP Helicopter (ERA10TA493)

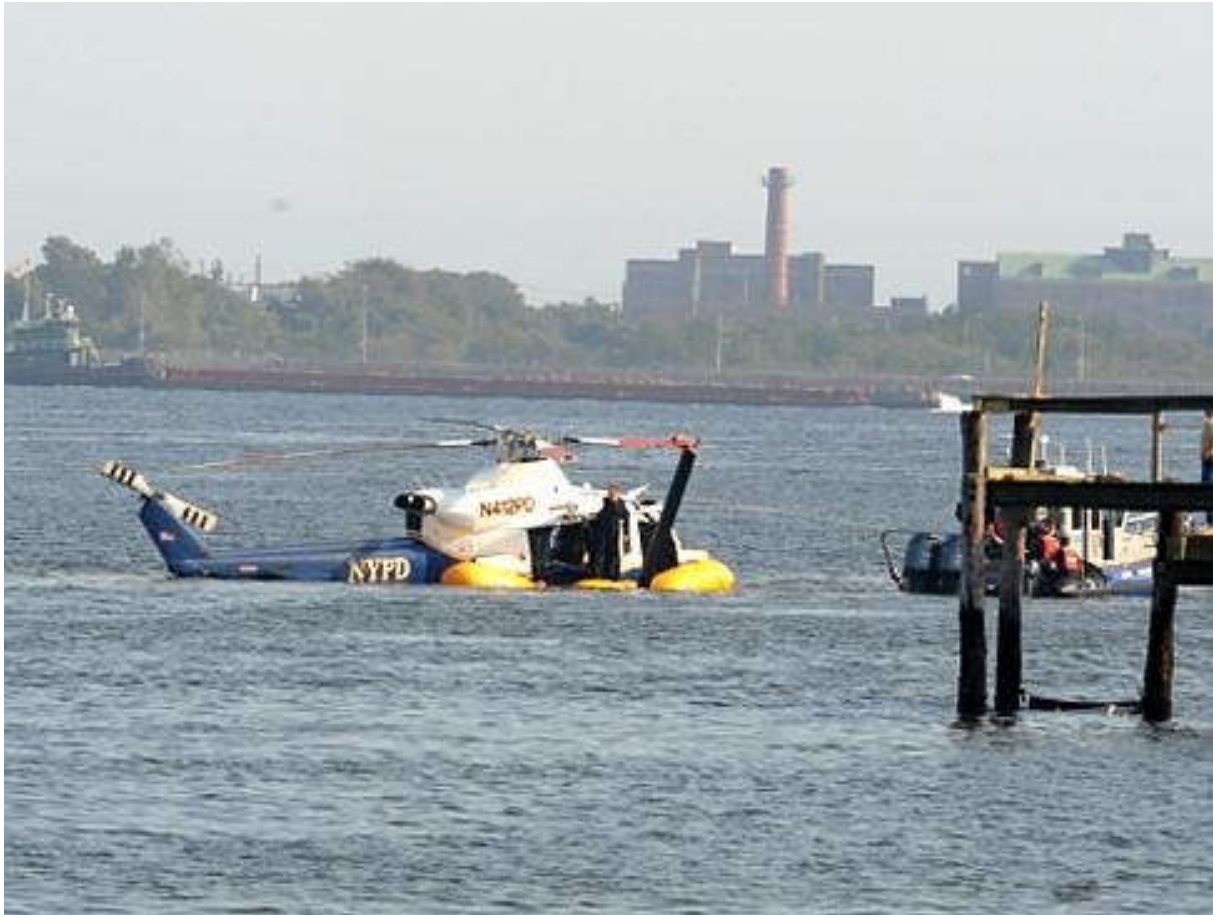
On September 22, 2010, a Bell 412EP helicopter, operated by the New York City Police Aviation Unit, was involved in a critical incident during its final approach to Floyd Bennett Field in Brooklyn, New York. The helicopter, carrying six crew members, experienced a sudden mechanical failure, forcing an emergency autorotation landing into Jamaica Bay. While all occupants sustained only minor injuries, the helicopter itself suffered significant damage, particularly to its powerplant system. As seen in Figure 1, the helicopter's flotation devices deployed upon impact with the water, allowing it to remain afloat and preventing it from sinking, despite the substantial damage it sustained.

Figure 1. The Bell 412EP helicopter resting in Jamaica Bay after the emergency landing.

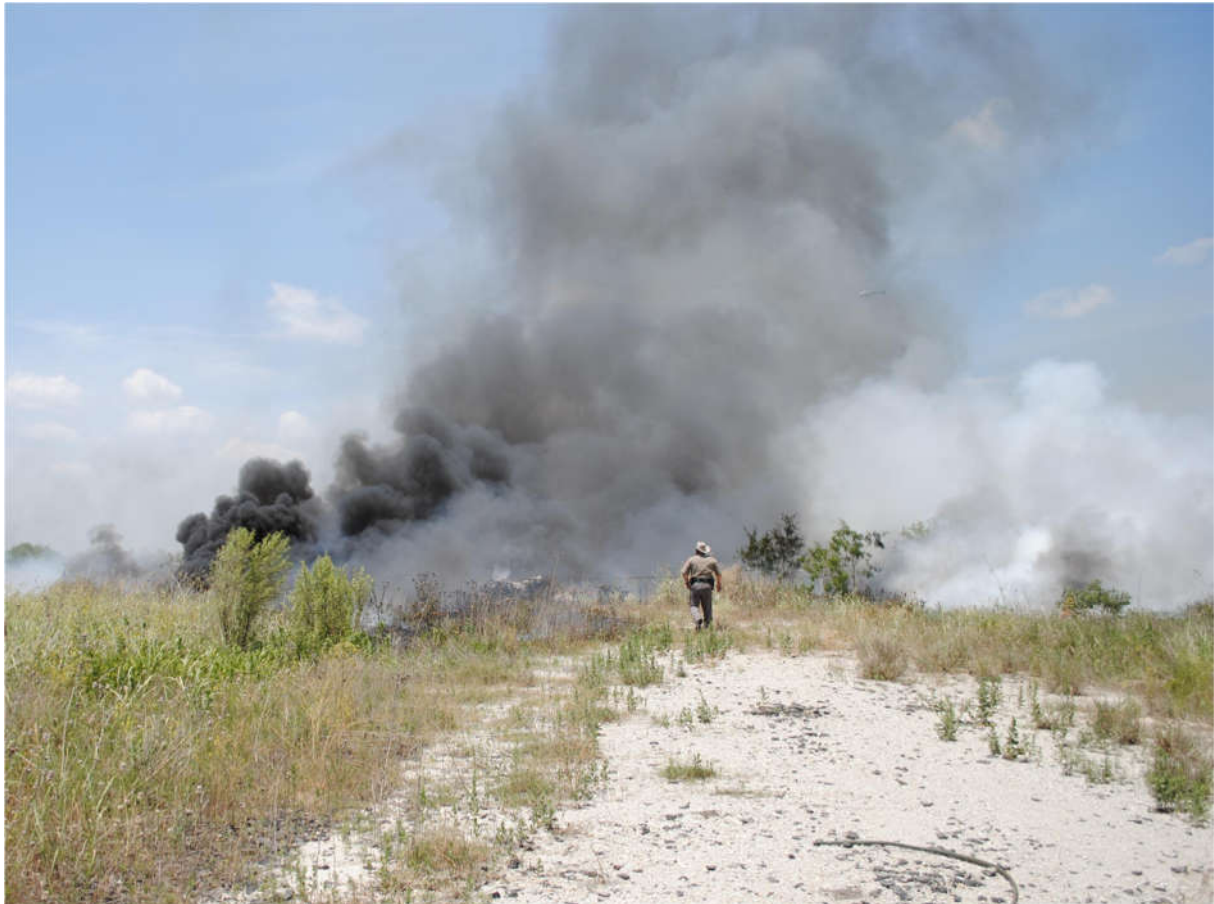
On June 2, 2010, a Bell 222U helicopter, operated by CareFlite, experienced a catastrophic in-flight breakup during a post-maintenance flight near Midlothian, Texas. The helicopter, piloted by an airline transport pilot and accompanied by a mechanic, encountered structural failure that led to the separation of critical components, including the tail boom and main rotor hub. Witnesses reported seeing debris falling from the helicopter before it collided with the ground and erupted into flames, tragically killing both crew members. Figure 4 shows the wreckage and first responders on the scene, as captured by the Midlothian Fire Department.

Figure 4. Photo of first responders on-scene after the Bell 222U crash, with visible black smoke and the main wreckage (Courtesy: Midlothian Fire Department).

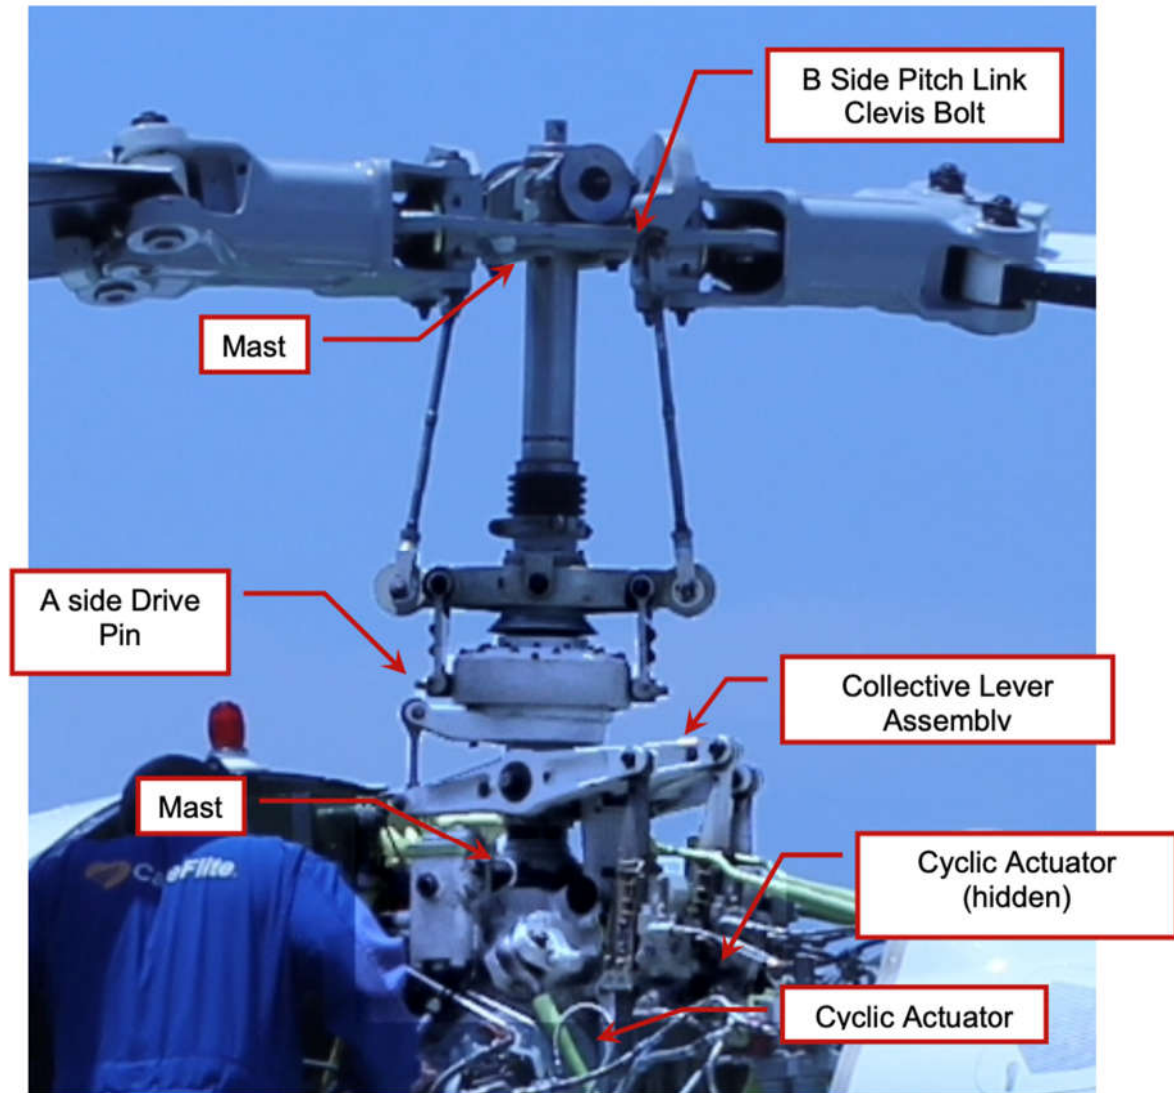
Before the incident, the rotor components of the helicopter were intact and fully operational. Figure 5 shows the rotor head of the Bell 222U helicopter before the accident, highlighting key components such as the A-side drive pin, the B-side pitch link, and the cyclic actuators.

Figure 5. Image showing the rotor head of the Bell 222U helicopter before the accident, with critical components identified.

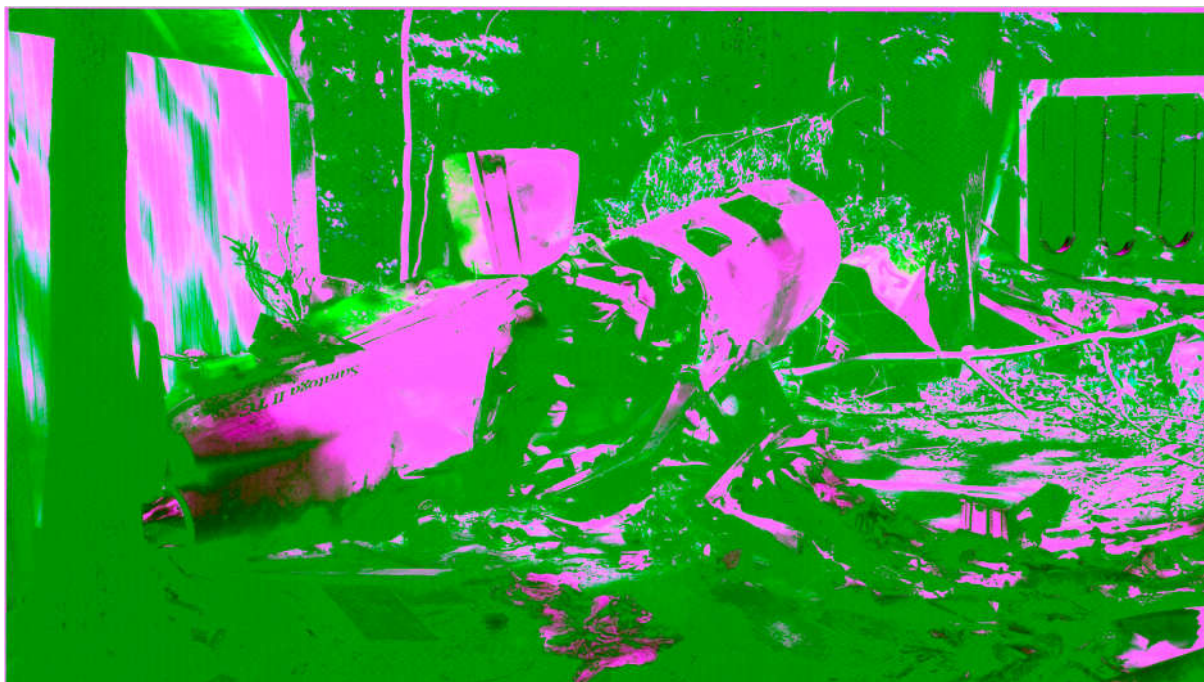
On September 8, 2002, a Piper PA-32R-301T (registration C-GKLY) suffered a catastrophic engine failure while cruising at 3,500 feet above Byram Township, New Jersey. The aircraft, operated by a private pilot, experienced a total loss of engine power due to the failure of the crankshaft gear retaining bolt. The failure led to a forced landing in wooded terrain, where the aircraft was destroyed on impact, killing the pilot and one passenger and seriously injuring two other passengers. Witnesses reported the aircraft maneuvering low over the trees before descending into the forest. Figure 10 shows the crash site, with first responders on the scene following the incident.

Figure 10. Photo of first responders at the crash site of the Piper PA-32R-301T, showing wreckage and the fire that followed the forced landing (Byram Township Fire Department).

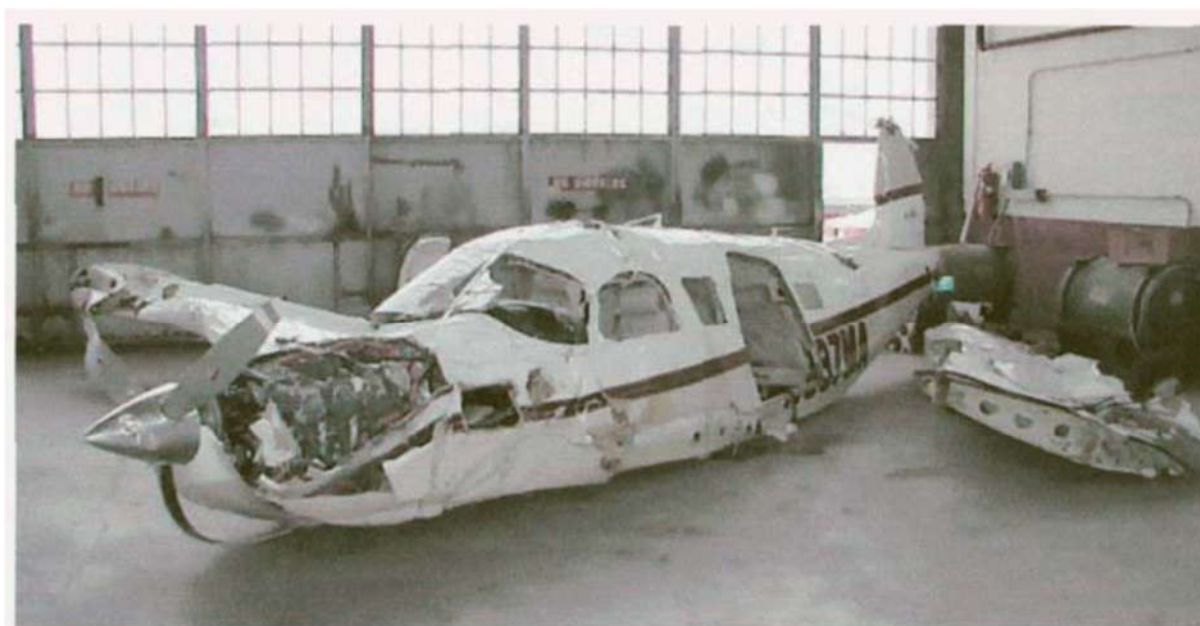
On June 7, 2002, a Piper PA-32R-301 (registration N697MA) suffered a catastrophic engine failure while conducting instrument approach practice at Key Field, Meridian, Mississippi. The aircraft, piloted by Dr. Mark Durrelle Williams, was conducting a training flight under VFR conditions when a loud "pop" was heard, followed by a complete loss of engine power. The engine failure occurred at an altitude of approximately 500-600 feet, as the pilot was following the published missed approach for runway 01. Unable to maintain altitude, the pilot attempted to return to the runway but was forced to land in a field, where the aircraft impacted trees and flipped over. The pilot sustained serious injuries, and the aircraft was destroyed. Figure 13 shows the aircraft wreckage after recovery to Meridian Aviation.

Figure 13. Front view of the aircraft wreckage after recovery at Meridian Aviation.
