Corrosion Failure Analysis of Duplex Stainless Steel Used as Shell and Tube Heat Exchanger with Seawater as the Cooling Medium

Materials Science and Engineering Research Group, Faculty of Mechanical and Aerospace Engineering,
Institut Teknologi Bandung, Bandung 40131, Indonesia

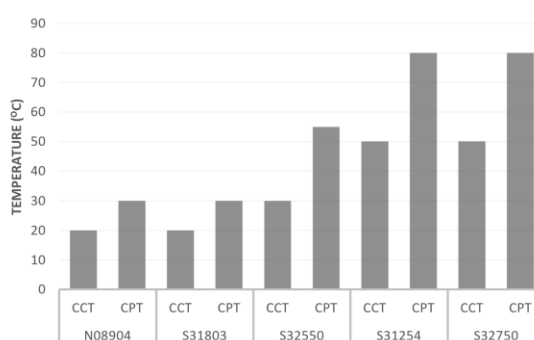
Figure 12. Critical pitting temperature (CPT) and critical crevice temperature (CCT) of some alloys [37.]

UNS S31803 has the lowest pitting and crevice corrosion resistance among duplex stainless steel. The critical crevice temperature of UNS S31803 is about 20°C; above this, crevice corrosion will occur. The severity and rate of crevice corrosion will depend on the crevice's geometry and the seawater's quality. Crevice corrosion of the tube-sheet is likely to occur under the gasket and between tube to tube-sheet joint. Crevice corrosion under the gasket is a consequence that cannot be prevented for seawater service unless a better design and a better material are selected. The expanded joint type is not recommended for tubes and tube sheets used in seawater service, as the possibility of crevice formation is much higher than that of a welded joint. Applying an overlay on the tube-sheet surface is accepted, but the overlay material shall be selected to avoid crevice corrosion. The current overlay was insufficient to prevent crevice corrosion, as some have been attacked. The surface quality of the overlay should also be considered because a rough surface will create tiny crevices that can harm the surface.
