Development of a GIS Tool for a High Precision PV Degradation Monitoring and Supervision: Feasibility Analysis in Large and Small PV Plants

Abstract: It is well known that working PV plants show several maintenance needs due to wiring and modules degradation, mismatches, dust and PV cells defects and faults. There are a wide range of studies that show the theoretical and some laboratory tests of how these circumstances may affect the PV production. Thus, it results mandatory to evaluate the whole PV plant performance and, then, it's payback time, profitability and environmental impact or carbon footprint. However, very few studies include a systematic procedure to quantify and supervise the real degradation effects and faults impacts on the field. In this paper, the authors first conduct a brief review of the most frequent PV faults and degradation that can be found on real conditions operative PV Plants. Then, they propose and develop an innovative Geographic Information System application to locate and supervise them. The designed tool has been applied to either a large PV plant of 108 kWp and a small PV plant of just 9 kWp installed on a home rooftop. For the large PV plant, 24

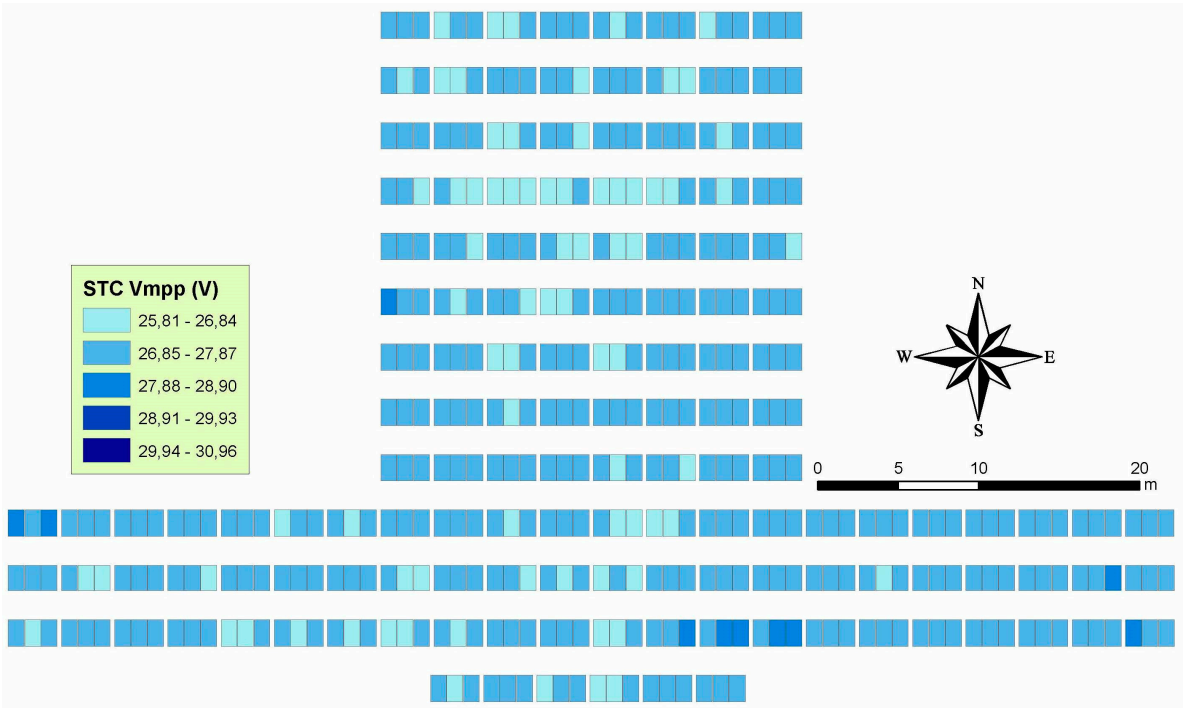
Figure 13 – STC maximum power voltage distribution analysis (108 kWp PV plant).

Figure 13 shows the STC maximum power voltage distribution. In this case, the distribution seems to be less homogeneous than the one seen for the maximum power current. Lowest maximum power voltage modules, in the range 25.81-26.84 are located in the northern and center parts of the PV plant, while certain modules located in the second row from the South show a higher voltage value. Histogram for this parameter, which can be seen in sub-figure 18.f shows a distribution close to the normal. with less than 4% of the voltage values higher than 27.68 V and less than 3% of the values lower than 26.40 V.

In Figure 12 it can be easily distinguished groups of PV modules with high values for the STC maximum power current. Distribution on the PV field of this electrical value is not uniform and low values can be correlated with low values of the STC maximum power voltage in Figure 13. Undoubtedly, those PV panels must be inspected with caution. Let's notice that higher differences on this value between close located PV modules can be found than when analyzing the maximum power voltage distribution.

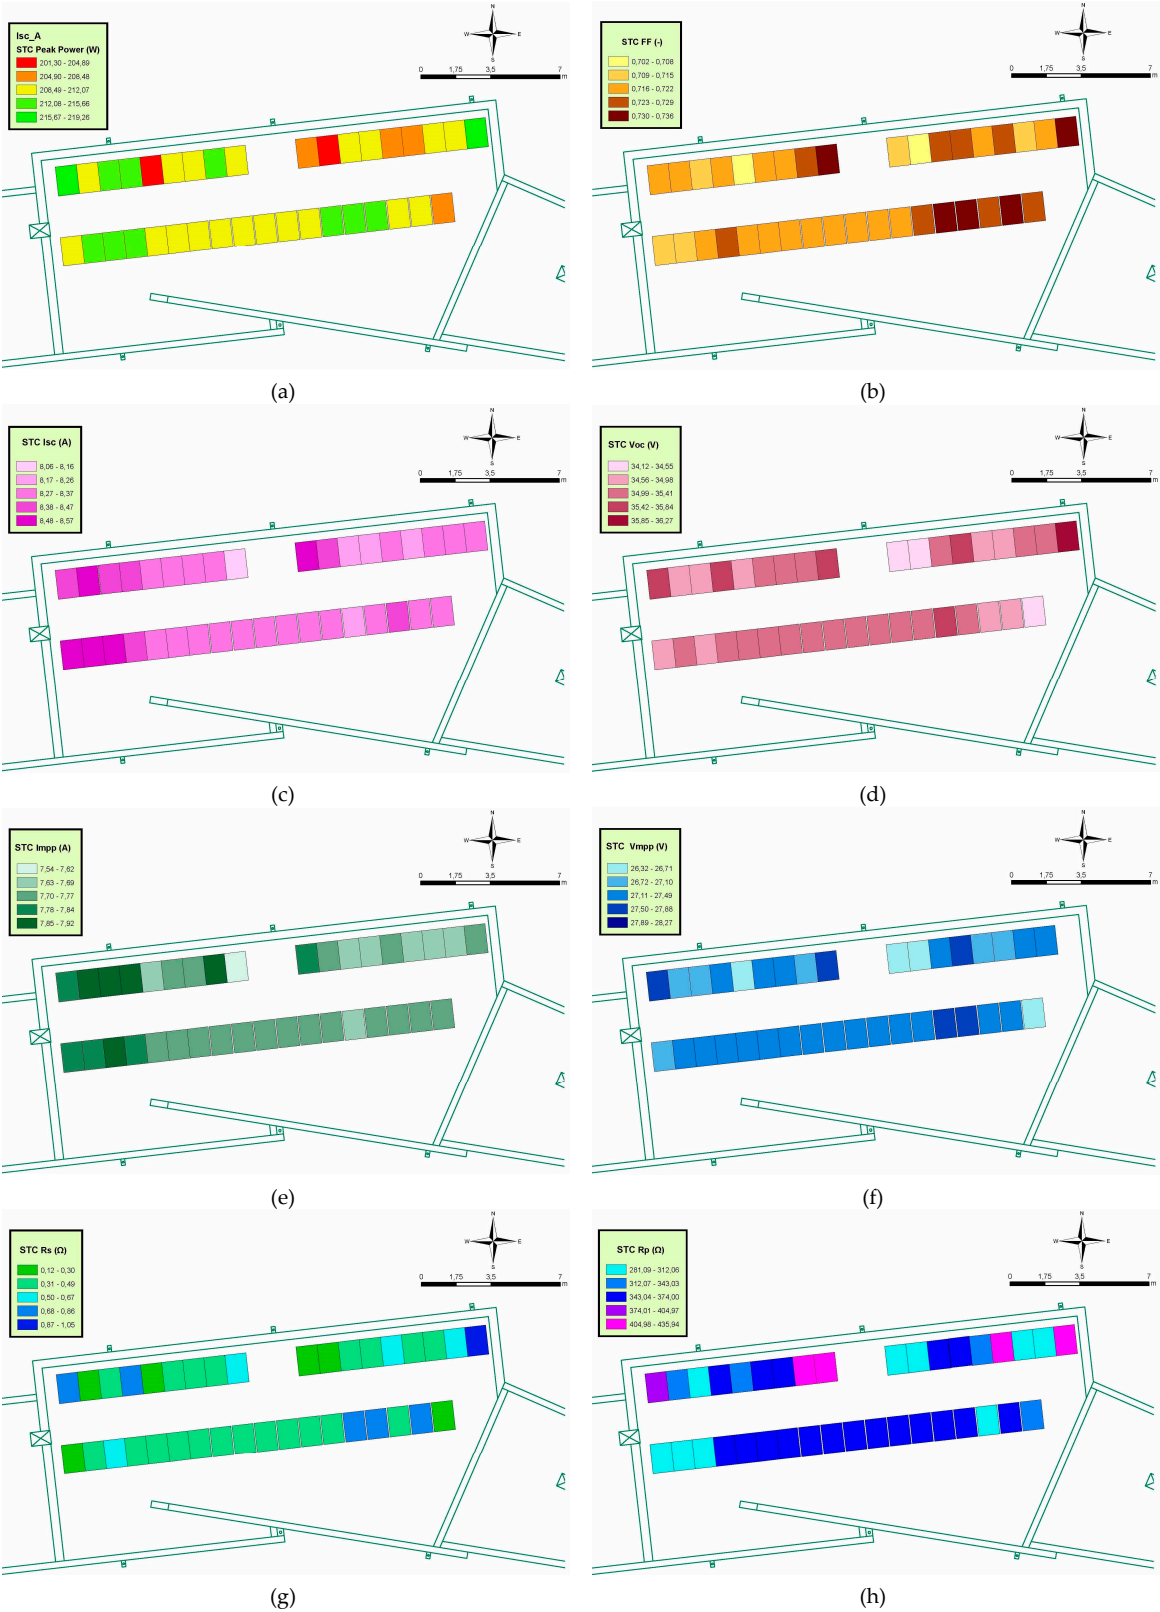
Figure 22 – Electrical parameters in STC conditions distributions: (a) peak power, (b) fill factor (c) short circuit current, (d) open circuit voltage, (e) maximum power current, (f) maximum power voltage, (g) series resistance, (h) parallel resistance (9 kWp PV plant).

Figure 22 shows the electrical measures distributions for the second case study. The distributions in all cases are more homogeneous than in the previous case study due to the lower rate of degradation. In this case, major variations are found for maximum power current 22.c, short circuit current 22.f and parallel resistance 22.h. Actually, a correlation between low values of short circuit values and cell discolorations can be found in this case.

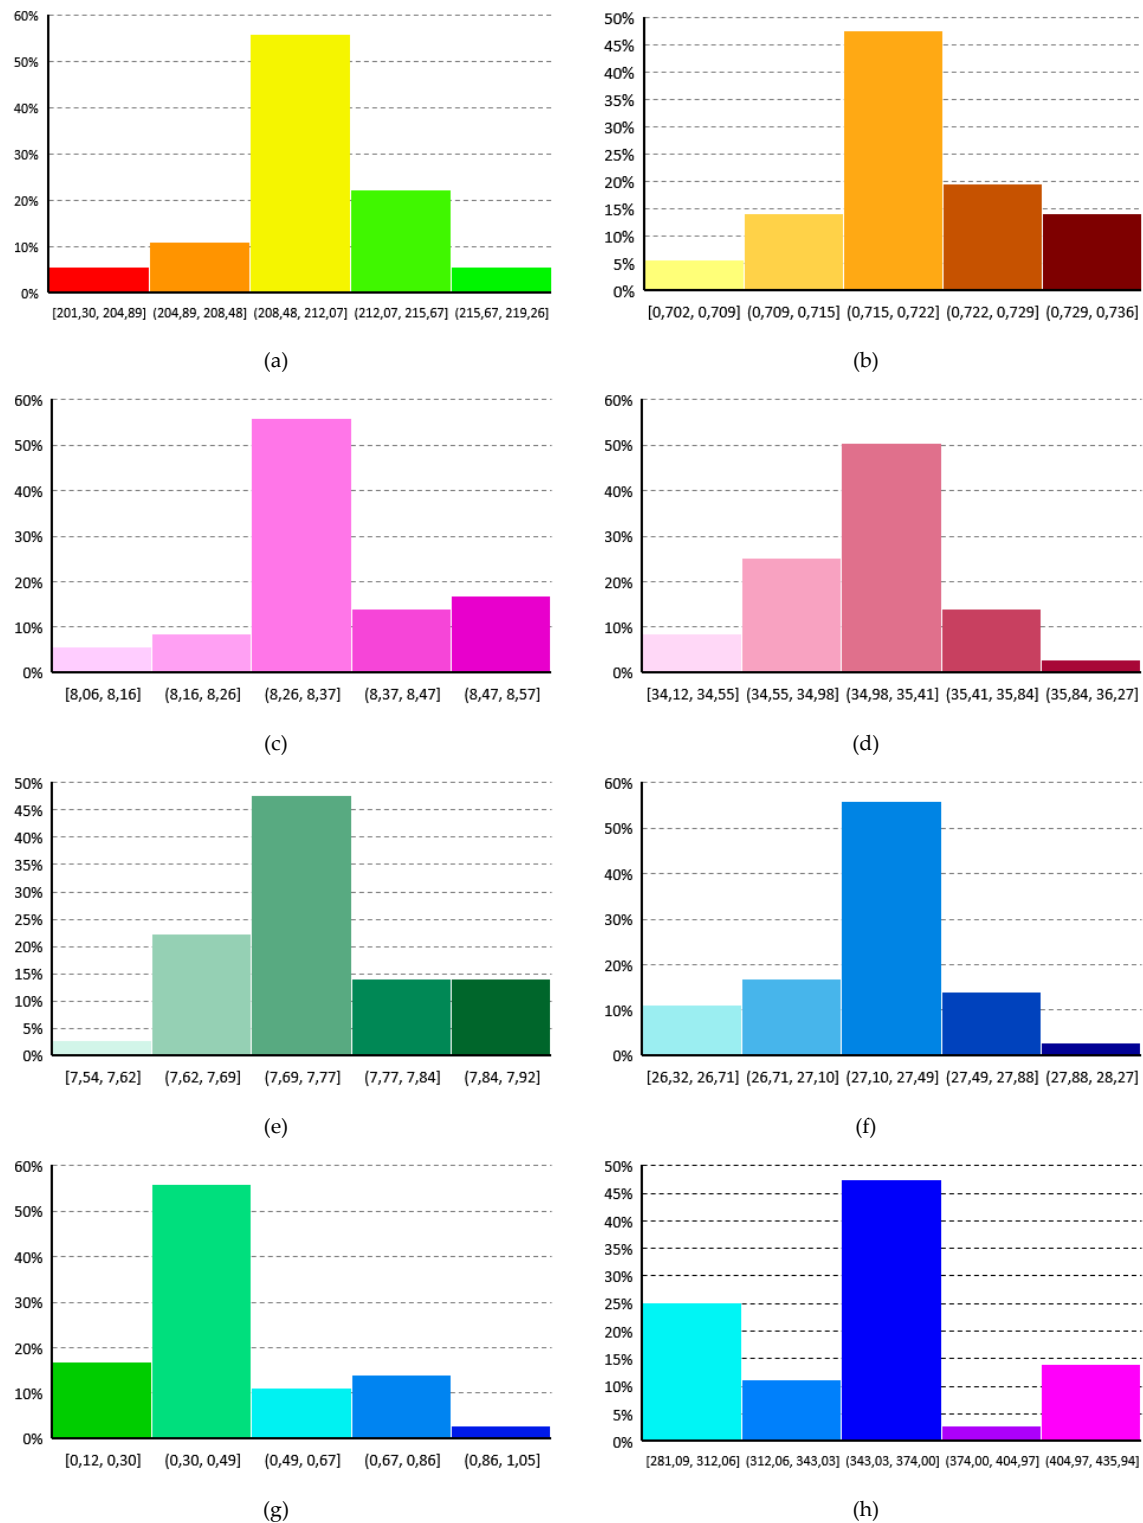
Figure 23 – Histograms of the measured parameters in STC conditions for the 9 kWp PV plant: (a) peak power, (b) fill factor, (c) short circuit current, (d) open circuit voltage, (e) maximum power current, (f) maximum power voltage, (g) series resistance and (h) parallel resistance.

Figure 23 shows the histograms for the measured electrical parameters for this case study. In this case, dispersions of the values are lower than for the 108 kWp power plant and, thus, fewer bins are identified. Subfigure 23.a shows that the average STC peak power is 210.77 Wp and less than 5% of the modules have less than 204.89 Wp. On the other hand, fill factor for the PV modules installed in this plant have a higher value, closer to the nominal one. 80% of the PV modules have a fill factor in the range between 71% and 73%.

Sub-figures 23.c-f show the histograms for I_{sc} , V_{oc} , I_{mpp} and V_{mpp} , respectively. Dispersion of these parameters is too low and no high differences with the nominal values are observed.

Finally, sub-figures 23.g and 23.h show the histograms for the series and parallel resistances. 55% of the modules have a series resistance in the range between 0.30 and 0.49 ohms, while for the parallel resistance, 47% are in the range between 343 and 374 ohms, but a significant 25% of the modules have a parallel resistance lower than 312 ohms.
