**Failure Analysis of fractured Fixing Bolts of a Mobile Elevating Work Platform
using Finite Element Methods**

Keywords: Fatigue Analysis, Finite Element Analysis(FEA), Mobile Elevating Work Platforms(MEWPs), Fixing bolt

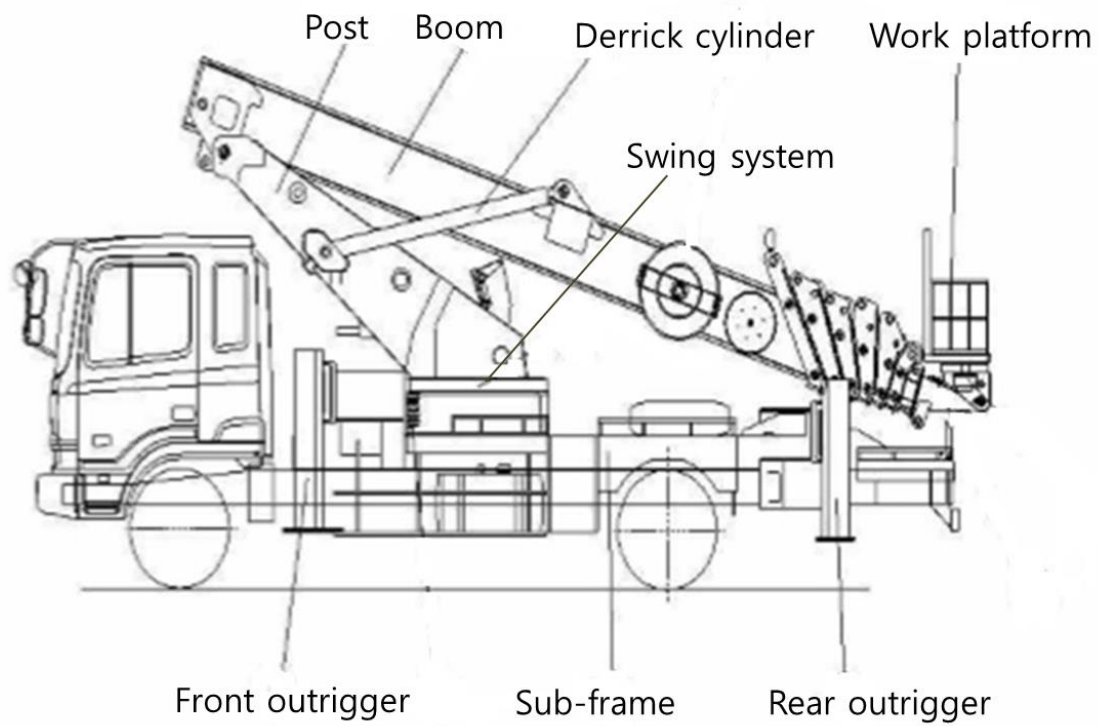
Fig. 1. Schematic of mobile elevating work platform working device*

The failed MEWP of this study consists of a middle frame, X-shape front outrigger, rear outrigger, turntable, 6-stage boom, one boarding work platform, and derrick cylinder, as shown in Fig. 1. The main composition has various functions, such as left-right 360° operation (boom rotation), withdrawal, and lead-in operation. These functions deal with the producer of oil pressure power, which contains the oil pump and system. . The turntable was jointed symmetrically to the swing system and post base by twenty M16 bolts of property class 10.9.

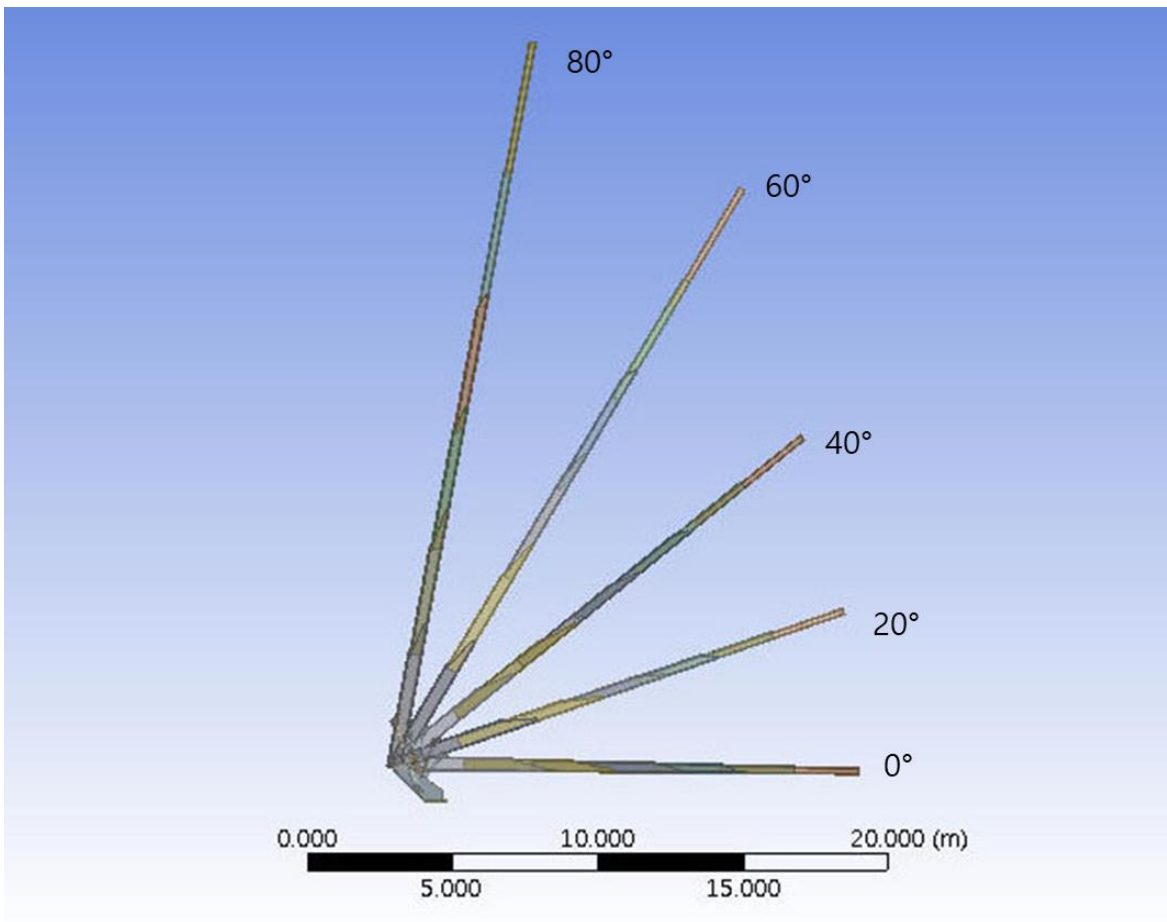
Fig. 5. Geometrical model of the MEWP in working radius

In this study, the height of the MEWP is 2985 mm, and it is equipped with a telescopic boom of 16,000 mm maximum withdrawal when the boom angle is 0° and 28,000 mm when the boom angle is 80° [12]. For structural and fatigue analysis of the turntable fixing bolts, as shown in Fig. 5, a 3D model consisting of a swing system, post, and booms 1–6 was modeled by SolidWorks. The 3D model was in the form in which the boom angle was increased by 20° intervals from 0° to 80° within the working radius of the MEWP.

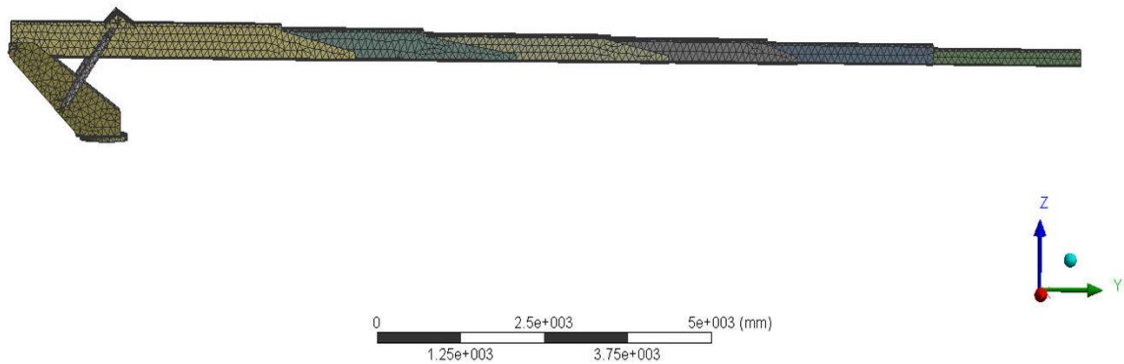
Fig. 6. Finite element model when boom angle is 0°

To simplify the 3D shape for mesh work, unnecessary weld structures attached to the post were removed, and mesh operations were performed. The type of element used is a tetrahedral element, and the number of nodes and elements of the model according to each boom angle are shown in Table 5, with the finite element model shown in Fig. 6.

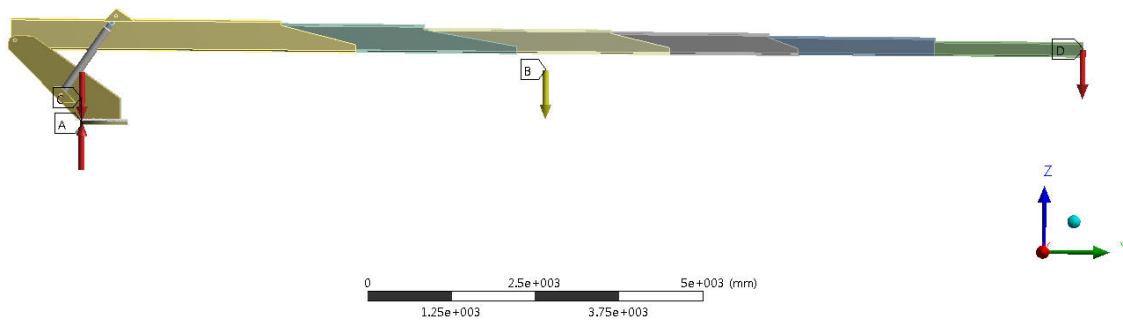
Fig. 7. Boundary condition when boom angle is 0°

The boundary conditions of the structural analysis are shown in Fig. 7. The fixed support at the lower end of the swing system was bonded to the post base, each boom and the corresponding bolt head were bonded to the post base, the post base was bolted to the swing system without separation, and the bolt side was bonded to the swing system, which was fully engaged with thread. Each joint and pin served as a cylindrical support with a fully fixed radius and axial direction, and the tangential direction was free [18].

- Fixed Support
- Standard Earth Gravity: 9806.6 mm/s²
- Bolt Pretension: 1.05e+005 N
- Force: 56000 N
