# Maintenance Management in an Un-renovated Building

#### 4. Case study: a neo gothic palace

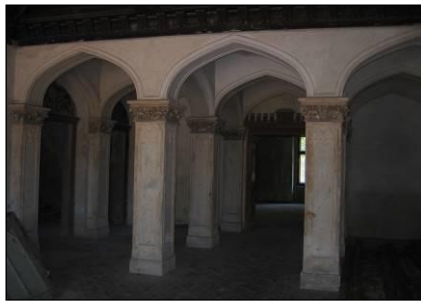
**Fig. 2.** Ground floor. View onto the arcades in the central part. Preserved decorative caps. Plasters of columns original, arcades – secondary

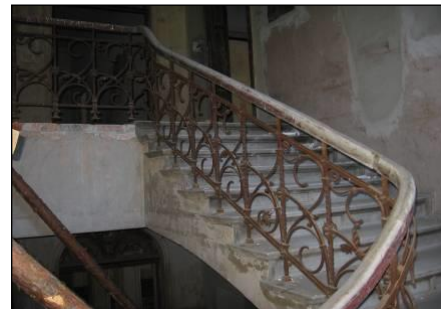
**Fig. 3.** Stairwell fragment. Preserved cast-iron balustrade with floral ornamentation
