Non-Destructive Test to Diagnosing Wear of Marine Gas Turbine Blades

In this paper, a non-destructive test to diagnose wear of blade's compressor of a gas turbine is reported. Gas turbine was operating in Campeche City, Mexico, in a very aggressive environment, where the entry of solid particles is unavoidable. The objective was to reduce cost of maintenance in this equipment. Analysis on a blade of gas turbine was performed, which was in operation on an offshore platform. Compressor blade was exposed to a severe damage by the impact of particles and environmental pollutants such as salts, sands and sulphurs.

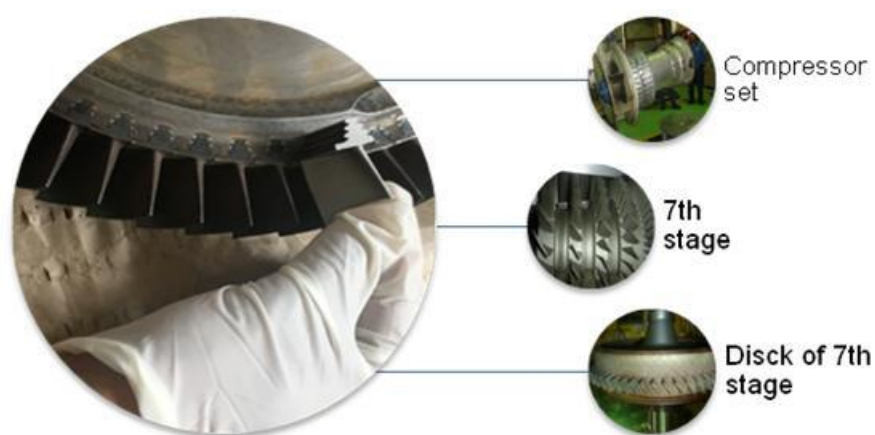
Figure (3). 7th. Stage's blade, Rotor Axial Compressor.

A study of wear damage of a seventh-stage's blade of axial compressor of a gas turbine (see Figure 3) was carried out. Manufacturer recommends routine maintenance at 30,000 hours to reduce chances for shutdown of gas turbine. In this study, the C40 gas turbine at 24,000 hours (shutdown) in field and out of service after 30,000 hours was analysed. This gas turbine was operating in Campeche City, Mexico (see Table 2), in a very aggressive environment, where entry of solid particles is unavoidable.

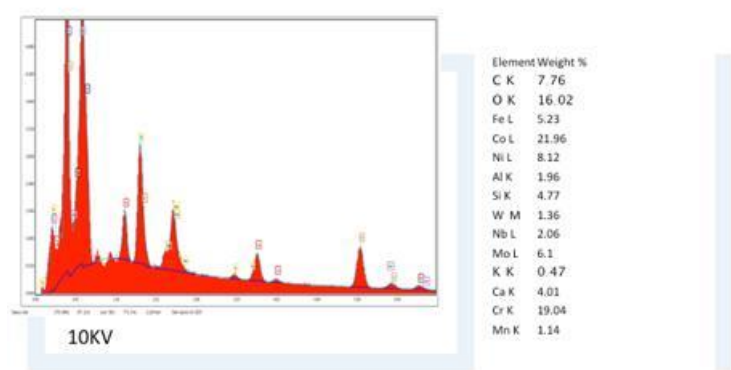
Figure (10). Chemical analysis in a leading edge (chemical elements and EDS graph).

Elements such as cobalt (Co), nickel (Ni), niobium (Nb) and molybdenum (Mo), with exception of Ni, these elements and weight percentages are close to martensitic stainless steel
