Characteristics of Corrosion Products of Friction-type High-Strength Bolted Joints of Steel Bridge: A Case Study

Therefore, this paper first analyzed the main diseases of the FHSB connection nodes of the Dongying Shengli Yellow River Bridge, which has been in operation for 33 years. Then after selecting seven representative FHSB connection sub-samples and eight steel plate samples, the SEM, the EDS and the XRD were used to analyze the microscopic morphology and chemical composition of corrosion products on the sample surface. Finally this paper discussed the relationship between the corroded sample surface and environmental corrosion in order to provide reference for scientific anti-corrosion protection measures for the nodes in aging steel bridges in the future.

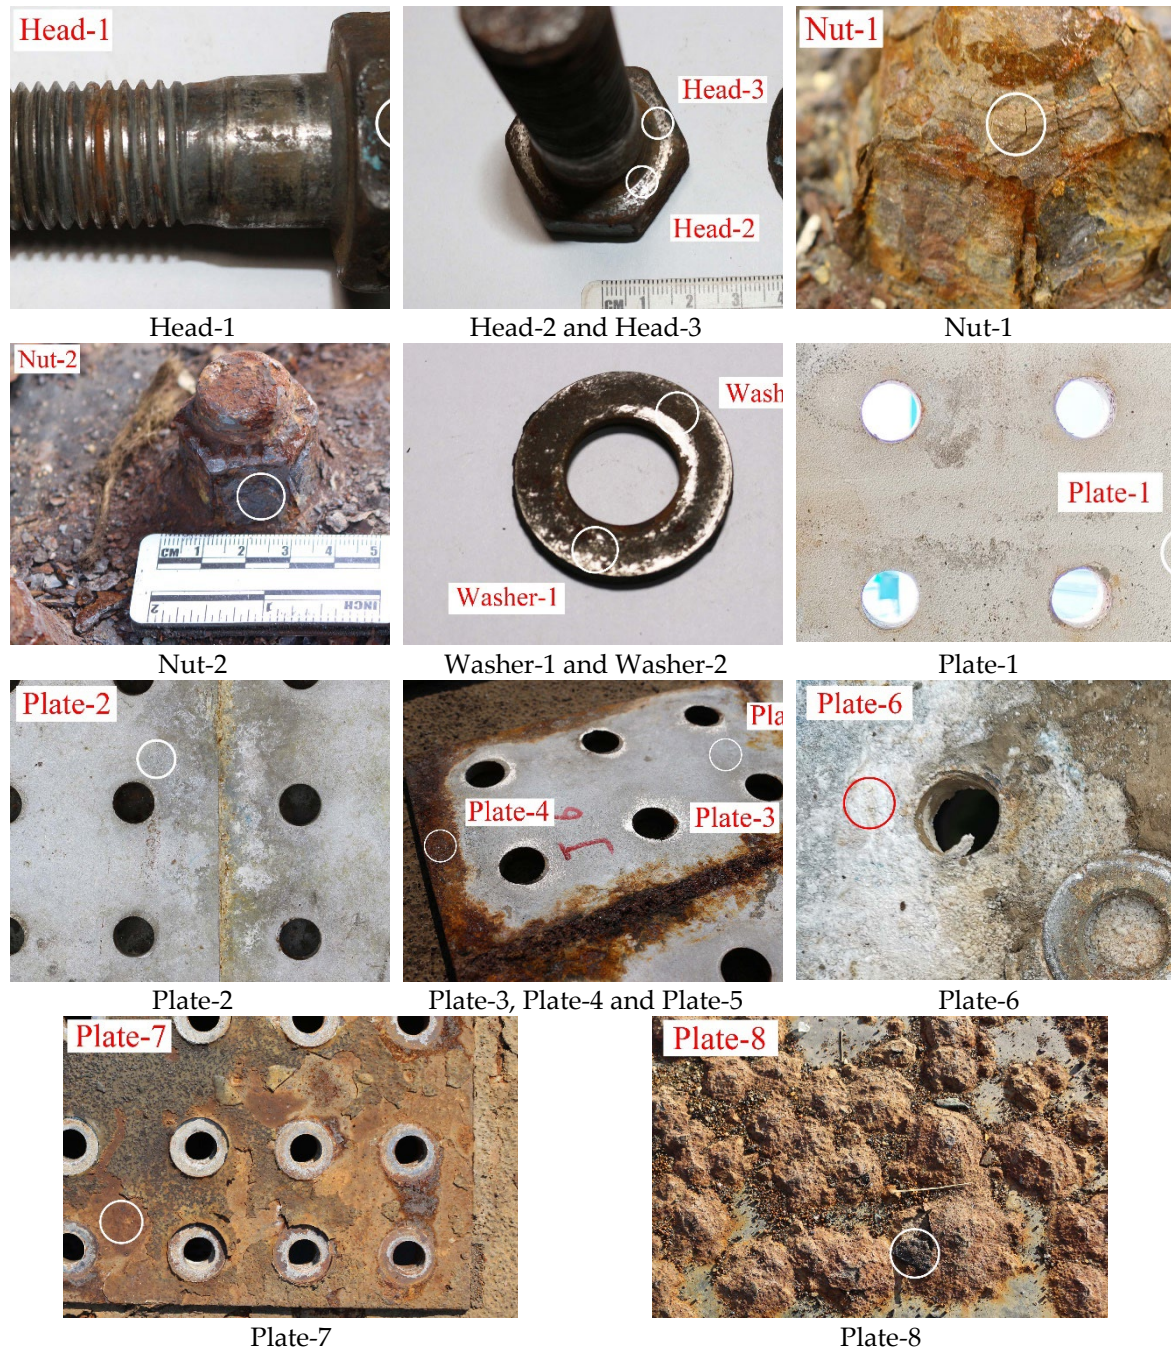
Figure 4. Sample selection position legend.

In order to study the surface characteristics of the FHSB connection node assembly, fifteen representative samples at different positions of the node were selected. Table 1 describes the sample material, sampling location and surface corrosion degrees. A total of seven samples were selected from the surface of the high-strength bolt connection pair, with three (Head-1~Head-3) from the bolt head, two nuts (Nut-1 and Nut-2), and two gaskets (Washer-1 and Washer-2). Among these samples, three (Head-1, Nut-1 and Nut-2) were in direct contact with the atmosphere, two (Head-2 and Head-3) were in contact with the gasket, and two (Washer-1 and Washer-2) were in contact with the upper splice plate. A total of eight samples were selected from the surface of the connecting steel plate assembly, with two (Plate-1 and Plate-2) from the contact surface of the lower splice plate, five (Plate-3~Plate-7) from the contact surface of the upper splice plate, and one (Plate-8) from the contact surface of the roof. Among these samples, five (Plate-1, Plate-2 and Plate-4~Plate-6) were in contact with the roof, and three (Plate-3, Plate-7 and Plate-8) were in direct contact with the atmosphere. It should be particularly pointed out that six samples (Plate-1~Plate-6) were mainly used to study the characteristics of corrosion products of aluminum sprayed steel plate contact surface with different corrosion degrees. Sample selection position legend is shown in Figure 4.
