Applying Infrared Thermography to a Latest Residential Building in France: Case Study, Verifying Dwellings National Thermal Regulations RT 2012 Mainly Thermal Bridges Assessment

Harry Ramenah

LCOMS laboratory, University of Lorraine, Metz France; harry.ramenah@univ-lorraine.fr

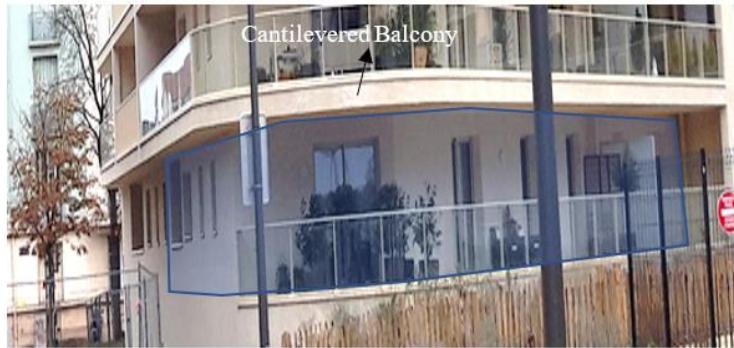
Figure 5. Real image of the concerning building at upper ground.

They also neglected the thermal bridge effect at a concrete beam embedded in an external wall as represented in Figure 4. In this study case, the considered building has cantilevered balconies which is the most critical thermal bridges in a building envelope and more when cantilevers are non-insulated. Figure 5, illustrates a real image of the regarding building for this study case with cantilevered balcony. The concerning apartment is the upper ground floor indicated by the blue frame in Figure 5.

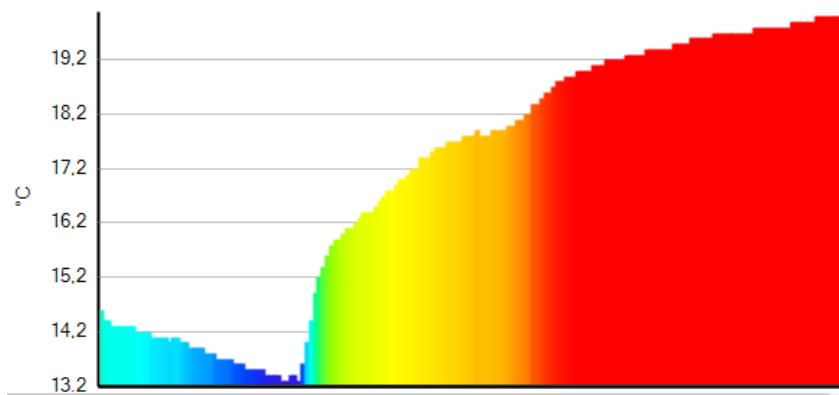
**Figure 10.** Profile temperature of line P1 in the thermal image.

The lower part of this wall to wall thermal bridge is showed in Figure 9 with the corresponding real image. In Table 2, the lowest measured temperature is close to 13°C indicated by M1, for a reference temperature 20.8°C indicated by M3, which is a dark alarm clock in the real image. Line P1 in the thermal image is the profile temperature that is plotted in Figure 10. The difference between the reference temperature and lowest temperature in the thermal bridge is 7.9 °C.

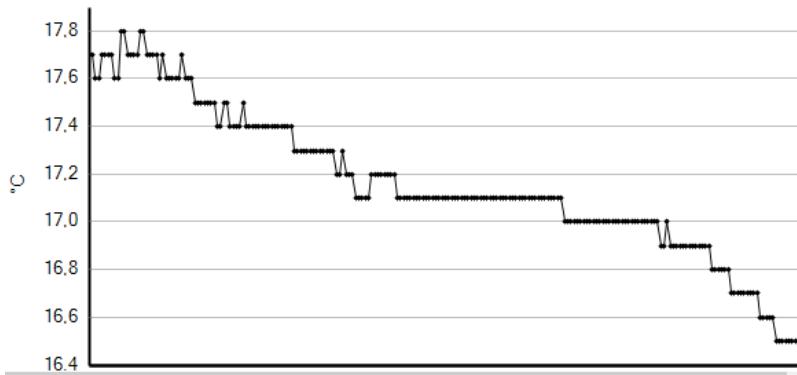
Figure 18. Temperature profile along the thermal bridge in the thermogram.

The balcony thermal bridge is all around the building structure and we have chosen to give results for this last junction at the orange line in Figure 6. This zone has a south orientation. The least measured temperature at M1 position in the thermogram of Figure 17 is 16.6°C as indicated in Table 7. The line P1 is the temperature profile along the balcony wall thermal bridge and represented in Figure 18. We retain a temperature difference of 4.4°C for this thermal bridge.

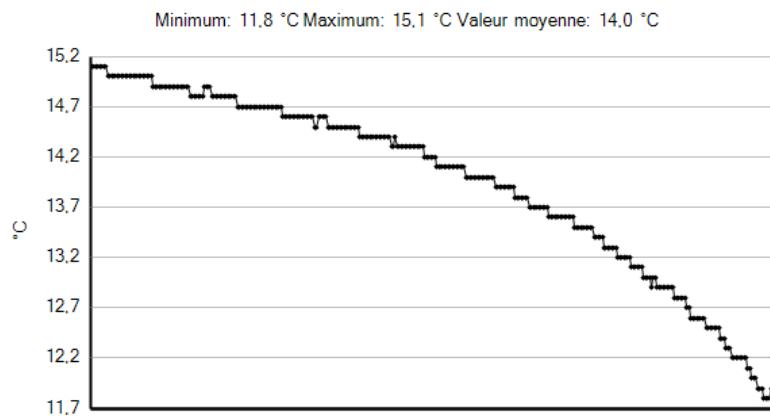
Figure 25. Temperature profile at P1 in the thermogram.

Figure 24, is the thermogram of a window door of the room indicated by the orange line in Figure 6. The thermogram, is not only showing low temperatures at the bottom part of window frame but also air leakage along line P1 and the temperature profile is indicated in Figure 25. Table 12, are temperatures at the window door frame.

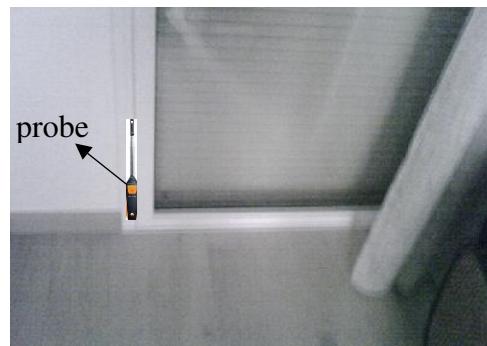
**Figure 26.** Probe position.

In face of the unexpected temperature profile in Figure 26, it seems interesting to perform another test at the windows to highlight the air leaking. A wireless smart probe such as Testo 405i thermal anemometer has been used to measure the air speed around all the windows. The probe position was initially determined in the thermal image such the one along line P1 in Figure 25 and as illustrated in Figure 26. The air speed was measured between 10 minutes and two hours.
