# Analysis of the 2022 El Tejado Ravine Mudflow (Quito, Ecuador) from the Sedimentological and the Published Multimedia Documents Approach

Posted Date: 23 April 2024

doi: 10.20944/preprints202404.1489.v1

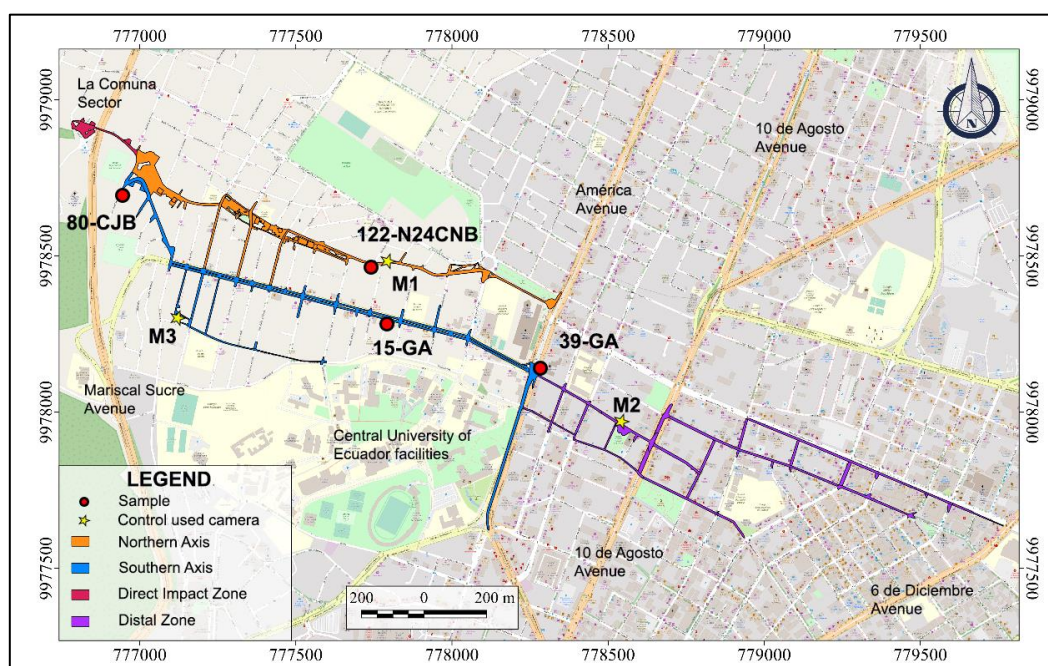
The study area is located in Quito's north-central and western sectors, in the Belisario Quevedo urban parish (Figure 3). It includes the sectors called Comuna de Santa Clara de San Millán (also named as La Comuna) and La Gasca and focuses on the streets and avenues affected by the direct impact of the flood of January 31, 2022; that is, from the pluvial sewage collector construction on Fulgencio Araujo Street to 6 de Diciembre Avenue (in the NW-SE direction) and from Núñez de Bonilla Street to Indoamérica Square (in the N-S direction).

**Figure 3.** Mudflow spread area from the first occurrence, the collector (NW) to the end of the flow in the 6 de Diciembre Avenue (SE). Modified from [17] using a base-map from Spanish version of [13].

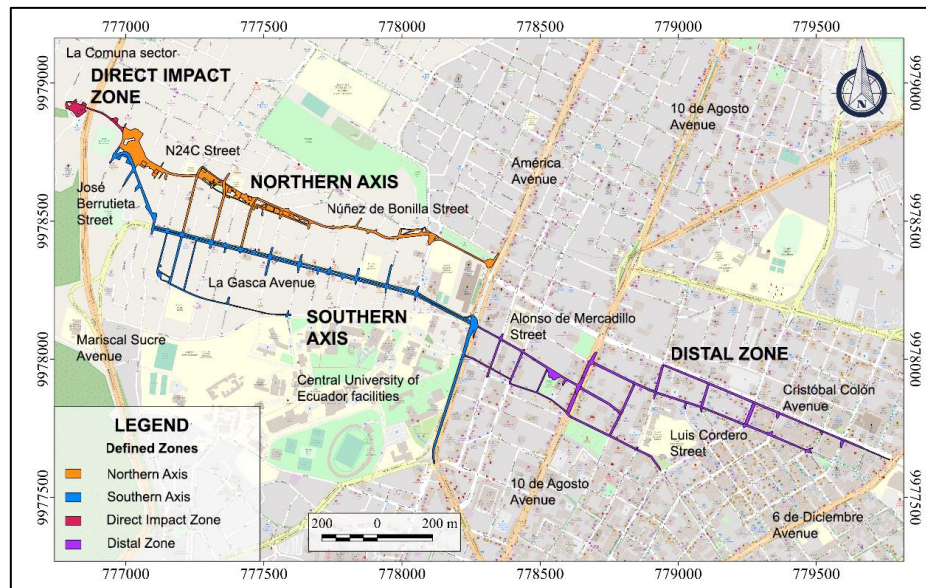
From considering the behavior of the flow, it was divided into four zones for this analysis (Figure 6):

- 1. The Direct Impact Zone (collector area and surroundings)
- 2. Northern Axis (along the Núñez de Bonilla Street)
- 3. The Southern Axis (along the La Gasca Avenue)
- 4. The Distal Area (between América and 6 de Diciembre avenues)

**Figure 6.** Map with the sections' classification according to the mudflows' behavior on January 31, 2022. Modified from [20] using a base-map from Spanish version of [13].

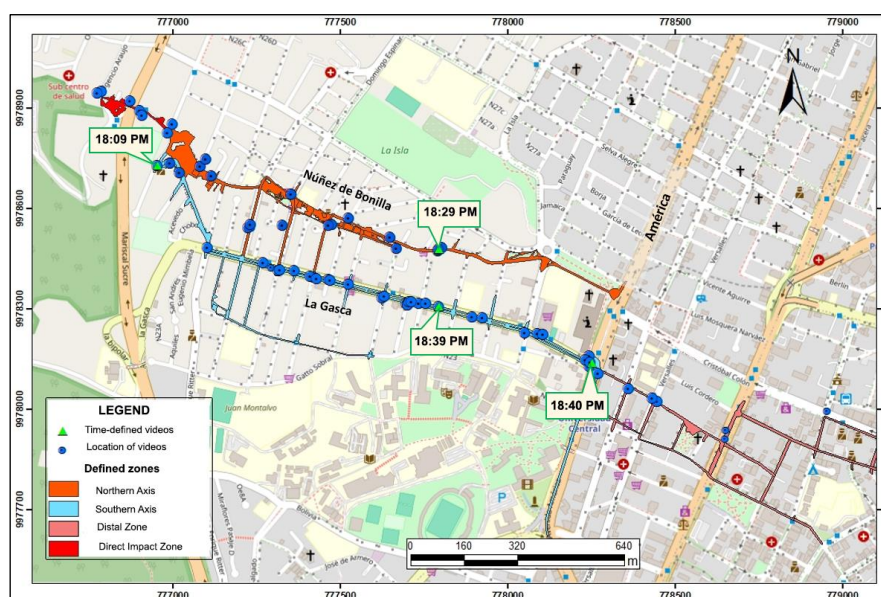
About the multimedia material, a total of 65 videos documenting the mudflow's development were identified and georeferenced. However, only four videos had a time record that allowed the start time and progress to be established (Table 1). These times have a high degree of uncertainty given that there is no information on the accuracy of the equipment that recorded the event (Figure 7) [20].

**Figure 7.** Spatial and temporal location map of videos of the development of the mudflow on January 31, 2022. Modified from [20] using a base-map from Spanish version of [13].

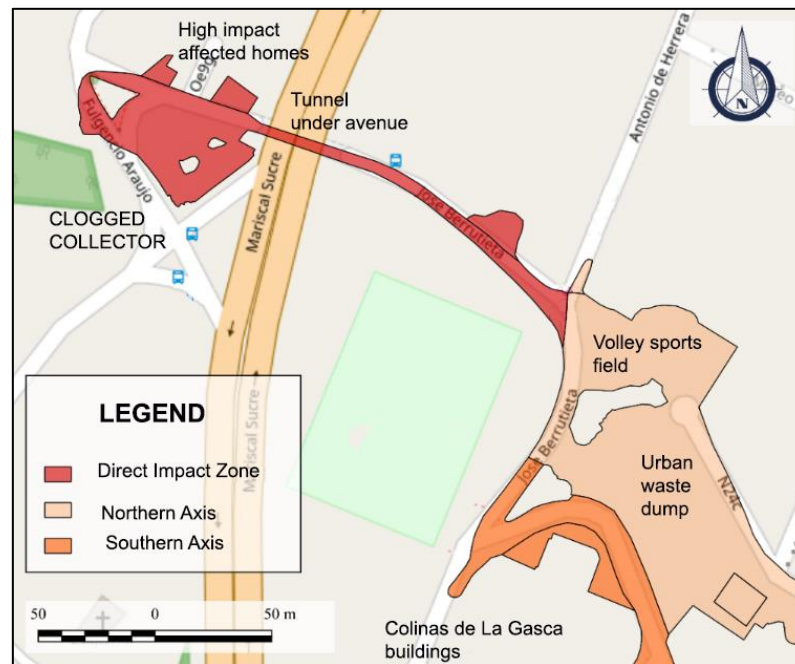
The Direct Impact area corresponds to the La Comuna sector, where the flow occupies the streets Fulgencio Araujo, Padre Semanate, and José Berrutieta before entering the Belisario Quevedo volleyball sports field (Figure 8). At the intersection of José Berrutieta Street with Antonio de Herrera Street the flow was split into two branches.

That flow presented a turbulent behavior, and those zones were considered an erosional area due to the street slopes, between 5° and 12°. The observed deposit had a maximum thickness of 1 cm, and the flood footprint reached 2 m on building walls.

**Figure 8.** A detail of the areas of direct impact in the La Comuna sector. Modified from [17] using a base-map from Spanish version of [13].

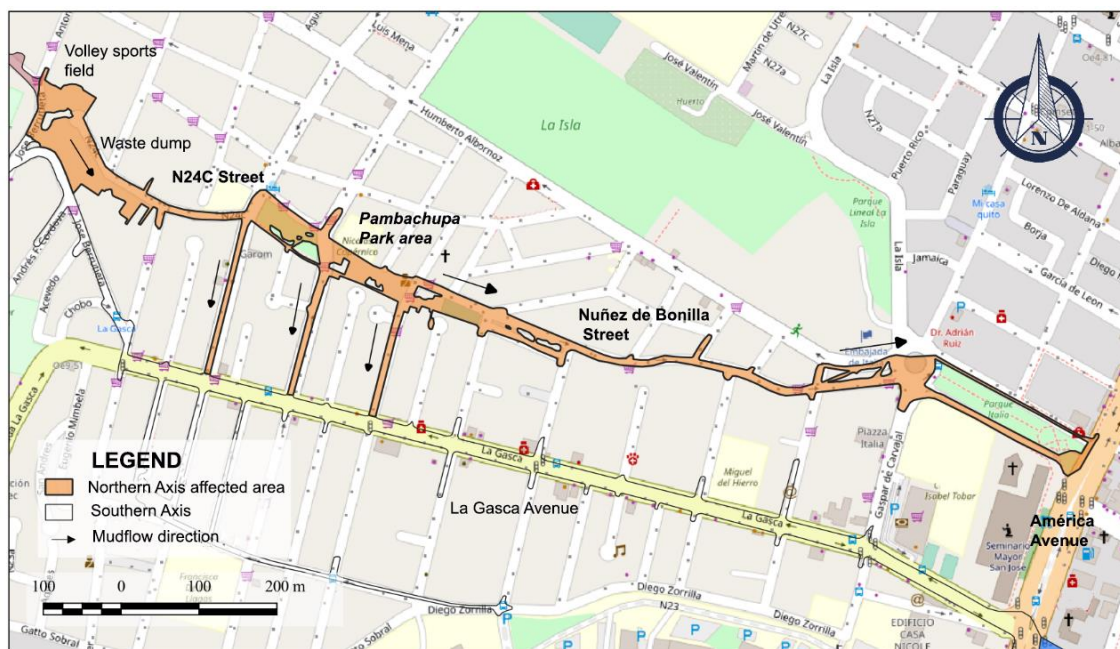
According to [17], on N24C Street, a sedimentary deposit with an average thickness of 7 cm and 40 to 20 cm was found on the ground floors of the buildings located east of the waste dump that were directly impacted. [20] points out that on this street, the flow had a high-energy turbulent and erosive flow behavior that destroyed the structures (enclosing walls) of several buildings and showed high load capacity by dragging cars, tree trunks up to 2.5 m, and debris from 10 cm to 200 cm in diameter. An analysis of several frames estimated a surface speed between 10 and 11 m/s.

The damage in the east area of the waste dump is summarized in homes with total collapse, a high degree of structural damage, and non-habitable homes on the street elevation ground [14]. Therefore, the waste dump and the change in the main slope ( $10^\circ$  inclination) influenced the variation in flow behavior (higher speed and energy) that determined a high degree of impact on the homes with a greater exposure (by the closeness) to this diverse material accumulation area.

**Figure 10.** Map showing the total flow path of the North Axis. Modified from [17] using a base-map from Spanish version of [13].

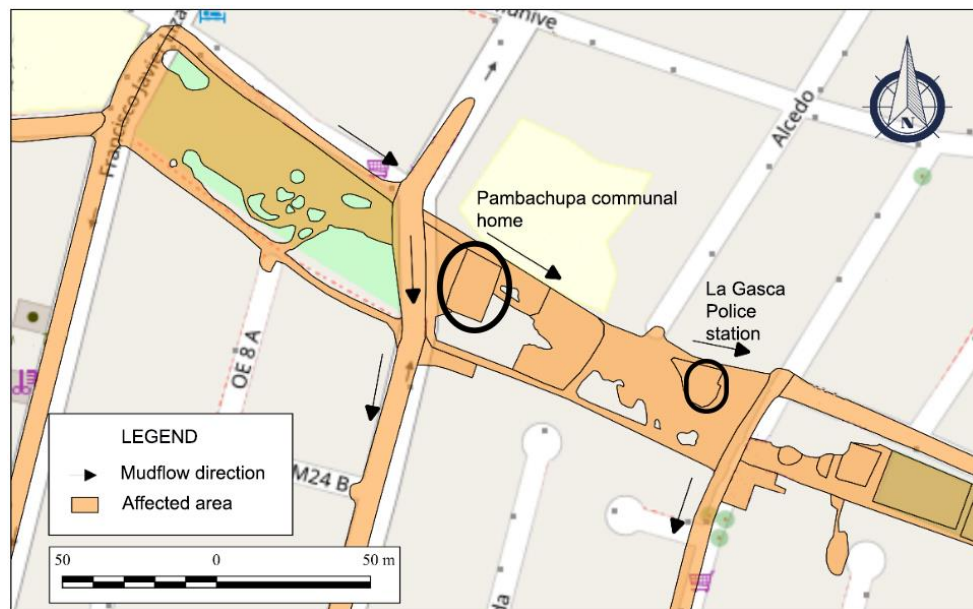
To the east of N24C street, the flow entered the Pambachupa Park, a linear area of 440 m long and 30 meters wide approximately (Figure 10), characterized by green fields on stepped terraces with a main inclination of  $4^\circ$  towards the southeast. The presence of two buildings (a communal house and a community police unit) inside the park generated artificial barriers where the flow collided. It allowed a part of the flow to enter through transversal streets from the park (Domingo Espinar and Fernández de Recalde streets). It was determined that the entrance through Francisco Lizarazu Street (at the upper head of the park) was the product of an inclination towards the south (Figure 12). According to [20], the surface speed, calculated from the surveillance camera frames on Domingo Espinar Street (where it has a  $1^\circ$  to  $2^\circ$  inclination), was less than 2 m/s. In addition, the mudflow flowed with a dense behavior able to transport trees larger than 1 m and some cars.

**Figure 12.** A detail of the Figure 10 map showing the Pambachupa Park area. Modified from [17] using a base-map from Spanish version of [13].

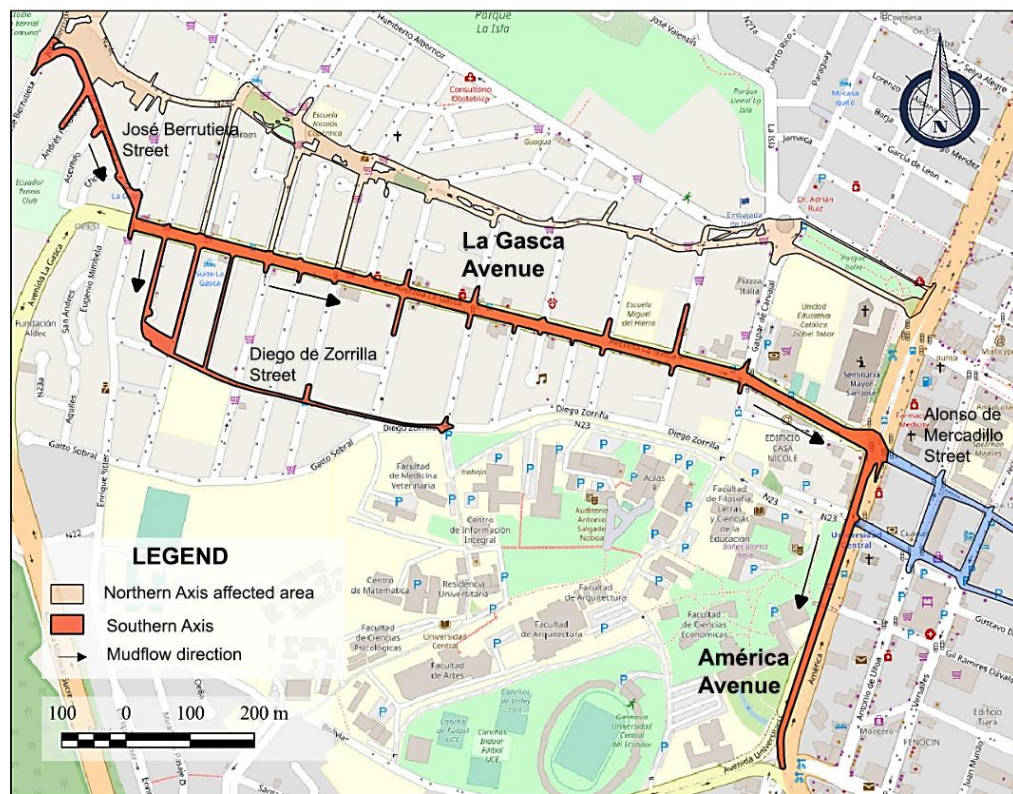
The Southern Axis was defined as spreading along José Berrutieta Street through La Gasca and América Avenues, entering the transversal streets of Atacames, Francisco Javier Lizarazu, and Romualdo Navarro. That flow fed a new split branch that crossed from west to east along Diego Zorrilla Street for approximately 500 meters. This branch constitutes the southern boundary of the affected area and is located approximately 400 m wide to the south of the Northern Axis, being the most widespread (Figure 13).

**Figure 13.** Southern Axis affectation area. Modified from [17] using a base-map from Spanish version of [13].

It can be observed that on La Gasca Avenue, the flow still had a high load capacity. The videos and pictures show the transporting of cars, garbage containers, several sizes of debris, and tree trunks of up to 2.5 meters. The average thickness of the deposit along that avenue was 5 cm. In this area, the wave's behavior was changed because the largest fraction of material was deposited (up to 3.0 m). At the same time, the aqueous flow and finest parts overflowed the accumulated material, generating a new waved flux phenomenon [17].

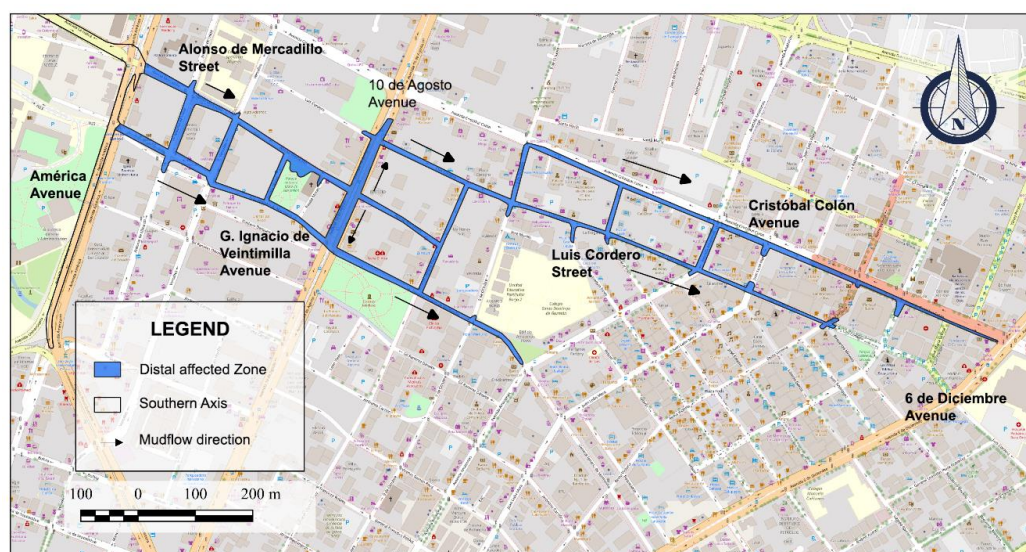
Avenue and the transversal streets (all in NW-SE direction) until the main avenues, such as 10 de Agosto and 6 de Diciembre Avenues, which have NE-SW directions (Figure 15). During the information gathering on February 2, 2022, it was determined that the deposit in this area was made up of primary and remobilized material (lithic sediments), as a product of the artificial washing of La Gasca Avenue (for removing the mud).

That change in thickness sedimentation behavior is because, in this area, there was a change in slope from 5° that gradually passes to 0° and the influence of vial structures (street steps and sidewalks approximately 30 cm high from street pavement elevation). Those conditions acted as barriers to the advance of the mud flow towards the east and became deposit areas for most sediment. In addition, this caused the flow to be driven to 10 de Agosto Avenue and advanced through Luis Cordero, Alonso de Mercadillo, and Ignacio de Veintimilla streets. The most extended branch is the one located to the north, over Luis Cordero Street, which, in its advance, entered through Cristóbal Colón Avenue until the intersection with 6 de Diciembre Avenue. That was 3.2 km from the collector.

According to the analysis of the multimedia material, the flow advances through the Distal Zone as a flood of water with low sediment load, speed, and energy [20].

**Figure 15.** Distal Zone of affectation. Modified from [17] using a base-map from Spanish version of [13].
