Characterization of Micro-threaded Stem Taper Surface of Cementless Hip Endoprostheses

[Drago Dolinar](#) , Boštjan Kocjančič , Klemen Avsec , [Barbara Šetina Batič](#) , [Aleksandra Kocijan](#) , [Matjaz Godec](#) , [Mojca Debeljak](#) , [John T Grant](#) , [Timon Zupanc](#) , [Monika Jenko](#) *

Posted Date: 13 May 2024

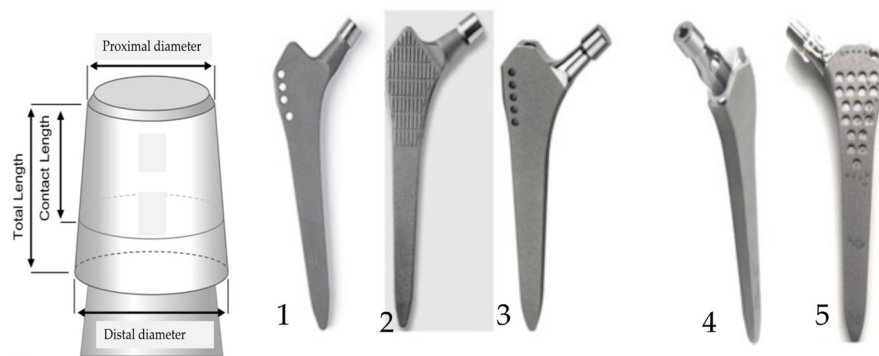
Figure 1. The measured taper characteristics are proximal female and distal male diameters, contact length, and total length, as shown for a stem taper at the left. The investigated cementless hip stems from different manufacturers. 1-SL-Plus, Smith & Nephew, 2-Alloclassic Varial Zimmer, 3-Alloclassic Zweymüller Zimmer, 4-Adler Ortho Modula, and 5- Lima corporate ZM C2.

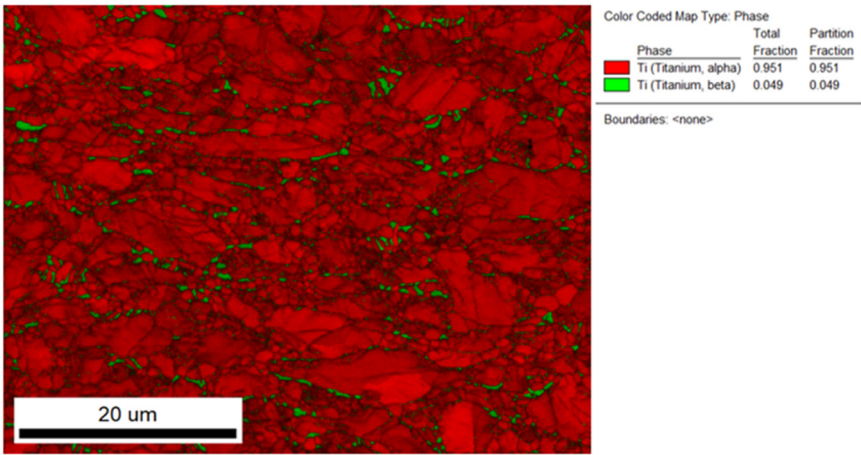
Figure 5. EBSD image of Ti6Al7Nb new sample. α phase is Ti matrix in hcp structure, red, and with Nb enriched β phase, bcc structure green.

The quantitative determination of phase distributions in the new sample Ti6Al7Nb alloy is possible by using the electron-backscattered diffraction integrated technique on the field emission scanning electron microscope, EBSD, where the stem-taper microstructure is ($\alpha+\beta$), Figure 5. The EBSD method is compatible with the XRD method, but on a smaller scale and for that reason is mounted on the FE-SEM. The EBSD method is very precise, the limitation of EBSD besides being a very accurate, precise method, is that it is very time consuming, and for that reason is suitable for basic research and development of new biomaterial alloys.
