# Preserving Heritage Riverine Bridges: A Hydrological Approach to the Case Study of the Grau Bridge in Peru

[Joel Ccancappa Puma](#) , Alejandro Víctor Hidalgo Valdivia , [Alain Jorge Espinoza Vigil](#) \* , [Julian Booker](#)

Posted Date: 27 May 2024

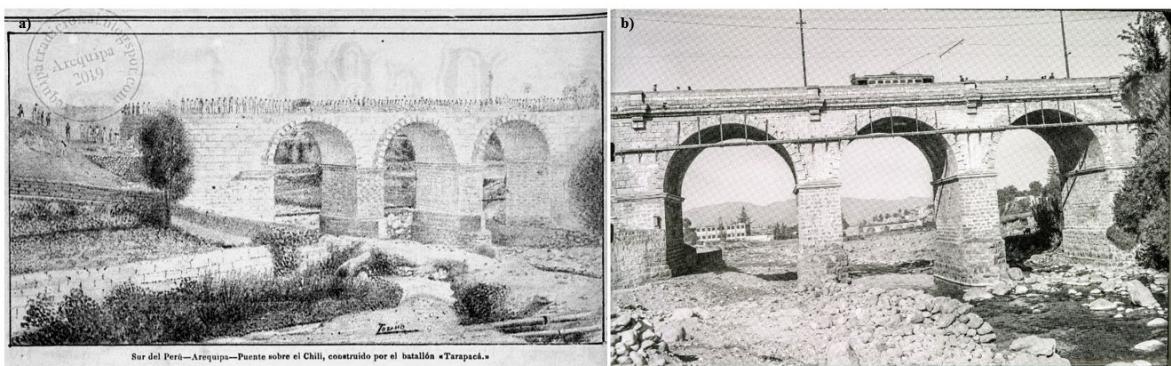
**Figure 1.** (a) Grau Bridge in 1889, taken from Bedregal La Vera (2015) [20]; (b) Grau Bridge in 1930, taken from Espinoza (2012) [21].

Figure 1a shows the new bridge in Arequipa (Puente Grau) of 1889, one year after its construction and subsequent operation according to its review and chronology (Figure 2). Figure 1b shows the Grau bridge of 1930 during the aristocratic republican transition to democracy (1895-1968).

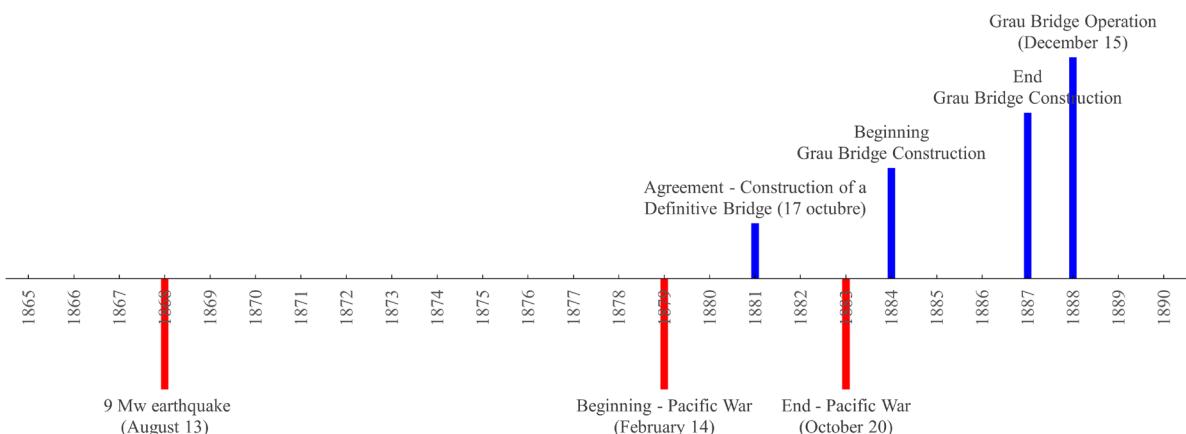
**Figure 2.** Chronology for the construction of the Grau Bridge in the republican era of debacle and reconstruction.

In the 20th century, the Grau Bridge was not only one of the busiest roads, but also contributed to the urban growth of the city since its operation in 1888 (Figure 2). However, over time, the bridge suffered serious damage. The first incident on October 21, 1953, was when the roadway and its corresponding baluster collapsed due to excessive seepage and continuous overflows from the irrigation ditch along Cortaderas de Yanahuara Street [18], mainly due to factors such as landslides and destroyed drinking water systems that supplied the city from La Tomilla. The second in early 1975, was due to an increase in the flow of the Chili River as a result of rainfall, threatening the foundations of the Bolognesi and Grau bridges due to flooding in what is now known as Barrio Obrero eroding the pillars of the bridges [18].

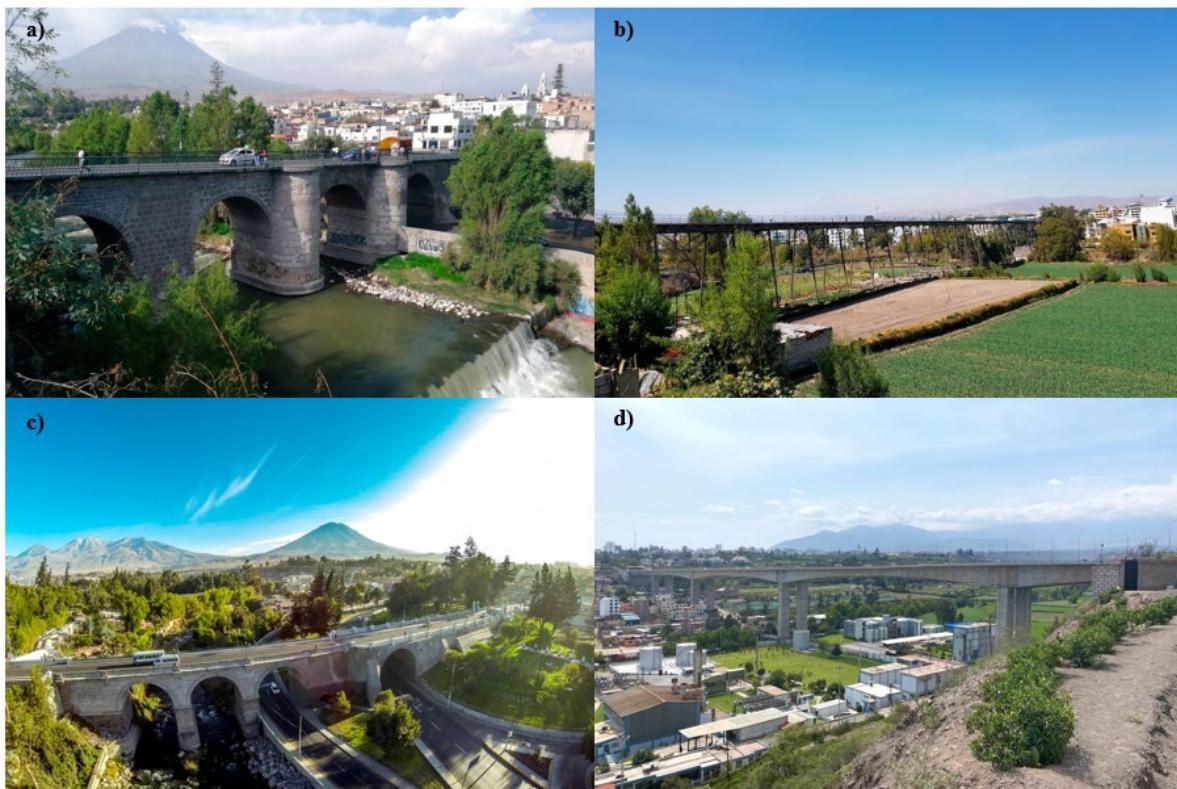
It should also be added that Spanish colonialism had a clearly urban character since the founding of Arequipa on August 15, 1540 and facilitated communication between distant cities through ports, bridges and the construction of churches [22]. As can be seen in Figure 3, four of the most important bridges in the city, both for their historical significance and their role in current transport system, are: Puente Viejo or Bolognesi, Puente Bolívar or Puente de Fierro, Puente Nuevo or Puente Grau, and Puente Chilina. The Bolognesi Bridge (Figure 3a), one of the most important constructions of the colony, represented a constant concern for the local authorities, not only because of the earthquakes of 1582, 1600, 1604 and 1784, but also because of the torrential rains and the overflowing of the Chili River, such as the deluge of 1819 that caused flooding for five months [23]. The Fierro Bridge (Figure 3b) is now pedestrian only. Thus, in 2014, in view of the urban growth and aging of the bridges, the largest urban bridge in Peru of contemporary times was built, called Chilina Bridge (Figure 3d), whose material is prestressed concrete 562 meters long with piers of 21.1 m, 28.9 m, 35 m and 39.7 m, and seismic analysis based on an earthquake with a return period of 1000 years [24]. The Grau Bridge (Figure 3c), located in the center of the city, is 62.5 m long, 10 m wide, and 17.3 m high from the riverbed, supporting more than 10,000 vehicles per day, including light and heavy vehicles.

**Figure 3.** (a) Old Bridge (Bolognesi) (1608); (b) Bolívar Bridge (Fierro) (1870); (c) New Bridge (Grau) (1888); (d) Chilina Bridge (2014) [25].

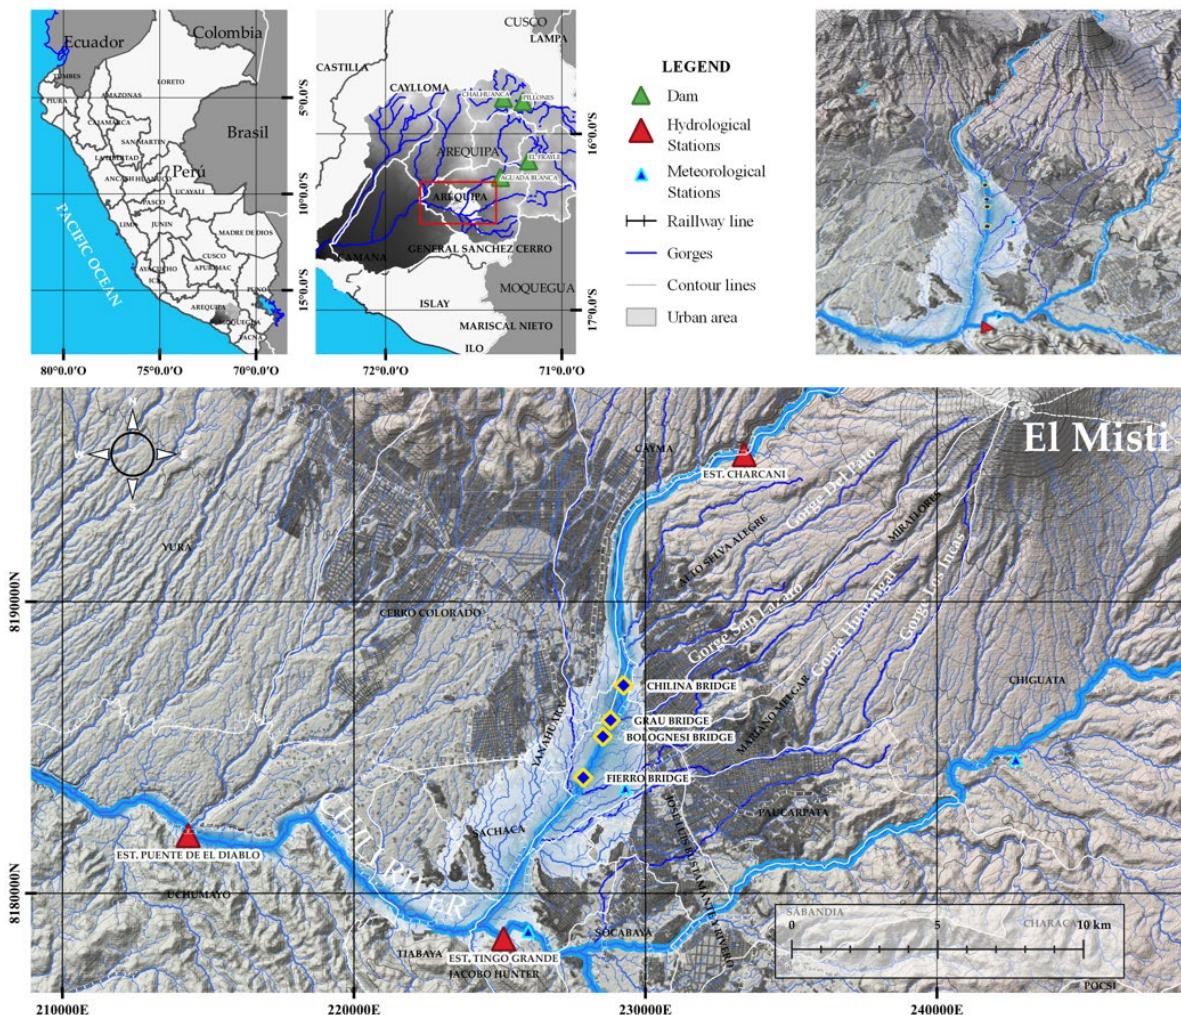
The Quilca - Chili basin (Figure 4) is located on the Western slope of the Andes Mountains and therefore belongs to the Pacific Ocean slope. The basin has a complex system of dams called the "Chili Regulated System" to meet Arequipa's water requirements. The Chalhuanca and Pillones dams are operated and maintained by EGASA (Empresa de Generación Eléctrica de Arequipa) and AUTODEMA (Autoridad Autónoma de Majes) of the El Frayle and Aguada Blanca dams, which protect the city of Arequipa by regulating the Chili River floods. Considering the latent risk of increasingly intense and recurrent rainfall due to the effects of climate change [26,27], a hypothetical breach of El Frayle would cause Aguada Blanca to break, generating a wave front that would reach the city. In addition, the dams age and present sedimentation problems, causing them not to function at design volumes. As a result, some 15,000 people would be affected because the river flow would increase by approximately 1,600 m<sup>3</sup>/s [28]. Figure 4 shows the location of the Grau Bridge in the regulated system of the basin.

**Figure 4.** Location of the Grau Bridge in the Regulated System of the Middle Quilca - Chili Basin below the Misti volcano.

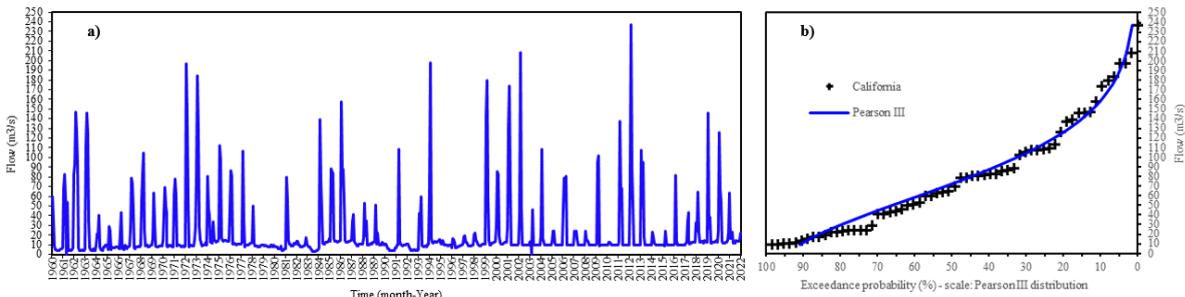
The hydrological study consisted of identifying the maximum flows in the urban area of the city of Arequipa, where the Grau Bridge is located. Hydrometric information was collected from the "Chili Regulated System", which provided by AUTODEMA with a record of 63 years (1960 - 2022) [36]. Frequency analysis was then performed according to the Manual of Hydrology, Hydraulics and Drainage of the Ministry of Transport and Communications [MTC] [37], for eight theoretical probability distribution functions (Normal, Log Normal II/III Parameters, Gumbel, Log Gumbel, Gamma II/III Parameters and Log Pearson type III) with seven empirical probability functions (Hazen, California, Weibull, Chegodayev, Blom, Gringorten and Cunnane) to determine the best fit to the peak flow series through the nonparametric goodness-of-fit Smirnov-Kolmogorov test with a significance level of  $\alpha=0.05$ . The empirical California function and the theoretical Pearson III function were the best fit. Figure 6 shows the frequency analysis and the fit.

**Figure 6.** Hydrological statistical analysis; (a) frequency analysis; (b) Smirnov-Kolgomorov adjustment.

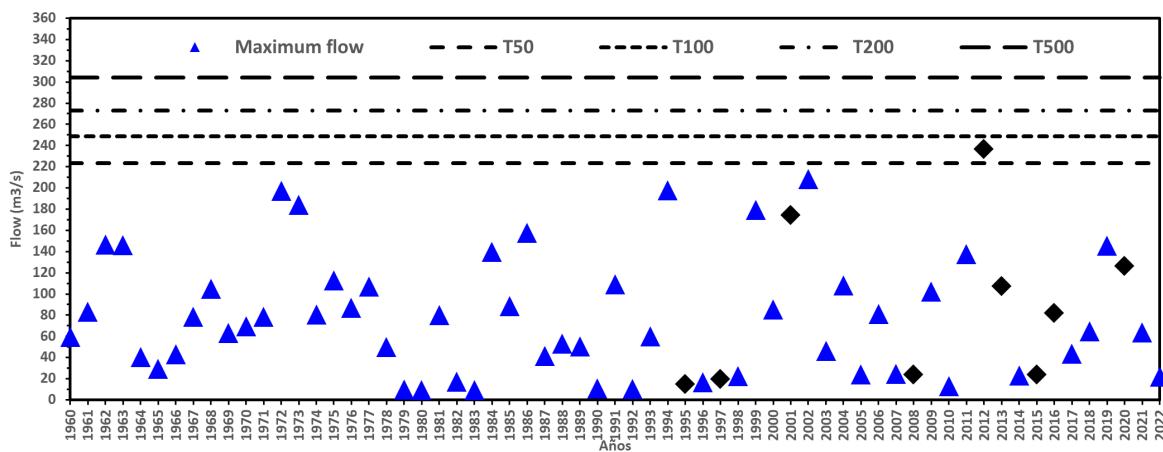
The city of Arequipa is faced with extreme events such as high intensity rains, but of short duration that generate floods and flooding of the Chili River [40]. Consequently, over time these extreme events triggered the activation of Del Pato, San Lazaro, Venezuela and Los Incas streams in 1995, 1997, 2001, 2008, 2012, 2013, 2015, 2016 and 2020 as historical events [40,41], increasing the flow of the Chili River. Thus, it can be seen in Figure 8, flow thresholds greater than 223.0 m<sup>3</sup>/s (T=50 years) resulting from the frequency analysis of the Charcana station and flows resulting from rainfall in basins not gauged by historical events, are increasingly critical. This makes heritage bridges exposed, due to the stochastic nature of floods [42].

**Figure 8.** Maximum flow thresholds from the frequency analysis of the Charcana hydrometric station (1960 - 2022).
