Effect of Scarf Repair Geometry on the Impact Performance of Aerospace Composites

Abstract: This experimental study investigates the effect of scarf geometry in restoring the impact response of scarf patched 3 mm thick glass-fibre reinforced polymer (GFRP) matrix composite laminates. Traditional circular along with rounded rectangular scarf patch configurations considered as repair patches. Experimental measurements revealed that the temporal variations of force and energy response of the pristine specimen are close to that of circular repaired specimens. The predominant failure modes were witnessed only in repair patch which include the matrix cracking, fibre fracture, delamination and no discontinuity in adhesive interface was witnessed. When compared with the pristine samples, the top ply damage size of the of the circular repaired specimens is larger by 9.91 %, while that of the rounded rectangular repaired specimens is larger by 434.23 %. The results show that circular scarf repair is more suitable choice of repair approach under the condition of 37J low-velocity impact event even though the global force-time response is similar.

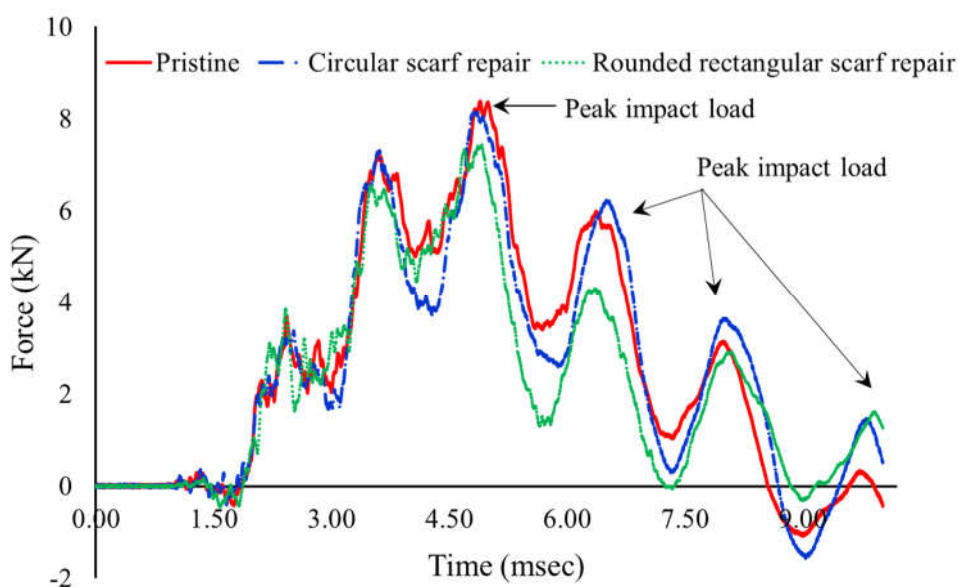
Figure 3. Force versus time response of impacted samples.

The force-time history of the impacted samples is plotted in Figure 3, as the impactor impinges the test sample initially it can be observed that the load increases sharply due to Hertzian contact and has a sudden drop. The Hertzian contact force of pristine and circular repaired samples is (3.68 kN) and that of rounded rectangular repair sample is 3.87 kN which is 5.1 % higher than pristine sample. Hirai et al. [18] in their work which dealt with impact response of the woven fabric found that the incipient damage load in their tests on woven GFRP laminates was a consequence of interface failure or matrix cracking near the tension dominant side (bottom side) of the laminates and is given in terms of mode-II fracture toughness (G_{IIc}) as [19] (the predictions of threshold load value for damage initiation from this simplified model were shown to be in good agreement with experimental load values that correspond to the initial occurrence of damage [20]),

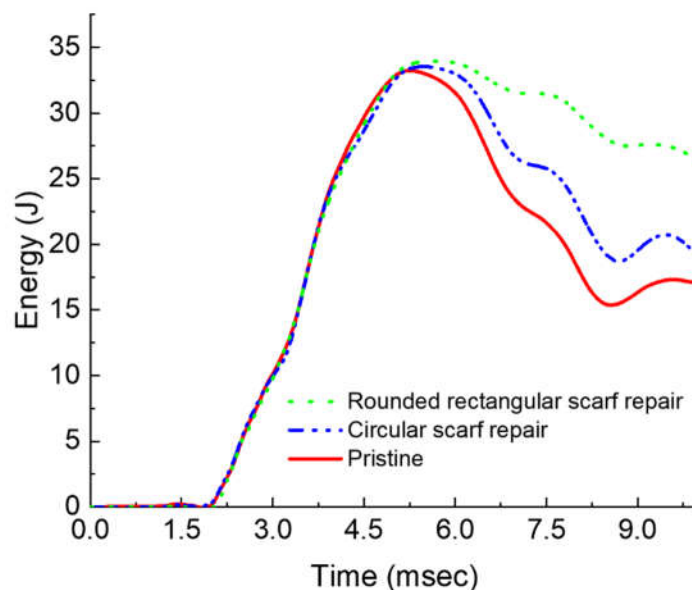
Figure 4. Energy versus time response of impacted laminates.

Typical impact energy versus time responses is depicted in Figure 4. Within experimental scatter, the peak energy absorbed by all the three samples is around 33.5 J, close to that of 37 J potential energy imparted by the drop-weight. It is to be clarified that the energy plot in figure 4 has been plotted for total duration of the experiment, whereas in Figure 3 the impact event starts at ~1.5 msec and ends at about 9.5 msec with impact event duration being 8.5 msec approximately. According to the energy profile diagram (EPD) proposed by Liu [22], the closeness of impact and absorbed energy indicate the laminate failure by projectile through penetration. It can be observed that the rounded rectangular repaired sample (I) has absorbed 52% energy more compared to pristine and 36% more compared circular scarf repaired laminates post peak energy at the point of impact. High energy absorption by the rounded rectangular scarf repair can be directly correlated to its damage area (Figure 5), which will be discussed in section 4.1. Similarly, the energy absorbed by the circular scarf repaired samples post peak energy at the point of impact is greater than pristine and its damage area (Figure 5) is also larger compared to pristine.

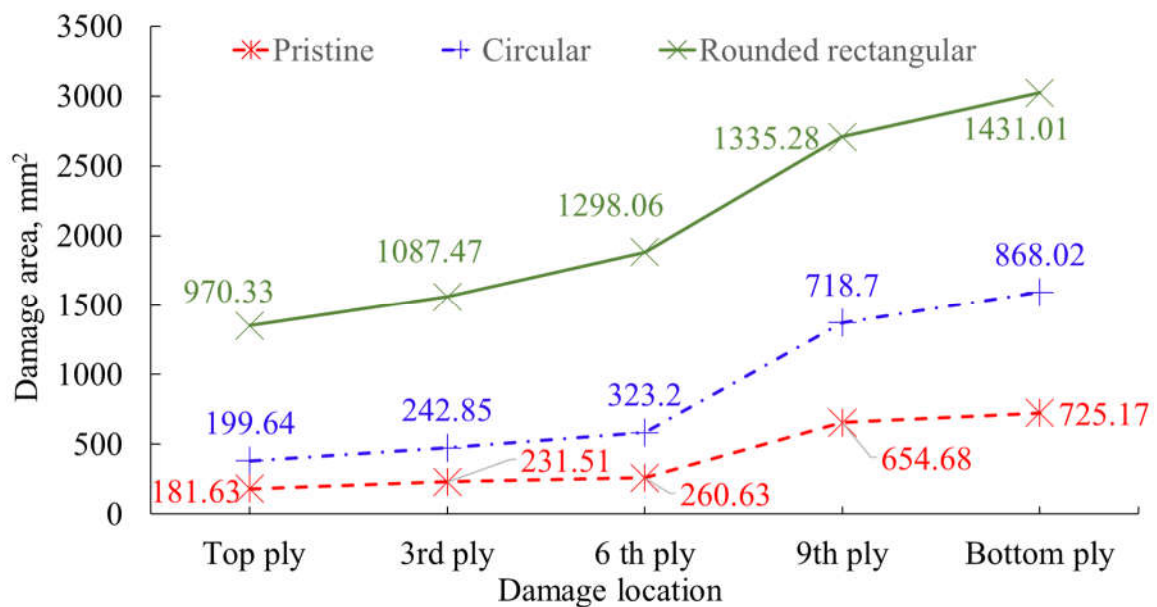
Figure 6. Damage area for different plies for tested configurations.

Tested samples were further inspected with the help of Nikon XTH 225 ST computed tomography (CT), where the raw images were reconstructed by segmenting the volume. From the scanned images, voxels (volumetric elements) were adjusted by changing the isosurface setting to visualize the impact damages and fibre yarn. Figure 6 illustrates the damage area relative to the damage size in the top ply across various plies. Figure 7 illustrates the damage propagation across various plies in through thickness. It can be seen that the pristine and circular scarf patch repaired laminate (Figures 7a and 7b) had demonstrated similar pine tree pattern [23], whereas in rounded rectangular repaired laminate (Figure 7(c)) had cylindrical pattern. These results can also be translated degradation of bending stiffness with change in the sample configuration [24] i.e. pristine sample has highest bending stiffness amongst tested samples followed by circular and rounded rectangular repaired scarf patch laminates.
