Studying the Water Supply System of the Roman Villa of Pisões (Beja, Portugal) Using Ground-Penetrating Radar and Geospatial Methods

Keywords: GPR survey; Roman Villa of Pisões; Water Supply Location; Combined archaeological data; Roman Lusitania.

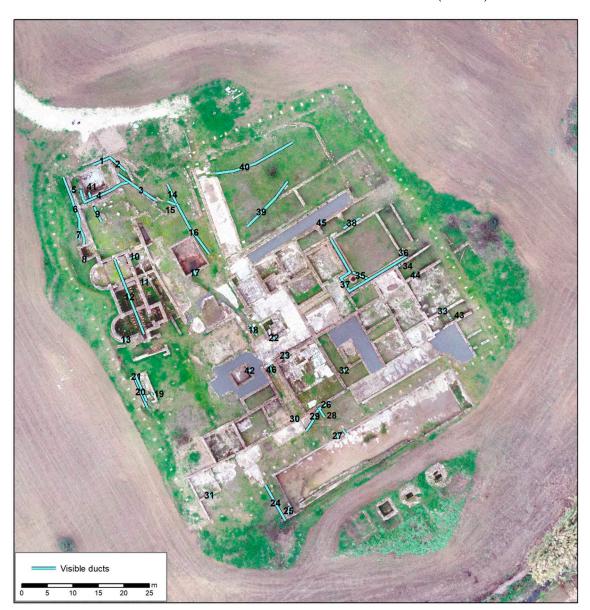
In the first stage of surface work, we have been able to discover a total of 46 water conduits in the villa, within which they serve different functionalities and may not be related to each other. Figure 3 shows the visible conduits, which are described below in groups according to their function. The altitude values of the visible ducts were measured with differential GNSS (Table 3).

Figure 3. Location of visible water conduits in Pisões on the orthophotography of the site.

Ducts 1 to 9 correspond to the original supply of the thermal building, where pipe 1 is at an elevation of 181.60 m, the highest topographical point in the whole villa. This part of the complex can be understood quite well, given that the water flows from pipe 1 and 2 to 6 and from there through 3, 4 and 5 to the *natatio* located there, the water exiting at pipe 9.

The ducts 10 to 13 are part of the main private *therma* or *balneum*, but only 12 and 13 correspond to the water exit of the whole, while the other two elements are isolated and at lower levels.

Ducts 14, 15 and 16 correspond to a very shallow water supply circuits which is difficult to pinpoint, as we can neither see its origin nor its end.

Ducts 17 and 18 correspond to the exit of one of the large pools and a small sewer that is visible near the center of the villa, which corresponds to pipe 46.

Elements 19, 20 and 21 are related to the latrines, a clean water inlet and a sewage exit.

Ducts 22 and 23 are the water exit of the central impluvium and the water inlet of one of the rooms, which due to its marble cladding could be a low recreational pool.

Ducts 24 and 25 are the water exit of the monumental *natatio* and possibly another conduit that takes water from other parts of the villa to this point, which seems to be a collector.

The remaining ducts are very difficult to identify. The elements 26, 27, 29 and 30, whose connection is not clear. The same for pipes 35, 36, 37 and 38, which seem to be related to a well located to the northeast of the villa. It is not clear whether element 40 is a wall or a conduit, but structure 39 is an aqueduct with manholes that must have supplied water to the town, given that it is located at a very high elevation. The remaining elements are isolated in the villa and in general, do not seem to be connected to other hydraulic elements. They are mainly holes in the walls measuring 8 x 16 cm which could well be elements for cleaning the rooms or even in the restoration and consolidation of the elements themselves to prevent the accumulation of rainwater.

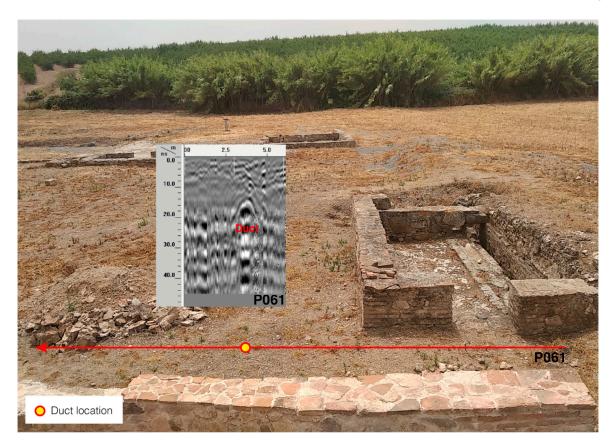
Figures 10 and 11 shows the B-scan reflections in the continuation of a drainage conduits.

Figure 10. Representation of the B-scan P059 and location in the field.

Figure 11. Representation of the B-scan P061 and location in the field.
