Microstructure of 09G2S Steel Near a Fatigue Crack Healed by Pulsed Current

[Ilya S. Sugonyako](#) , Danila V. Tarov , [Elena A. Korznikova](#) , [Gulnara R. Khalikova](#) , [Alexander S. Semenov](#) * ,
Konstantin V. Kukudzhanov , [Sergey V. Dmitriev](#) *

Keywords: electric pulse treatment; fatigue crack; crack healing; melting zone; heat-affected zone; microstructure; lamellar martensite; microhardness

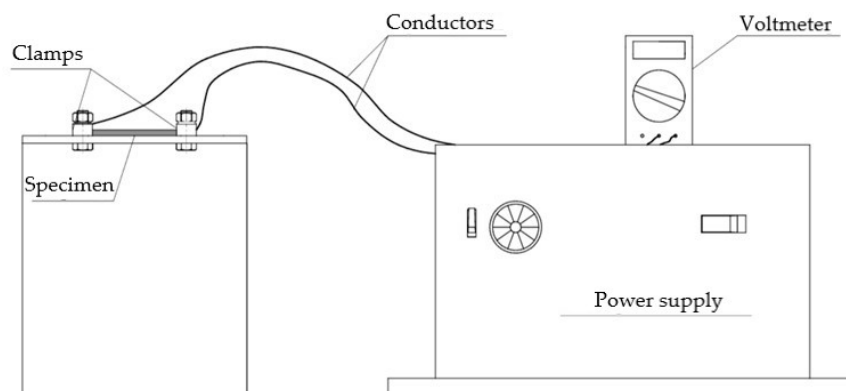
Then, in order to conduct pulsed current treatment, the cracked specimen was fixed with copper clamps, which were connected to the experimental setup. The connection diagram for the specimen to the setup is shown in Figure 1. The electrical circuit of the experimental setup is presented in [34,35].

Figure 1. Scheme of connecting the sample to the experimental setup.

The capacitor capacitance was 25 mF, the current pulse duration was 10^{-4} s, and complete healing of the crack was achieved in six current pulses. For the first three pulses, the voltage across the capacitor battery was 200 V and the current density was 10^4 A/mm²; for the subsequent three, the voltage was 250 V and the current density was 1.25×10^4 A/mm², respectively.

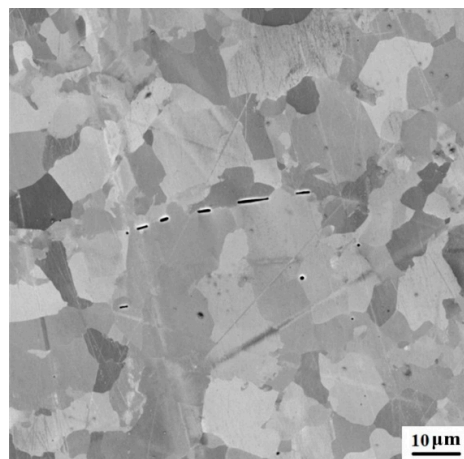
Figure 2 shows the microstructure of 09G2S steel in its initial state. It consists of recrystallized ferrite grains and elongated cementite (Fe_3C) inclusions arranged in directed chains within the ferrite matrix.

Figure 2. Microstructure of 09G2S steel in its initial state in BSE mode.

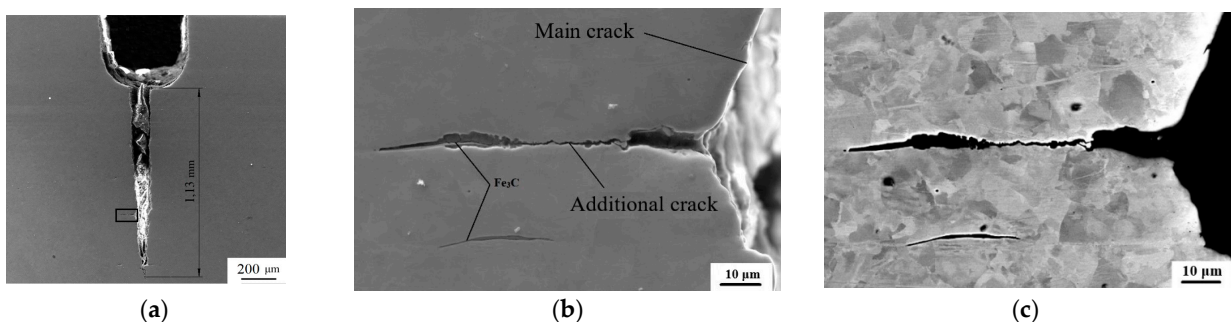
Figure 3 shows a wedge-shaped main crack approximately 1.13 mm long grown during fatigue testing, along with a section containing an elongated Fe_3C inclusion near the main fatigue crack. The structure near the crack also consists of a ferrite matrix with cementite inclusions. Figure 3b,c show that an additional crack perpendicular to the main crack formed near it, containing a carbide inclusion at its apex. The formation of this additional crack is due to the fact that carbides act as stress concentrators under cyclic loads and, therefore, can act as nucleation sites for fatigue cracks.

Figure 3. Structure after fatigue test: a – SEM image of a main fatigue crack, b – SEM image of a section with carbide near a crack in SE mode, c – SEM image of a section with carbide near a crack in BSE mode. In (a) the rectangle area presented in (b) and (c) is shown.

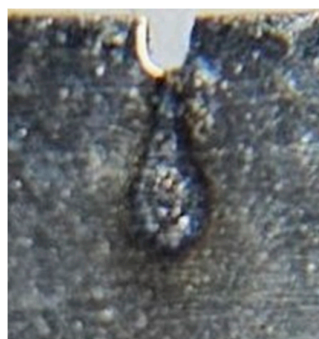
As mentioned above, EPT with six current pulses resulted in complete healing of the main crack. Figure 4 shows a specimen with a healed crack after six current pulses.

Figure 4. Optical image of the crack healed by six current pulses.

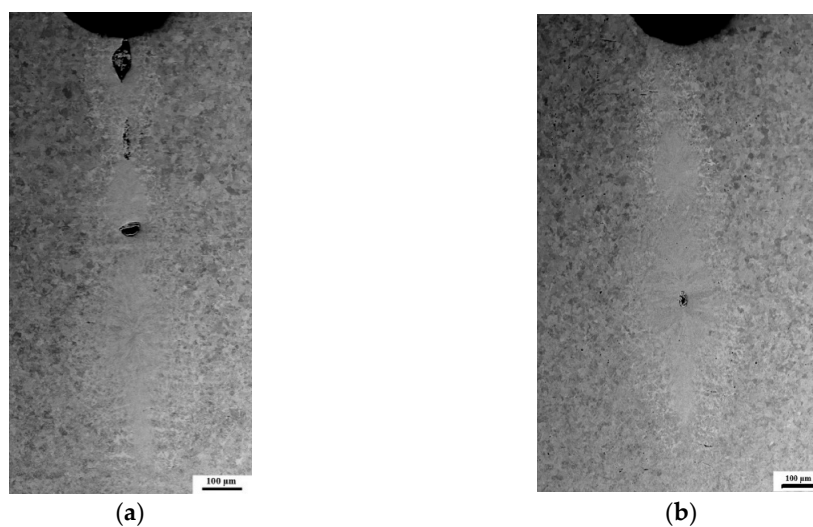
Figure 5 shows the macrostructure of a fatigue crack after healing with pulsed current at depths of 0.1 mm and 0.5 mm from the surface. In both cases, three zones can be distinguished in the specimen structure: the melting zone (MZ), located around the healed fatigue crack; the heat-affected zone (HAZ), located between the MZ and the base metal zone (BMZ). The structure of the three zones in the specimen after pulsed current treatment is shown in Figure 6 at larger magnification.

It is evident that the HAZ is characterized by a distinct grain orientation from the edge of this zone toward the center. Equiaxed grains of varying contrast were observed in the HAZ. At a depth of 0.1 mm, a defect was observed at the crack base, an incompletely healed section of the crack, and an impurity accumulation center at the midpoint of the HAZ height. At a depth of 0.5 mm from the surface, in the central part of the widest region of the HAZ, an impurity accumulation center was also observed. The formation of the impurity accumulation center is explained by the fact that, when exposed to a current pulse, current lines concentrated near the crack tips, where Joule heat generation was more intense, leading to localized melting of the material. When the current pulse was interrupted, the metal cooled due to rapid heat transfer from the crack into the metal. The crystallization front moved from the solid metal toward the crack, displacing impurities, which lowered the melting point of the metal. As a result, the last crystallized volumes are characterized by an increased concentration of these impurities.

Figure 5. SEM images of the microstructure after crack healing: (a) – at a depth of 0.1 mm from the surface and (b) – at a depth of 0.5 mm from the surface (the middle plane of the specimen).

Figure 9 shows (a) the microhardness measurement region along the direction perpendicular to the healed crack and (b) the measurement results. The center of the impurity cluster shown in Figure 5b was used as the reference point (0 mm). Microhardness was measured along the line shown in Figure 9a. The increased microhardness of the HAZ is explained not only by the presence of impurities but also by its structure, since martensite has increased hardness due to lattice distortion, increased dislocation density, and high internal stresses. The microhardness of the HAZ was higher than that of the original material but lower than that of the MZ.

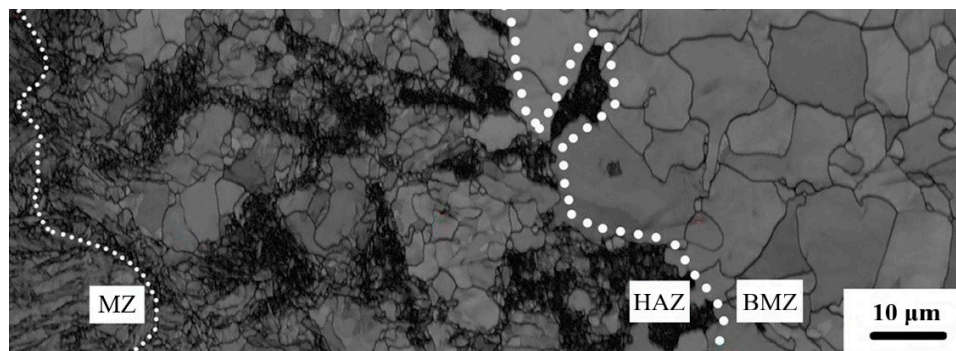
Figure 6. Three zones in the sample after pulsed current treatment: MZ – melting zone, HAZ – heat-affected zone, BMZ – base metal zone.

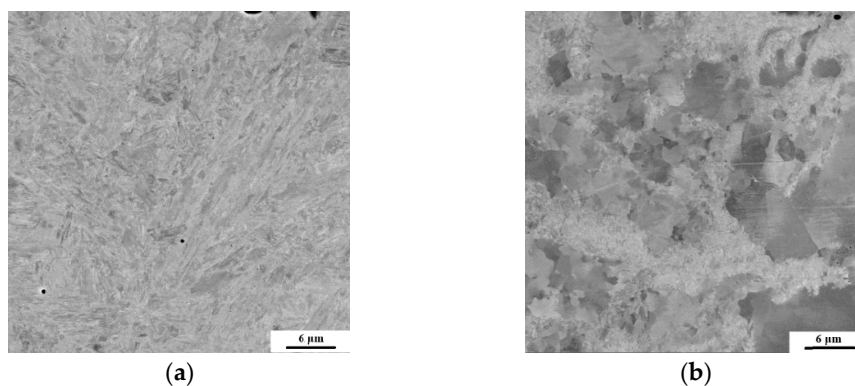
Figure 7 shows SEM images of the MZ and HAZ microstructure in BSE mode. Crack healing occurred in six stages, from the crack tip to its root. Each current pulse promoted melting of the metal

at the crack edges, filling the crack volume, and subsequent melt crystallization. The high cooling rate, caused by localized high-temperature heating of the material in a small volume and rapid heat transfer into the sample, led to significant supercooling of the crystallizing melt and the formation of elongated (in the direction of heat transfer) austenite grains. As a result of rapid cooling to a temperature below the martensitic transformation temperature upon interruption of the current pulse, quenching occurred in these grains, with a $\gamma \rightarrow \alpha$ phase transformation of austenite into lamellar martensite via a shear mechanism.

Figure 7. SEM-images in BSE mode of: (a) – melting zone (MZ), (b) - heat-affected zone (HAZ).

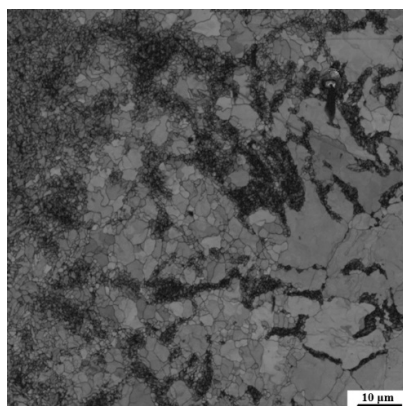
A heterogeneous structure was observed in the HAZ, consisting of areas with smaller equiaxed ferrite grains compared to the original material and areas with a strong contrast with even smaller ferrite grain sizes, as can be seen from the EBSD analysis results in Figure 8. The formation of equiaxed grains is explained by the fact that the grains were subjected to non-uniform deformation as a result of fatigue testing and subsequent heating due to heat release under the influence of pulsed current. Primary recrystallization occurred in the deformed grains of the ferrite matrix as a result of heating, and nuclei of new grains were formed in areas with an increased dislocation density, where the largest lattice distortions are concentrated. Their further growth led to the formation of a structure with small equiaxed grains. The heterogeneity of the deformed microstructure resulted not only in a non-uniform distribution of recrystallization nuclei but also in a non-uniformity of the stored energy responsible for grain growth. Microstructure regions with increased stored energy recrystallized first. The rate of grain growth decreases with time and is proportional to the driving force. Even if nucleation is relatively uniform, grain growth proceeds more rapidly in grains with higher stored energy. In this case, not only does the growth rate decrease with the progression of recrystallization, but grain growth is also limited by the collisions of adjacent growing grains within the original grains. Therefore, as a result of primary recrystallization, both small and large ferrite grains were observed in the microstructure. Elongated cementite inclusions were also present in some areas.

Figure 8. Heat-affected zone in Band Contrast mode.

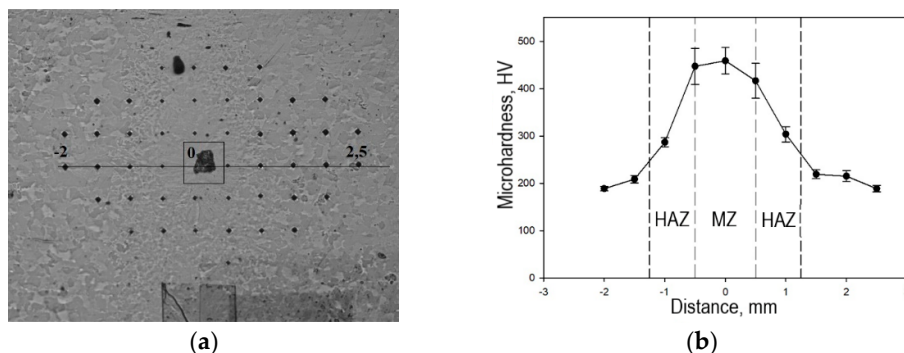
Figure 9. Measurement of the microhardness of the sample after healing of the crack: (a) – map of the points at which measurements were taken, (b) – distribution of microhardness along the direction normal to the healed crack.
