# In-Situ Alteration of the Hydro-Mechanical Behaviour of a Compacted Stabilised Expansive Soil

Keywords: soil stabilization; durability; expansive soils; compressibility; shrinkage

The embankment is 5 m high with a slope of 1:2, and its width is 25 m at the base and 5 m at the top [39]. The embankment was constructed with the clayey soil presented in Section 2.1 and was divided into 3 contiguous sections (Figure 1). For each section, the lower part (from 0.40 to 2.50 m of height) and the upper part (from 2.50 to 3.70 m of height) were built with different treatment mixes (Table 2). The base (from 0 to 0.40 m of height) and the top (from 3.70 to 5.15 m of height) of the embankment were not considered in this study.

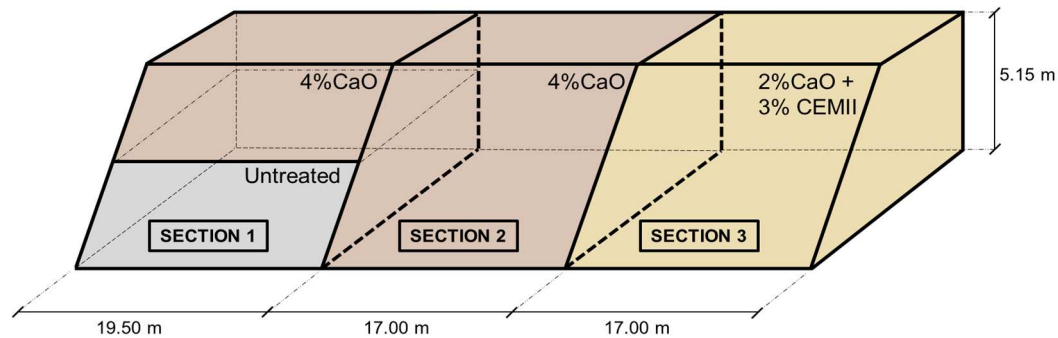
**Figure 1.** Structure of the studied embankment.

The sampling campaign was carried out in November 2021. Figure 1 presents the different zones sampled during the operation. Horizontal coring was carried out in the upper part of the three sections, approximately 1.80 m above the natural ground level. Vertical coring was also performed in the three sections from the top of the embankment to sample the lower part of the embankment. Rotational coring with water as the drilling fluid was chosen in order to ensure the quality of the samples. A mean recovery rate of 97% was achieved for the cores.

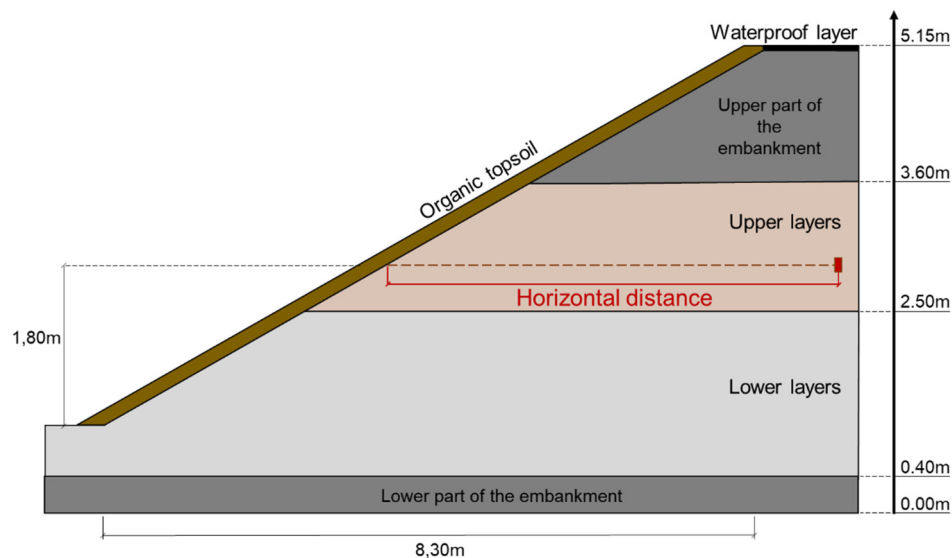
**Figure 2.** Core drilled zone in the upper and lower part of the embankment.

Identification tests were first carried out along the horizontal axis (Figure 2) to assess the state of the embankment at the time of sampling. Figure 3a, 3b and 3c respectively correspond to the moisture content and dry density evolution along the horizontal cores for section 1 treated with 4% lime, section 2 treated with 4% lime, and section 3 treated with 2% lime and 3% cement. For section 1, the mean moisture content was 36.1% (Figure 3). The average dry density was found to be 1.266 mg/m<sup>3</sup>. In section 2, the average dry density was also 1.266 mg/m<sup>3</sup>, while the average moisture content was 37.5%. The mean value of the moisture content in the section was 33.4%, while the average dry density was 1.284 mg/m<sup>3</sup>. The densities and moisture contents found in section 3 were slightly different from those in the other sections, as the optimum moisture content depends on the treatment dosage. For all sections, the lowest water content values were found close to the edge of the backfill.

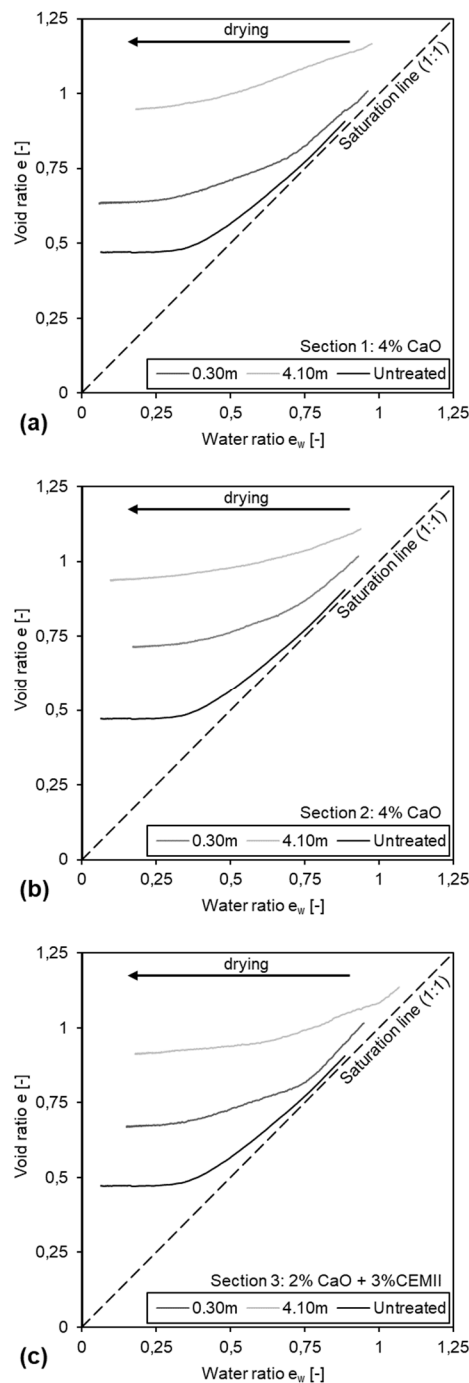
The shrinkage curves of all samples are displayed in Figure 6 in the plot of void ratio  $e$  against water ratio  $e_w$  (water volume over solid volume). For each section, three results are presented: one obtained on a reference specimen from the untreated part of the embankment, one specimen from

the edge of the embankment (0.30 m of horizontal distance), and one specimen from the inner part of the embankment (4.10 m of horizontal distance). The shrinkage potential values  $P_{SH}$  and the shrinkage limits  $e_{w,SL}$  were evaluated for each test and are presented in Table 1.

**Figure 6.** Shrinkage curves of specimens from the edge and from the inner part of the embankment, and compared to the shrinkage of the untreated sample.

The shrinkage curve of the untreated material started at a low void index of 0.87, in accordance with the targeted void index given in Table 3. Along the drying path, the shrinkage limit  $e_{w,SL}$  was reached at 0.35, corresponding to the end of the volume variation. Final volumetric shrinkage was assessed when the moisture content of the soil stabilised at a value of 22.8%.

The shrinkage curve of the clayey soil taken from section 1 is displayed in Figure 6a, where it can be seen that the shrinkage behaviour of the samples differed significantly as a function of the

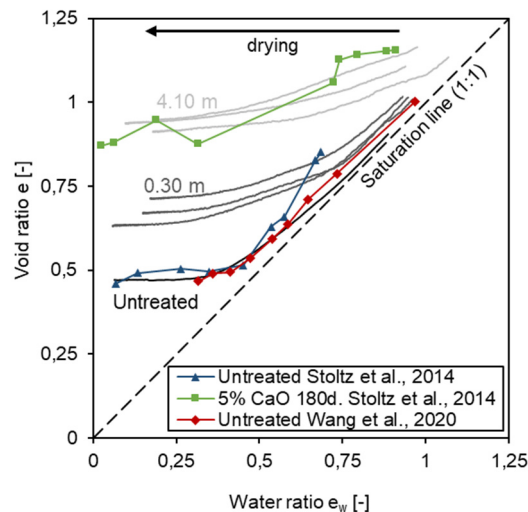
**Figure 7.** Shrinkage curves from the edge and the inner part of all three sections and compared to shrinkage curves obtained in the laboratory by Stoltz et al. (2014) [46] and by Wang et al. (2020) [7].
