Strengthening Earth-Fill Embankments with Waste Tyre Reinforcement for Improved Flood Resilience

Nuha Chowdhury, Ioanna Stamataki and Panos Kloukinas *

School of Engineering, University of Greenwich, ME4 4TB, Chatham Maritime, Kent, UK

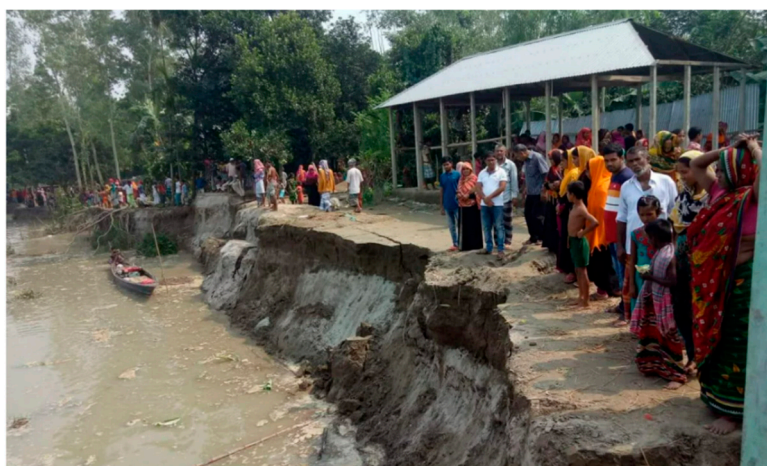
Figure 1. Flood defence system collapsed a year after construction in Bangladesh, Sirajganj (Image from DhakaTribune [6]).

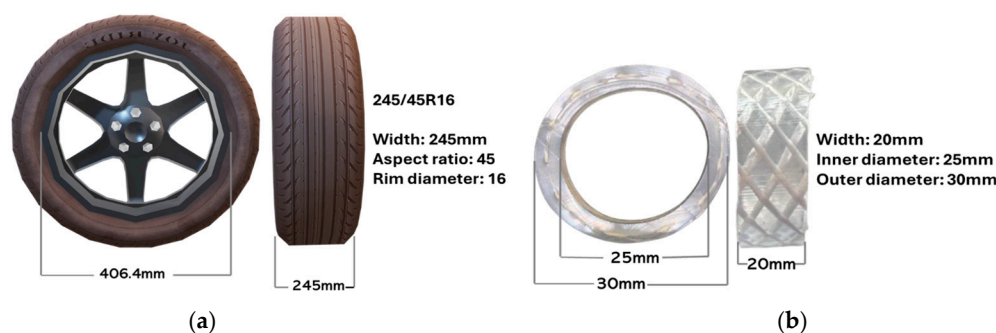
Figure 4. (a) Dimensions of the prototype tyre (Image and dimensions from Tire Size Calculator [40]); (b) the PVC hose model tyre.

Clear PVC hose with synthetic material was used to represent the tyres in the model. The experiment was scaled to a 1:50 ratio using a Froude scaling, enabling accurate representation of the reinforcement and its potential behaviour under real-life conditions as shown in Figure 4. Furthermore, the flow rate was also proportionally scaled to replicate the peak flow conditions of a flash flood event.

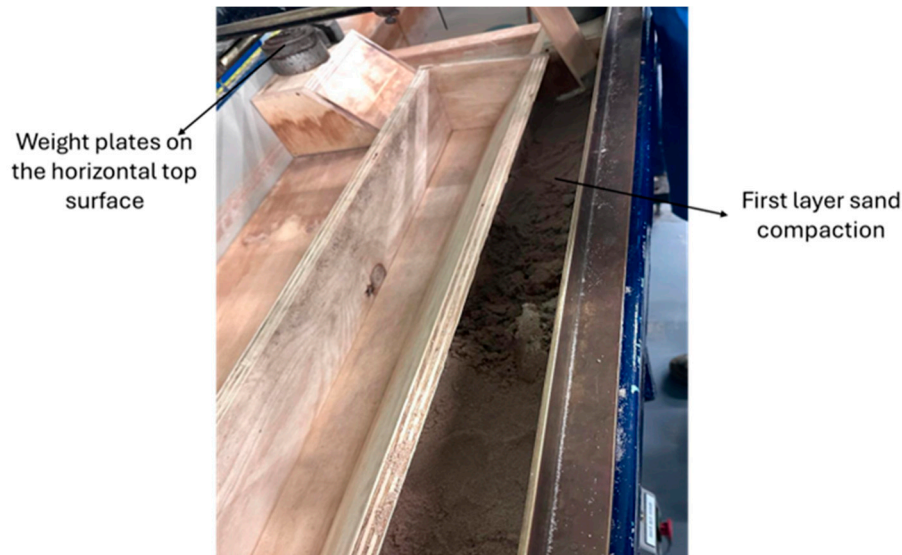
Figure 5. Compaction process of the sand during the construction of non-reinforced embankment.

The first step in the experimental procedure involved the preparation of the physical model. The wooden model form was placed into the sand flume apparatus, and weights were added to the horizontal top layers of the model to prevent it from floating, ensuring stability during the experiment. For the construction of the non-reinforced embankments (Tests 1-4), the sand was compacted in layers of 2cm thickness until it reached the horizontal top surface of the embankment ensuring uniform compaction throughout (Figure 5). A wooden shaper was then used to finalise the shape of the embankment (Figure 6). The sand material was wet and partially saturated during the compaction, in order to exhibit a “pseudo-cohesive” behaviour, due to negative pore water pressures and pre-consolidation [42]. In that way, a sand material can be used in the context of this experiment to simulate a natural slope with apparent cohesion.

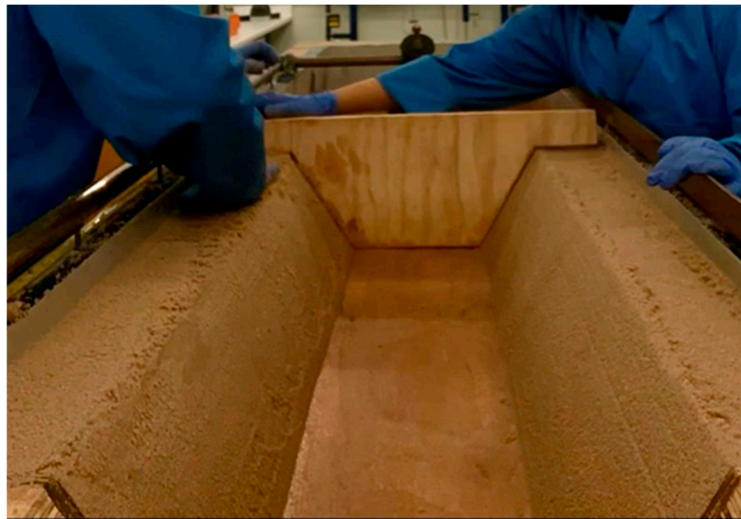
Figure 6. Application of the wooden shaper to finalise the shape of the embankment.

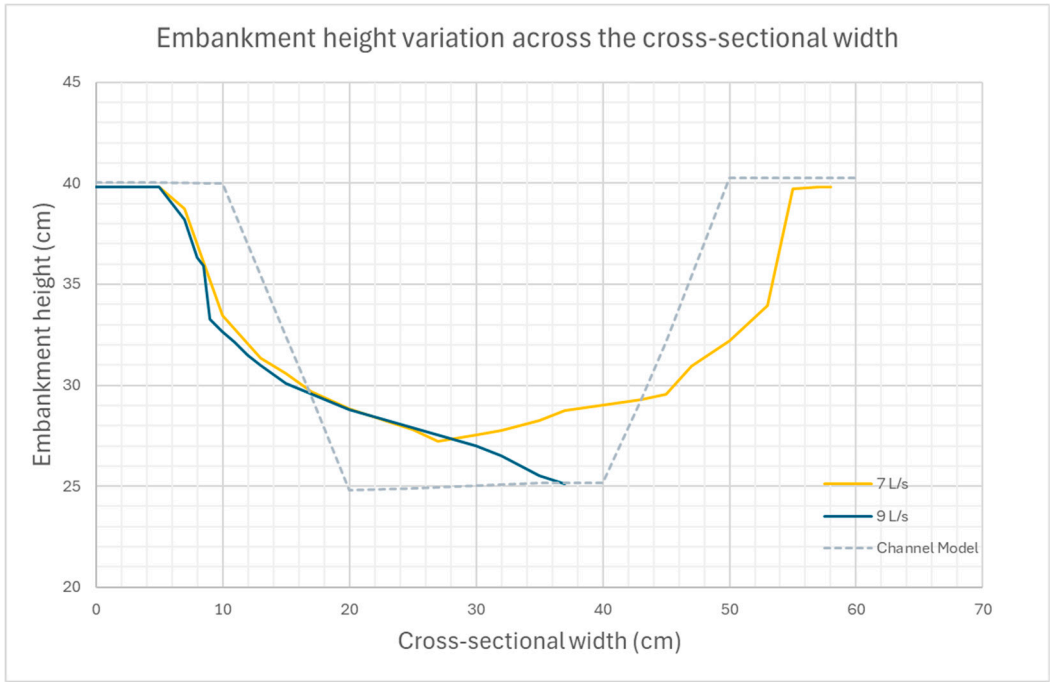
Figure 10. Average cross-sectional variation of the collapsed embankment for 9 L/s and 7 L/s.

Figure 10 displays the average cross-sectional embankment height obtained for flow rates of 7 L/s and 9 L/s. The graph's left side illustrates that the embankment slope for 9 L/s is slightly less steep

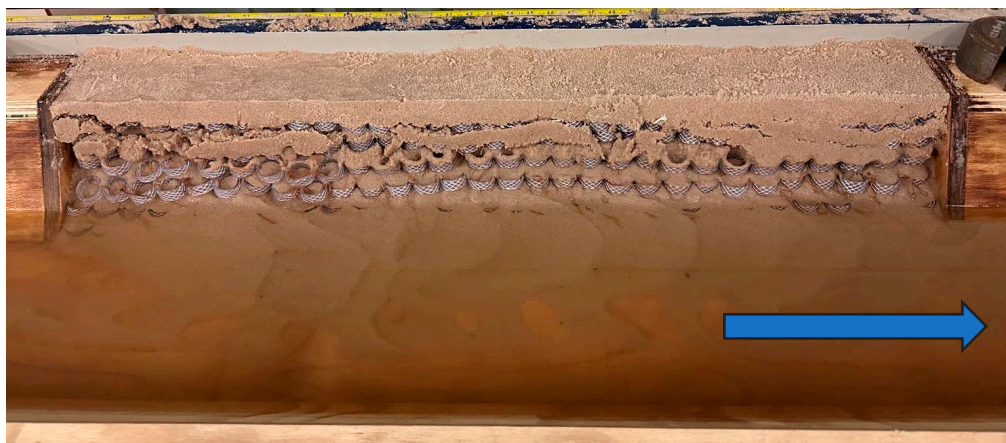
Figure 12. Collapsed reinforced embankment at 7L/s; the arrow represents the direction of the flow.

Figures 11 and 12 show the performance of the reinforced embankment after a three-minute test under flow rates of 9 L/s and 7 L/s respectively.

Figure 11 illustrates that by the test's completion, minor tensile cracks were visible on the upper surface of the embankment for 9 L/s, as only the sand on the slope surface was transferred during the test, but the under digging did not progress further inwards. Similarly, Figure 12 shows tensile cracks and soil particle flow throughout the length of the embankment's slope only on the slope surface, but the top flat surface of the embankment was not affected. This suggests that reinforcement enhanced the slope stability, by effectively slowing down the erosion process and retaining soil particles and interrupting their downslope motion and prevent severe under-digging.

From Figure 11, it can be observed that the erosion of the sand on the slope face has exposed the tyre geocells, which have also shifted from their original position. However, for 7 L/s, the effect was reduced as seen in Figure 12. Overall it can be noted that the reinforcements are efficient in holding sediments eroded from above and prevent complete collapse of the slope, and also that the reinforcement grids remain overall in place despite the damage patterns on the surface, as the buried part under the intact area of the slope provides sufficient anchorage. Figure 13a shows that there is the degree of erosion on the slope surface and the material deposition in the river bed is increased for the higher flow rate of 9 L/s compared to the 7L/s in Figure 13b, but in both cases the damage is limited on the slope surface and has not moved much deeper in the embankment.

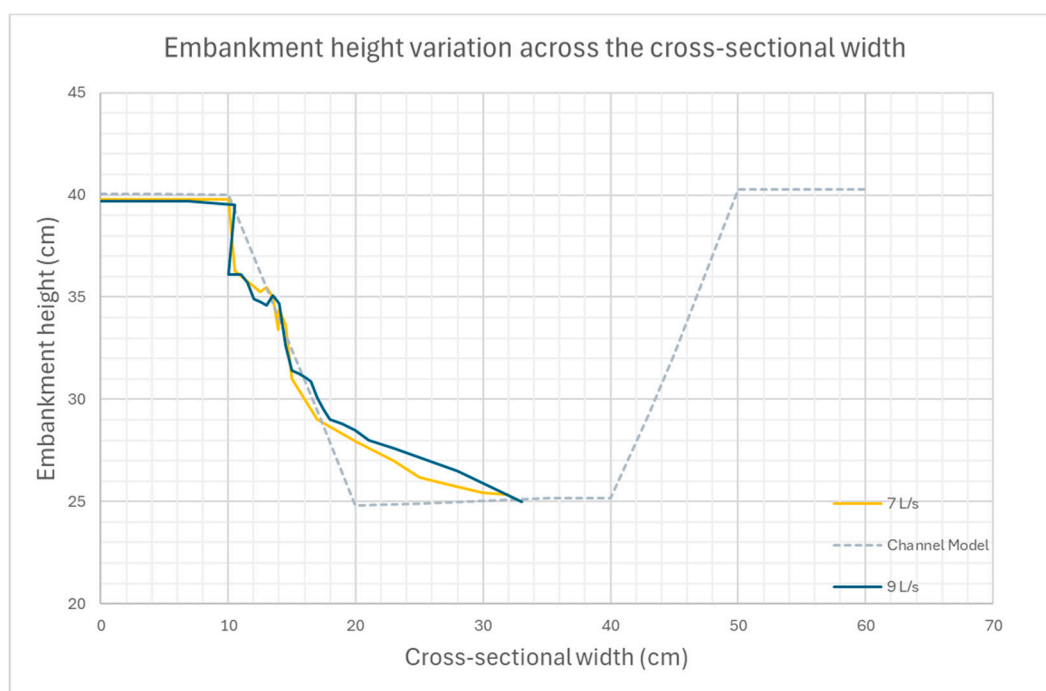
Figure 14 displays the plotted cross-sectional results obtained from the embankment's length for a flow rate of 7 L/s and 9 L/s. The plot clearly demonstrates that for 9 L/s, a higher amount of sediment was deposited at the bed of the channel compared to the 7 L/s, hence, illustrating higher erosion. The volume of eroded sediments was derived from the plots to allow quantitative comparison. The analysis shows that for a flow of 9L/s, $2.8 \times 10^3 \text{ cm}^3$ of sediments were deposited on the bank after the end of the test time, whereas for 7 L/s, $1.8 \times 10^3 \text{ cm}^3$ were deposited. Furthermore, this also reveals that 12.4% of the sand volume was removed from the embankment's total volume (volume of reinforcement and sand) for 9 L/s. Whereas, for 7 L/s, 8.0% was removed. Therefore, confirming even with reinforcements present, higher flow leads to higher erosion.

Figure 14. Cross-sectional variation of the collapsed reinforced embankment for 9 L/s and 7 L/s.

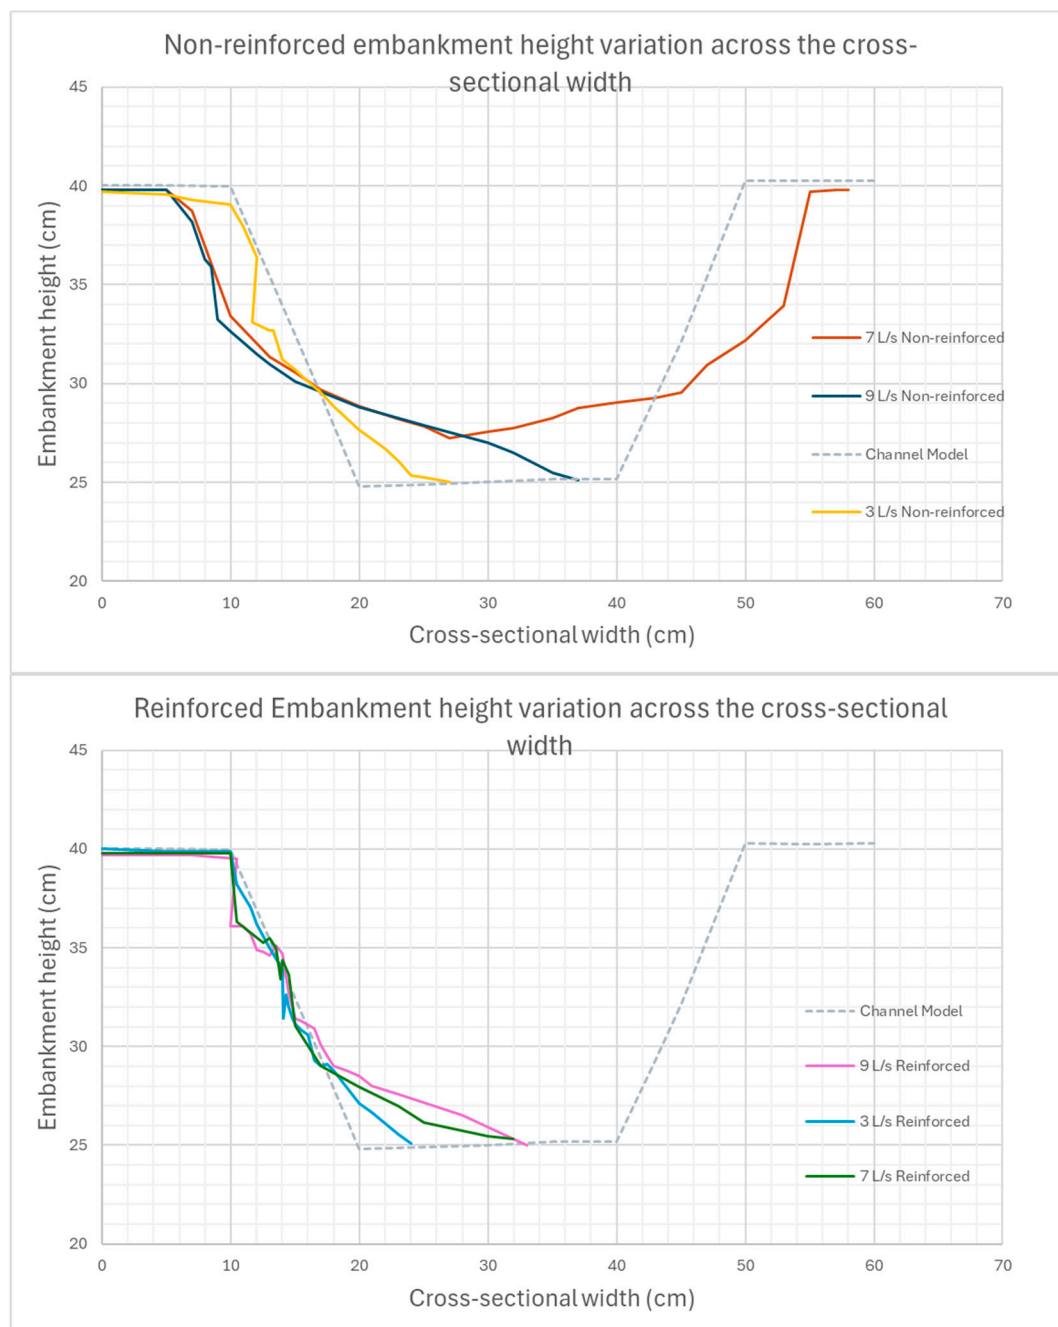
Figure 15. Cross-sectional variation of the collapsed embankment for the steady flow simulations for non-reinforced and reinforced scenarios.

Figure 15 illustrates the cross-sectional variation for 9 L/s, 7 L/s and 3 L/s of the collapsed embankment under both non-reinforced and reinforced scenarios. Analysing the graph further, it indicates that the incorporation of reinforcements contributed to a clear reduction in embankment erosion under all cases.

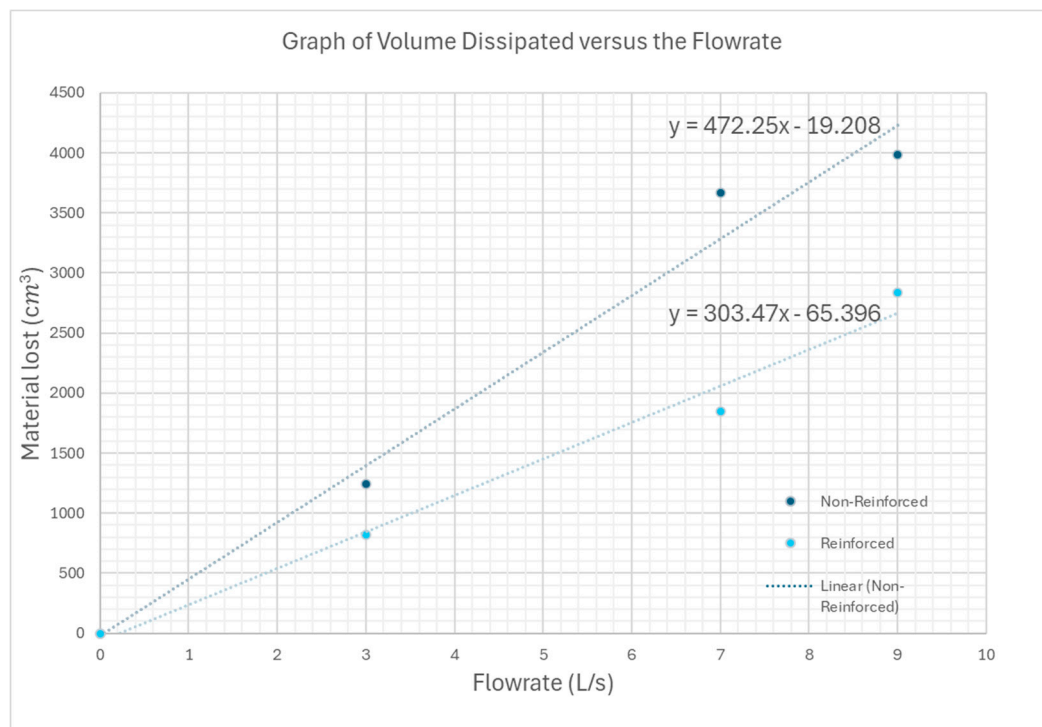
Figure 16. Graph illustrating the dissipated volume estimated as the flow rate increases.

In order to quantify the effect of the reinforcement on the reduction of material loss, the measured volumes of sediments deposited into the river are plotted in Figure 16 against the flow discharge. The data points reveal first that the volume dissipated increases proportionally with discharge, which is naturally expected. Looking at the specific flow rates, reinforcing the embankment significantly decreased erosion by 34.5% at 3L/s, 51.2% at 7L/s, and 28.3% at 9L/s. It must be noted that the calculated volume loss for the 7L/s run on the unreinforced slope, might be overestimated, due to modelling of both banks of the river, as explained earlier. Nevertheless, the important finding is that the trendline for the non-reinforced scenario is around 50% steeper than the trendline of the reinforced one. Even if the case of the 7L/s is disregarded, the reduction will still be within 30% and 50%. Moreover, it must be noted that this calculation is still not the complete picture; the cycle of scouring, collapse erosion in the case of an unprotected slope, can be triggered again as sediment transfer can remove material and scour the base again, resulting in retreating riverbanks. In the case of reinforced slopes, the prevention of a complete collapse, allows us to assume that further erosion and retreating riverbanks phenomena can be avoided, provided that adequate maintenance will follow after every severe flooding and damage event.

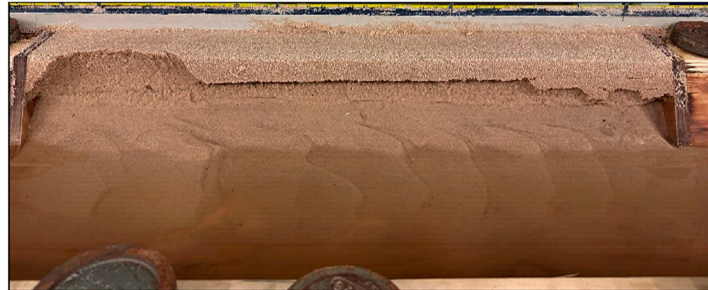
Figure A1. Photos of the collapsed unreinforced embankment at 5L/s.

Figures A1 and A2 show the collapsed sand embankment for a flow rate of 5L/s and 3L/s respectively after a period of 3 minutes (Tests 3-4).

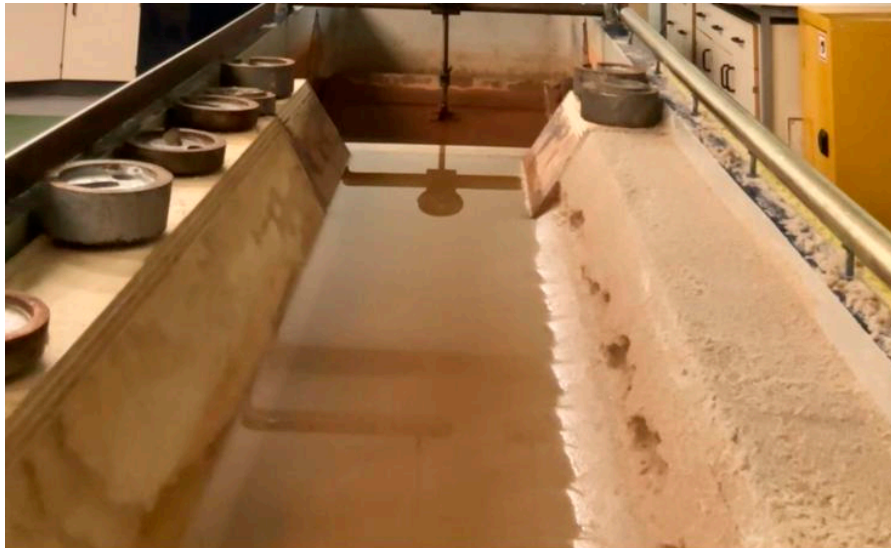
Figure A2. Photos of the collapsed embankment at 3L/s.

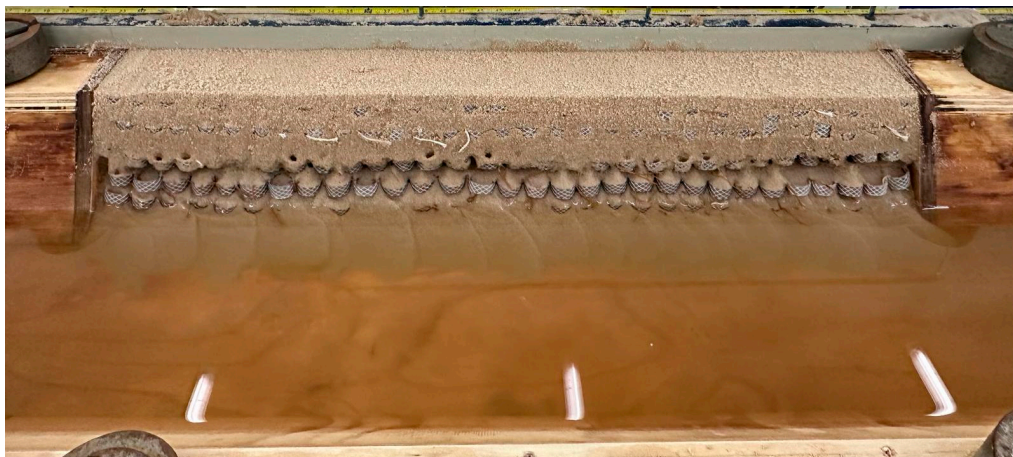
Figure A4. Photos of the reinforced collapsed reinforced embankment at 3L/s.

Figure A4 shows pictures of the collapsed embankment with reinforcement for a flow rate of 3 L/s (Test 8).
