# In Comparison of In-Service Surface Defects and Prefabricated Notches of High-Speed Train Axles

Keywords: high-speed train axles; prefabricated surface notches; circumferential V-shaped notches; fatigue characteristics; stress concentration factor (SCF); fatigue testing

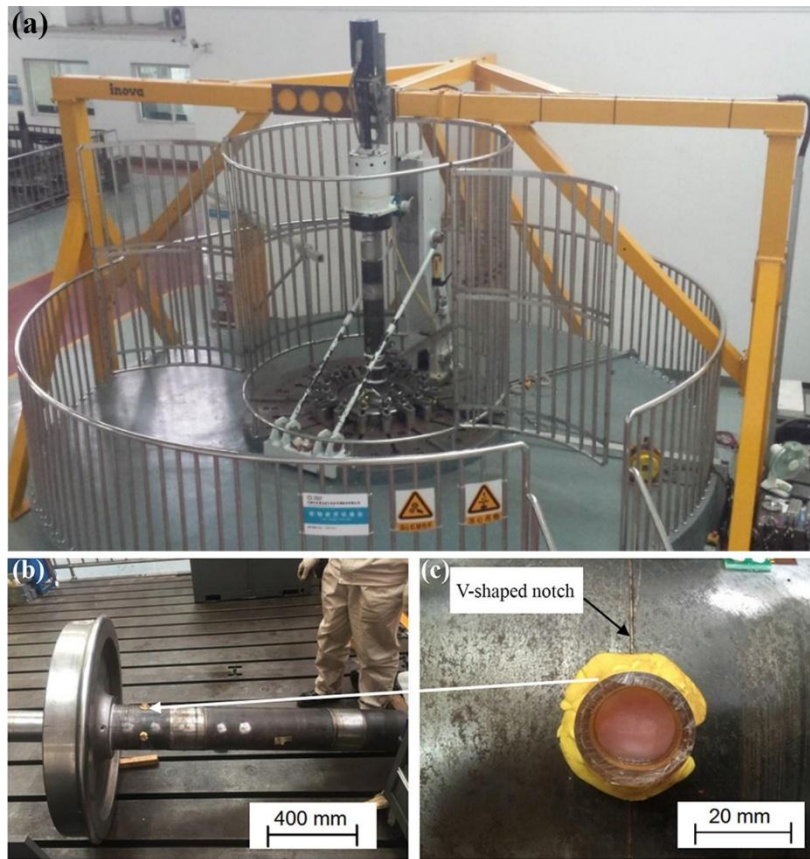
**Figure 3.** Fatigue test setup and prefabrication of surface notches: (a) the test bench equipped with an experimental high-speed train axle, (b) V-shaped notch on the testing axle, (c) replica sampling of the notch.

The axle fatigue tests were conducted on the wheel-axle test bench as shown in [Figure 3a](#). The tests were carried out at a loading frequency of 19.8 Hz, with a stress ratio of  $R = -1$ , and the total number of loading cycles was set to no less than  $2 \times 10^7$  cycles. After each  $10^7$ -cycle interval, magnetic particle inspection was performed to examine whether cracks had initiated at the artificially introduced notch on the axle body. Since the JIS E4501-1995 standard does not specify the fatigue limit or testing method for actual axles, the maximum load in the present fatigue experiments was determined according to the EN 13261 standard, setting the maximum applied stress at 240 MPa.

Based on the observed data of impact and fretting damage on axle surfaces, as well as the fatigue test results which investigated actual axles with circumferential V-shaped notches and the fatigue strength tests of notched three-point bending specimens directly extracted from the axle surface material, two actual axles were selected for testing (Axle Nos.: H31-6201 and H82-6217). The following circumferential V-shaped notches were designed and introduced on these axles: distance from the notch to the wheel seat 130 mm, notch angle  $\alpha = 90^\circ$ , notch depth  $t = 0.6$  mm, notch tip radius of curvature  $\rho = 0.4$  mm, stress concentration factor  $k_{t0} = 2.49$ . Based on the measured stress at the patch locations on cross-sections of the axles, and elastic beam theory, the maximum nominal bending stress at the V-shaped notch is calculated to be 220.2 MPa. The machined notch produced by lathe processing is shown in [Figures 3b–c](#).
